# Building and Pest Report

1/1 Sunrise  
Crescent  
Lennox Head

### Pest And Building Inspection

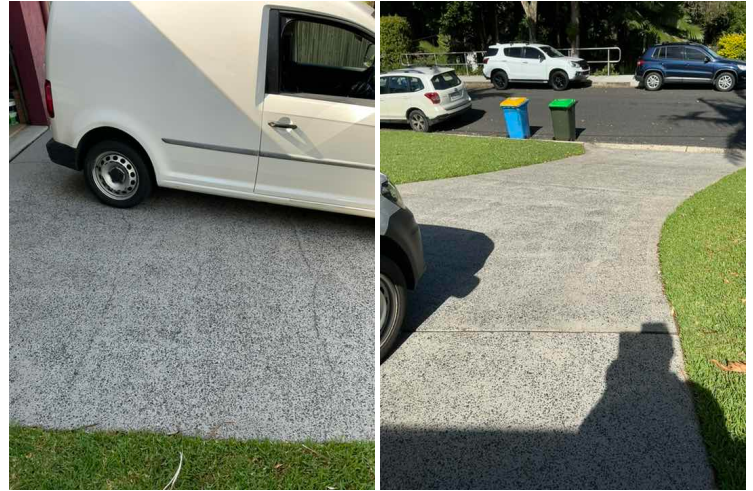
Upon visual inspection, the concrete driveway shows minor surface cracks. Typical for age of building "

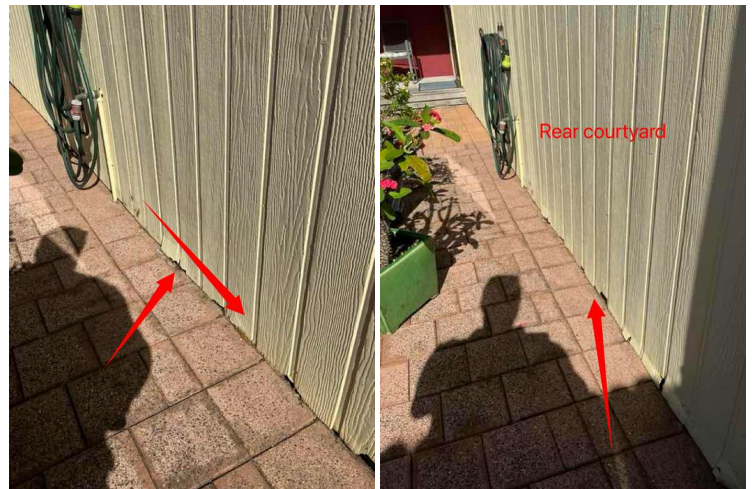
Upon visual inspection, the siding shows signs of warping and separation from the base. This may indicate moisture damage. It is recommended to have a licensed carpenter assess and repair the affected areas to prevent further deterioration. Ensure proper sealing and drainage to avoid future issues.

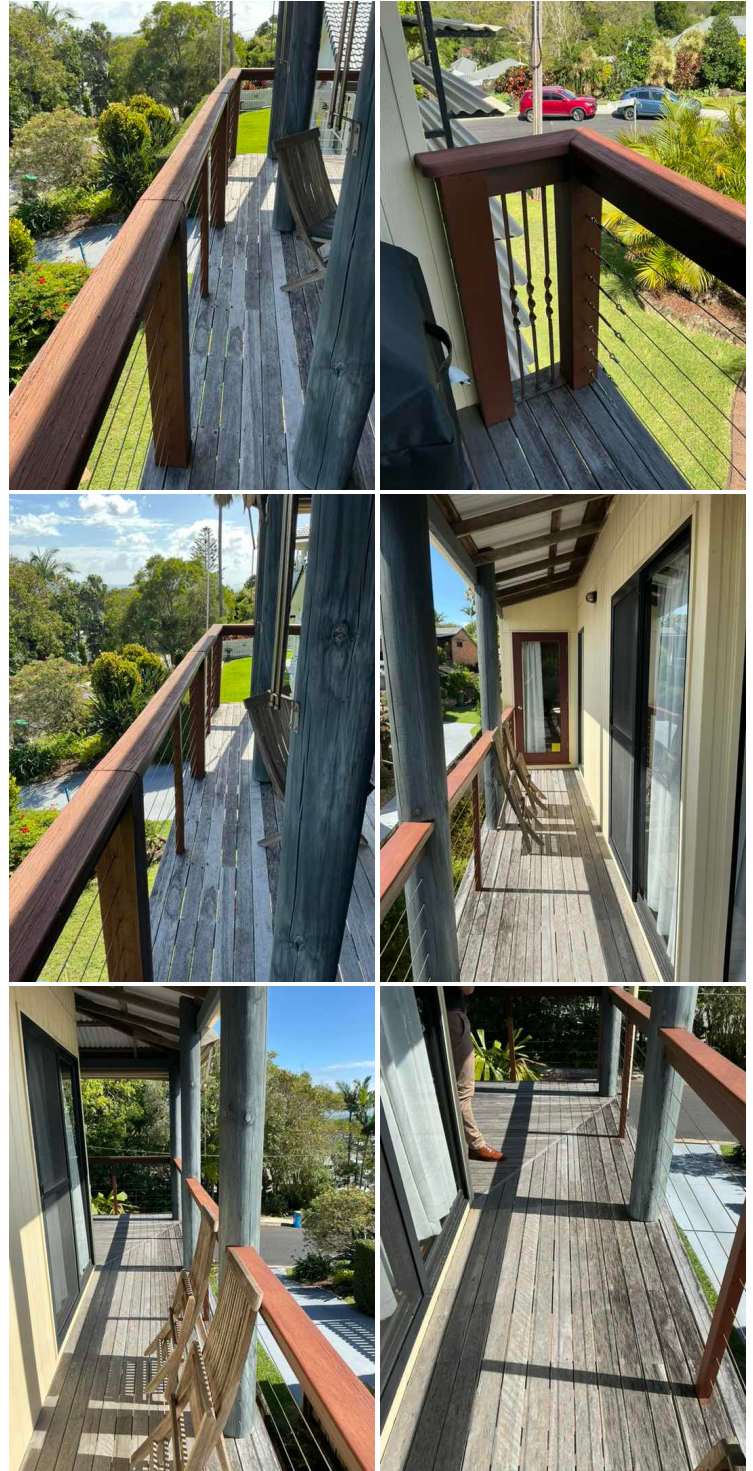
Upon visual inspection, the decking shows signs of weathering and potential wood deterioration. Recommend sanding and sealing the wood to prevent further damage. The railing appears secure, but regular checks are advised to ensure stability. Engage a licensed tradesperson for maintenance and repairs to prolong the deck's lifespan and ensure safety.

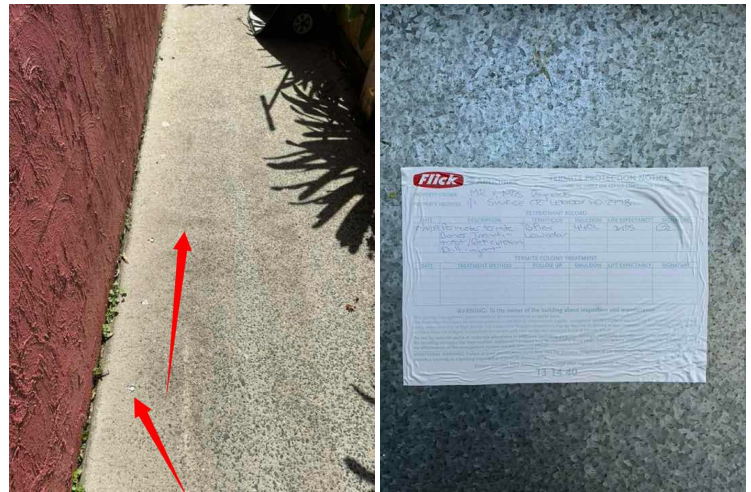
Yes, Drill Holes (Chemical Treatment) were located at the property.

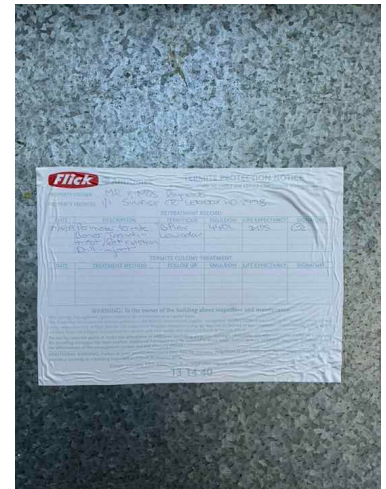
Yes, a durable notice was found in the meter-box during the inspection.

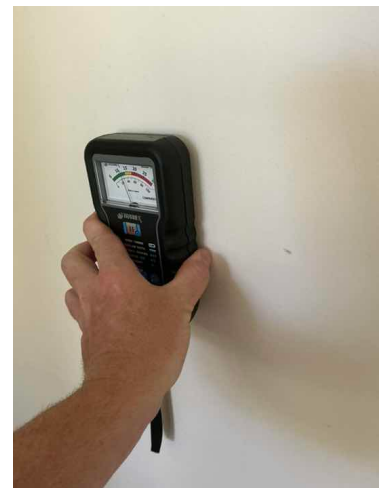
At the time of the inspection, our electronic moisture meter readings were normal.
