# Building and Pest Report

## 1 Lennox Street Lennox Head

### Pest And Building Inspection

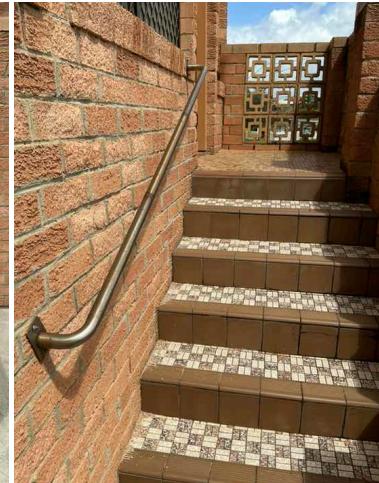
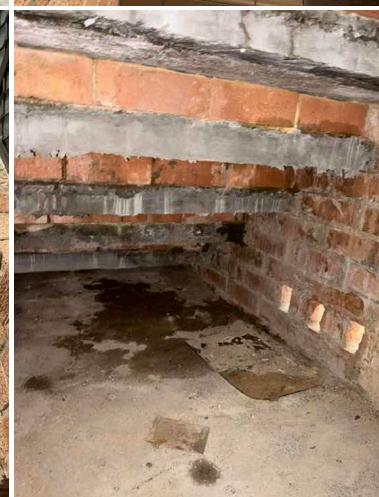
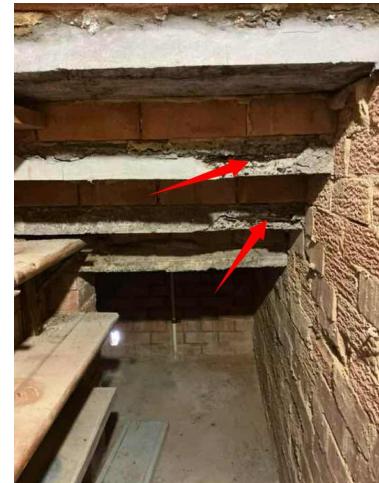
Upon visual inspection, there are signs of structural deterioration in the brickwork and concrete. Cracks and gaps suggest potential instability. Recommend engaging a licensed mason or structural engineer to assess and repair the compromised areas to ensure safety and integrity.

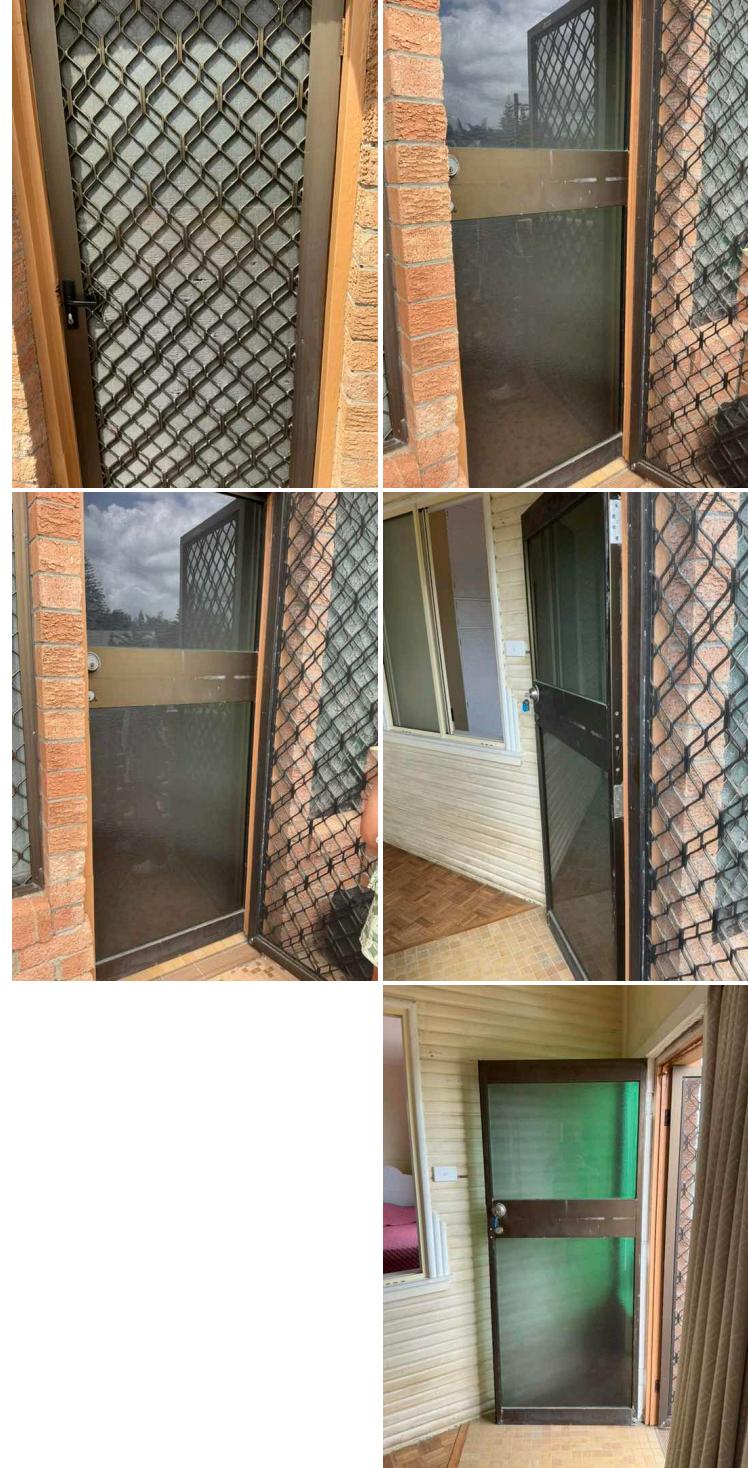
#3. Screen door damage/ageing. A qualified carpenter should be engaged for repairs

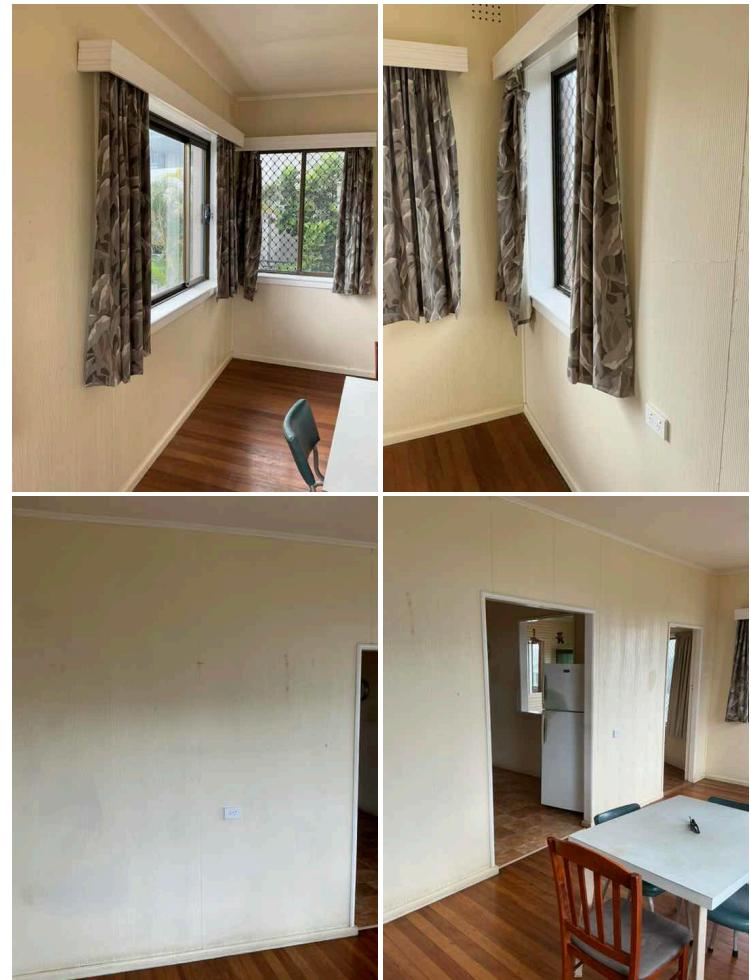
Upon visual inspection, there are visible cracks along the wall joints. It is recommended to engage a licensed plasterer to assess and repair the cracks to prevent further deterioration. Ensure proper sealing and repainting to maintain the wall's integrity and appearance.
