# Building and Pest Report

## 13 Cowrie Street, Lennox Head

# Inspection Report

**13 Cowrie St, Lennox Head, NSW, 2478**

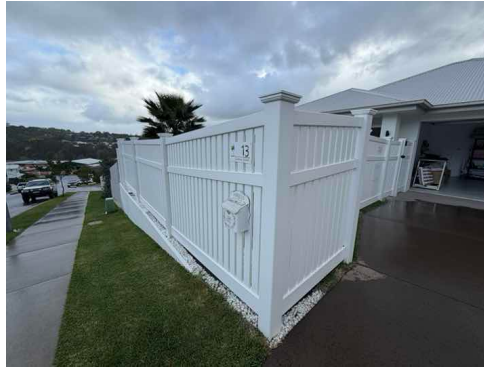
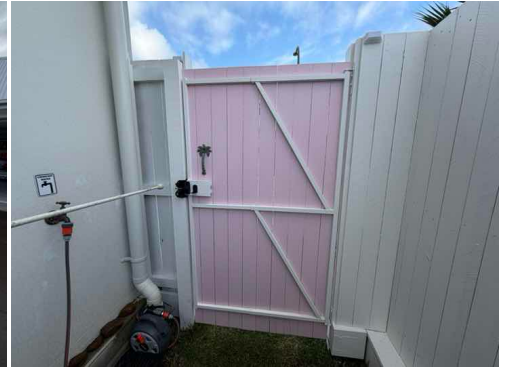
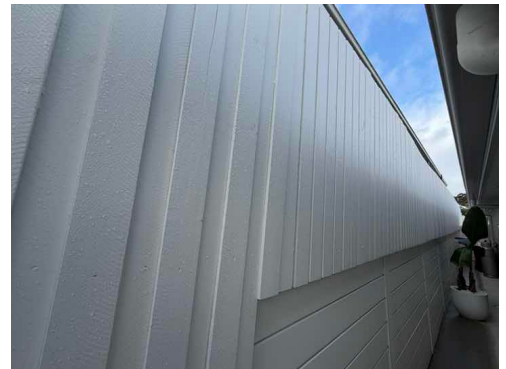
Of the visible areas, the general condition of the fences and gates is serviceable for the age of dwelling. General age/damage/binding of gate/s components -  
 Recommendations: A qualified fencing contractor should be engaged for advice and recommendations.

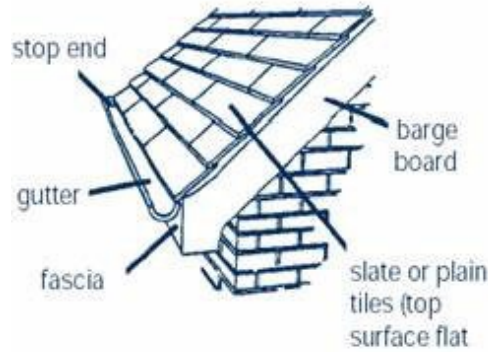
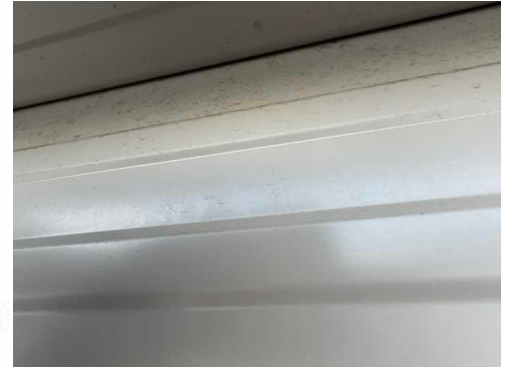
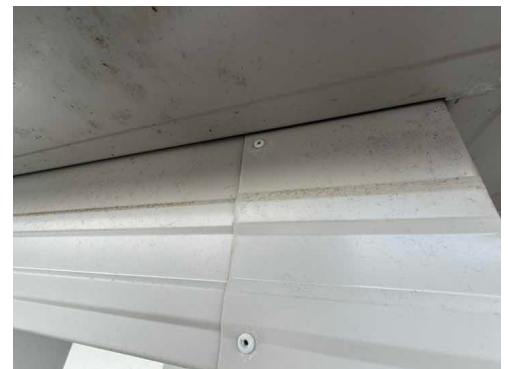
Upon visual inspection, surface rust was observed on metal components. This corrosion may lead to structural weakening if not addressed. It is recommended to clean the affected areas thoroughly and apply a rust-inhibiting primer followed by a protective topcoat. Regular maintenance checks should be scheduled to monitor and prevent further rust development. Consult a licensed tradesperson for proper treatment and repair.

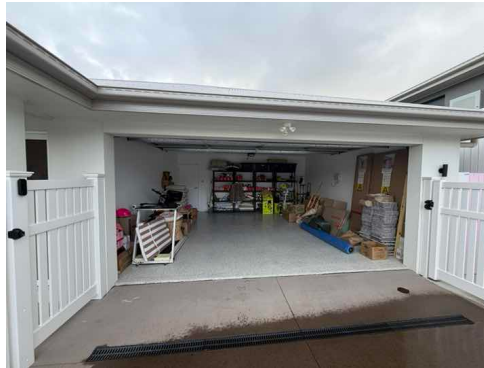
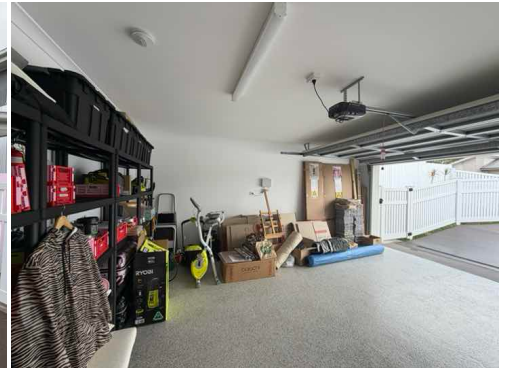
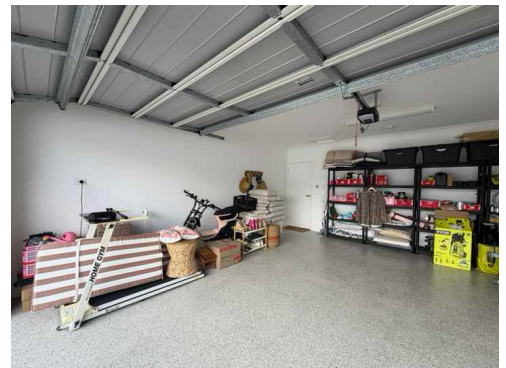
Stored items restricted a full and thorough inspection of this area. Defects may exist in the obstructed and inaccessible areas. It is strongly recommended that full access be granted to enable a thorough inspection as there may be timber pest activity, damage or defects. Note: Where vehicles and storage has restricted a full inspection it is advised that this area be cleared so a full and unobstructed inspection can be carried out.

From the visible and accessible areas, the garage appears to be in a serviceable condition for the age of the property with no notable structural defects sighted.

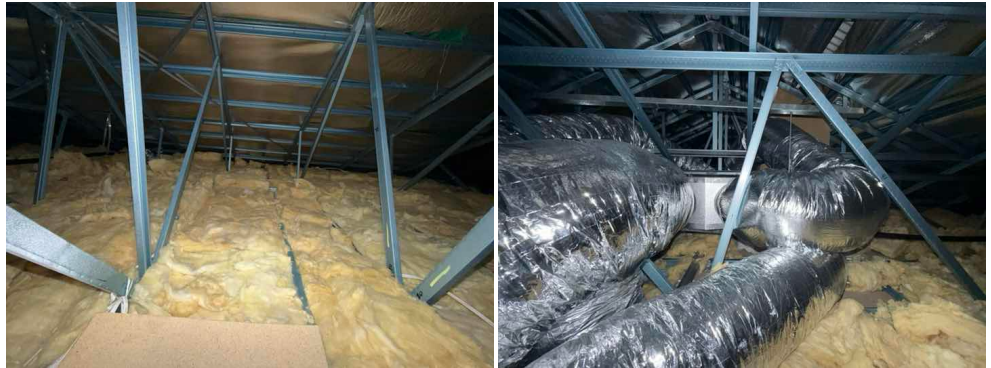
There is heating and/or cooling ducting present in the roof space. This is preventing a full inspection from being undertaken. It is strongly recommended that full access be gained as it could be harbouring timber pest activity, damage or defects.

There is insulation present in the roof space/void. This is preventing a full inspection of ceiling joists from being undertaken. It is strongly recommended that full access be gained as it could be harbouring timber pest activity, damage or defects.

There is sarking present in the roof space/void. This is preventing a full inspection from being undertaken. It is strongly recommended that full access be gained as it could be harbouring timber pest activity, damage or defects.

Visible sections of the roof void is in a serviceable condition for age of this dwelling.
