PEST AND BUILDING PRE-PURCHASE REPORTS

BUILDING & PEST INSPECTIONS

70 Ross Lane

Kinvara

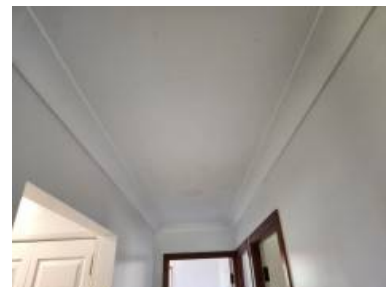
Smoke Detectors / Alarms are **Not Present** - Installation required.

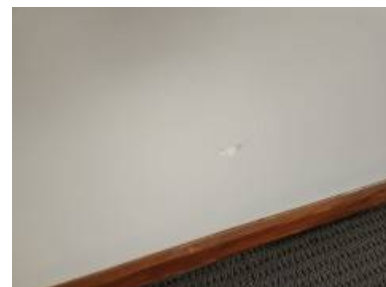
Some minor damage to wall sheeting requires touching up / repair / repainting.

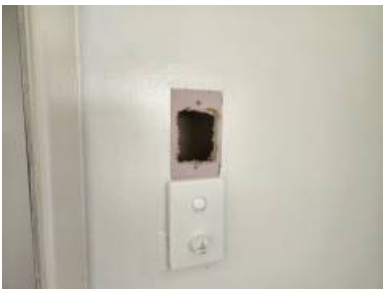
Some minor damage to wall sheeting requires touching up / repair / repainting.

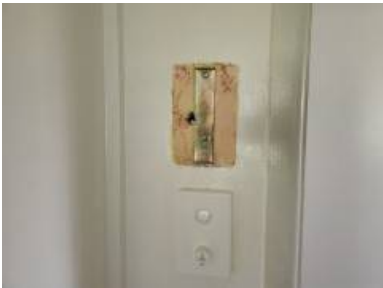
Some paintwork / walls require touching up / repainting.

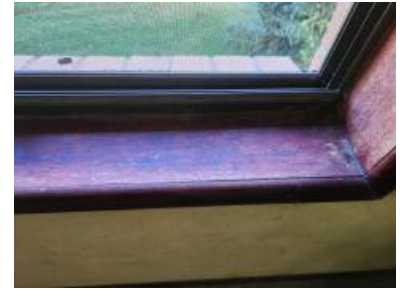
Some window reveals require repainting.

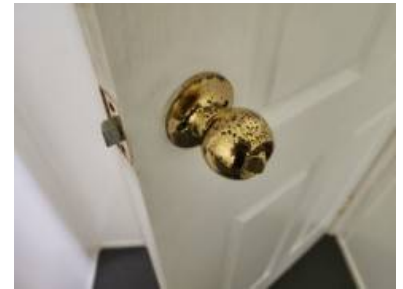
Signs of corrosion to some door handles.

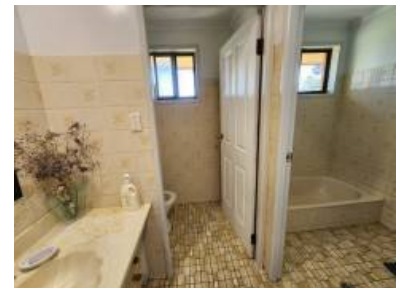
No lift off hinges present to the toilet door. This may comply with the date of construction however, this is a safety issue and therefore was included in this report. We recommend the installation of lift off hinges.

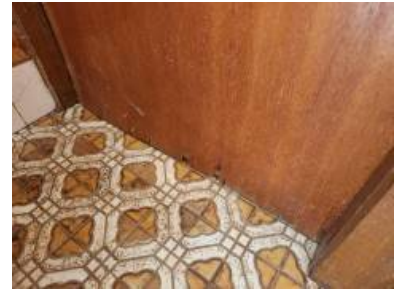
Toilet door requires replacement in laundry.

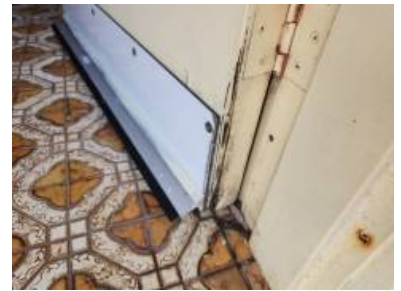
External Laundry door shows signs of weather damage and requires repair / sealing.

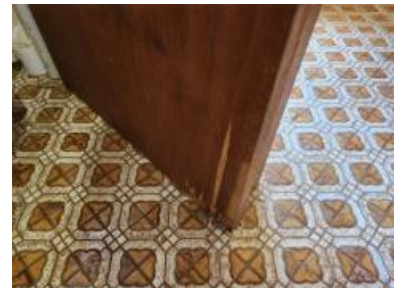
Bathroom door is damaged and requires replacement, Bathroom in laundry.

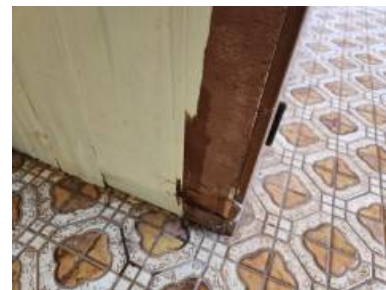
Cupboard wall lining in laundry requires replacement.

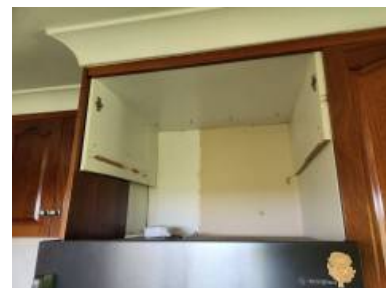
Cabinet above the fridge needs replacing.

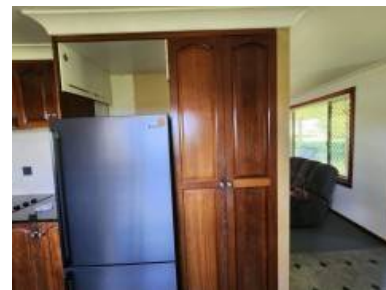
Some doors require adjustment.

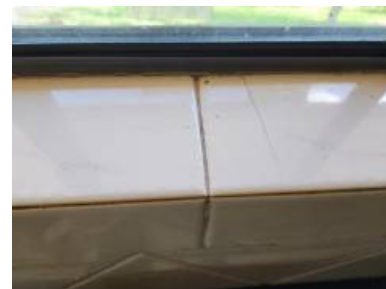
Crack to splash tile.

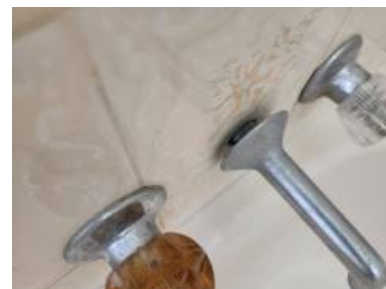
Bath spout is installed incorrectly.

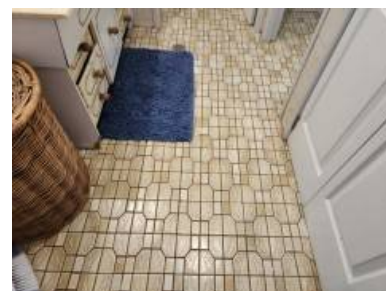
Drummy floor tiles present to various areas in bathroom and laundry. Floor tiles become drummy due to the loss of adhesion to the underside of the tiles and may become loose or cracked. I recommend that a qualified tiler be engaged for further inspection / advice.

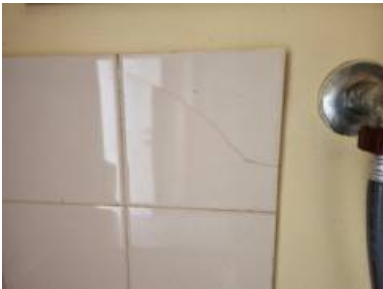
Cracks to laundry splash back and skirting tiles.

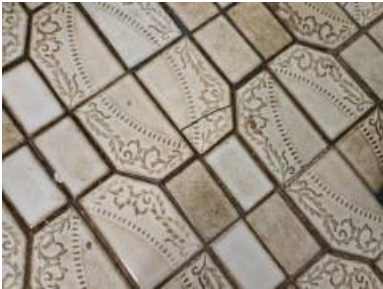
Cracks to some floor tiles to Bathroom.

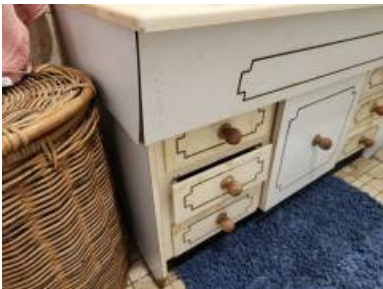
Damage
Signs of past water damage to Bathroom vanity cabinet.

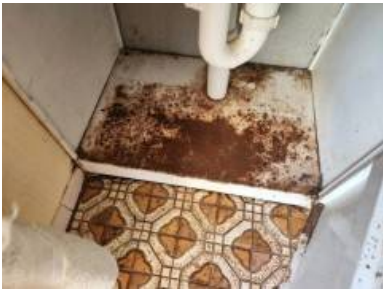
Laundry tub cabinet shows signs of rust and requires repair / painting with Killrust or better replacement.

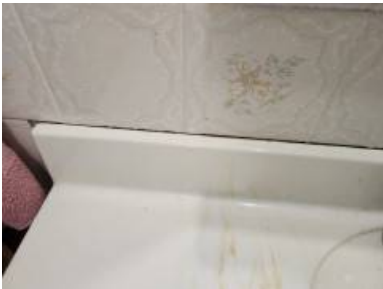
Junctions of Bathroom vanity and wall tiles require resealing with silicone.

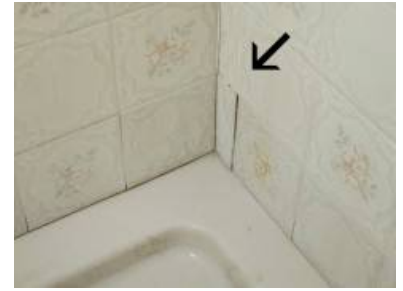
Some wall tiles are loose and require reglueing,

Junctions of Bathroom shower floor / wall tile joins require resealing with silicone.

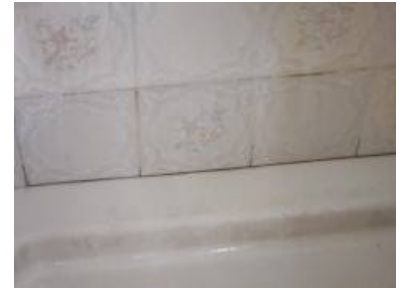
Junctions of Bathroom shower floor / wall tile joins require resealing with silicone.

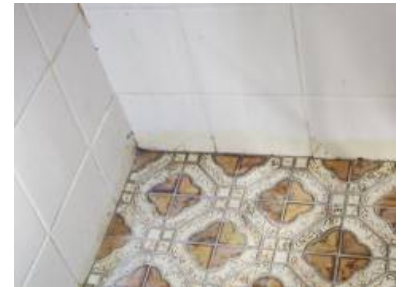
Some hairline cracks to some wall tiles at the base of the shower in Laundry.

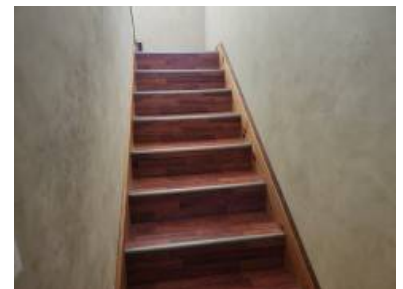
Some stair treads squeak / creak.

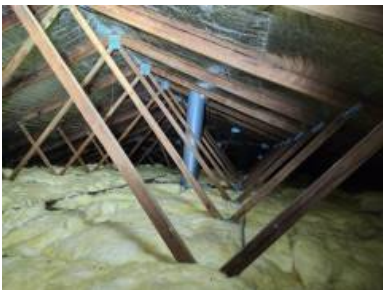
Older roof frames do not comply with current wind ratings. The roof framing is in satisfactory / typical condition for the age / construction date.

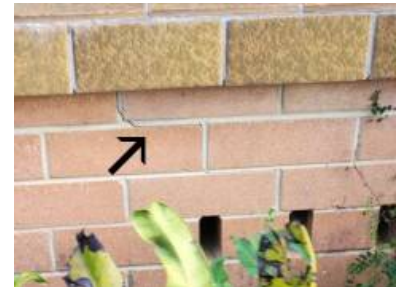
Mortar cracks to brickwork at under front balcony.

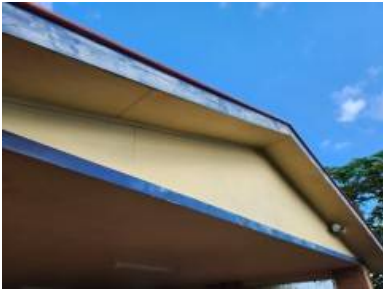
Condition:
External paintwork / finish to various external surfaces and timberwork is generally poor. Various sections / areas require touching up / repainting.

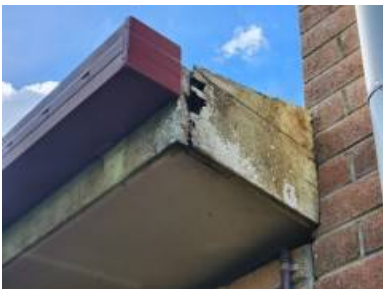
Condition:
Some fascia timbers show signs of weather damage and require repair.

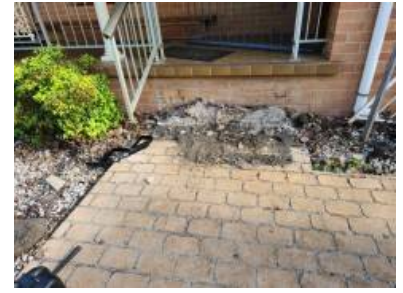
Stairs and hand rail need rectification to front of house.

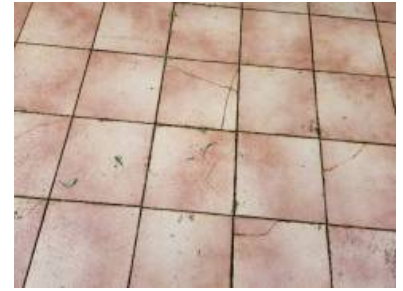
Cracked and drummy tiles to back patio off laundry.

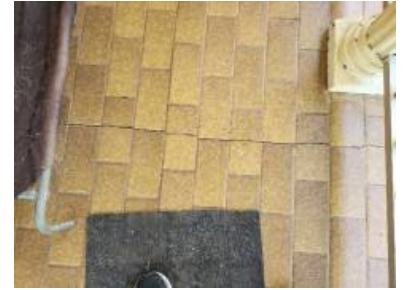
Crack to front patio slab.

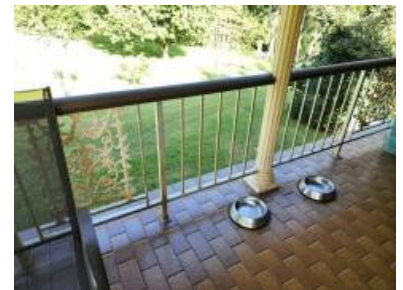
The handrail & balustrades do not comply with current BCA standards however, they may comply with the date of construction. Although this report does not generally comment on items of compliance, this issue may become a safety issue / fall hazard and therefore was included in this report. We recommend you further investigate this matter and upgrade if / where necessary.

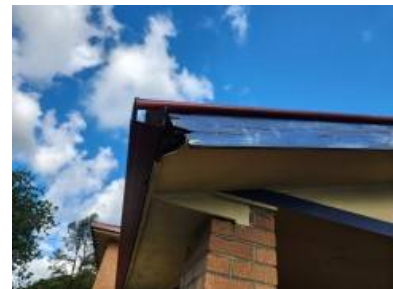
Some fascia timbers show signs of weather damage and require repair / replacement.

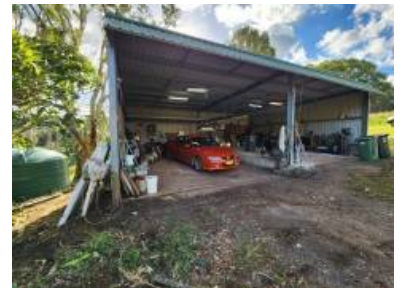
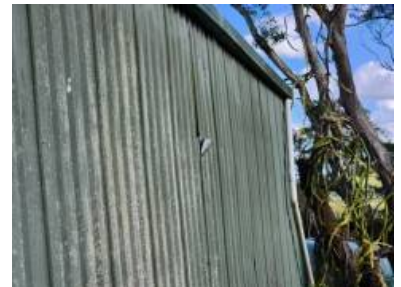
Condition:
Minor damage to some wall sheets.

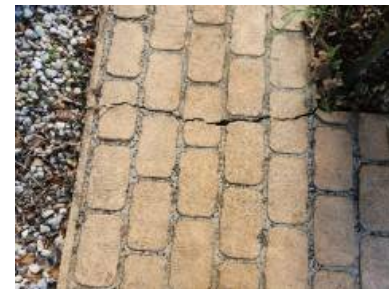
Some cracks to concrete slabs.
