# Building and Pest Report

## 19 Amber Drive, Lennox Head

# Inspection Report

**19 Amber Drive, Lennox Head, NSW, 2478**

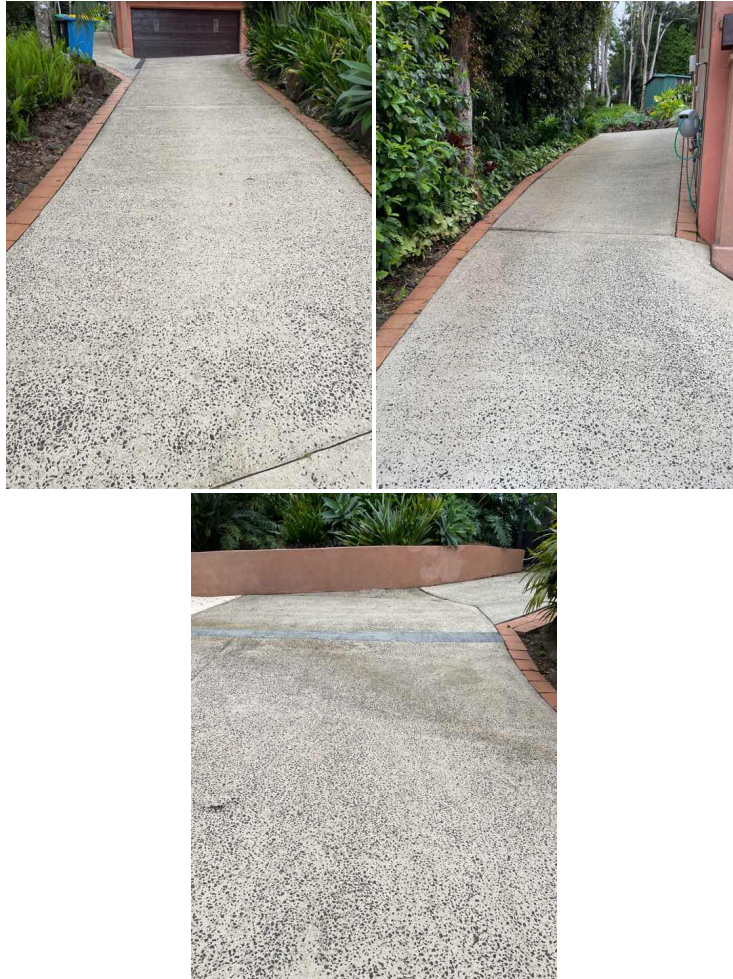
Common cracks were observed on the driveway. Whilst these cracks appeared to be typical at the time of inspection, we strongly recommend you monitor these cracks and if worsening occurs contact a concreter for further advice.

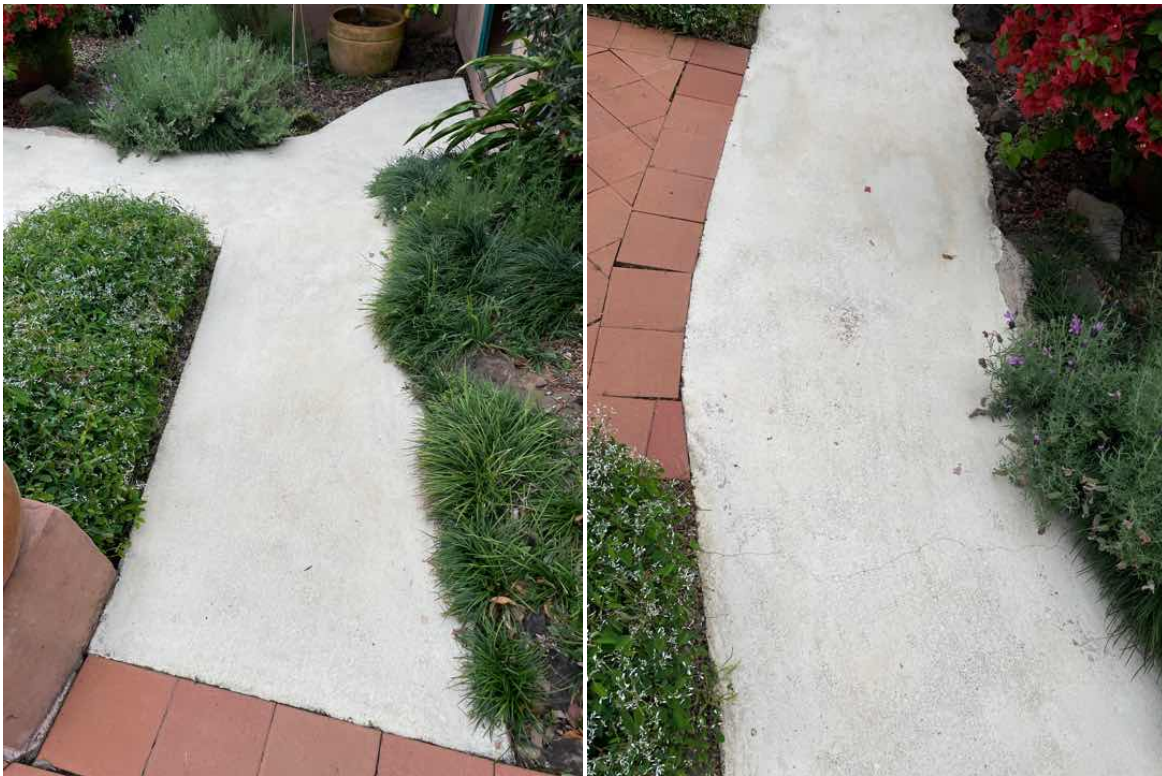
Common cracks and settlement were observed on paths. Whilst these cracks appeared to be typical at the time of inspection, we strongly recommend you monitor these cracks and if worsening occurs contact a concreter for further advice.

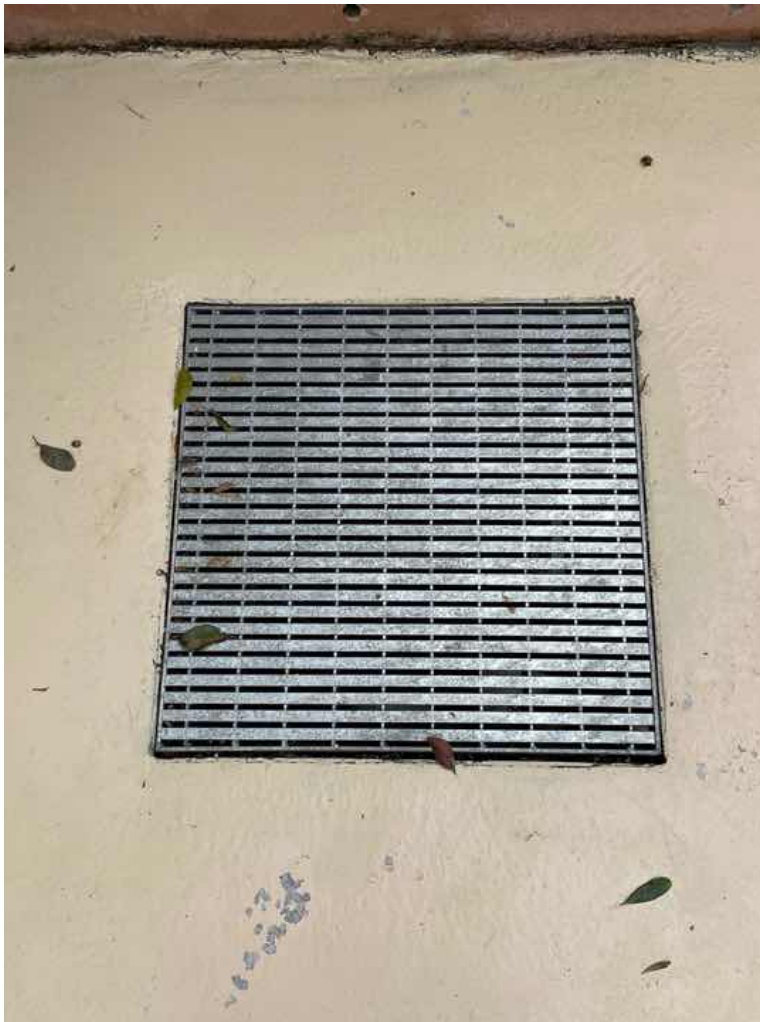
Recommend installing a drainage point under the tap to assist with drainage.

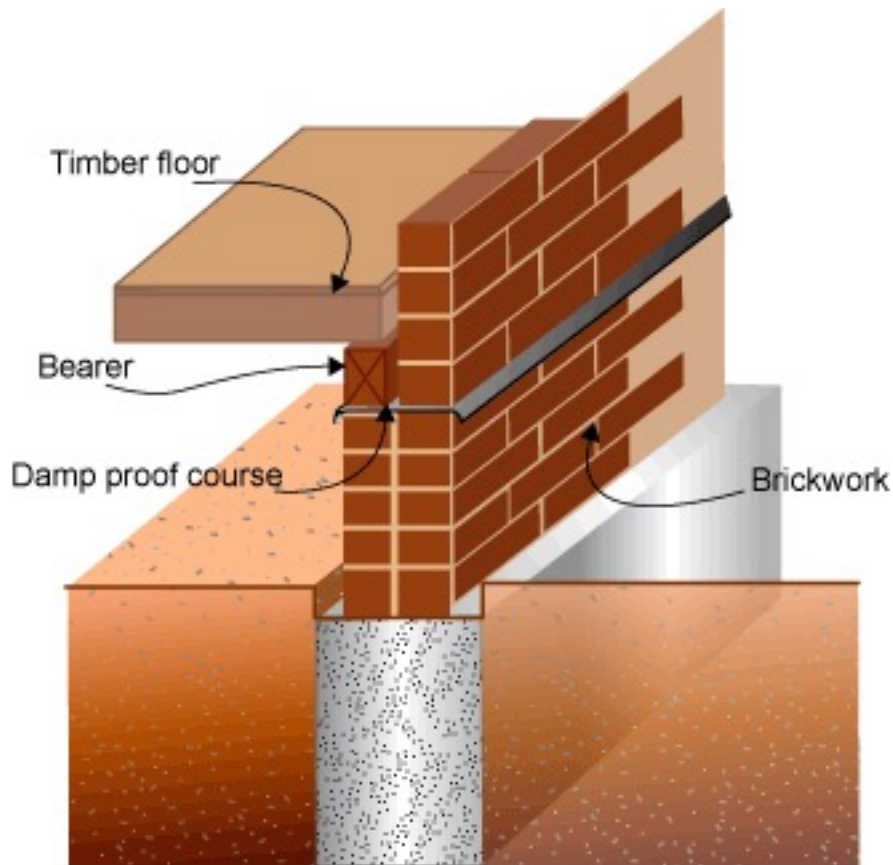
| Section | Location | Name | Comment |
|---|---|---|---|
| EXTERIOR | Rising Damp | Damp Proof Course | A damp proof course is not visible or could not be visually identified. This may cause rising damp issues. Contact a specialist in this field to further investigate and make recommendation. |

A damp proof course is not visible or could not be visually identified. This may cause rising damp issues. Contact a specialist in this field to further investigate and make recommendation.

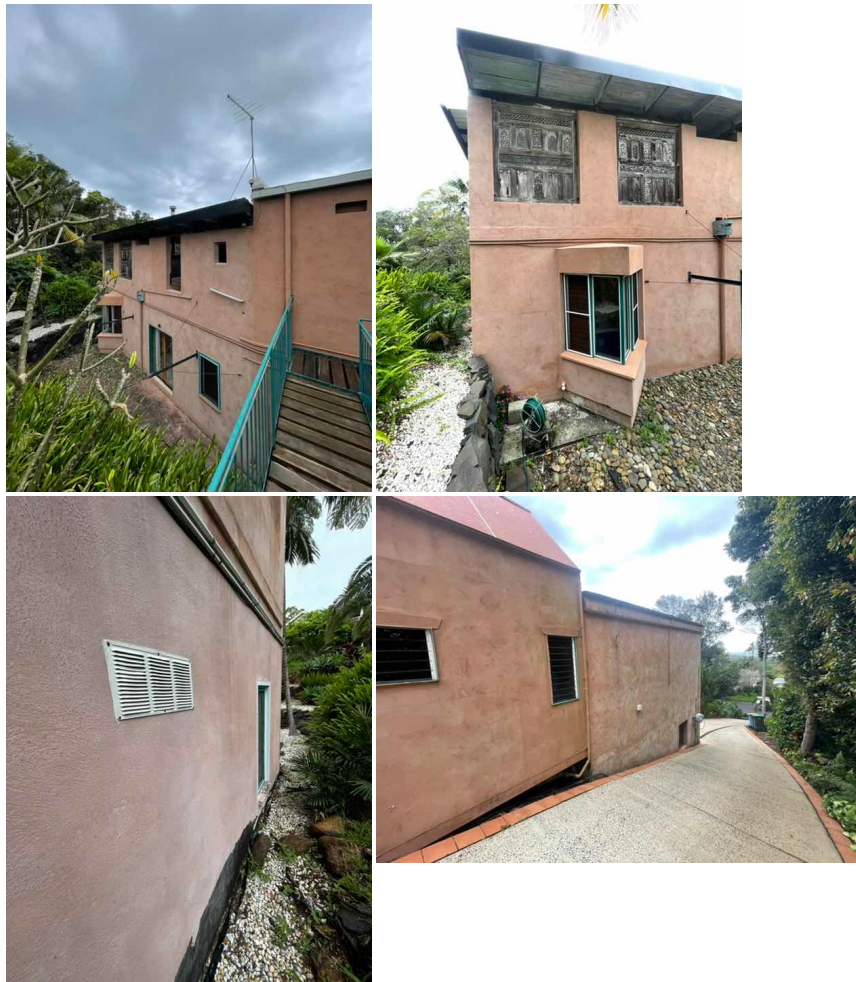
| Section | Location | Name | Comment |
|---|---|---|---|
| EXTERIOR | Walls | Condition | <p>There appears to have been some settlement in the building which has caused some cracking to the walls. These crack are catergorized as 0 to 2. This can also cause some doors to bind or be out of square. In the inspectors opinion these cracks are due to settlement, usually due to ground movement and subsequent movement to building materials can be expected. Any cracks should be monitored and if cracks increase in size, further investigation should be carried out by a structural engineer.</p> <p>For clarification on the catergory of cracks please refer to Cracking of Building Elements in Section 2D of the Terms and Conditions contained in this report.</p> |

There appears to have been some settlement in the building which has caused some cracking to the walls. These cracks are categorized as 0 to 2. This can also cause some doors to bind or be out of square. In the inspectors opinion these cracks are due to settlement, usually due to ground movement and subsequent movement to building materials can be expected. Any cracks should be monitored and if cracks increase in size, further investigation should be carried out by a structural engineer.

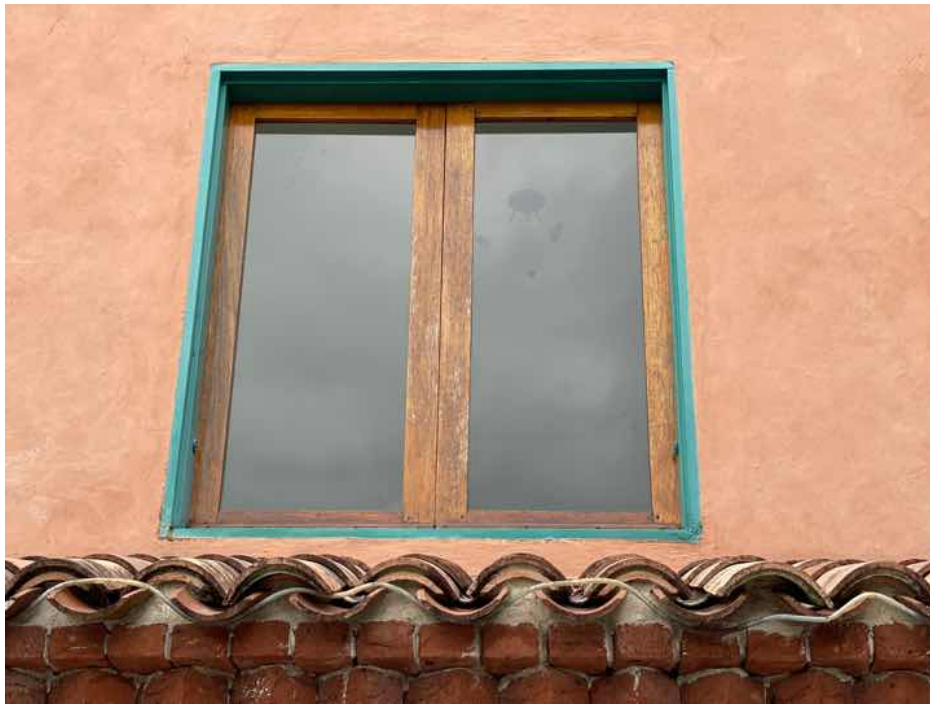
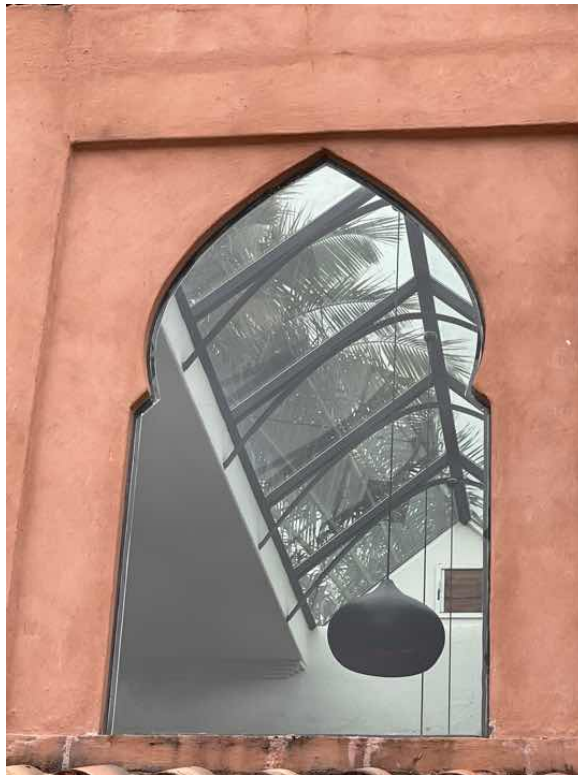
| Section | Location | Name | Comment |
|---|---|---|---|
| EXTERIOR | Windows | Overall Condition | General age/damage has occurred to window components. Recommendations: Restoration work recommended. A qualified carpenter should be engaged for advice and recommendations. |

General age/damage has occurred to window components. Recommendations: Restoration work recommended. A qualified carpenter should be engaged for advice and recommendations.

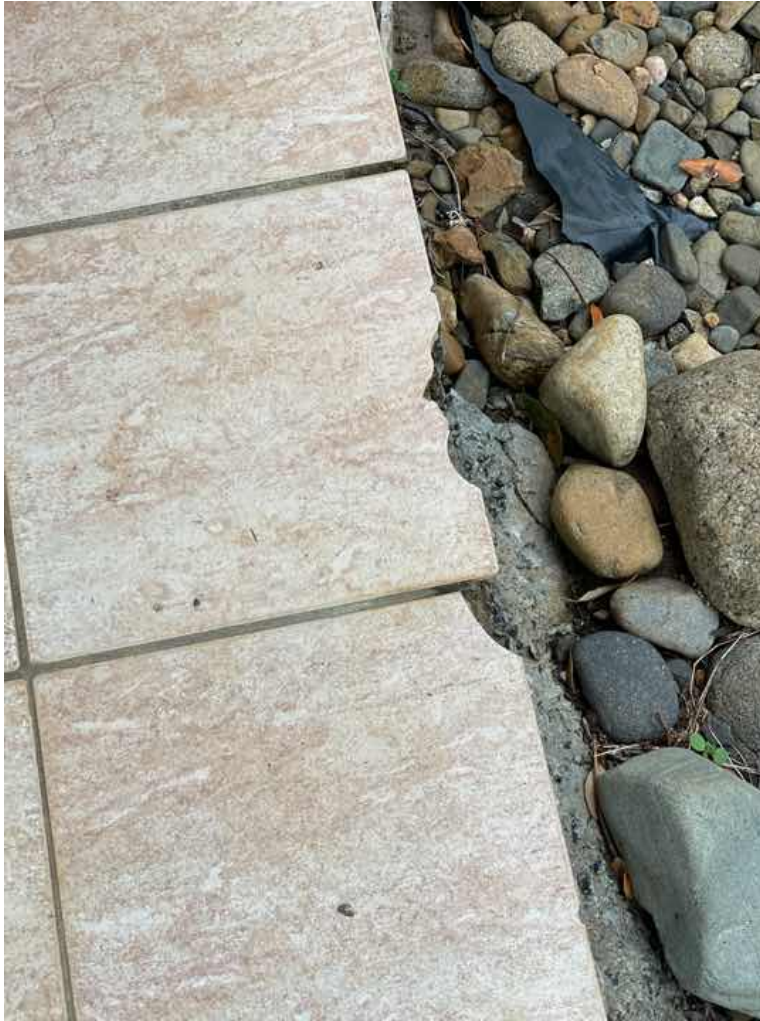
| Section | Location | Name | Comment |
|---|---|---|---|
| STAIRS- PERGOLA- BALCONIES- DECKS | Balcony Findings | Flooring | Tile cracking observed. A qualified tiler should be engaged for advice and recommendations. This may cause leaking and water penetration. |

Tile cracking observed. A qualified tiler should be engaged for advice and recommendations. This may cause leaking and water penetration.

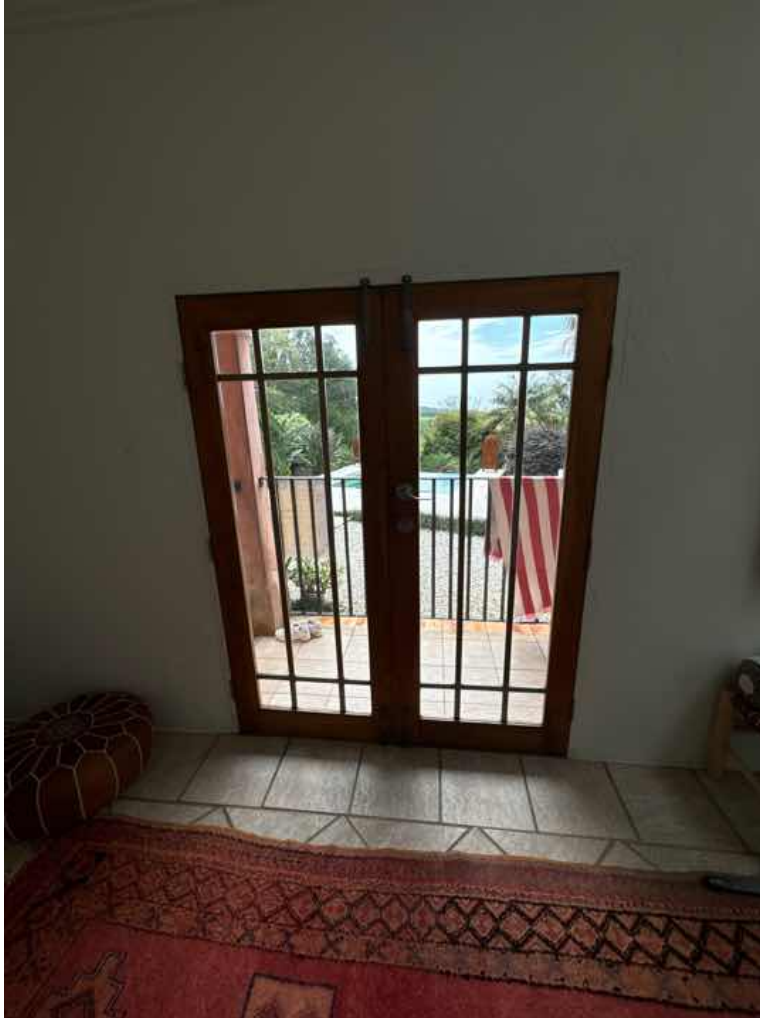
| Section | Location | Name | Comment |
|---|---|---|---|
| INTERIORS | Doors | Front Entry Doors | Entry door / frame deterioration - General age/damage has occurred to door frame, face or components. A qualified carpenter should be engaged for advice and recommendations. |

Entry door / frame deterioration - General age/damage has occurred to door frame, face or components. A qualified carpenter should be engaged for advice and recommendations.

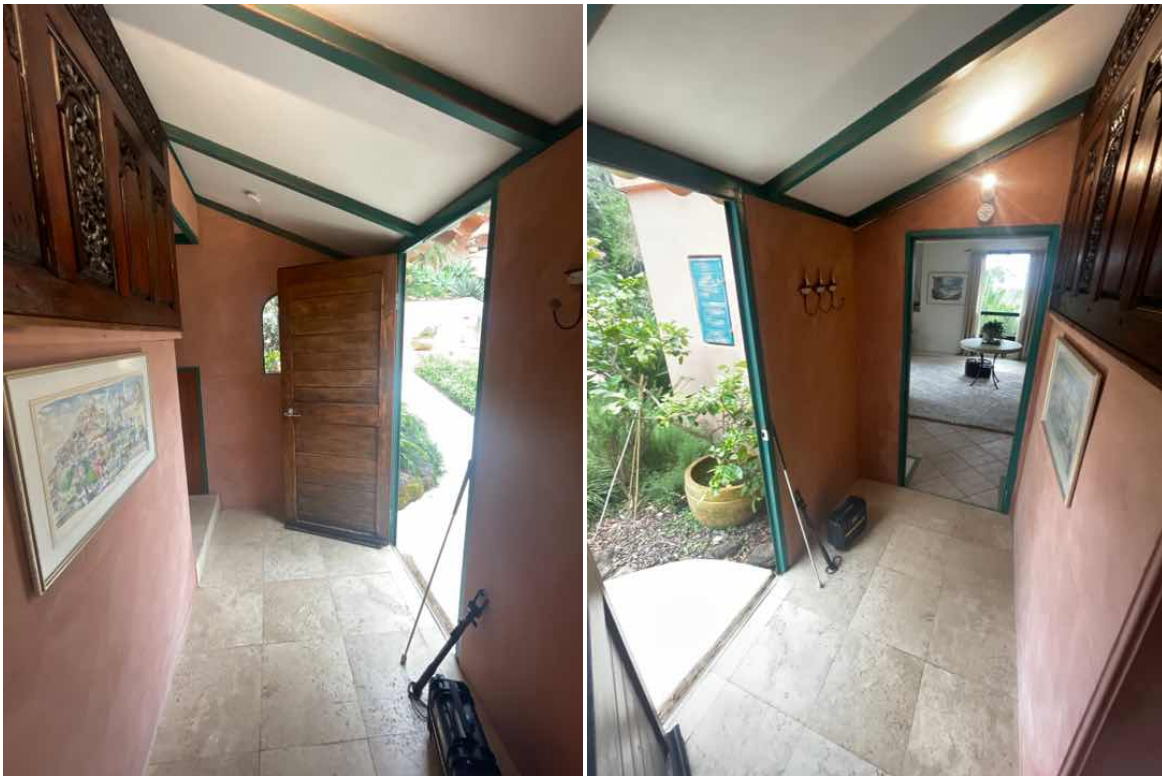
| Section | Location | Name | Comment |
|---|---|---|---|
| INTERIORS | Entry Foyer | Walls | Settlement Cracks Noted. These are typical and generally patch and paint will suffice, however we recommend you monitor these cracks and if they become wider or longer, you will need to contact a structural engineers to assess. |

Settlement Cracks Noted. These are typical and generally patch and paint will suffice, however we recommend you monitor these cracks and if they become wider or longer, you will need to contact a structural engineers to assess.

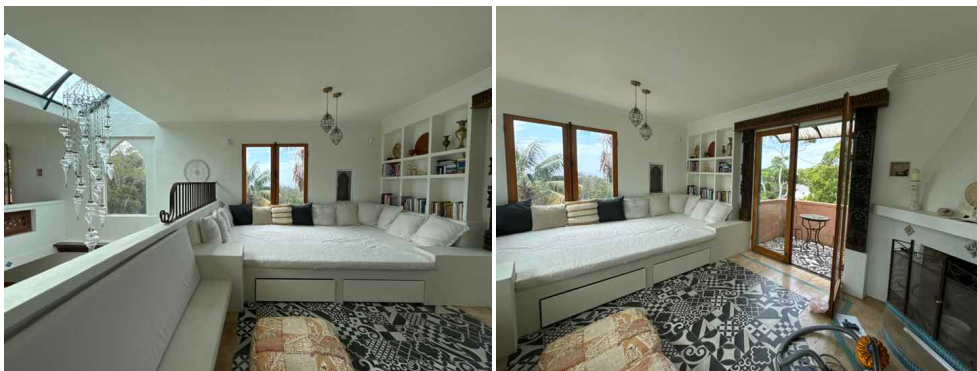
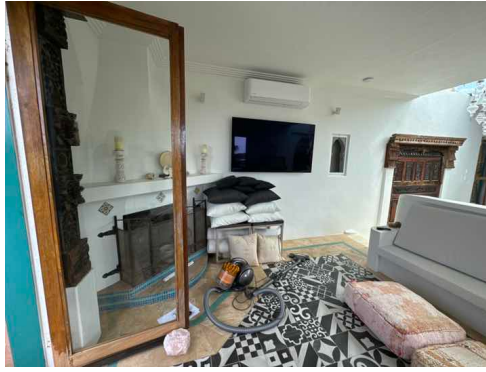
| INTERIORS | Entry Foyer(granny flat) | Flooring | Cracked floor tiles noted. A qualified tiler should be engaged for repairs. |

Cracked floor tiles noted. A qualified tiler should be engaged for repairs.

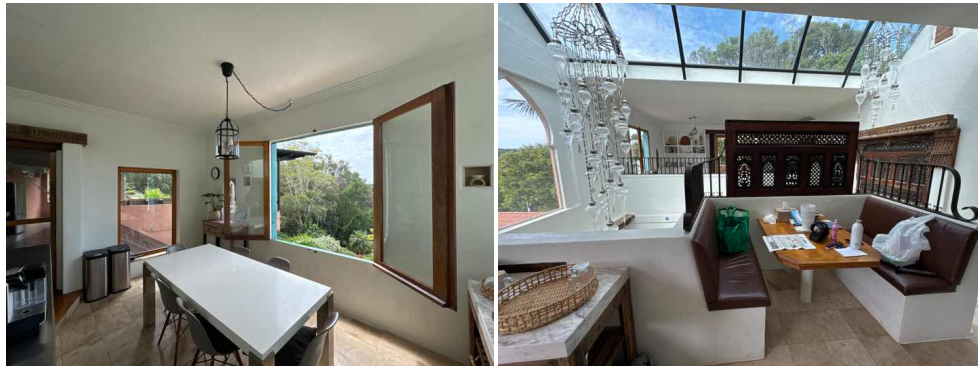
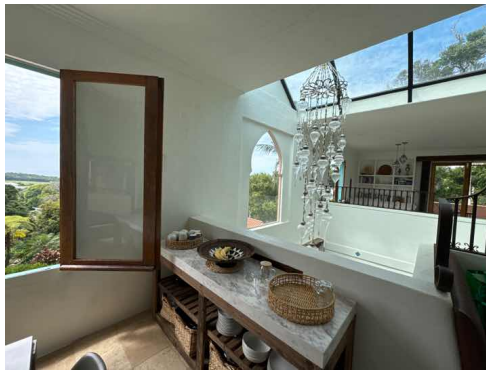
| INTERIORS | Living Room | Ceiling | Settlement Cracks Noted. These are typical and generally patch and paint will suffice, however monitoring these cracks is advised for 12 months and if they become worse, further investigation by a suitably qualified professional is advised. |
| INTERIORS | Living Room | Ceiling | Typical cornice separation/detachment observed. I recommend you contact a qualified painter for repairs. |

Settlement Cracks Noted. These are typical and generally patch and paint will suffice, however monitoring these cracks is advised for 12 months and if they become worse, further investigation by a suitably qualified professional is advised.

Typical cornice separation/detachment observed. I recommend you contact a qualified painter for repairs.

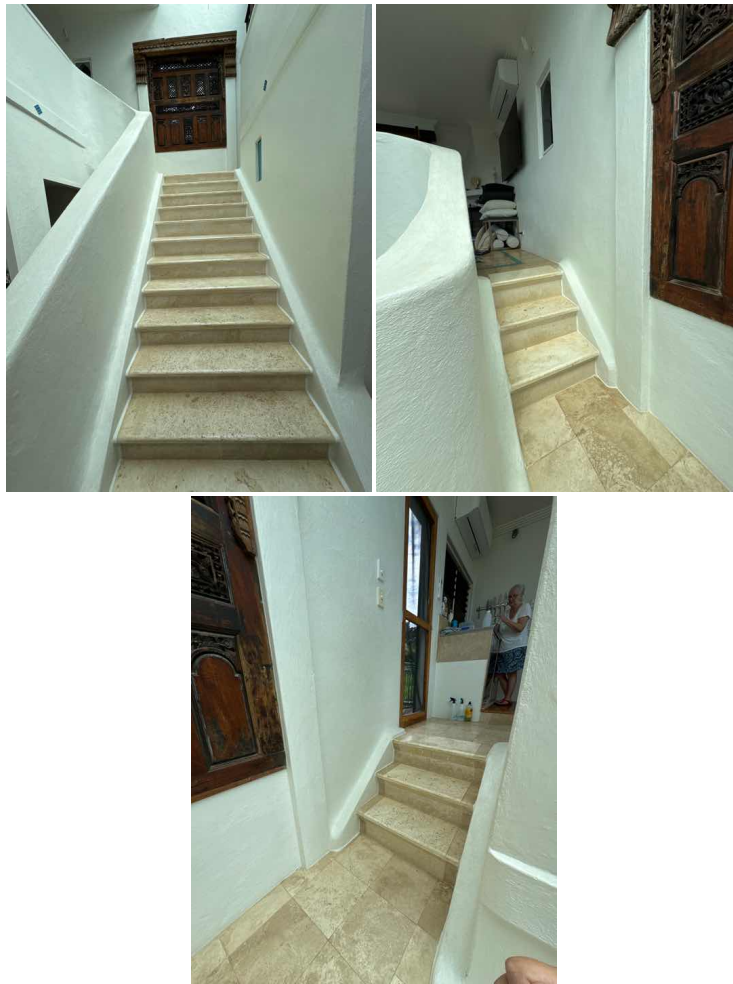
| Section | Location | Name | Comment |
|---|---|---|---|
| INTERIORS | Internal Stair Case | Condition | No hand rail installed to the staircase. This is a building requirement and presents a safety hazard. Contact a qualified carpenter or builder for repairs prior to purchase. |

No hand rail installed to the staircase. This is a building requirement and presents a safety hazard. Contact a qualified carpenter or builder for repairs prior to purchase.

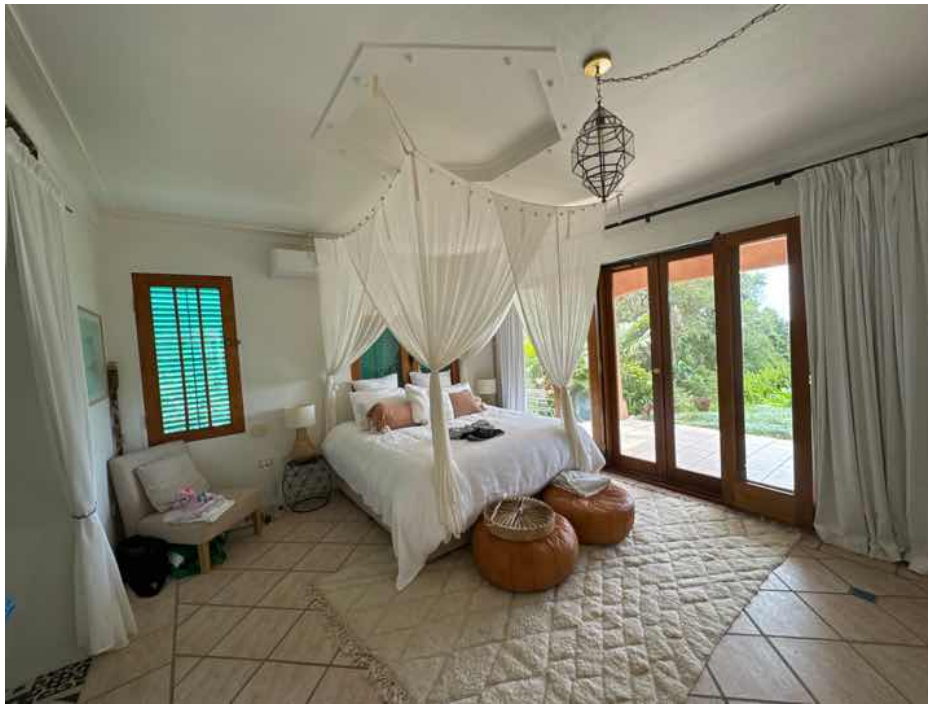
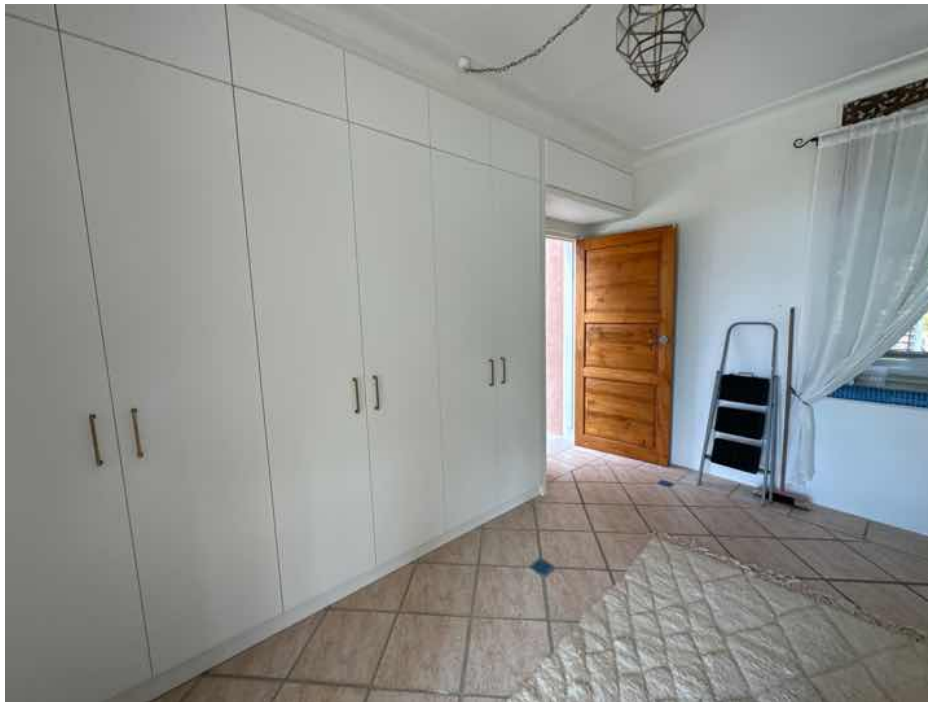
| INTERIORS | Bedroom 2 | Ceiling | Settlement Cracks Noted. These are typical and generally patch and paint will suffice, however monitoring these cracks is advised for 12 months and if they become worse, further investigation by a suitably qualified professional is advised. |

Settlement Cracks Noted. These are typical and generally patch and paint will suffice, however monitoring these cracks is advised for 12 months and if they become worse, further investigation by a suitably qualified professional is advised.

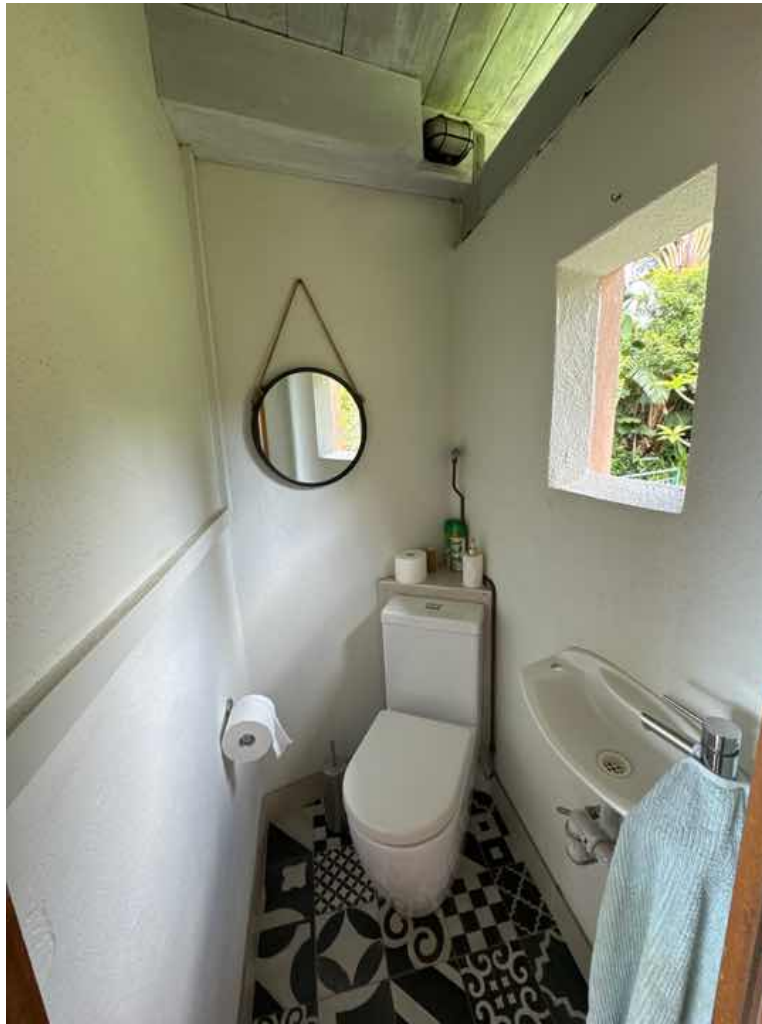
| BATHROOM(S) | Powder Room (granny flat) | Door | Binding/out of square door frame - This can relate to some differential settlement in the footings, frame movement, age, expansion, shrinkage and the like. A qualified carpenter should be engaged for advice and recommendations. |

Binding/out of square door frame - This can relate to some differential settlement in the footings, frame movement, age, expansion, shrinkage and the like. A qualified carpenter should be engaged for advice and recommendations.

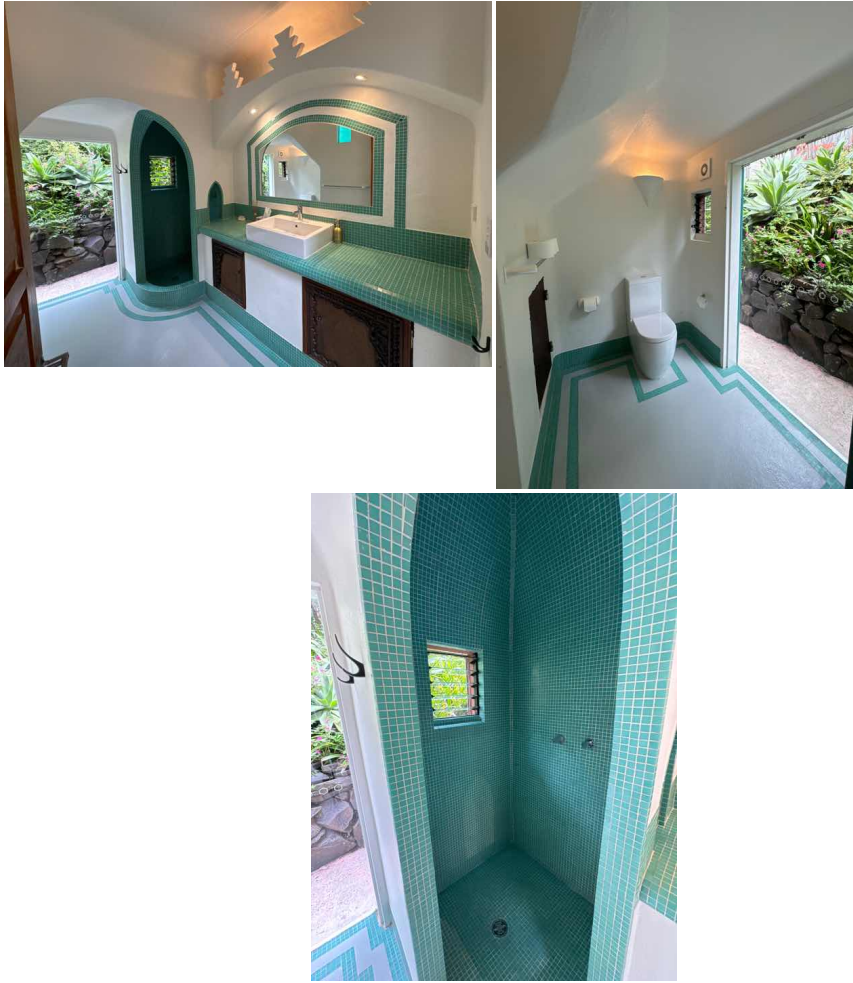
No exhaust fan is installed - Recommend having one installed.

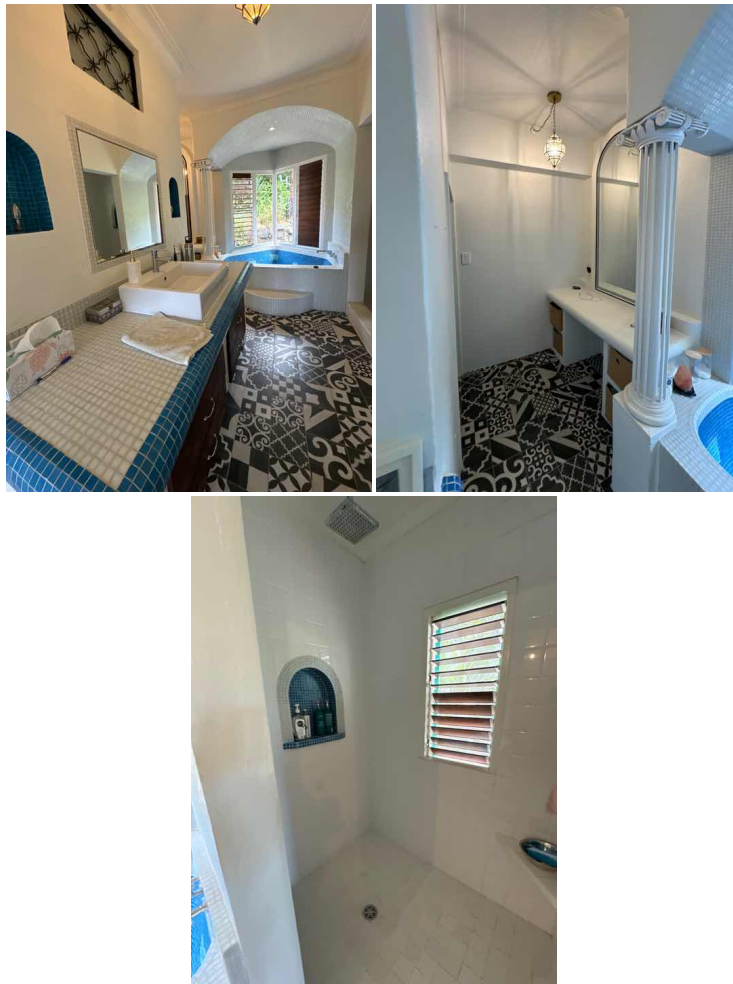
| BATHROOM(S) | Bathroom 2 | Walls | Settlement Cracks Noted . These are typical and generally patch and paint will suffice, however Monitoring these cracks advised for 12 months and if become wider or longer, you will need to contact a structural engineers to assess. |

Settlement Cracks Noted . These are typical and generally patch and paint will suffice, however Monitoring these cracks advised for 12 months and if become wider or longer, you will need to contact a structural engineers to assess.
