# Inspection Report

## East Coast Building Solutions

**24 Antrim Street, East Ballina, NSW, 2478**

### Pest And Building Inspection

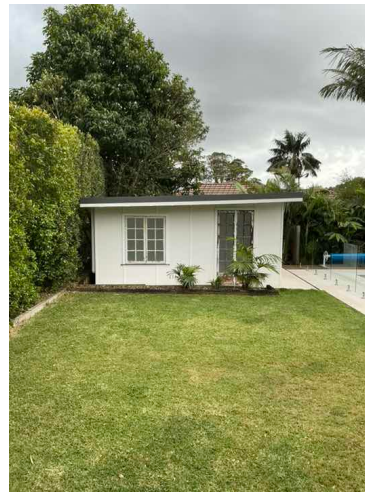
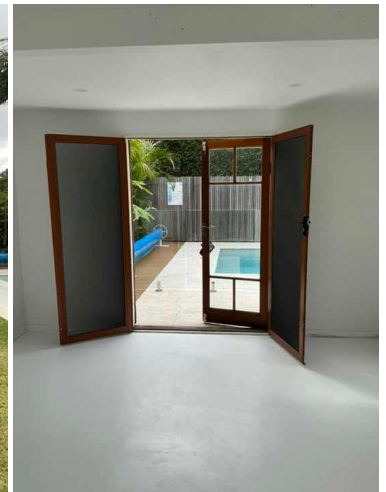
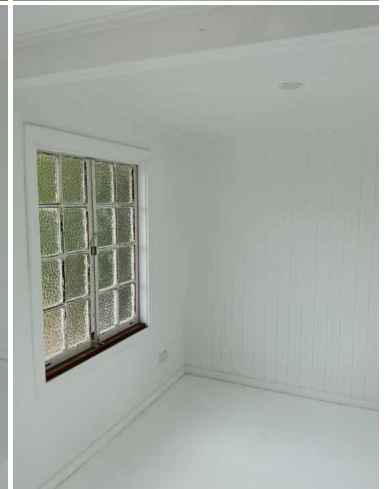
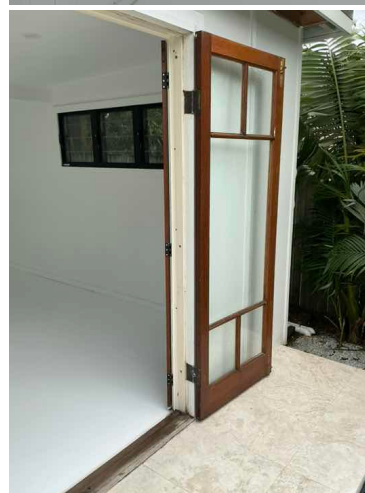
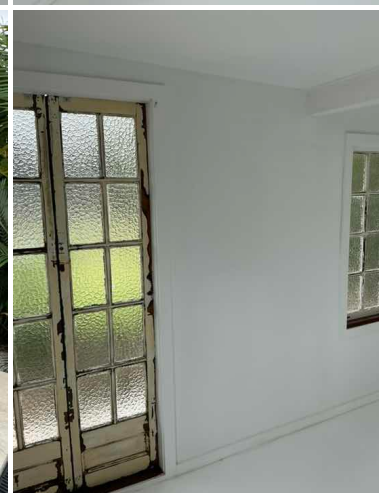
The shed is in fair usable condition.

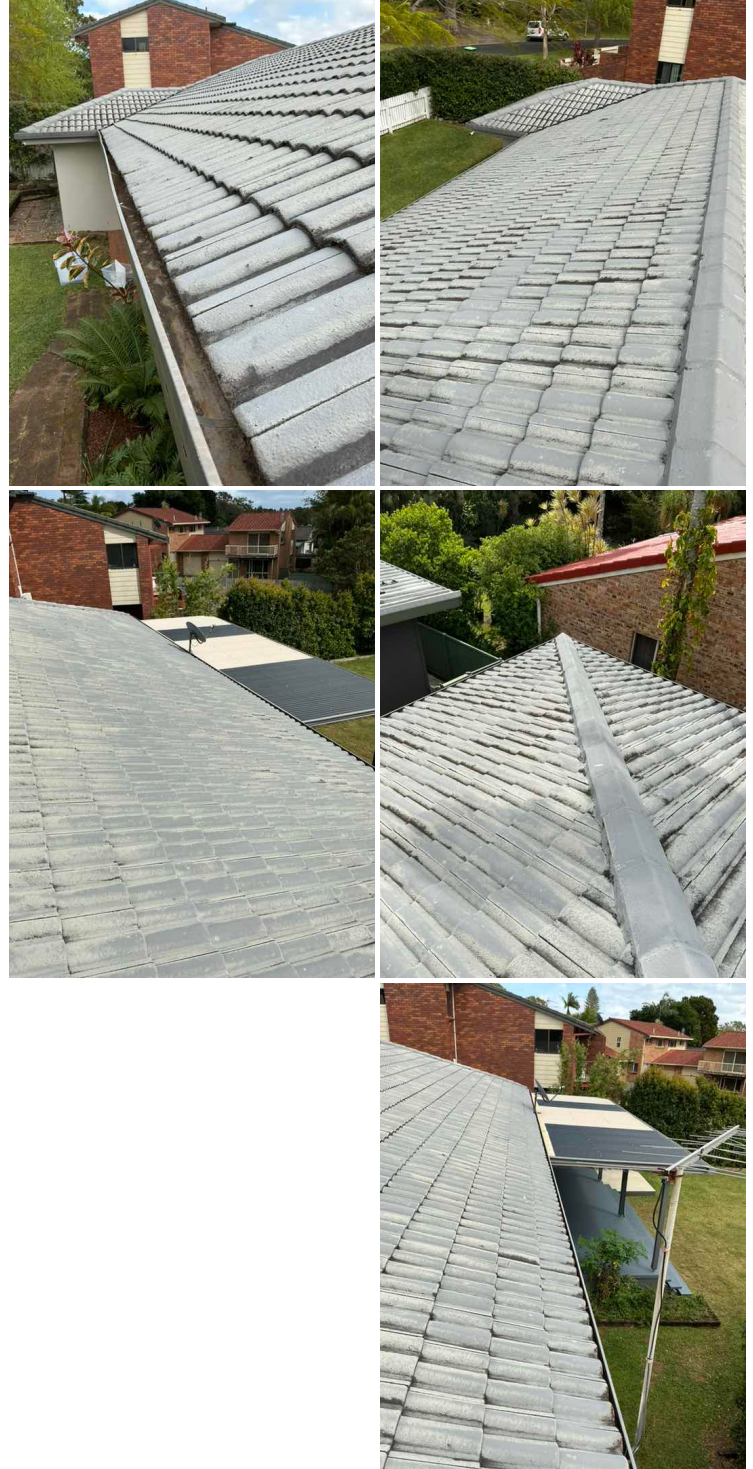
The roof is of concrete tiles.

Of the visible areas, the general condition of the roof is in serviceable condition for the age.

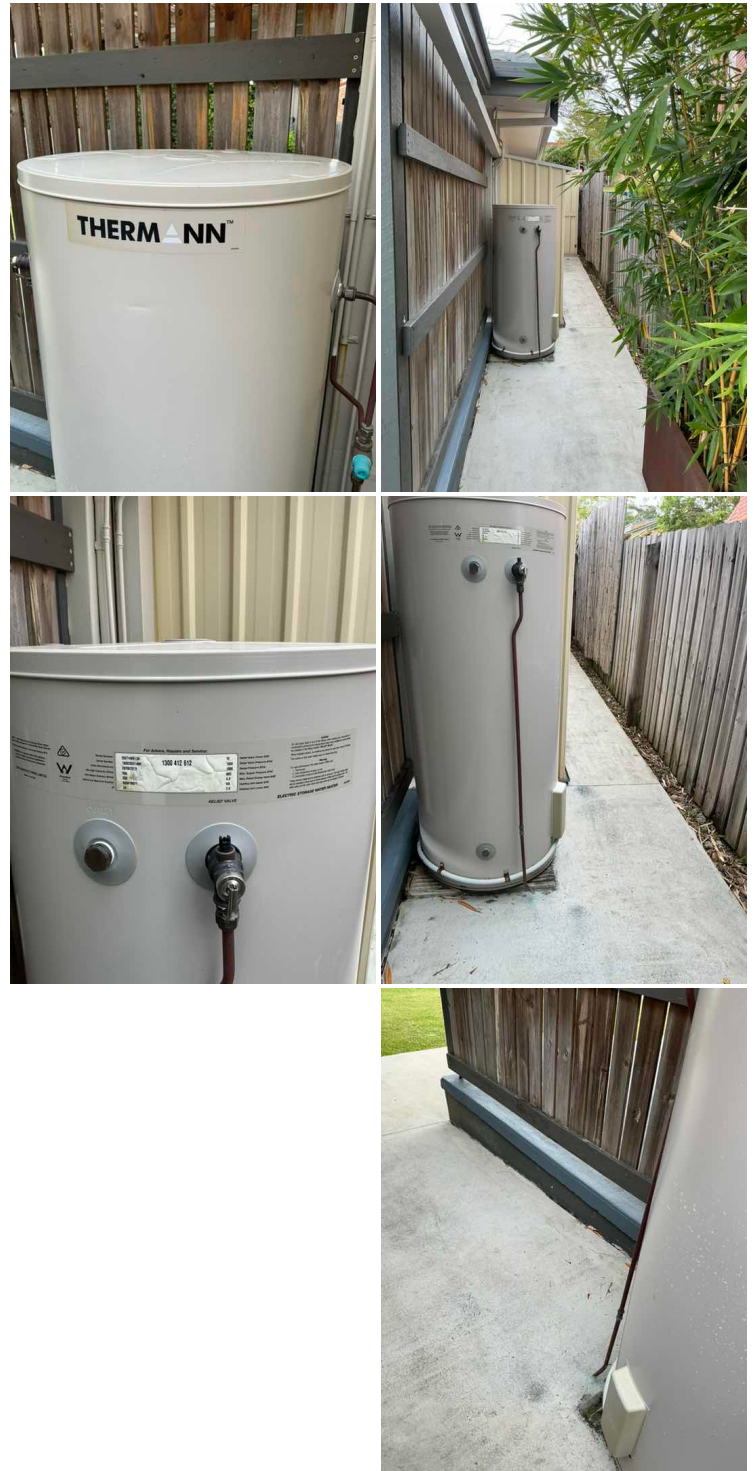
The hot water system appears to be in a serviceable condition. No specific tests other than running the hot water from a tap was carried out. No determination has been made as to the suitability or adequacy of the hot water system in relation to capacity or otherwise.

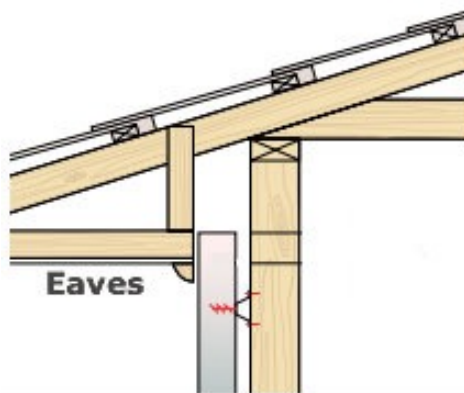
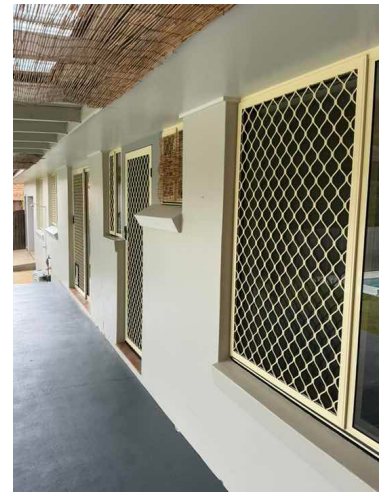
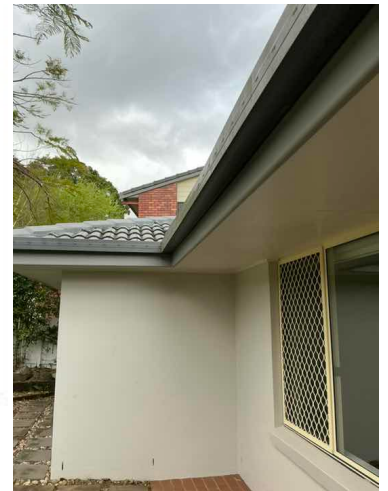
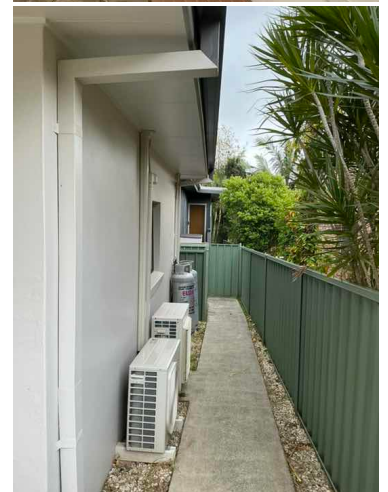
The soffit lining (eaves) are in a serviceable condition with no notable defects.

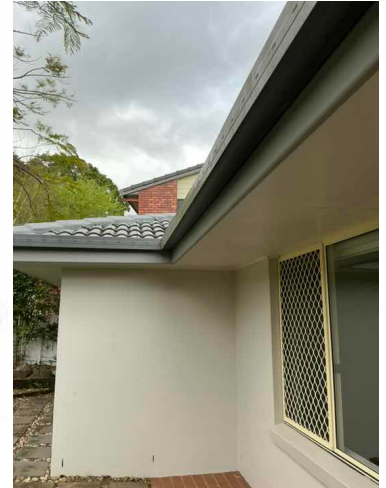
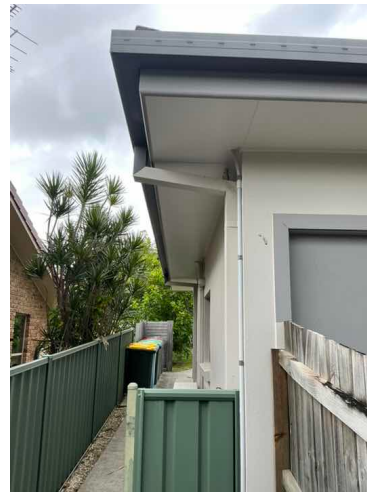
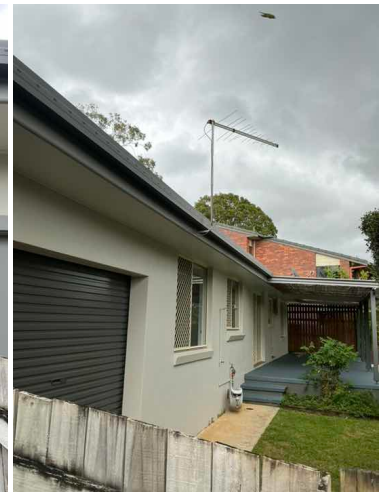
On visual inspection, the general condition of the fascia/barge boards is serviceable.

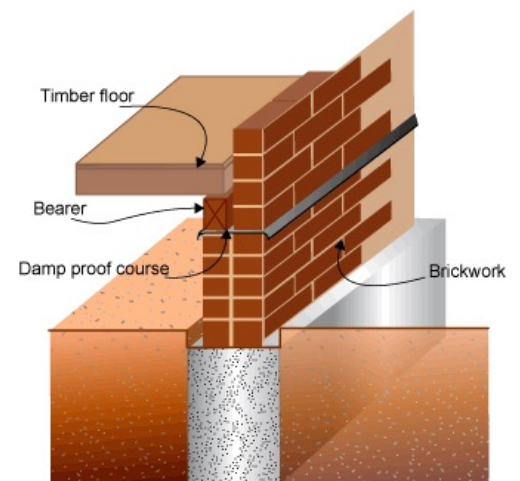
A damp proof course (DPC) was noted.

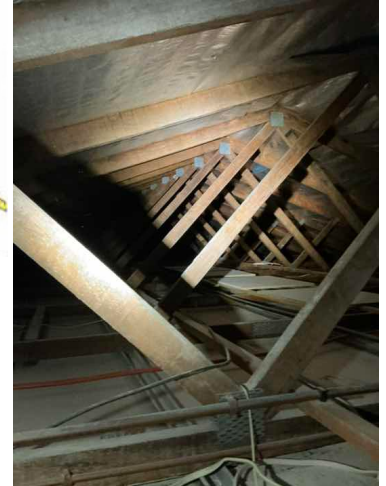
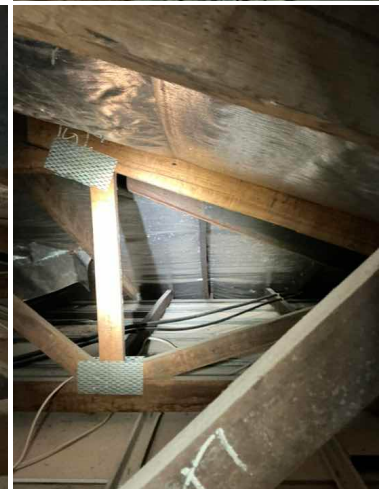
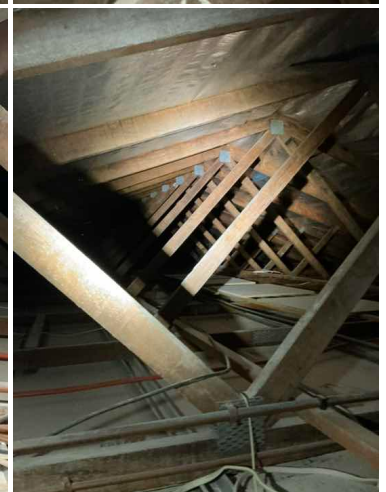
The roof frame is a truss timber frame.

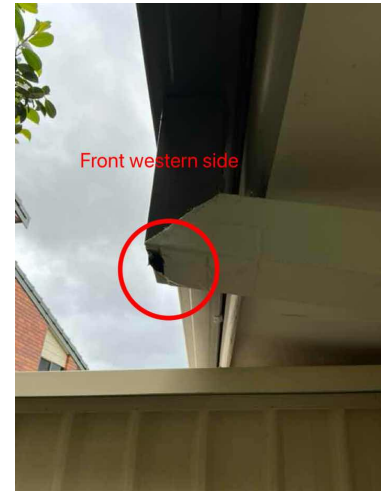
There was water leakage detected during the inspection from some downpipe joins. Consult a roof plumber for a scope of works and cost of repairs for the issue prior to contracts becoming binding.
