# Inspection Report

## East Coast Building Solutions

**24 Antrim Street, East Ballina, NSW, 2478**

### Pest And Building Inspection

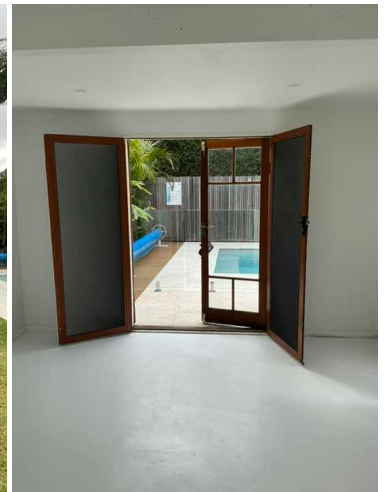
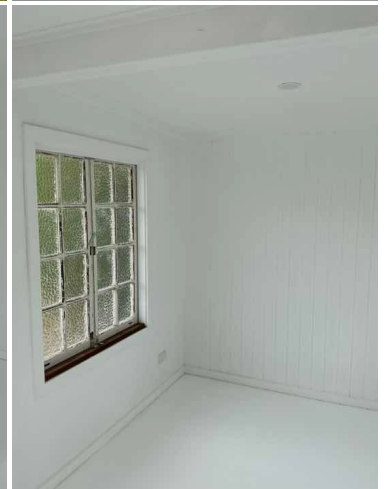
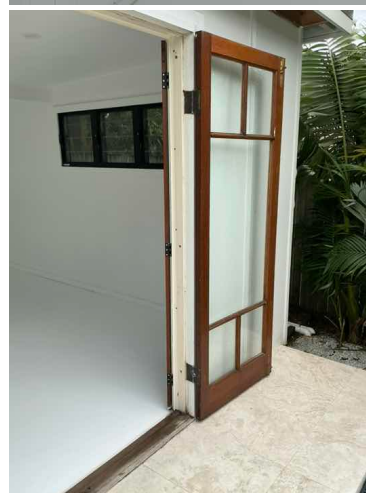
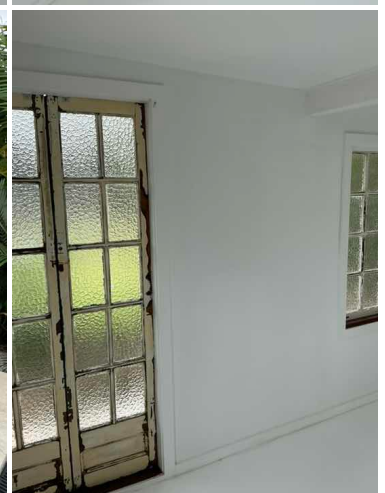
The shed is in fair usable condition.

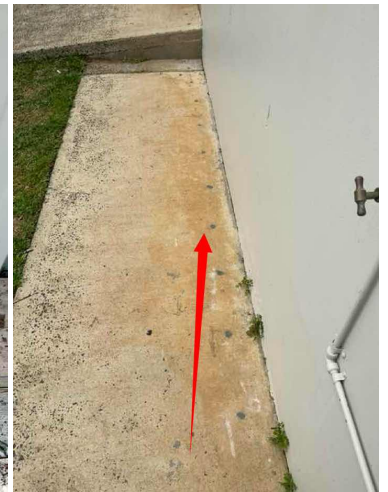
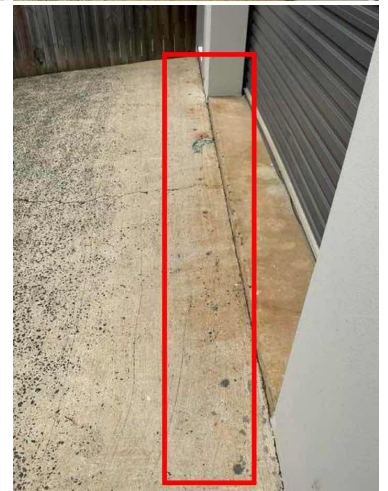
Yes, Drill Holes (Chemical Treatment) were located at the property.

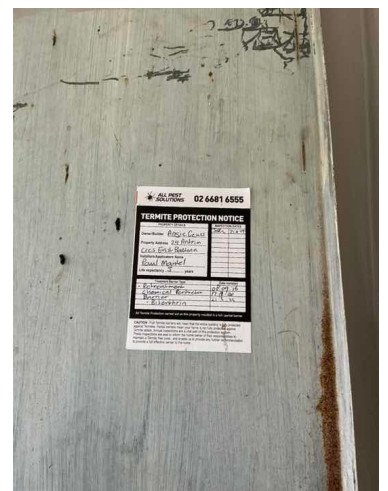
Yes, a durable notice was found in the meter-box during the inspection.

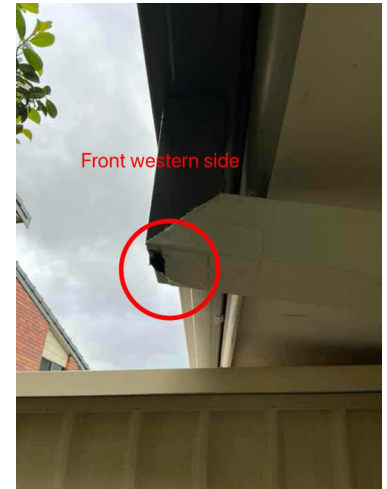
There was water leakage detected during the inspection from some downpipe joins. Consult a roof plumber for a scope of works and cost of repairs for the issue prior to contracts becoming binding.
