Building and Pest Report

2/32 Sunrise Cres Lennox Head

Pest And Building Inspection

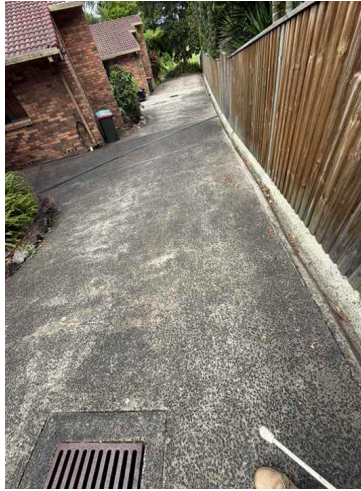
Driveway Condition

On visual inspection, the general condition of the driveway is serviceable.

Common cracks were observed on the driveway. Whilst these cracks appeared to be typical at the time of inspection, we strongly recommend you monitor these cracks and if worsening occurs contact a concreter for further advice.

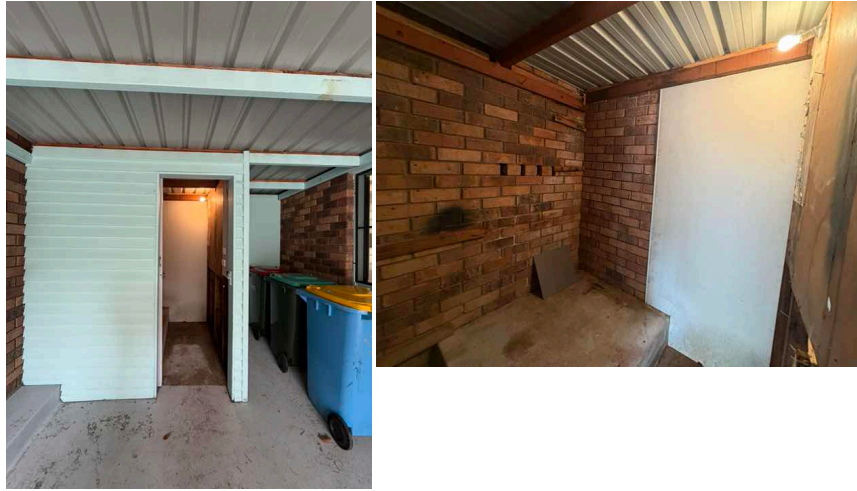
Shed Condition

The shed is in fair usable condition.

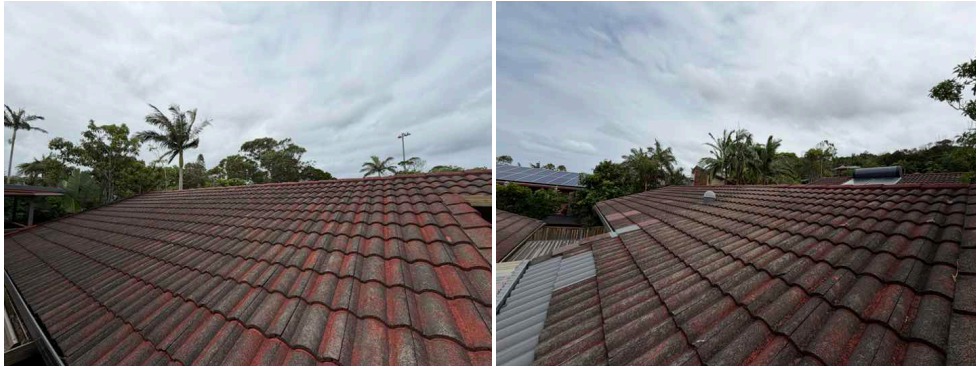
Roof Clad Condition

Visible section of The roof cladding appeared in a serviceable condition for the age of this dwelling. Annual maintenance inspection recommended.

Deterioration & ageing evident. I recommend you contact a roof restorer to clean, seal, and repoint the mortar.

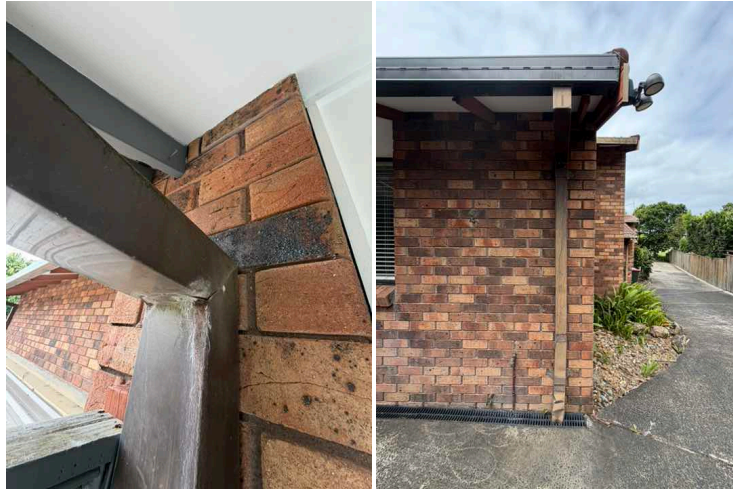
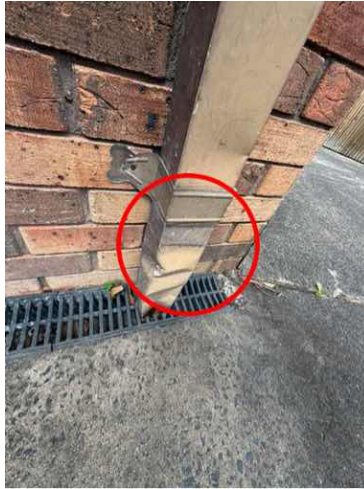
Impact damage noted to downpipe. Contact a roof plumber for replacement as required.

Leaking downpipe joints visible. This can be conducive to termite infestation and cause water damage to cladding over time. A qualified roof plumber should be engaged to repair.

Minor downpipe rust visible. A qualified plumber should be engaged for advice and recommendations.

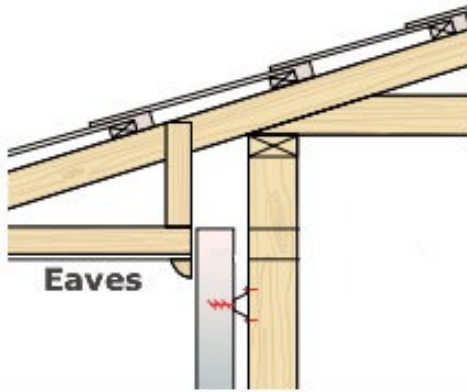
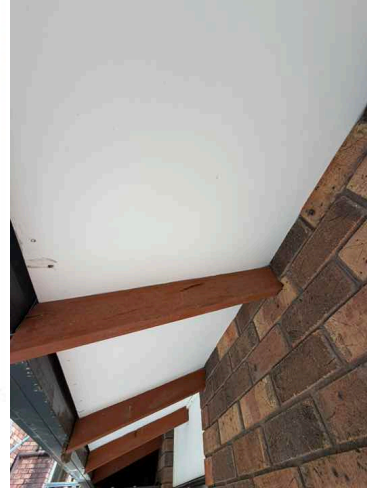
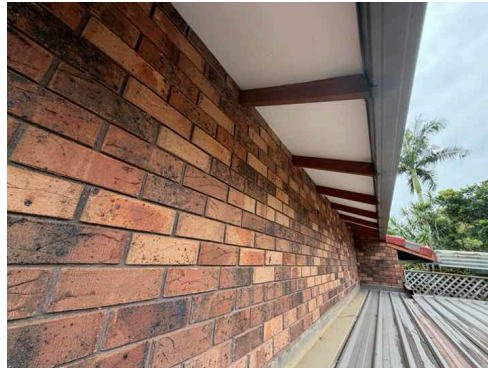
Eave Condition

The soffit lining (eaves) are in a serviceable condition with no notable defects.

Minor eave deterioration & ageing evident. Recommendations: Maintenance works, general upkeep should be carried out.

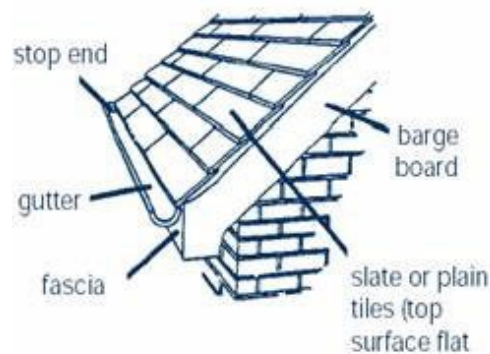
Minor deterioration & ageing evident. Recommendations: Maintenance works, general upkeep should be carried out.

Timber fungal decay (rot) visible. Recommendations: A qualified carpenter should be engaged to replace all affected timbers.

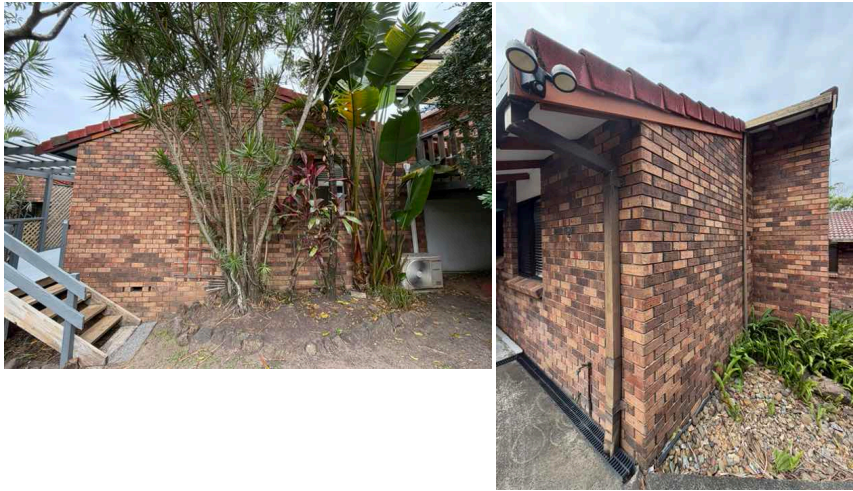
Windows

On visual inspection, the general condition of the windows is serviceable for the age.

General age/damage has occurred to window components. Recommendations: Restoration work recommended. A qualified carpenter should be engaged for advice and recommendations.

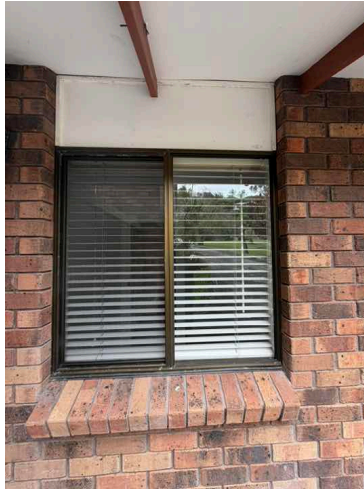
Weep Holes and Ventilation

The weep holes are unobstructed .

Weep holes blocked by soil. Recommendations: Lower finished ground levels to fully expose all weep holes on the lower brick courses around the dwelling.

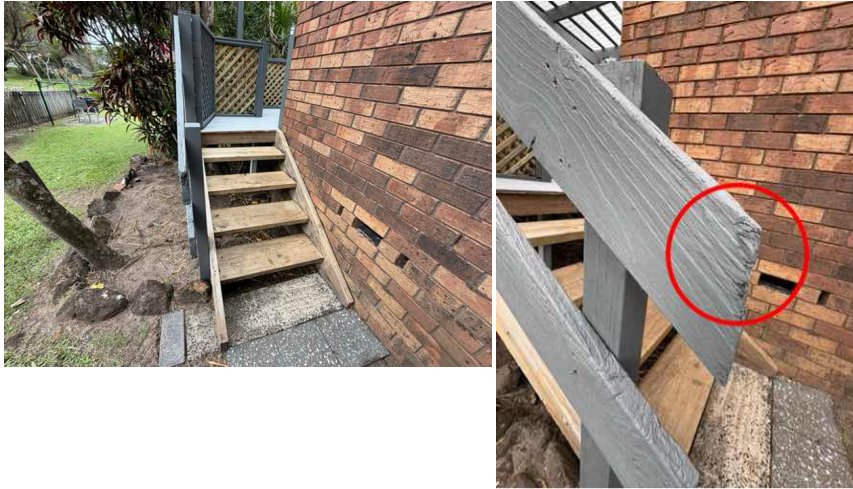
Balustrade and Rails

Balustrade rail height should be 1 m in height from deck/balcony/patio floor. In some circumstances this regulation was non-existent dependent on the age of the dwelling and technically there is no requirement to rectify. Recommendations: We strongly advise you rectify to comply for safety concerns.

Timber fungal decay in areas of balustrade and/or rails. Recommendations: A qualified carpenter should be engaged for advice and recommendations. This is a safety issue and requires immediate repairs.

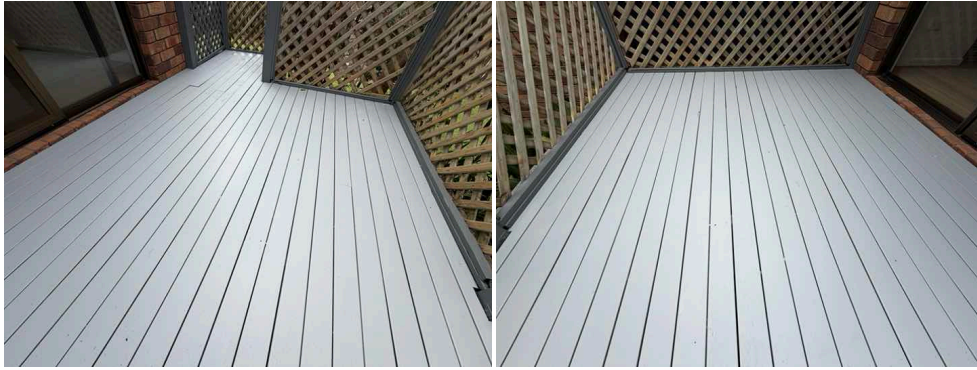
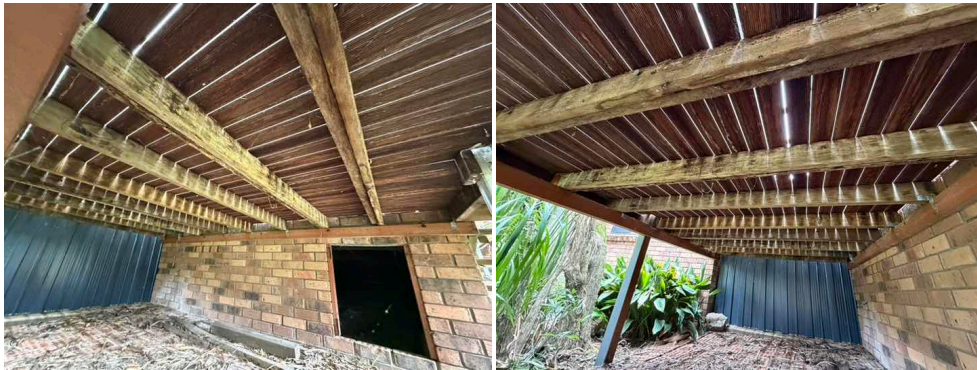
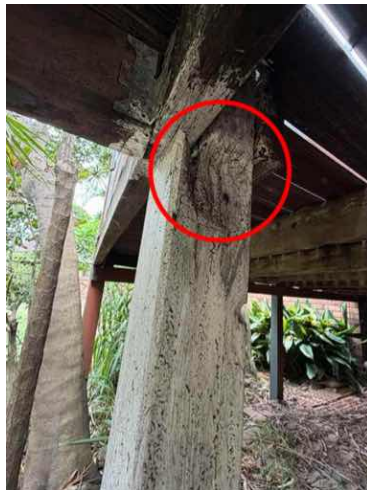
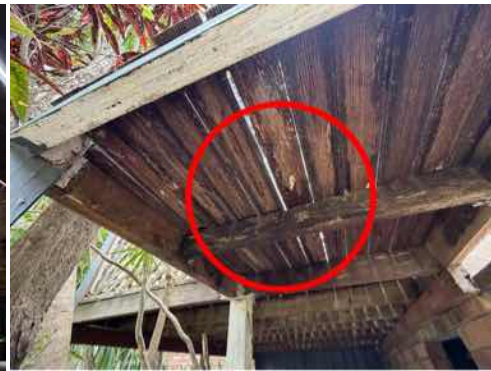
Deck Framework

Timber fungal decay in section of bearers or joists. This is a safety hazard and repair is required. A qualified carpenter should be engaged to replace all affected timbers.

Moisture damage was observed on deck boards - Recommendations: Evaluation and repairs by a qualified decking contractor.

Decking board surfaces are weathered. We recommend cleaning and maintenance as needed.

Balustrade rail height- should be 1 m in height from deck/balcony/patio floor. In some circumstances this regulation was non-existent dependent on the age of the dwelling and technically there is no requirement to rectify. Recommendations: We strongly advise you rectify to comply for safety concerns.

Post base timber fungal decay. Repairs as required. It is preferable to have posts on stirrups kept out of contact with soil. Timber in contact with ground is conducive to termite infestation and timber fungal decay.

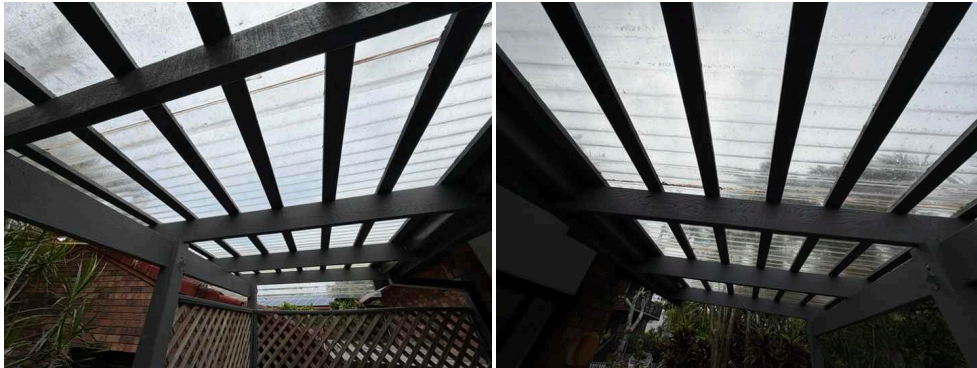
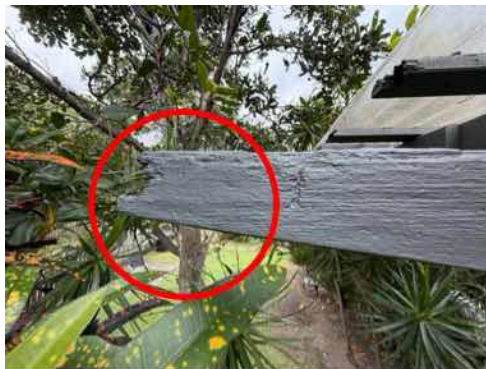
Pergola Framework

Timber fungal decay in the framework is visible. A qualified carpenter should be engaged for advice and recommendations.

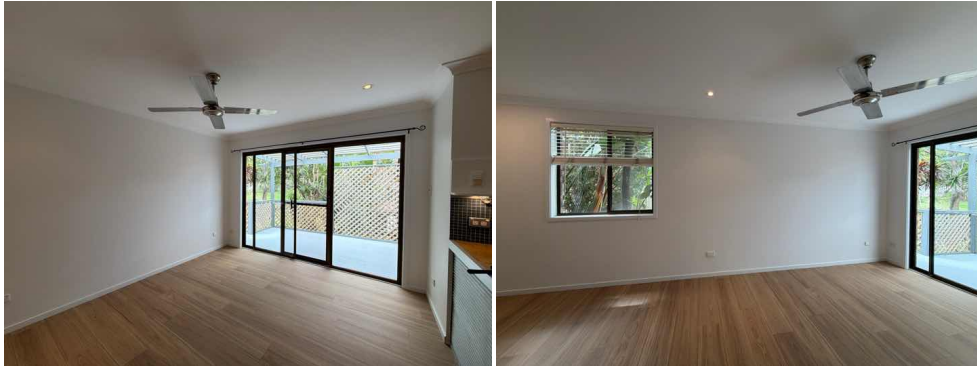
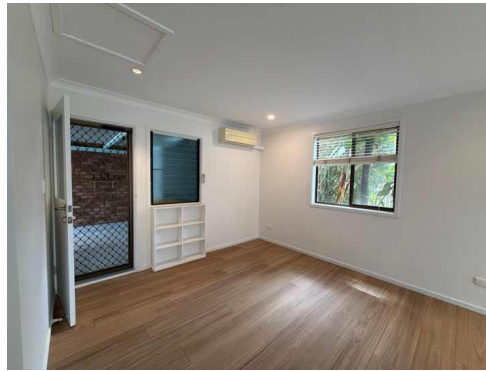
Flooring

Unevenness visible in floor. Possibly due to poor workmanship or excessive movement/settlement. A qualified carpenter should be engaged for advice and recommendations re levelling.

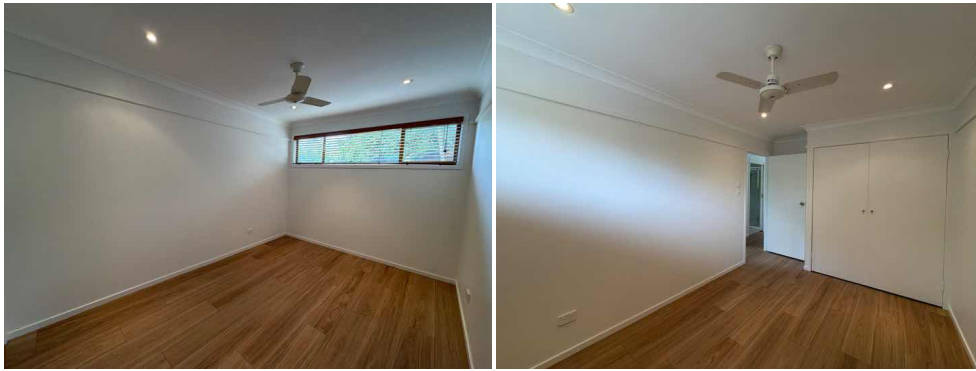
Door stop should be fitted - Wall damage from door handle impacting wall lining has occurred. I recommend you contact a qualified painter for repairs.

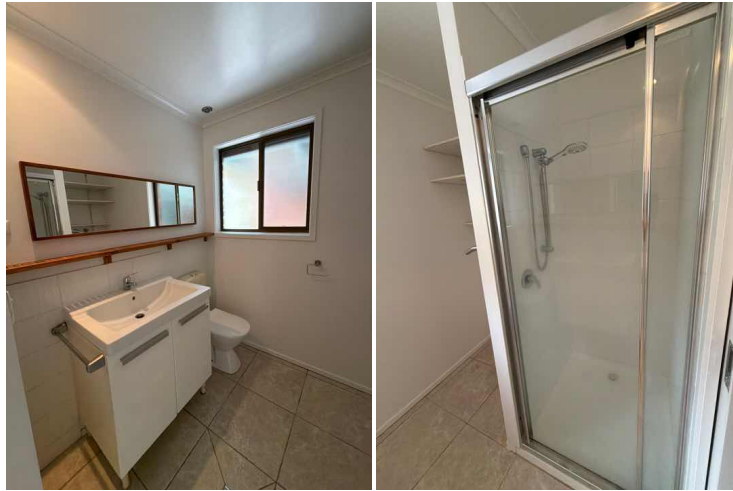
Walls

Settlement Cracks Noted . These are typical and generally patch and paint will suffice, however Monitoring these cracks advised for 12 months and if become wider or longer, you will need to contact a structural engineers to assess.

There are cracks to the vanity basin.

Shower head is leaking. Replacement recommended.

The shower screen door requires adjustment, maintenance or repair to operate properly.

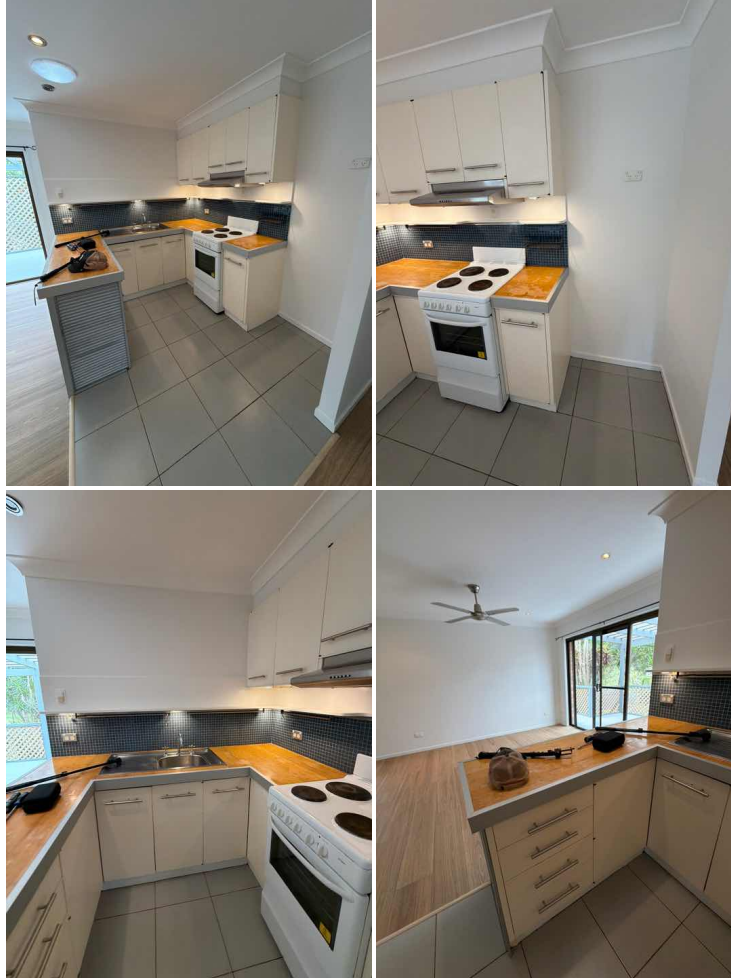
Cupboards And Bench Tops

Adjustment to cabinet doors required, in some instance hinges may need to be replaced.

Damage was noted to the cabinets, contact a joinery company for repairs

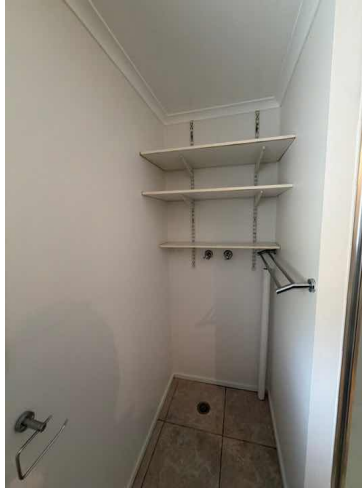
Ceiling

Cornice separation. I recommend you contact a licensed painter for repairs.

Settlement Cracks Noted . These are typical and generally patch and paint will suffice, however Monitoring these cracks advised for 12 months and if become wider or longer, you will need to contact a structural engineers to assess.

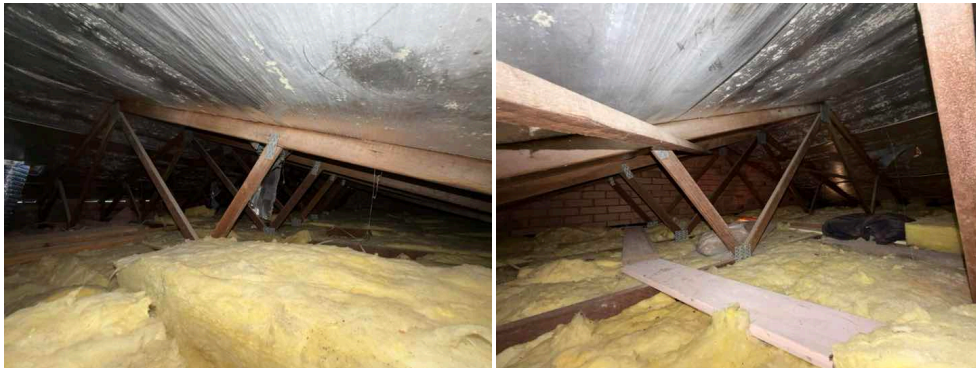
Insulation

Insufficient spacing between insulation and down lights. This poses a fire risk. Contact a qualified electrician for further advice and recommendations prior to a decision to purchase.

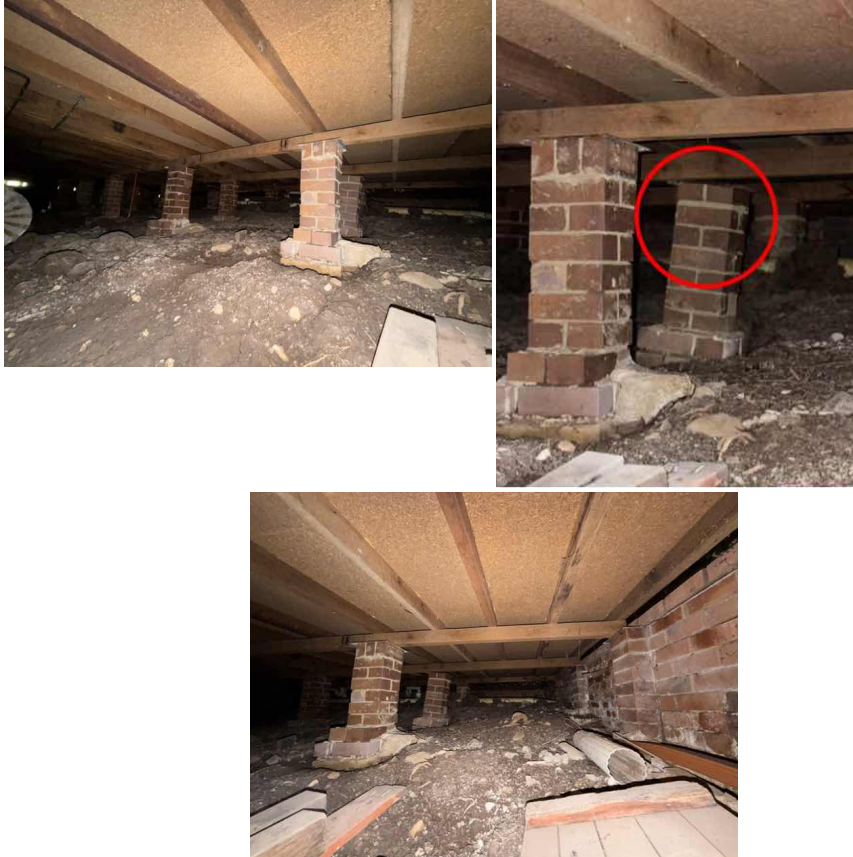
Piers And Foundation Walls

Rusted ant capping noted. Ant capping is not designed to prevent termite entry but to force the termites to reveal themselves by means of mud packing. Rusted, missing or defective ant capping will allow the termites to enter the building undetected. Contact a qualified brick layer for further advice

Evidence of minor subsidence (Sinking) was noted to the footings/piers that will require re packing or re building.

Some piers have settled over time, and are deflecting due to rotation. Some parts of the building have subsequently deflected from level. It is recommended that a licensed builder inspect the building's substructure and the defective piers be replaced as necessary.

Though dry at the time of inspection there is evidence of previous water ingress in sub floor. This is likely to happen again during periods of heavy rain. Further assessment and rectification is required as this may cause possibly create/add further footings problems and settlement to piers.

The underside of the residence is lower than the external ground level. This situation may cause external stormwater runoff to enter the sub floor area. The sub floor area should be monitored in times of heavy rainfall. Additional site drainage may be required

There was debris and other material in the subfloor, we recommend cleaning these to aid with ventilation and reduce the likely hood of rodents and pests.
