# Building and Pest Report

## 57 Lismore Road Alstonville

# BPI - INSPECTION REPORT

57 Lismore Road, Alstonville.

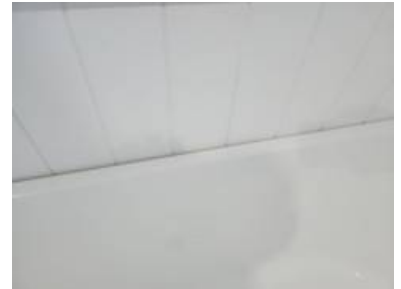
Junctions of Bathroom bath / wall sheeting require resealing with silicone.

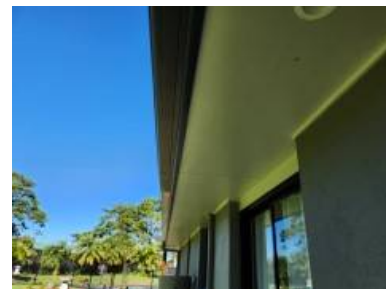
**Condition:**  
The external paintwork / finish to the external surfaces and timberwork is generally in good condition. There may be sections / areas that require touching up / repainting.

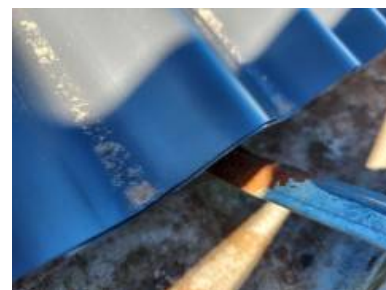
Some gutter brackets show signs of rust and require repair / painting with Killrust or better.

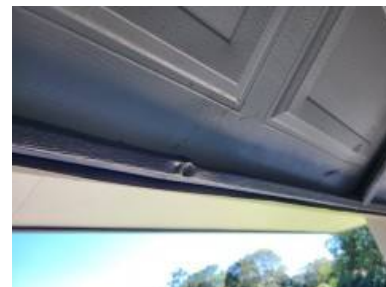
Minor damage to base of garage doors.

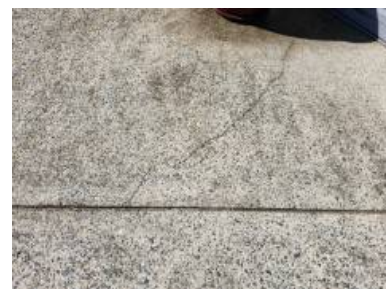
Some surface cracks to concrete slabs.

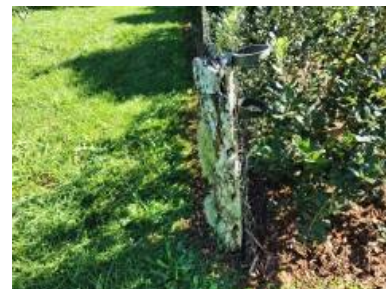
The timber fencing shows signs weather damage and require rectification work / replacement. The fencing will / may require further rectification / replacement at some stage in the future as timbers decay further.

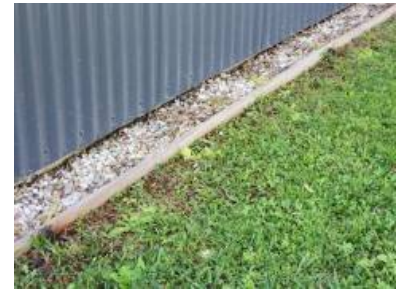
- I recommend that the slab edges to the perimeter be exposed by at least 75mm clearance as they are physical / visual termite barriers. If the slab edges are covered by things such as gardens, soil, paths or stored goods, they may allow concealed termite entry.
