Building and Pest Report

1/43 Silver Gull Dr East Ballina

Report/Agreement #	290426092547399
Inspection Date:	29 Apr 2026
Inspection Time:	09:25 am

Pest And Building Inspection

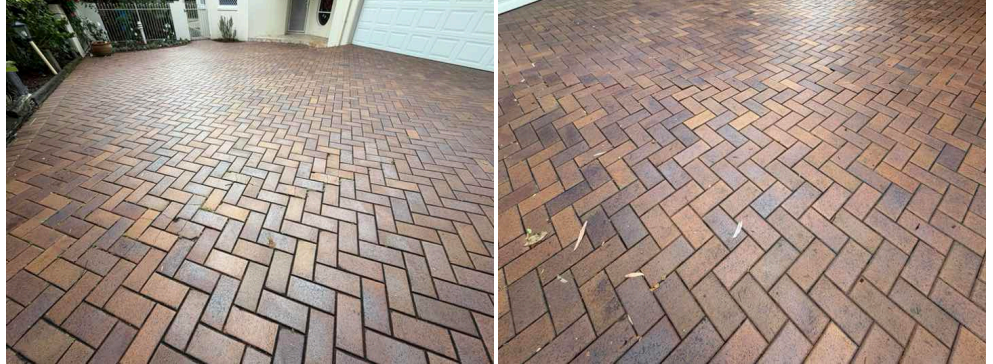
Driveway Condition

On visual inspection, the general condition of the driveway is serviceable.

Common cracks were observed on the driveway. Whilst these cracks appeared to be typical at the time of inspection, we strongly recommend you monitor these cracks and if worsening occurs contact a concreter for further advice.

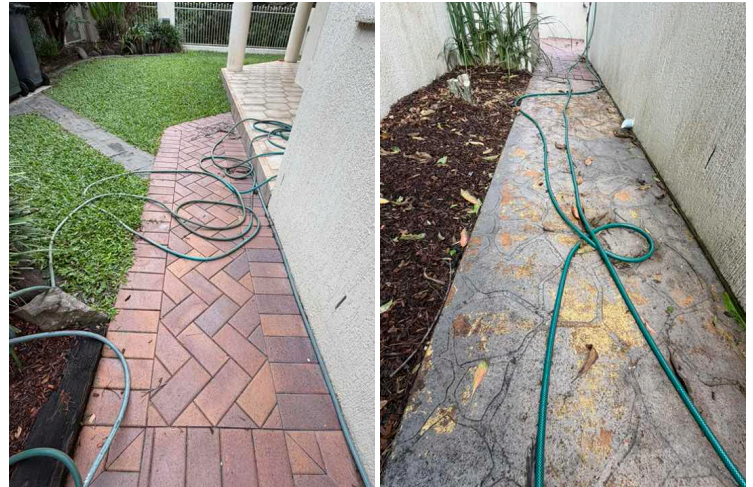
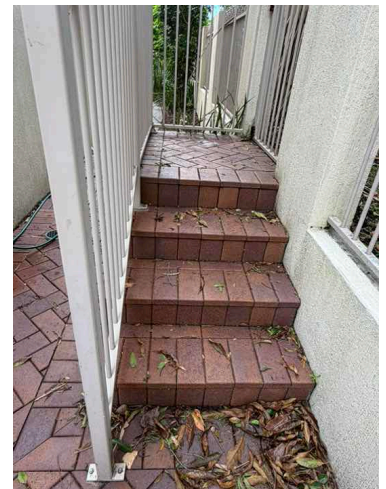
Pathways Condition

The paths around the home are in a serviceable condition for the age of this dwelling with no major defects visible.

Common cracks and settlement were observed on paths. Whilst these cracks appeared to be typical at the time of inspection, we strongly recommend you monitor these cracks and if worsening occurs contact a concreter for further advice.

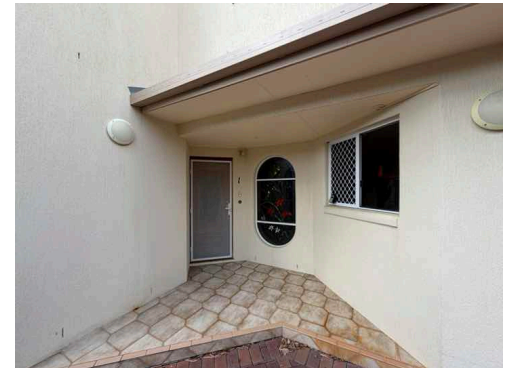
Base or Flooring Condition

Tile cracks evident on entry patio/porch - Recommendations: Engage a qualified tiling contractor to repair.

Upon visual inspection, several tiles were identified as drummy, indicating potential adhesion issues. This defect can lead to tile detachment if not addressed. It is recommended to engage a licensed tiler to assess the extent of the problem. The repair may involve re-bonding or replacing affected tiles to ensure stability and prevent further damage. Regular monitoring is advised to maintain tile integrity.

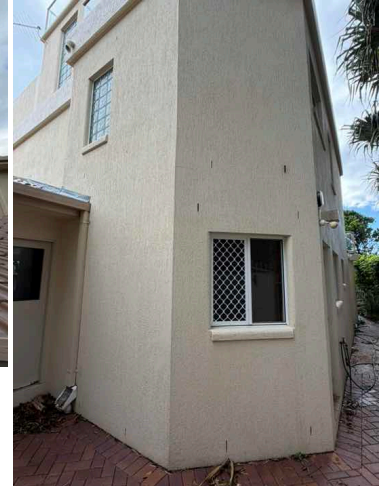
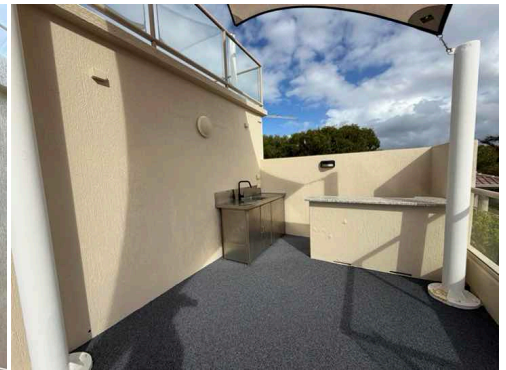
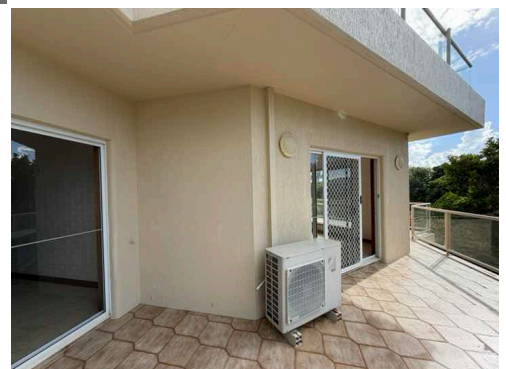
Condition

On visual inspection, the general condition of the exterior walls is serviceable for the age. External cladding is in contact with the ground. This is a conducive condition for moisture penetration causing decay and/or concealed termite entry. Contact a licensed builder for recommendations.

There appears to have been some settlement in the building which has caused some cracking to the walls. These cracks are categorized as 0 to 2. This can also cause some doors to bind or be out of square. In the inspectors opinion these cracks are due to settlement, usually due to ground movement and subsequent movement to building materials can be expected. Any cracks should be monitored and if cracks increase in size, further investigation should be carried out by a structural engineer.

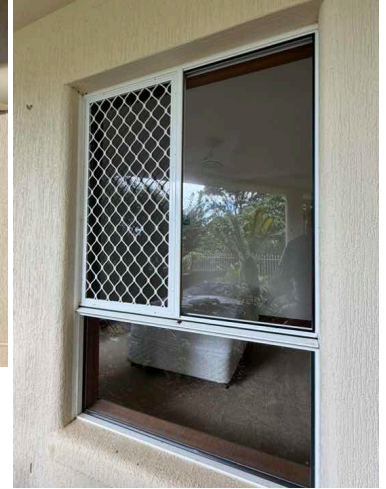
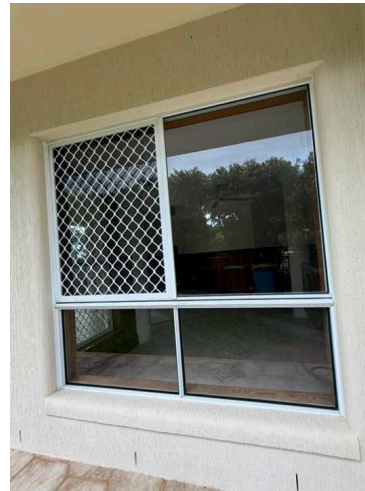
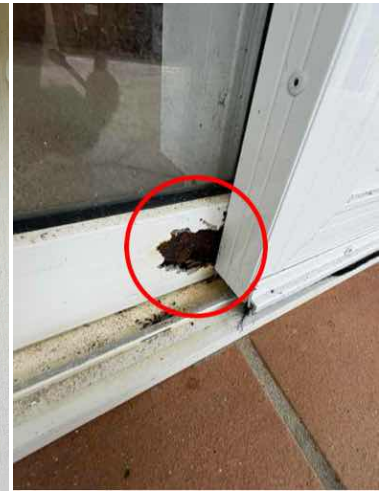
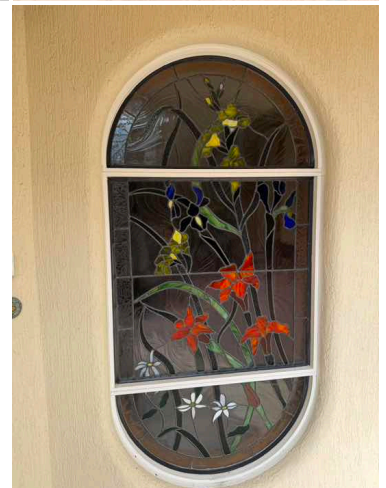
Overall Condition

On visual inspection, the general condition of the windows is serviceable for the age. General age/damage has occurred to window components. Recommendations: Restoration work recommended. A qualified carpenter should be engaged for advice and recommendations.

Rust is evident in sections of the homes window framework. Some areas should be repaired. A suitably qualified tradesman should be engaged for advice and recommendations.

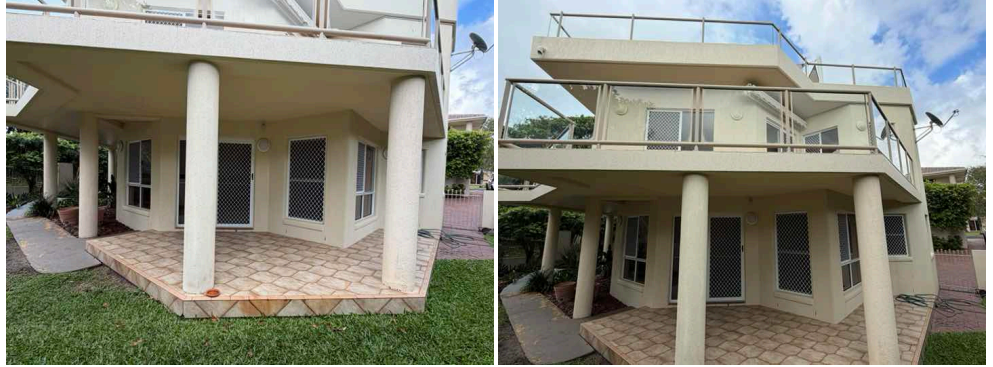
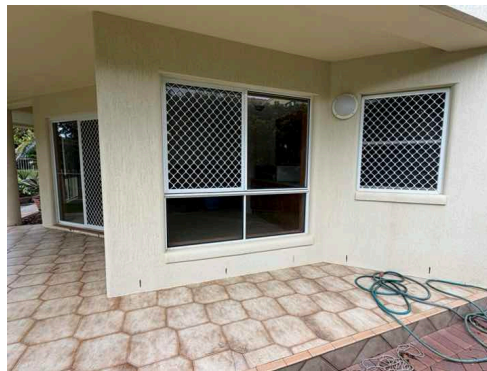
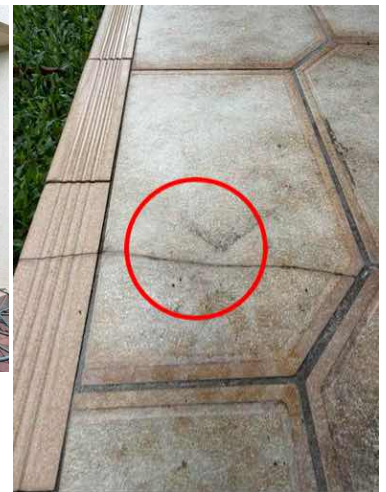
Flooring

Tiles are drummy and loose. This needs to be fixed by a qualified tiler to eliminate any water penetration issues.

Tile cracking observed. A qualified tiler should be engaged for advice and recommendations. This may cause leaking and water penetration.

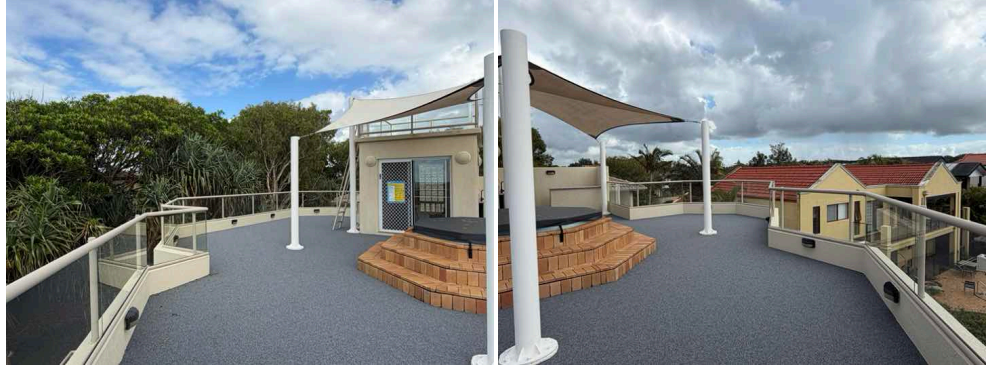
Balustrade Condition

Upon visual inspection, the glass balustrade shows chipping on the edges, compromising safety and aesthetics. Immediate attention is required to prevent further damage or potential injury. It is recommended to engage a licensed glazier to assess the extent of the damage and replace the affected panels. Ensure all installations comply with safety standards to maintain structural integrity and visual appeal.

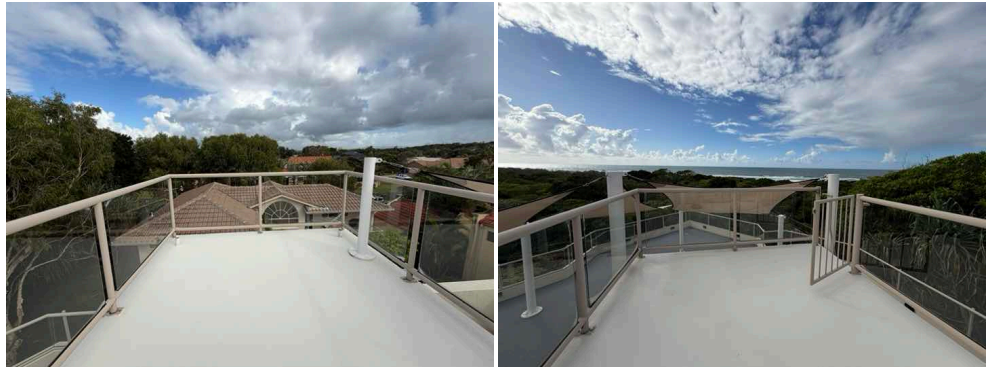
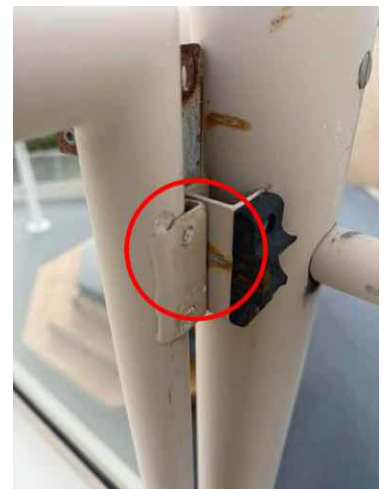
Balustrade Condition

Though we are not structural engineers the balcony/s appear to be in a serviceable condition. Upon visual inspection, cracks were observed in the exterior wall, indicating potential structural issues. Recommend engaging a licensed structural engineer to assess and repair the damage. Additionally, water stains on the ceiling suggest a possible roof leak. A licensed roofer should be consulted to identify and fix the source of the leak to prevent further damage.

Upon visual inspection, the glass balustrade shows chipping on the edges, compromising safety and aesthetics. Immediate attention is required to prevent further damage or potential injury. It is recommended to engage a licensed glazier to assess the extent of the damage and replace the affected panels. Ensure all installations comply with safety standards to maintain structural integrity and visual appeal.

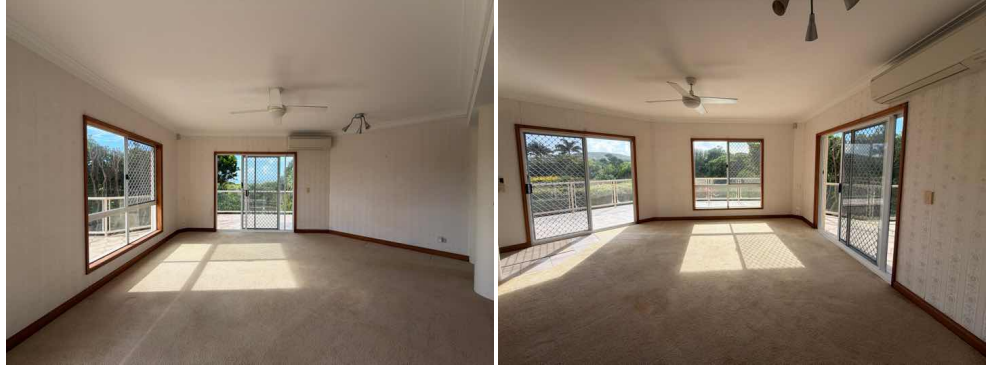
Door

Upon visual inspection, a water stain was observed on the architrave. This indicates potential moisture intrusion, possibly from a leak or condensation. It is recommended to engage a suitably licensed or qualified tradesperson to assess the source of moisture, repair any leaks, and replace or treat the affected architrave to prevent further damage and ensure structural integrity.

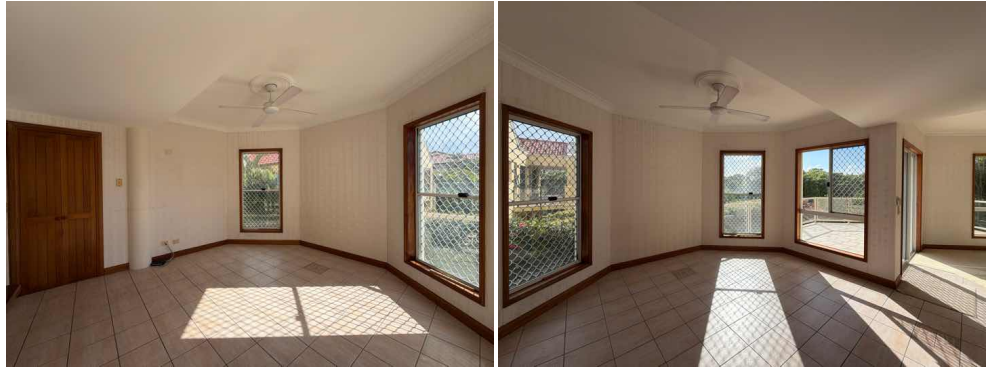
Walls

Upon visual inspection, moisture stains were observed on the skirtings, indicating potential water intrusion. It is recommended to engage a licensed tradesperson to assess the source of moisture, repair any leaks, and replace damaged skirting. Ensure proper sealing and ventilation to prevent recurrence. Regular monitoring and maintenance are advised to maintain the integrity of the area.

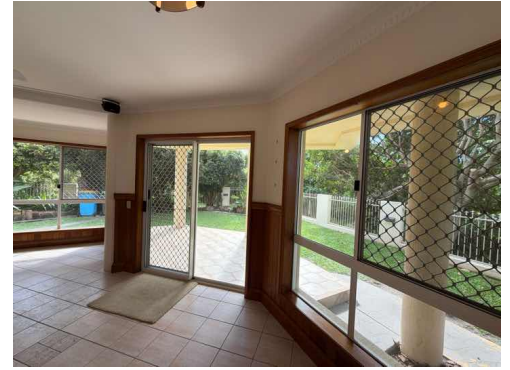
Windows

Upon visual inspection, moisture staining was observed on the architrave/skirting. This indicates potential water ingress or plumbing issues. It is recommended to engage a licensed tradesperson to assess the source of moisture, repair any leaks, and replace damaged sections. Ensuring proper sealing and ventilation will prevent future occurrences. Regular maintenance checks are advised to maintain the integrity of the area.

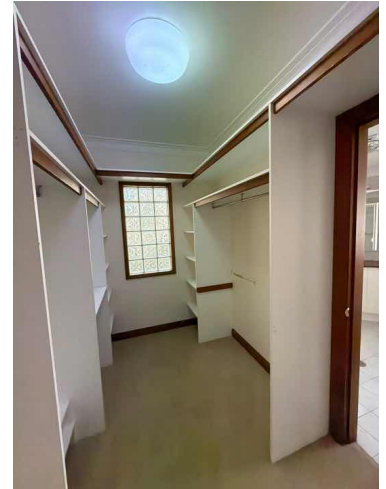
Windows

Upon visual inspection, moisture staining was observed on the architrave/skirting. This indicates potential water ingress or plumbing issues. It is recommended to engage a licensed tradesperson to assess the source of moisture, repair any leaks, and replace damaged sections. Ensuring proper sealing and ventilation will prevent future occurrences. Regular maintenance checks are advised to maintain the integrity of the area.

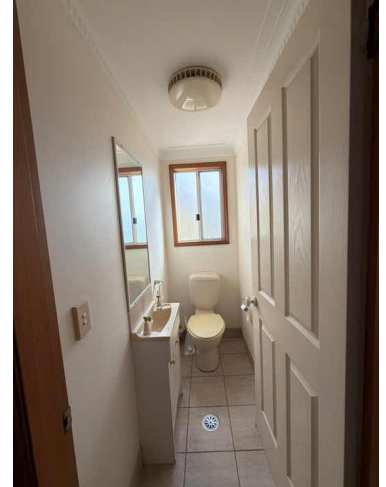
Door

Water damaged door. Possible due to leak in bathroom. Replacement recommended.

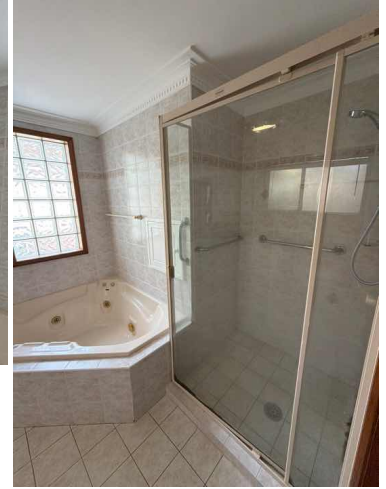
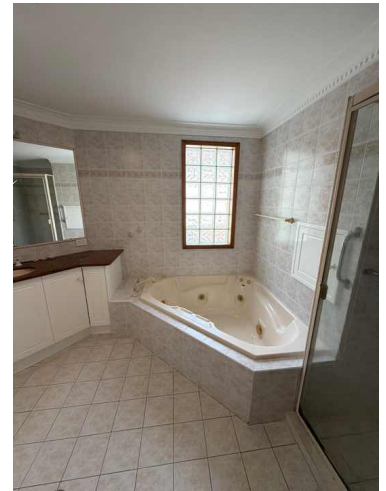
Walls

Damaged tile/s observed . Have repaired by a qualified tiler.

Deteriorated grout noted. This should be repaired as this will lead to water ingress under the tiles causing uplifting and possible water penetration.

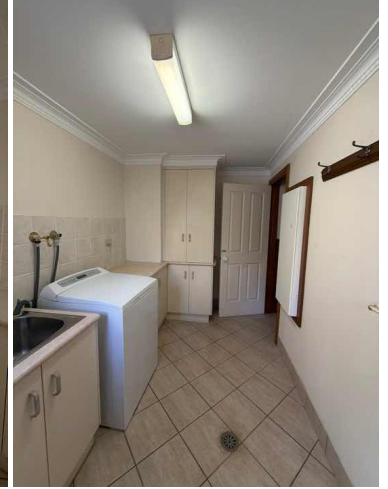
Doors

Door / frame deterioration - General age/damage has occurred to door frame, face or components. Recommendations: A qualified carpenter should be engaged for advice and recommendations.

Upon visual inspection, moisture damage was observed in the living room ceiling, likely due to a roof leak. Recommend engaging a licensed roofer to assess and repair the roof to prevent further water ingress. Additionally, a qualified tradesperson should replace damaged ceiling materials and ensure proper ventilation to mitigate future moisture issues. Regular maintenance checks are advised to prevent recurrence.
