# Building and Pest Report

## 7B Admiral Vista, Lennox Head

# Inspection Report

**7B Admiral Vista, Lennox Head , NSW, 2478**

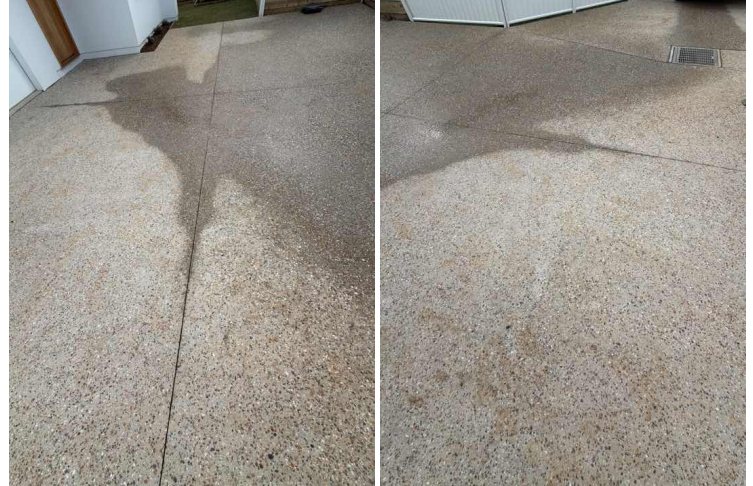
On visual inspection, the general condition of the driveway is serviceable.

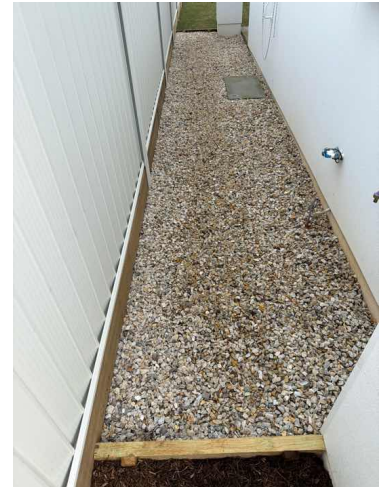
The paths around the home are in a serviceable condition for the age of this dwelling with no major defects visible.

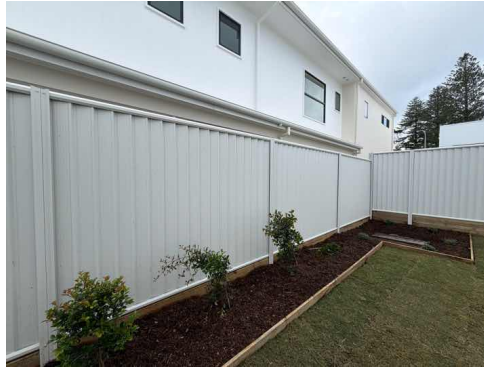
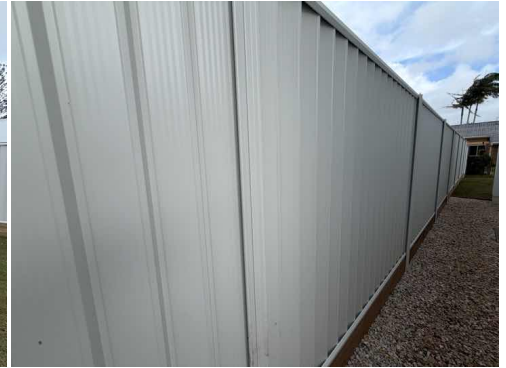
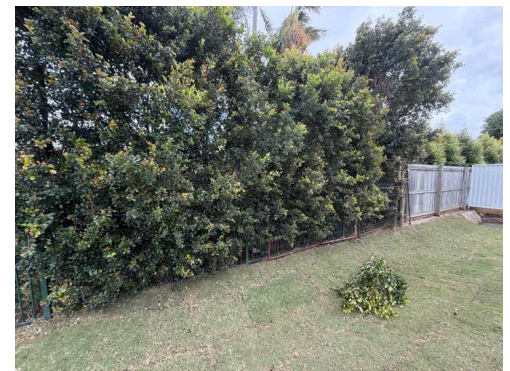
Of the visible areas, the general condition of the fences and gates is serviceable for the age of dwelling.

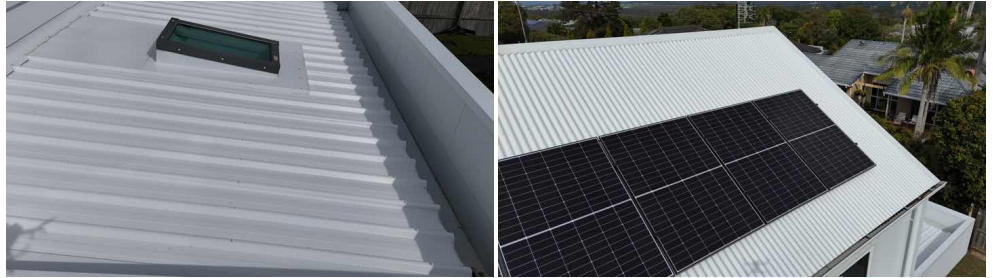
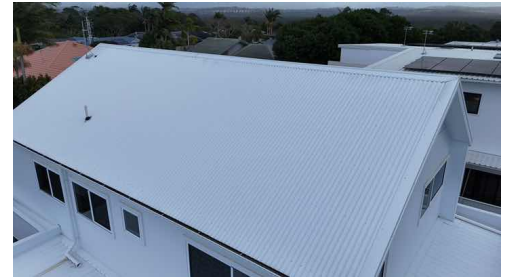
Of the visible areas, the general condition of the roof is in serviceable condition for the age.

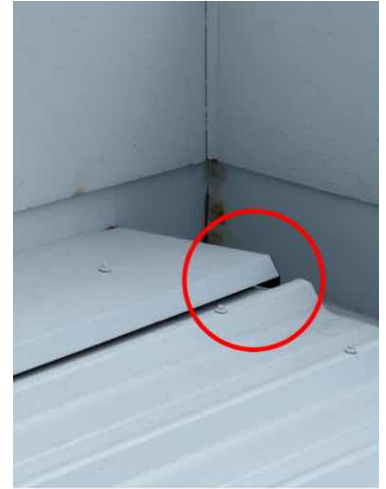
Minor flashing lift/detachment. A qualified roofer should be engaged for repairs and recommendations.

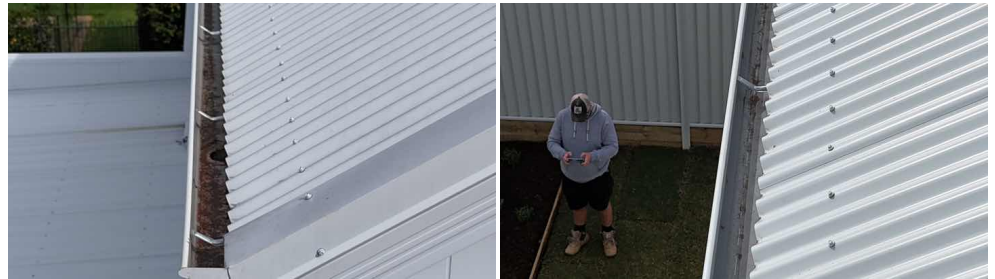
All visible and accessible of the physical nature of the guttering system appears to be in a serviceable condition with no apparent defects at the time of inspection. In the absence of prolonged rain fall efficiency of the guttering can not be assessed and you may find that further investigation or repairs maybe required. Note: Periodic maintenance checks should be carried out for rust penetrations and leaks.

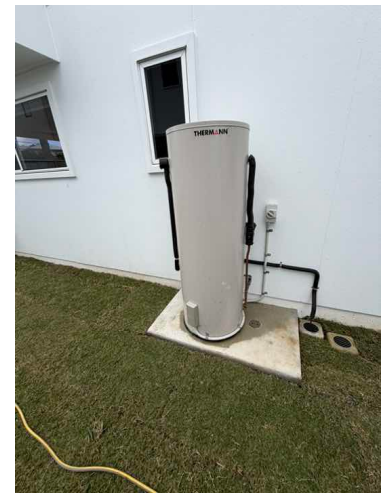
The hot water system appears to be in a serviceable condition. No specific tests other than running the hot water from a tap was carried out. No determination has been made as to the suitability or adequacy of the hot water system in relation to capacity or otherwise.

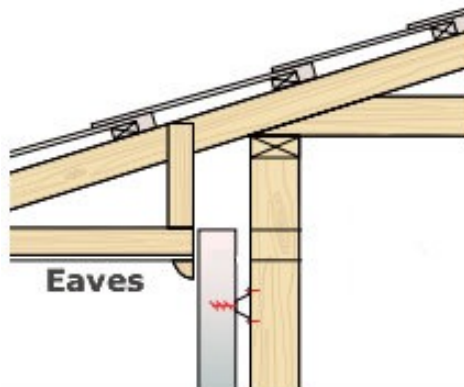
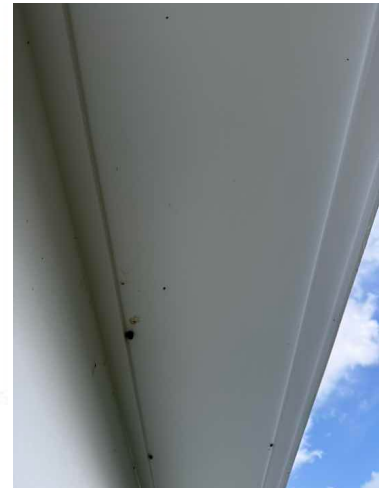
The soffit lining (eaves) are in a serviceable condition with no notable defects.

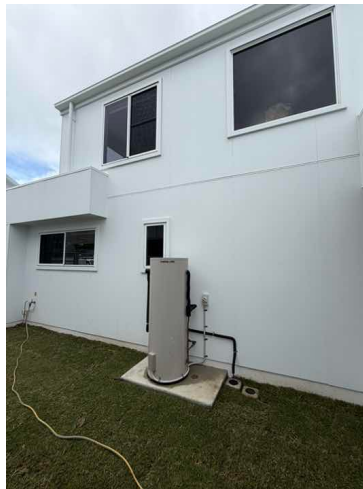
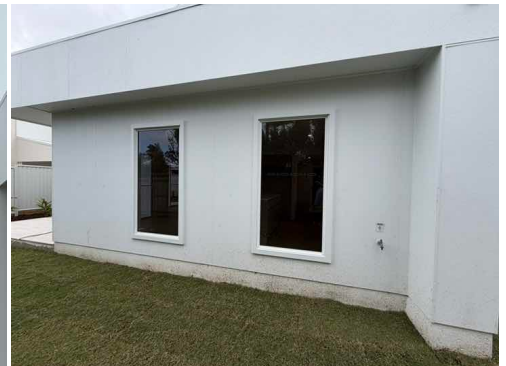
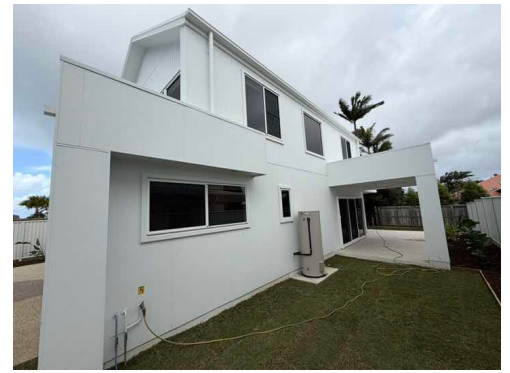
On visual inspection, the general condition of the exterior walls is serviceable for the age.

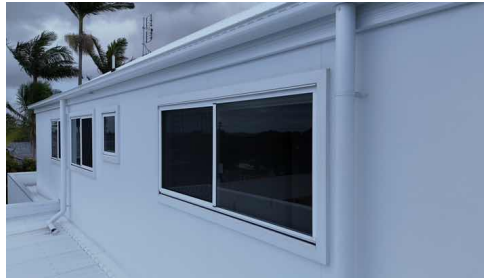
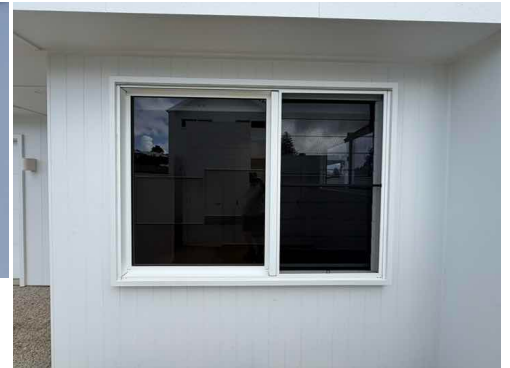
On visual inspection, the general condition of the windows is serviceable for the age.

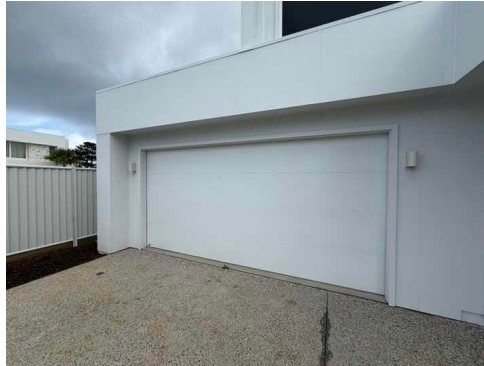
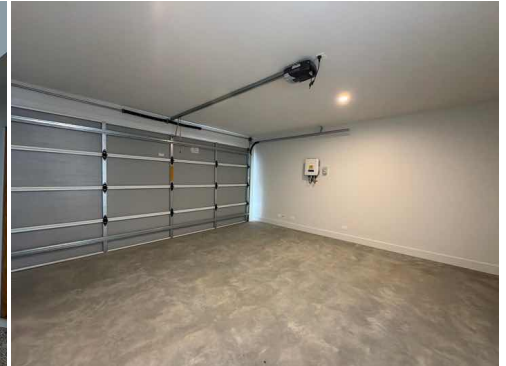
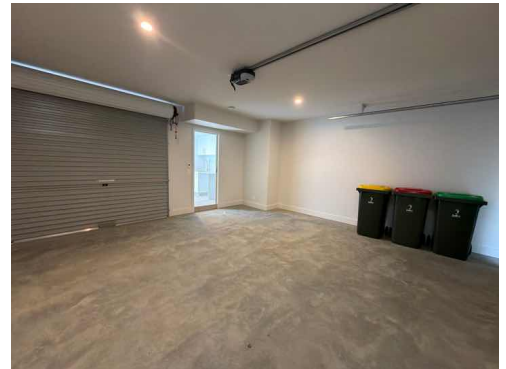
From the visible and accessible areas, the garage appears to be in a serviceable condition for the age of the property with no notable structural defects sighted.

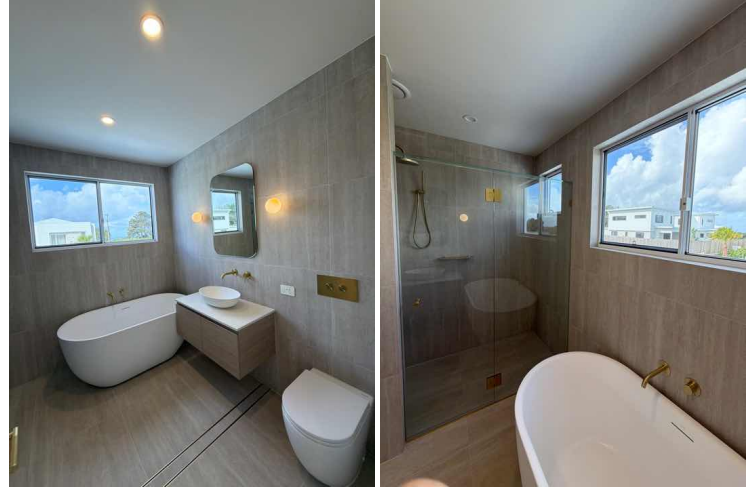
Door stop should be fitted - Wall damage from door handle impacting wall lining has occurred.  
Recommendations: A qualified carpenter should be engaged for advice and recommendations.

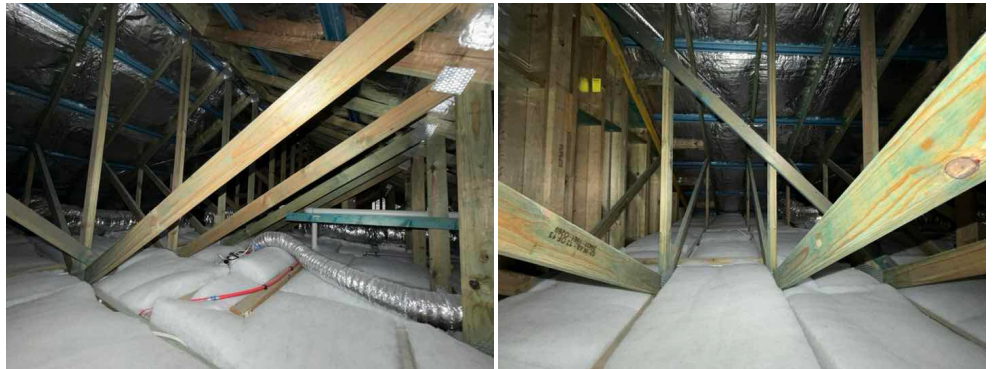
Visible sections of the roof void is in a serviceable condition for age of this dwelling.
