# Inspection Report

## East Coast Building Solutions

**58 Hutley Drive , Lennox Head , NSW, 2478**

### Pest And Building Inspection

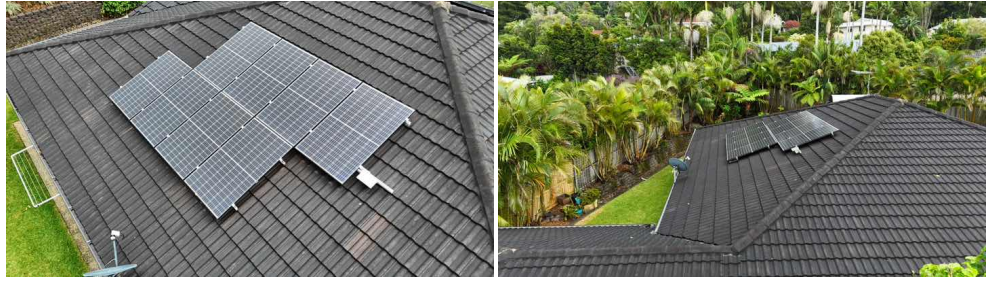
The roof is of concrete tiles.  
Upon visual inspection, the roof ridge shows mortar deterioration. Recommend engaging a licensed roofer to repair the damaged mortar to prevent water ingress and further structural issues. Regular maintenance checks should be scheduled to ensure ongoing roof integrity.

#1. Mortar cracks visible. We recommend having these repaired by a qualified roofer as they may contribute to water ingress.
