Building and Pest Report

58 Hutley Drive, Lennox Head

Report/Agreement # 2702260927567

Pest And Building Inspection

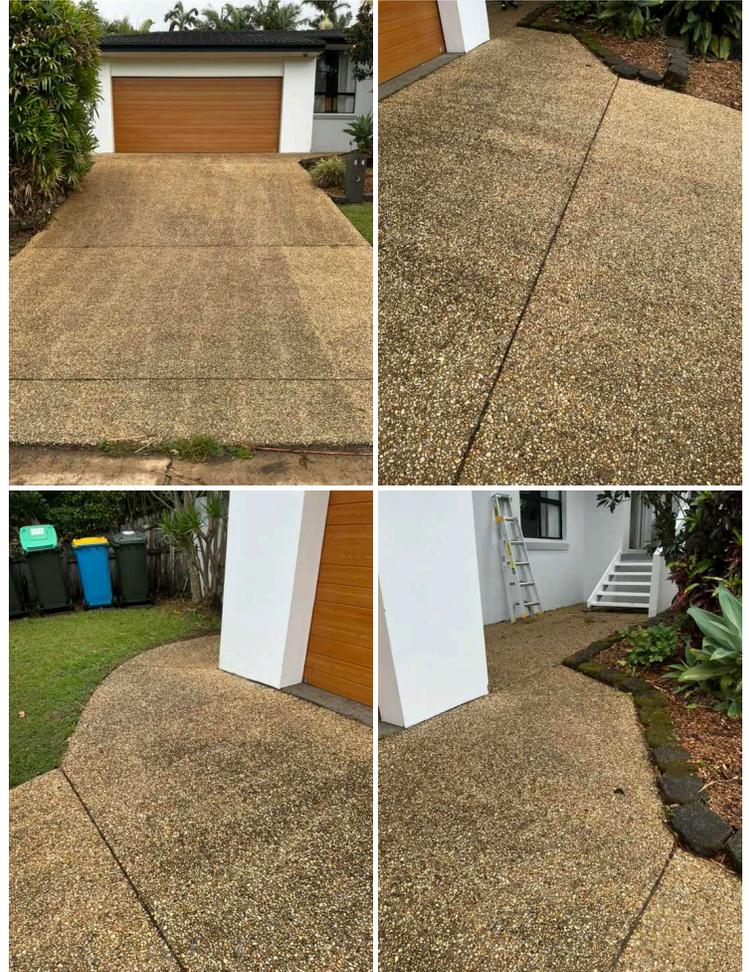
Driveway Condition

On visual inspection, the general condition of the driveway is serviceable.

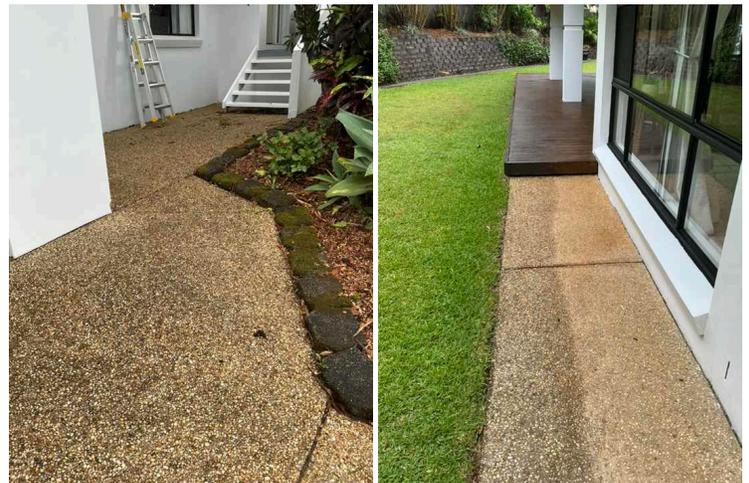
Pathways Condition

The paths around the home are in a serviceable condition for the age of this dwelling with no major defects visible.

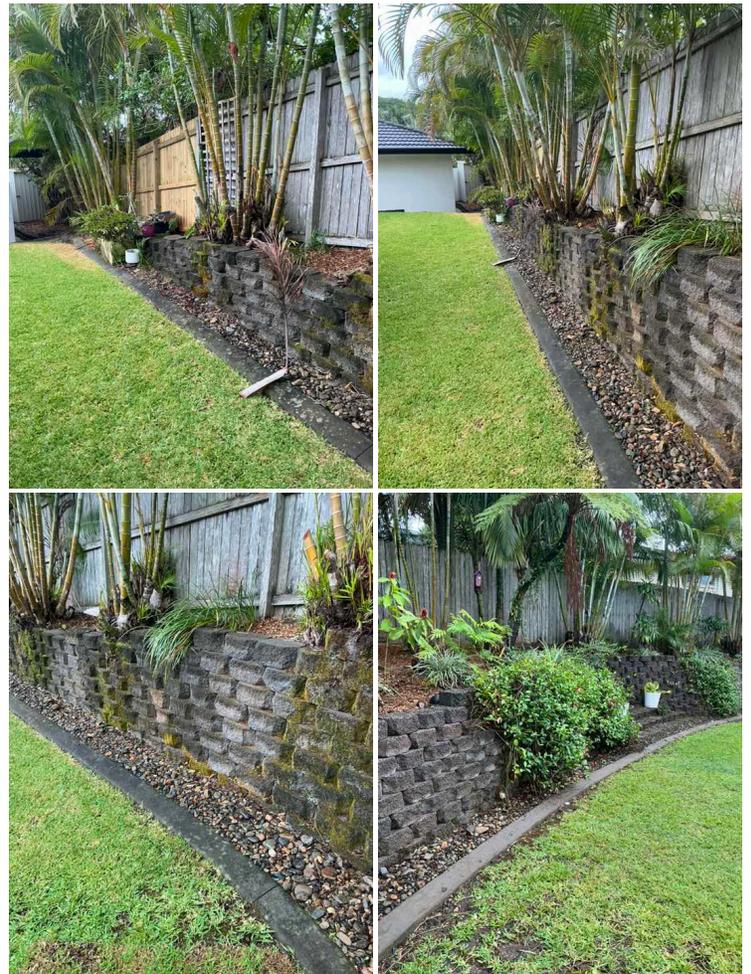
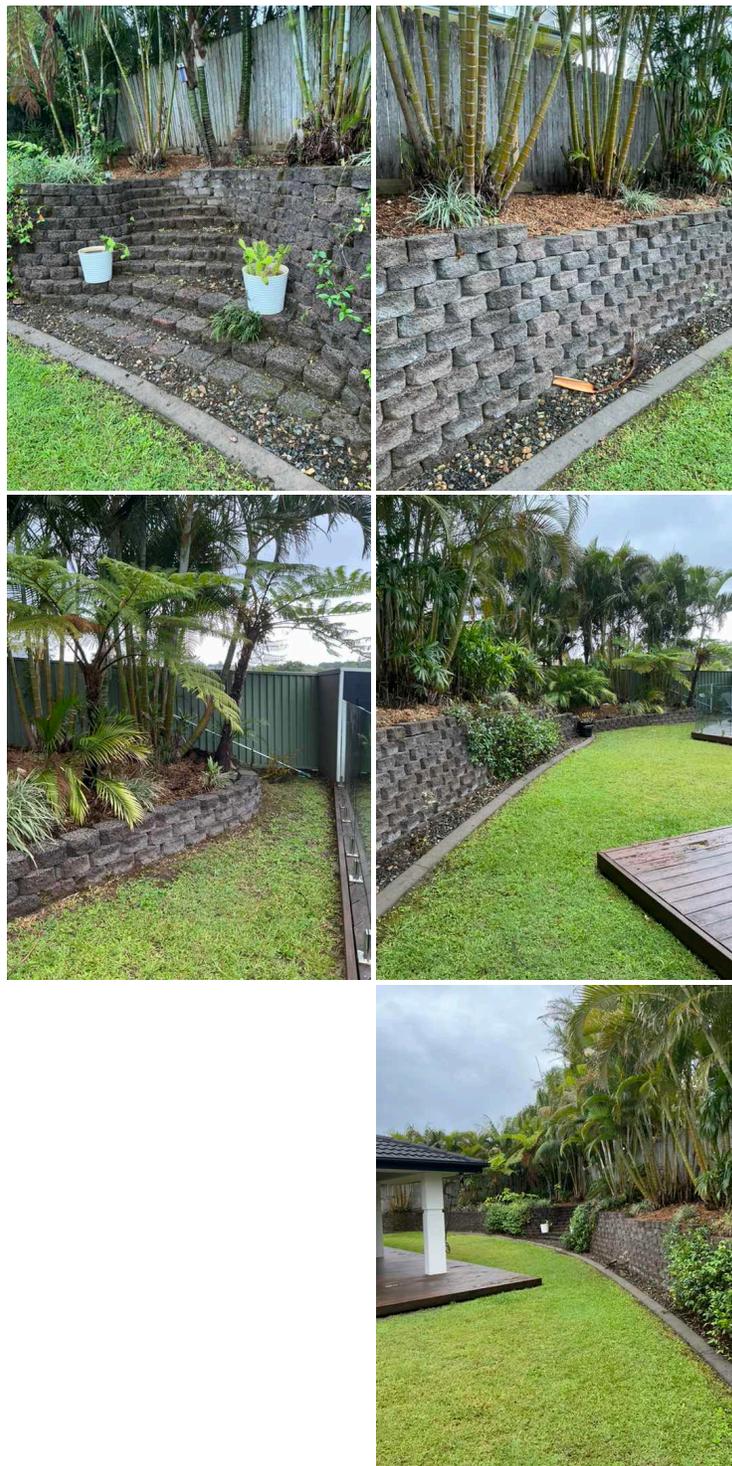
Overall Condition

Of the visible areas, the general condition is serviceable or in reasonable condition for age of dwelling.

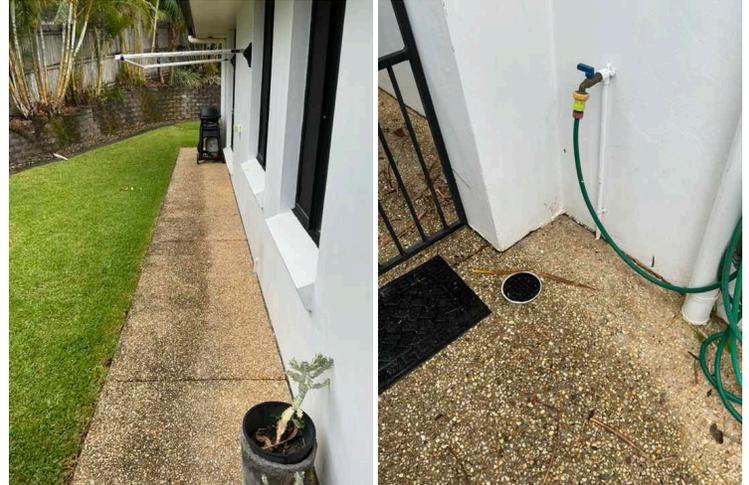
Drainage Findings

There was no visible evidence of excess ponding or fall towards the property walls at the time of the inspection. Regardless, it is difficult to ascertain in dry conditions and it is therefore recommended that you assess same after a rainfall period to be able to sufficiently ascertain if any problems exist in this regard. If water is ponding around perimeter walls and paths or appears to be flowing into the footings/foundations you must have assessed by a qualified plumber or landscaper.

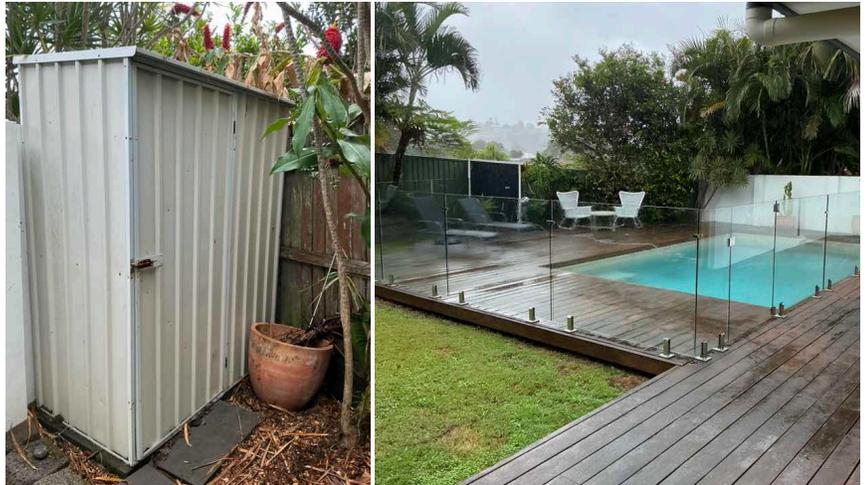
Shed Condition

The shed is in fair usable condition.

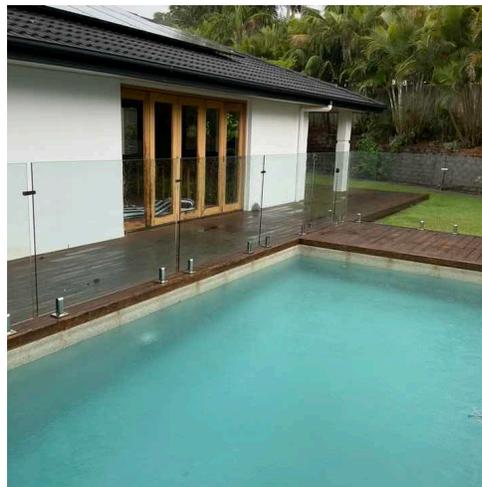
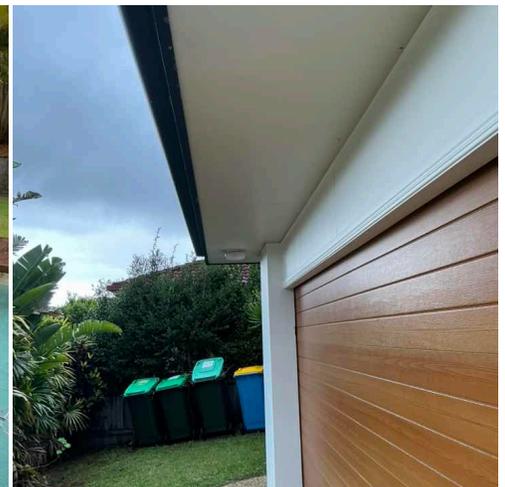
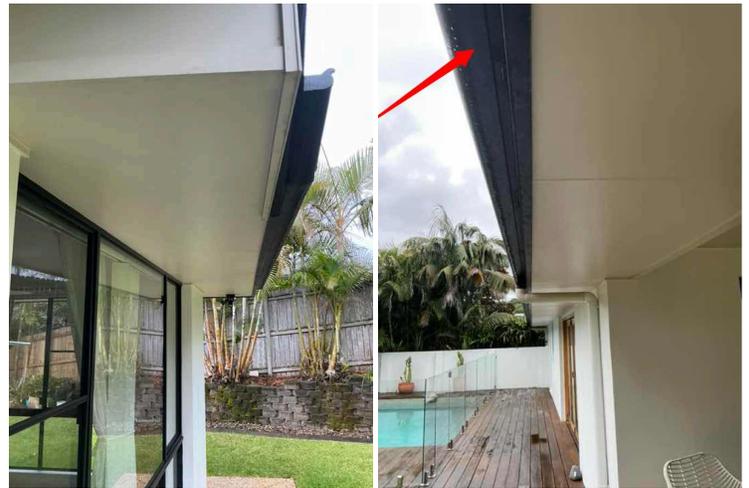
Gutter Findings

All visible and accessible of the physical nature of the guttering system appears to be in a serviceable condition with no apparent defects at the time of inspection. In the absence of prolonged rain fall efficiency of the guttering can not be assessed and you may find that further investigation or repairs maybe required. Note: Periodic maintenance checks should be carried out for rust penetrations and leaks.

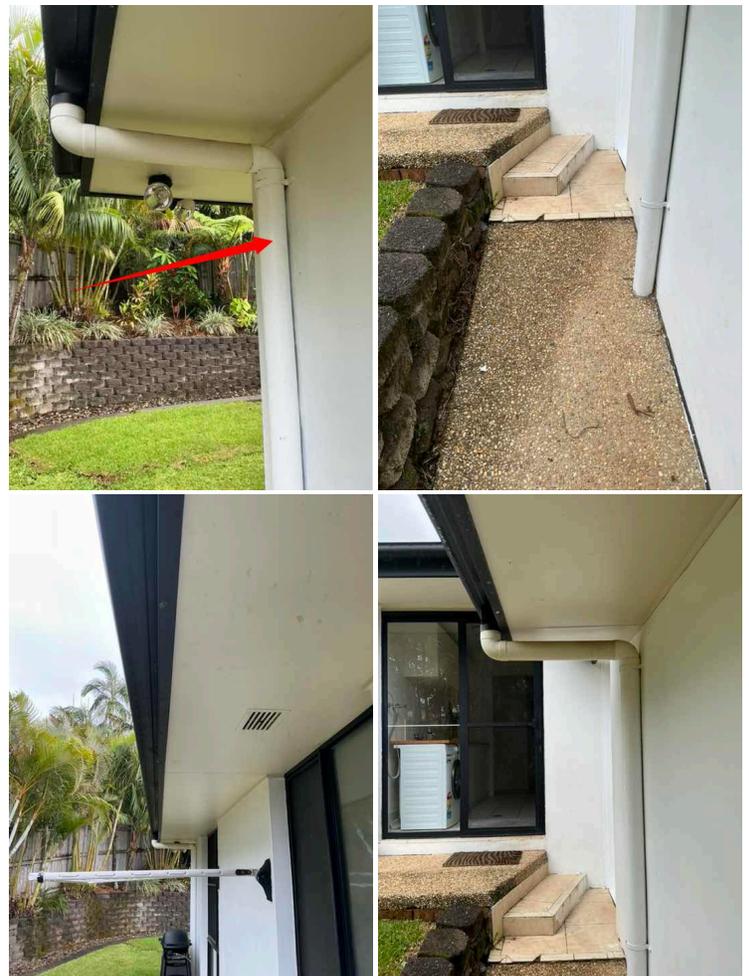
Downpipe Findings

On visual inspection no apparent defects were noted to the down pipes and are considered serviceable, however no comment can be made with regard to blockages or connections to stormwater or functionality in the absence of rain. Note: Periodic maintenance checks should be carried out for rust penetrations and leaks.

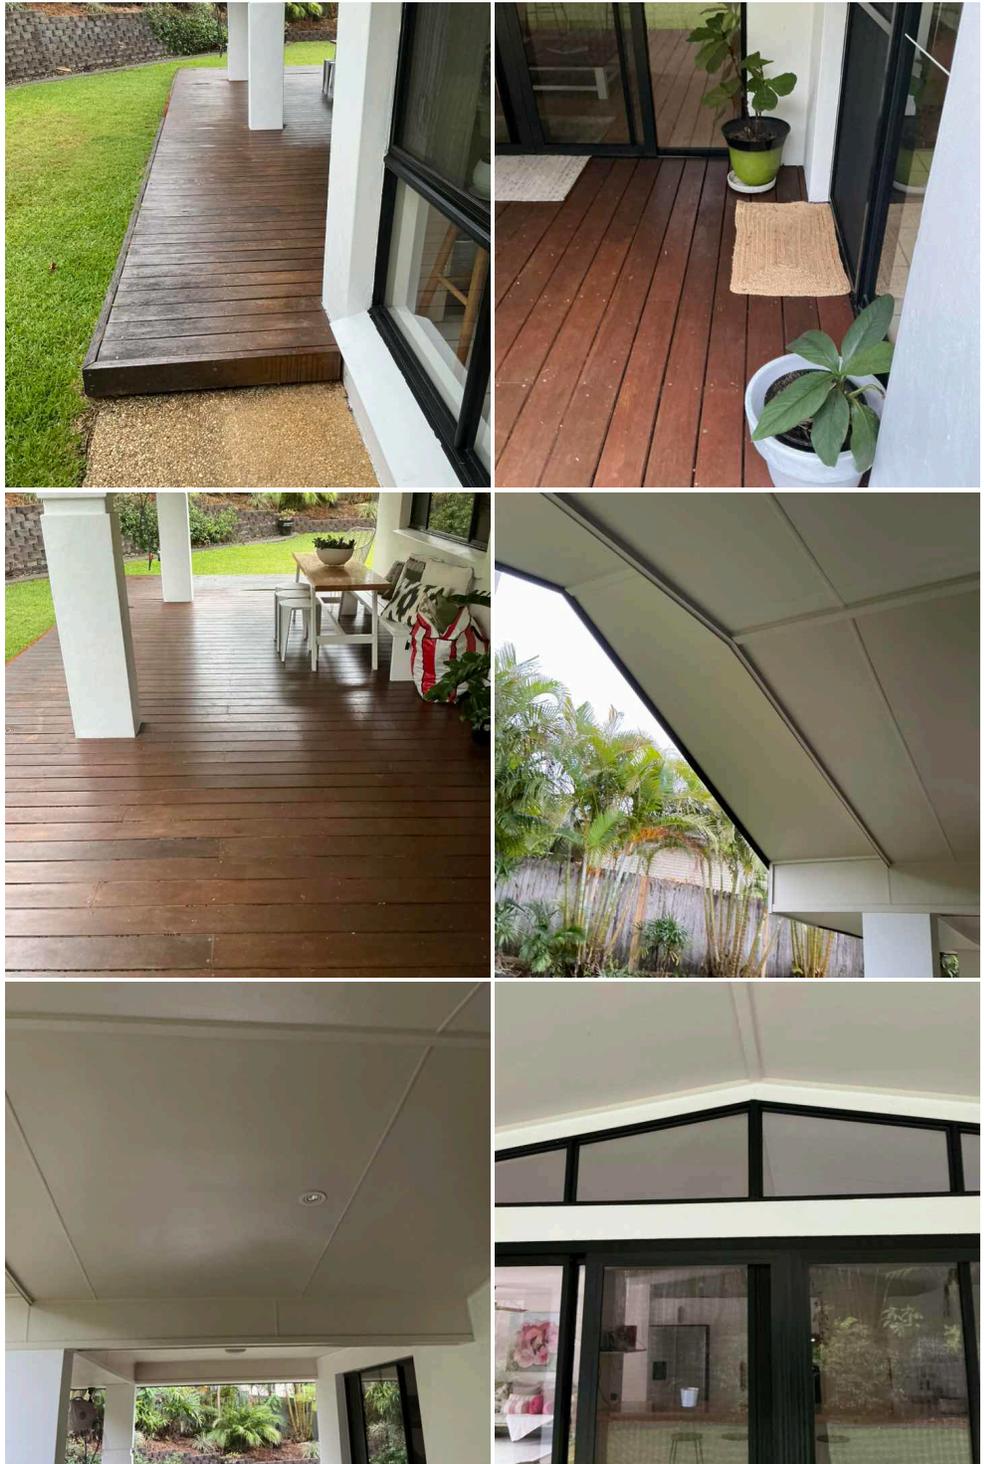
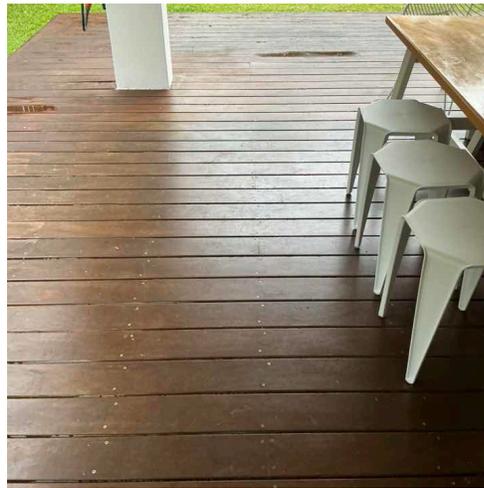
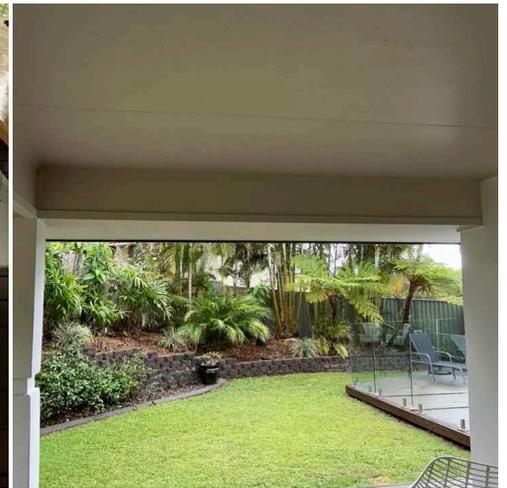
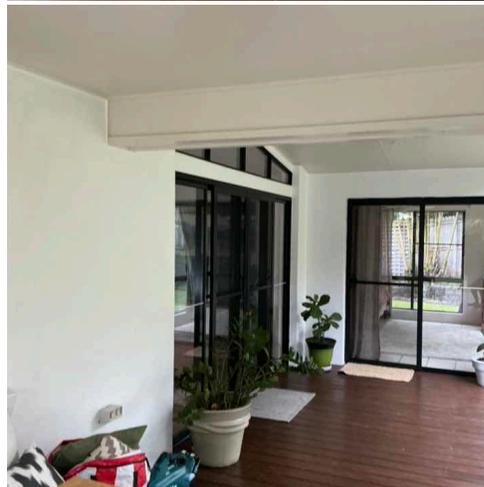
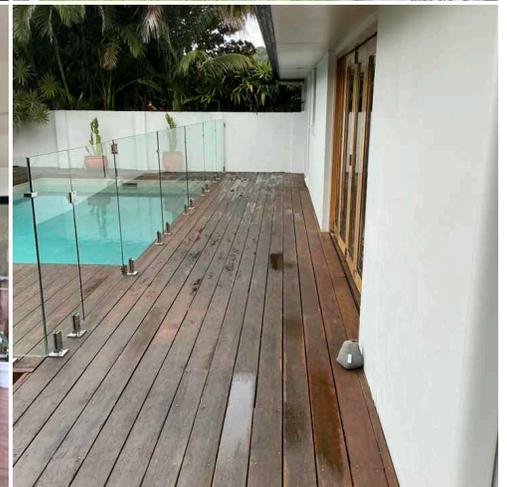
Visible sections of the Alfresco area are serviceable or in reasonable or condition for the age of this dwelling.

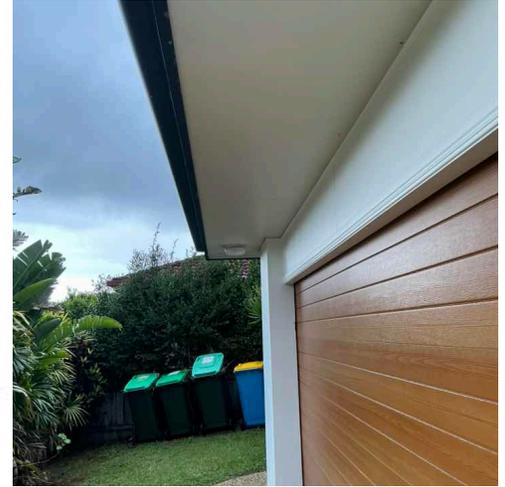
Eave Condition

The soffit lining (eaves) are in a serviceable condition with no notable defects.

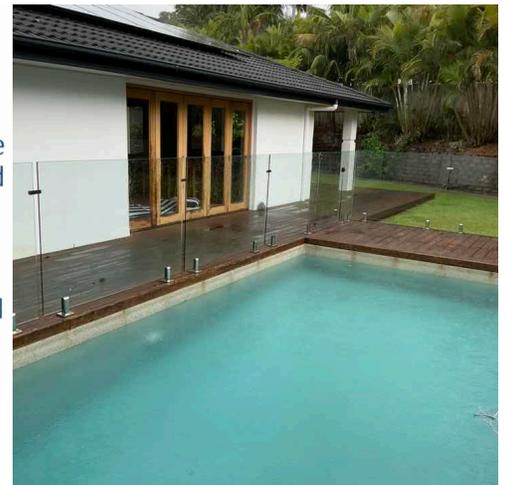
On visual inspection, the general condition of the fascia/barge boards is serviceable.

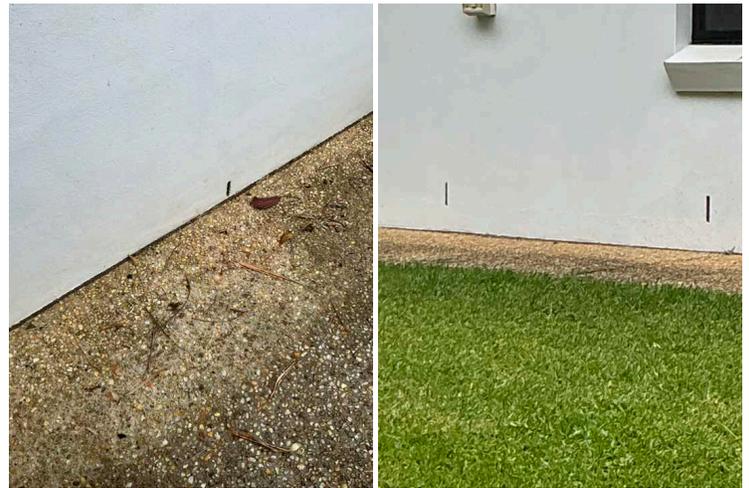
Rising Damp

Of the visible and accessible areas, there was no visible evidence of excessive rising damp on the external walls at time of inspection.

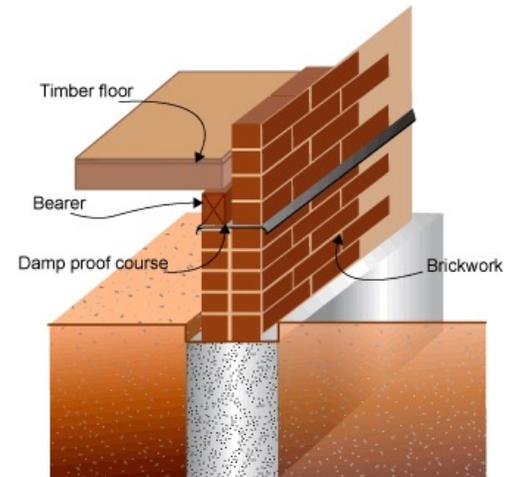
Damp Proof Course

A damp proof course (DPC) was noted.

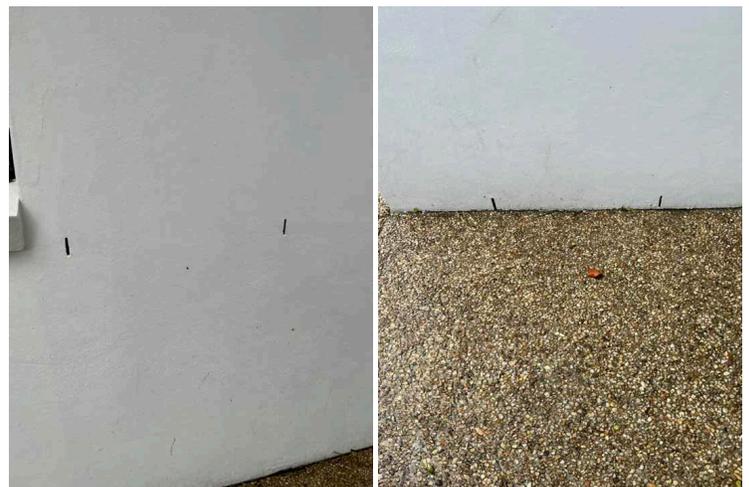
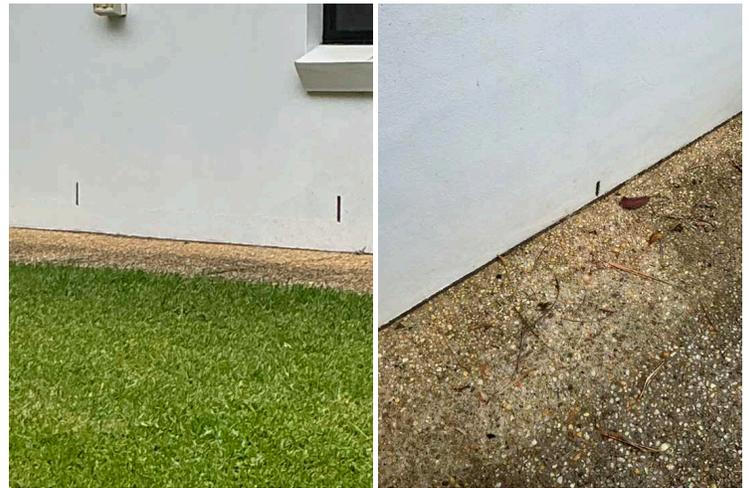
On visual inspection, the general condition of the exterior walls is serviceable for the age.

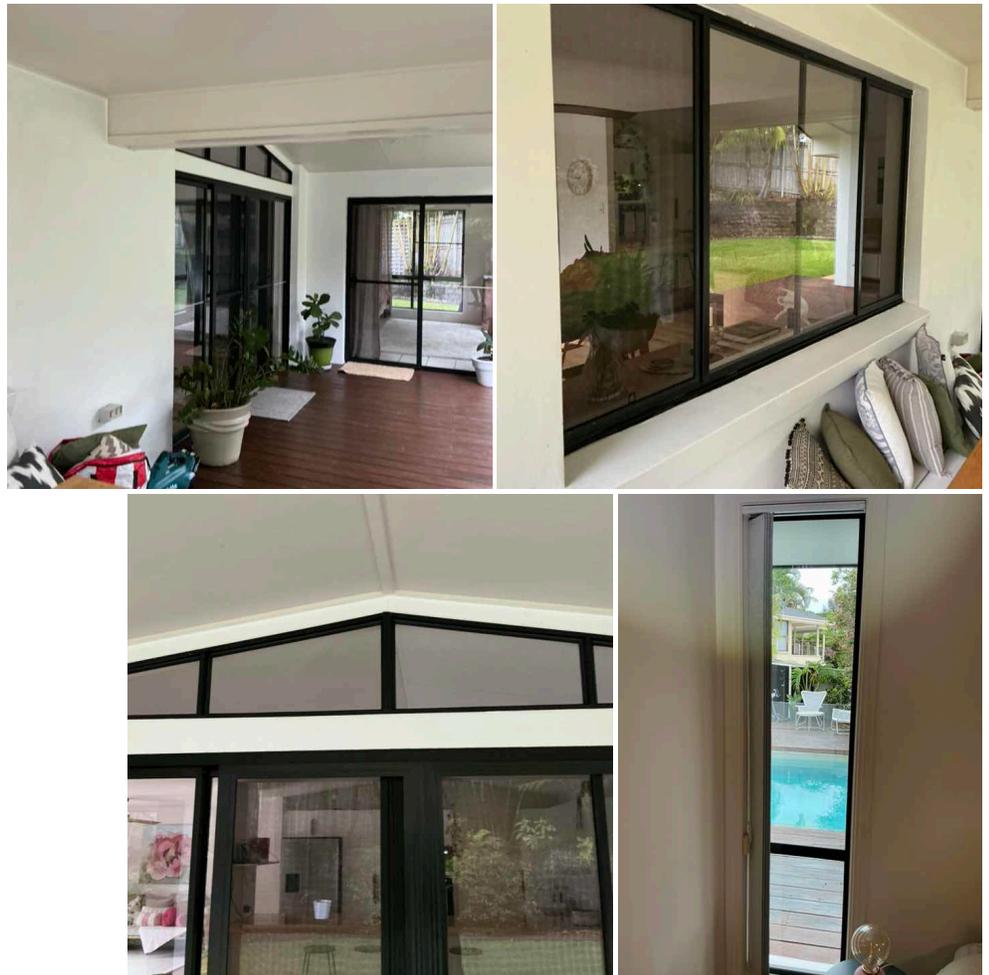
On visual inspection, the general condition of the windows is serviceable for the age.

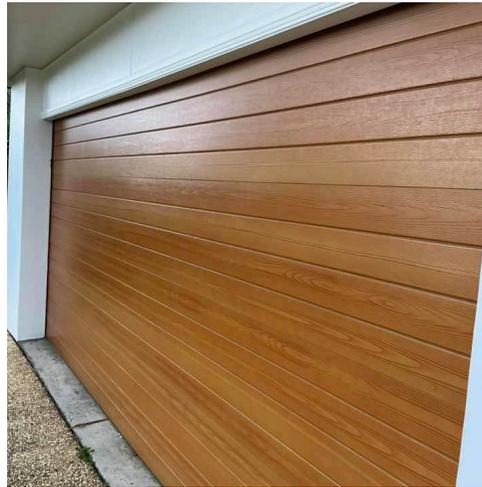
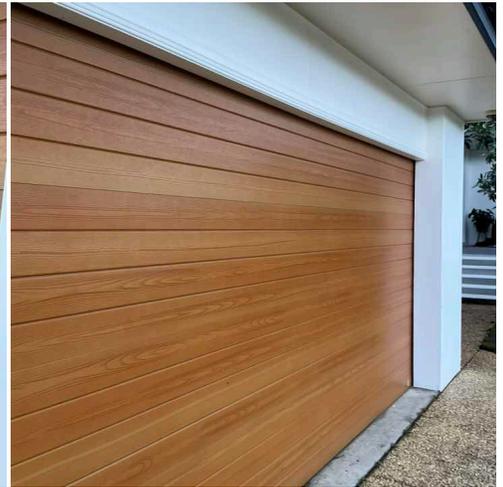
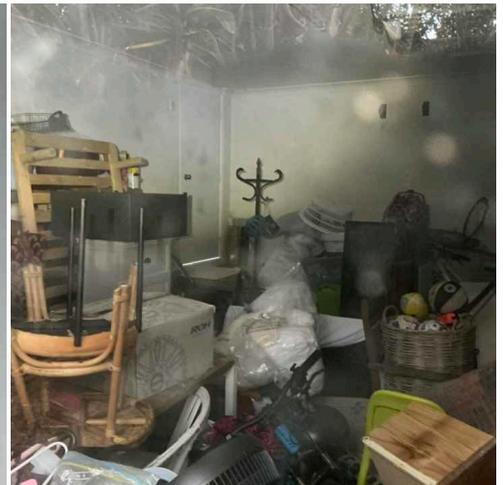
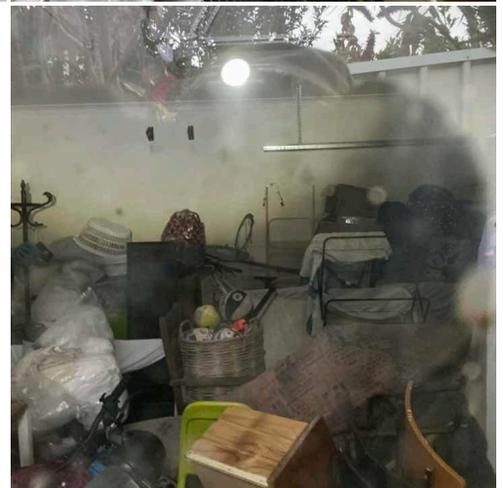
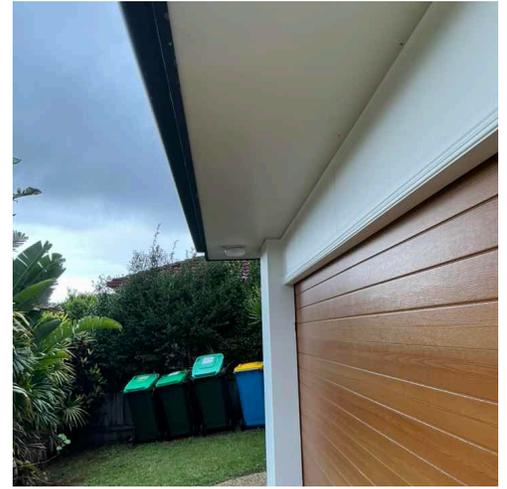
The garage was locked and no internal inspection was carried out. Defects may exist in the inaccessible areas. It is strongly recommended that full access be granted to enable a thorough inspection as there may be timber pest activity, damage or defects.

From the visible and accessible areas, the garage appears to be in a serviceable condition for the age of the property with no notable structural defects sighted.

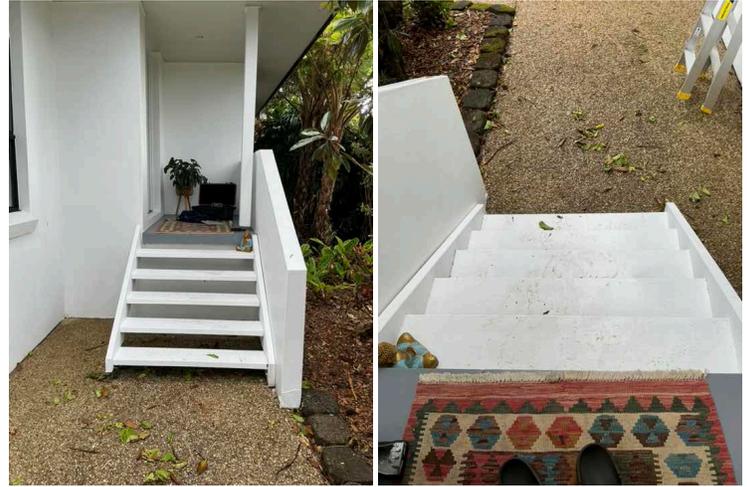
The stairs/steps appear to be serviceable with no notable defects.

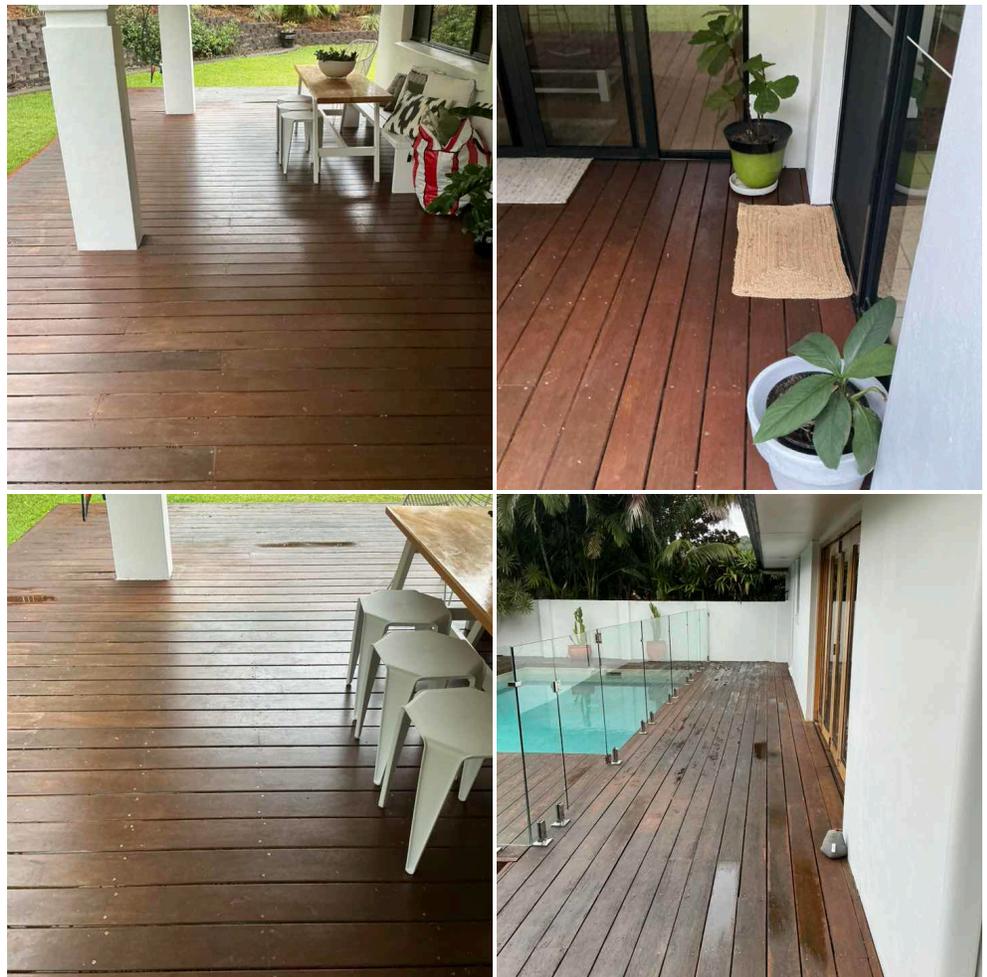
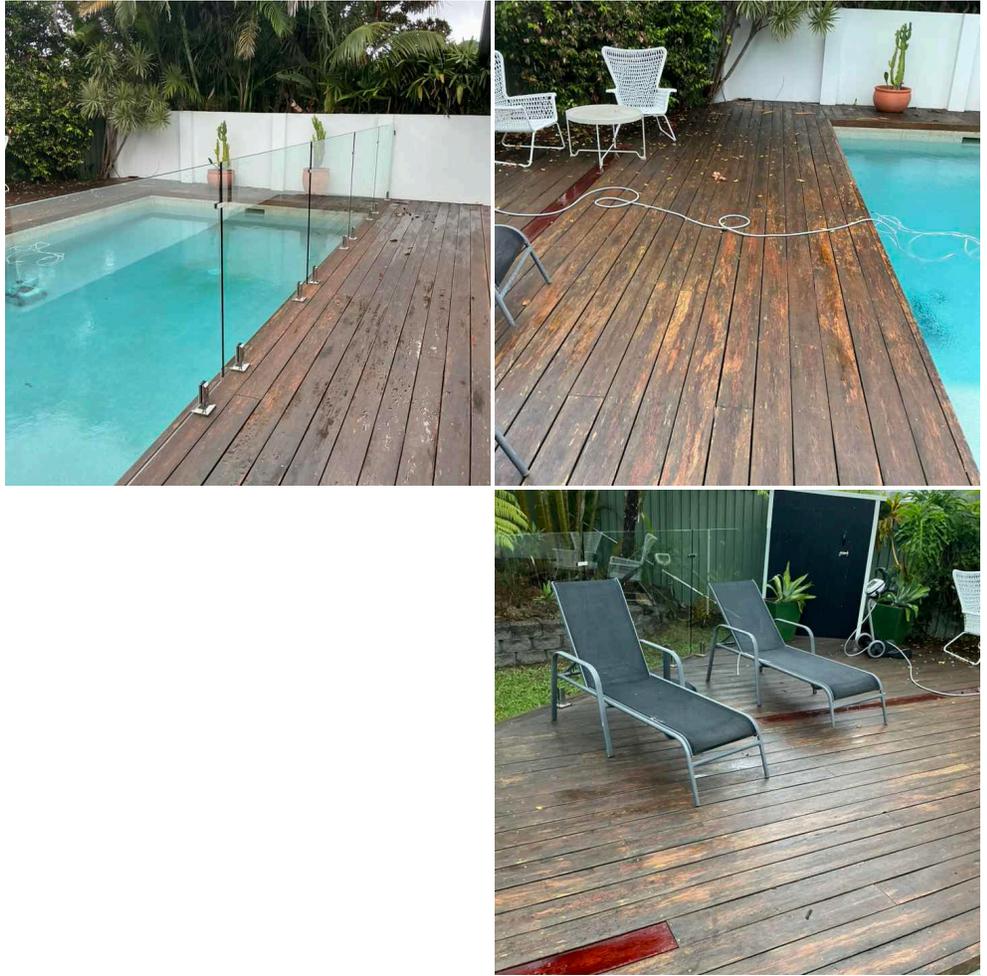
Decking Findings

Of areas visible, the decking appears to be in a serviceable condition.

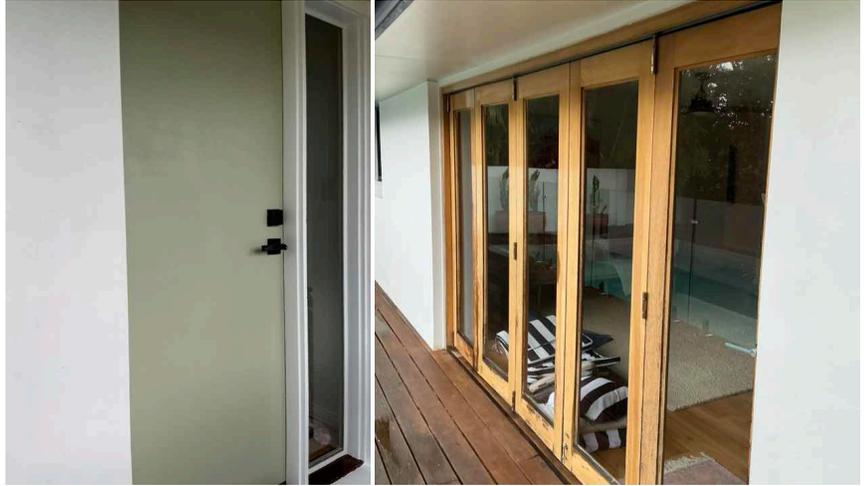
Front Entry Doors

The doors are in serviceable condition with no notable defects observed.

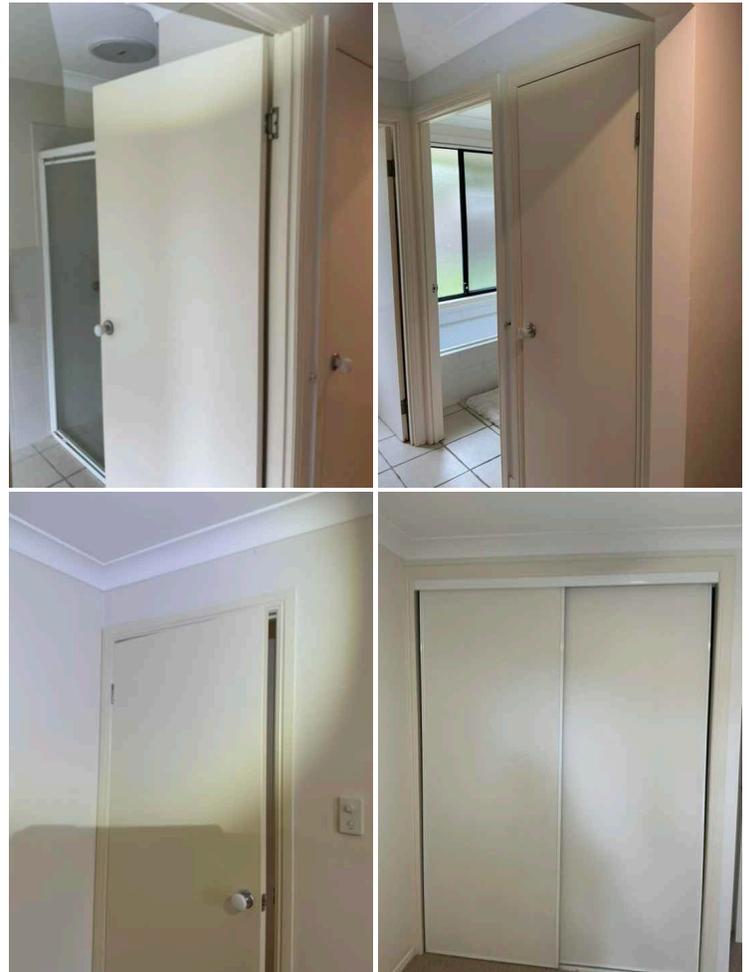
Other Doors

Other doors such as sliding , side entry etc.. appear to be in serviceable condition.

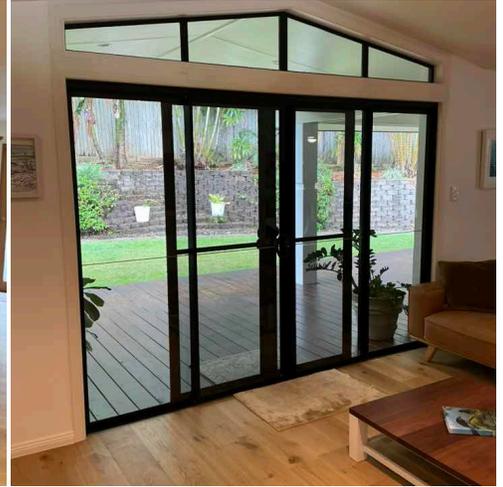
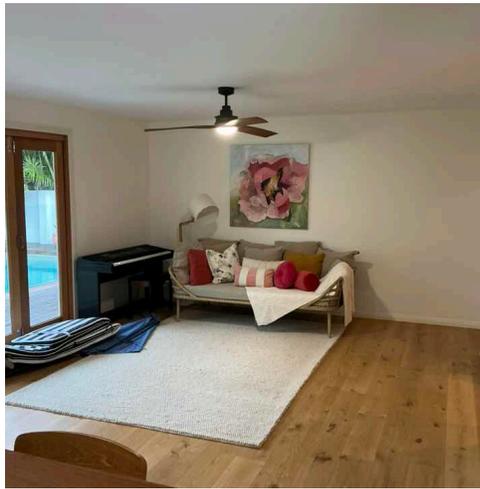
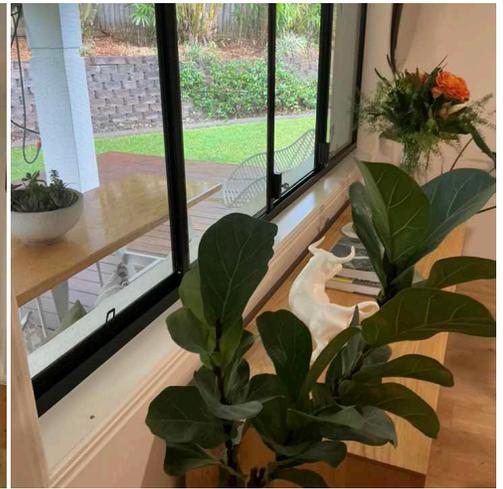
Living Room

From the visible and accessible areas, this room appears to be in a serviceable condition for the age of the property with no notable structural defects sighted.

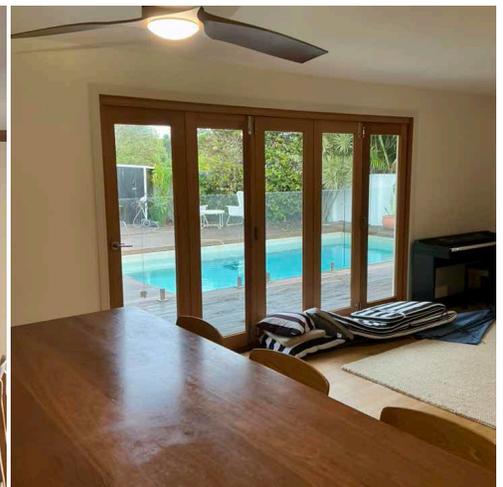
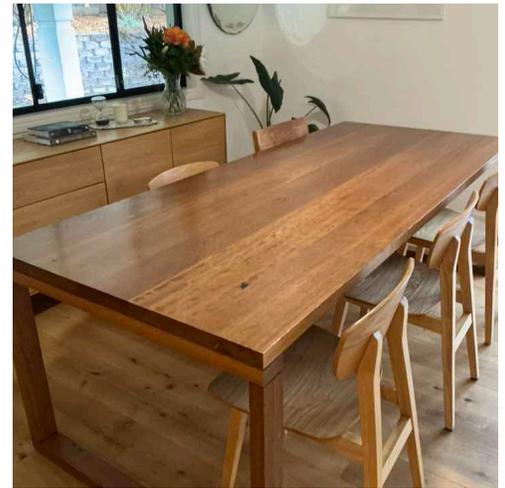
Dining Room

From the visible and accessible areas, this room appears to be in a serviceable condition for the age of the property with no notable structural defects sighted.

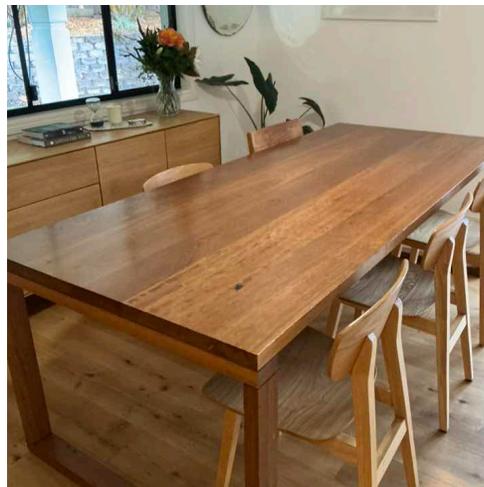
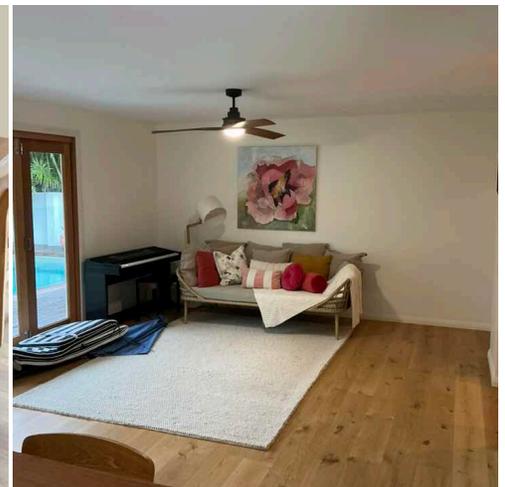
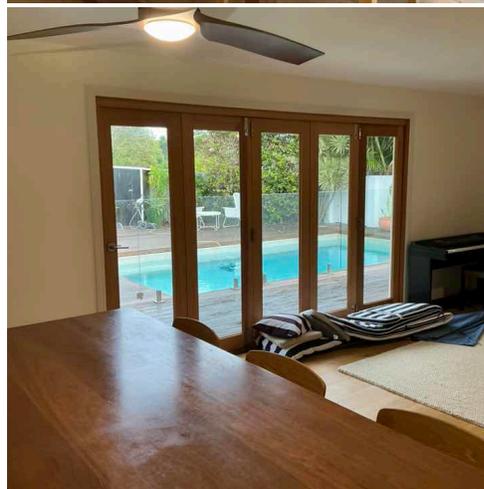
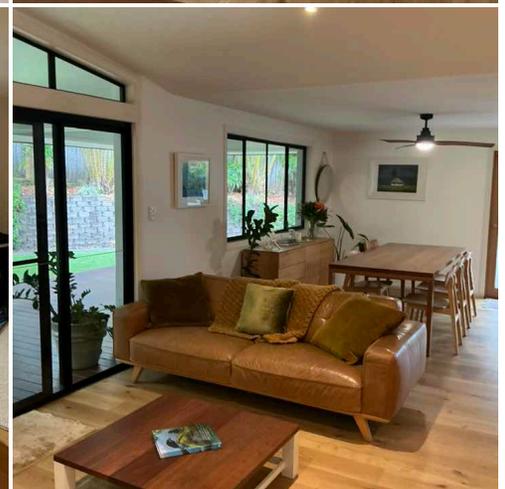
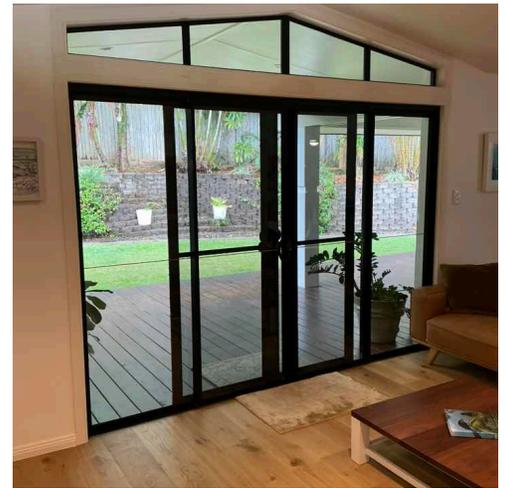
Combined Living & Dining

From the visible and accessible areas, this room appears to be in a serviceable condition for the age of the property with no notable structural defects sighted.

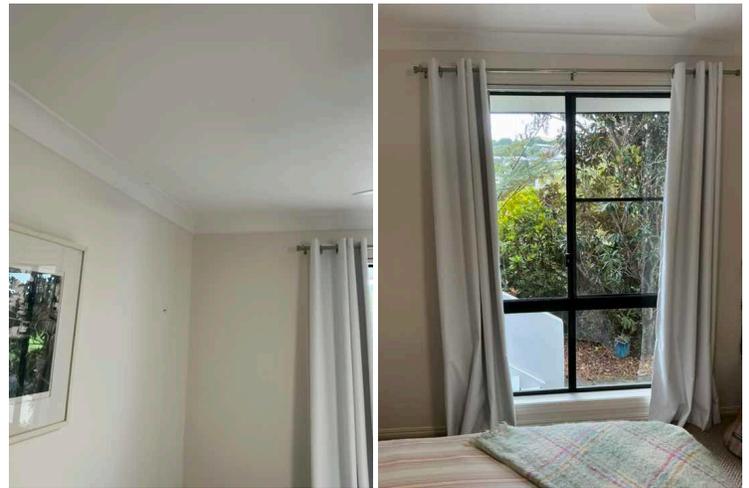
From the visible and accessible areas, this bedroom appears to be in a serviceable condition for the age of the property with no notable structural defects sighted.

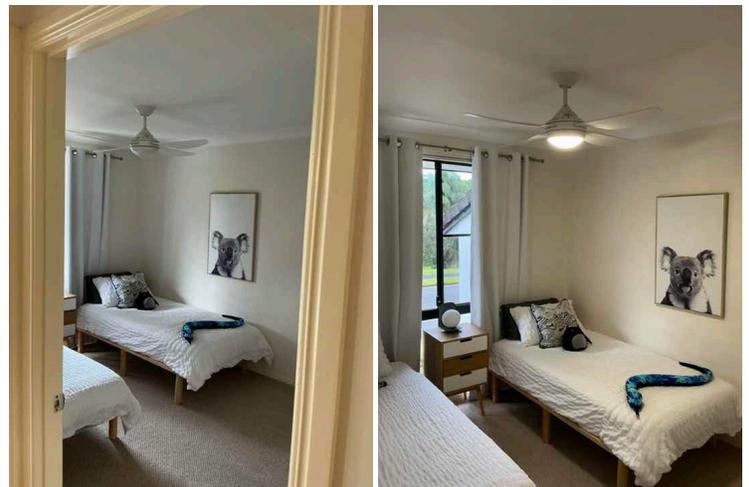
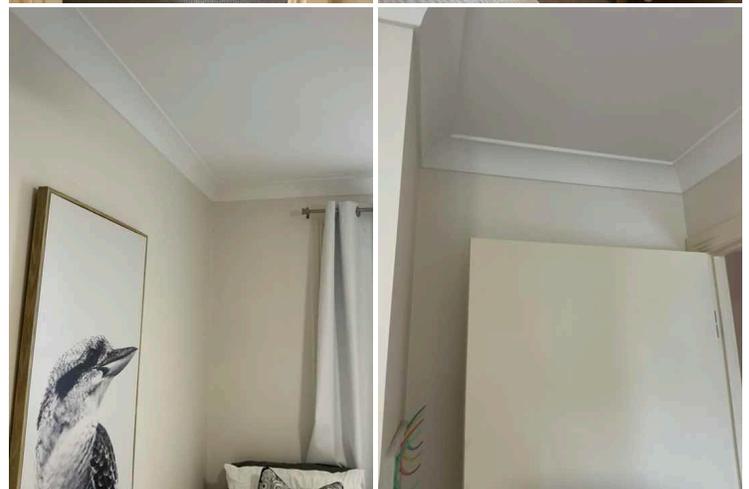
Bedroom 2

From the visible and accessible areas, this bedroom appears to be in a serviceable condition for the age of the property with no notable structural defects sighted.

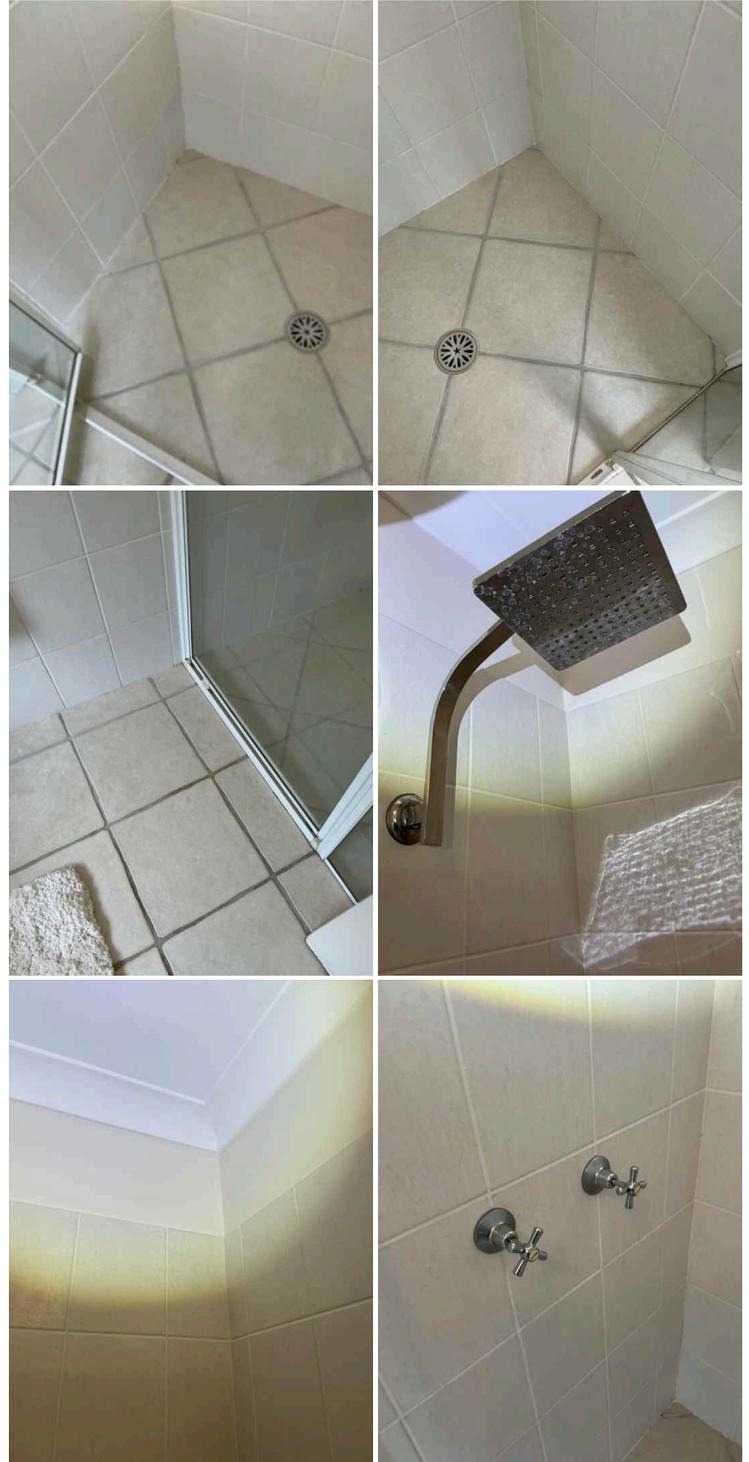
Of the visible areas, the general condition of this bathroom is serviceable or in reasonable condition for age of dwelling.

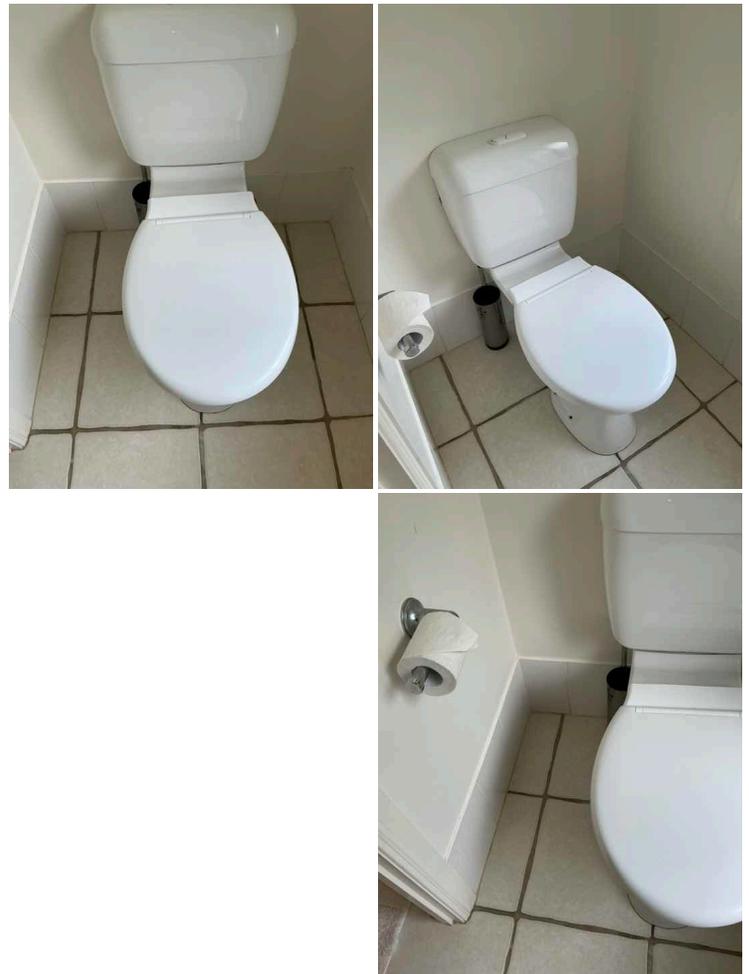
Of the visible areas, the general condition of this bathroom is serviceable or in reasonable condition for age of dwelling.

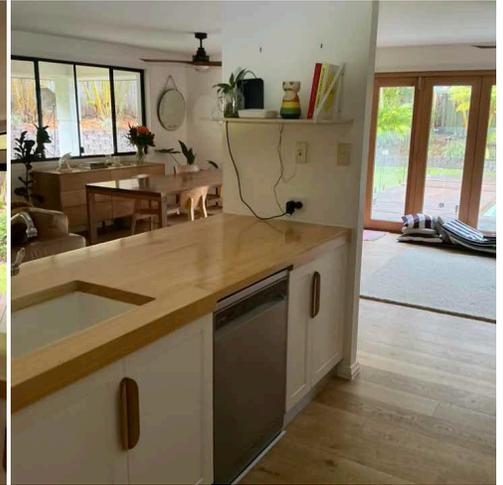
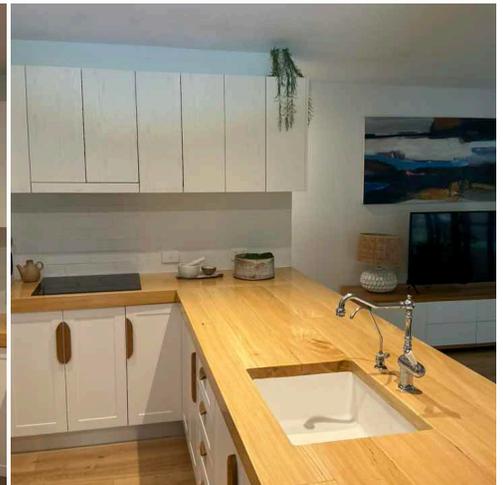
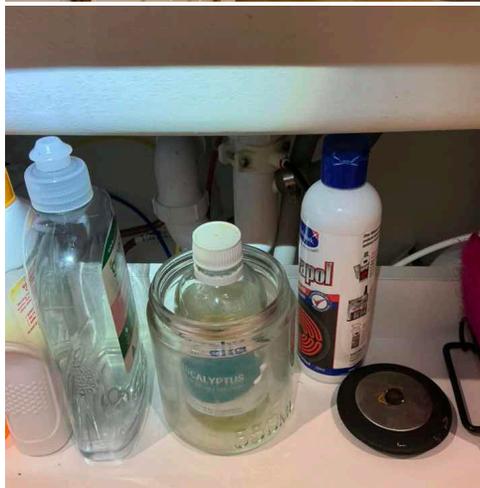
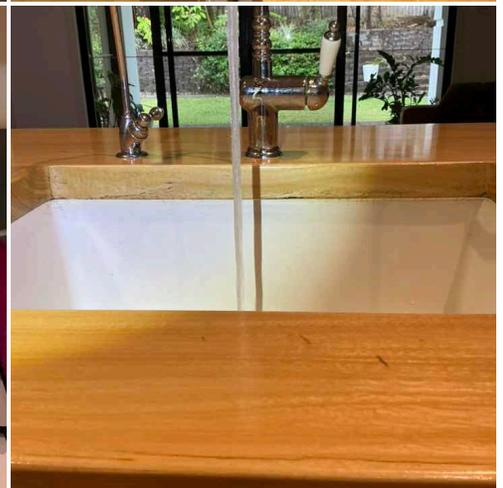
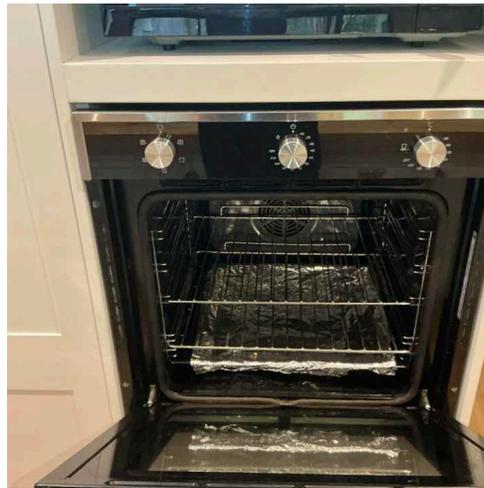
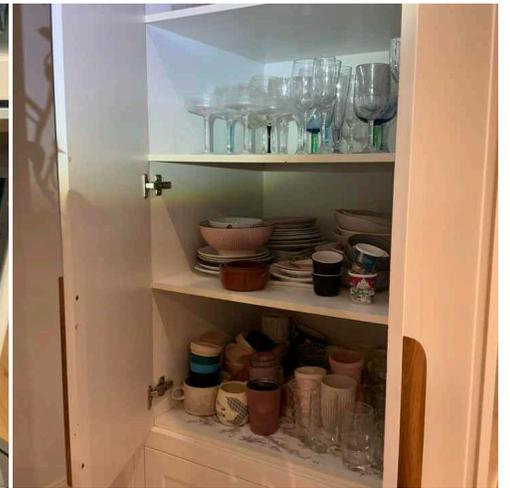
Of the visible areas, the general condition of the kitchen and pantry is serviceable or in reasonable condition for age of dwelling.
