Building and Pest Report

58 Hutley Drive, Lennox Head

Report/Agreement # 2702260927567

Pest And Building Inspection

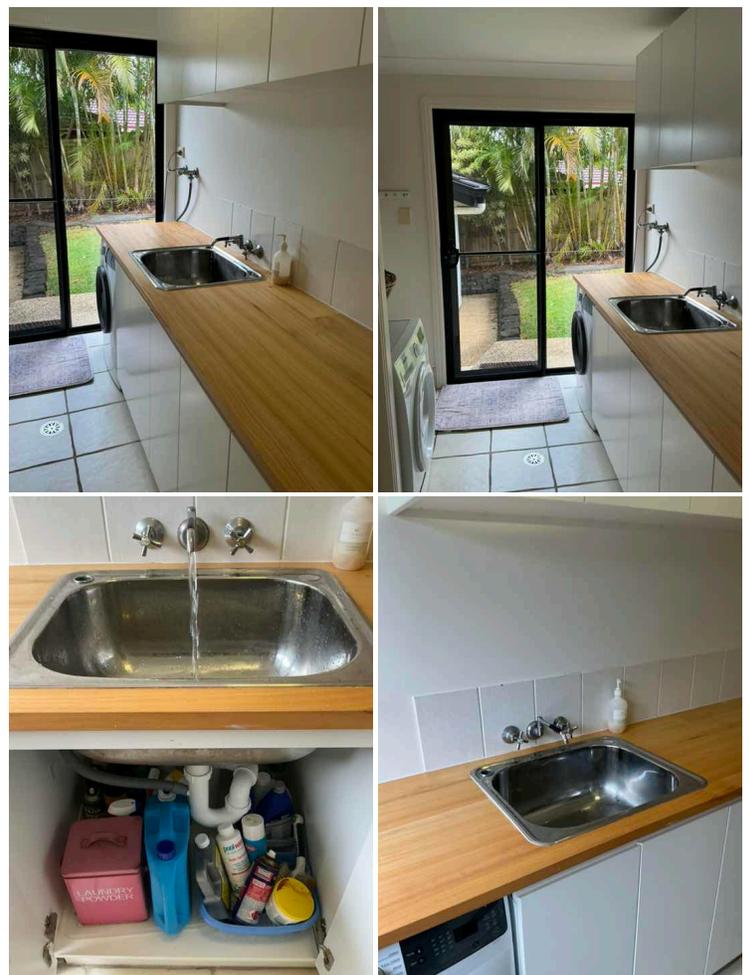
Of the visible areas, the general condition of the laundry is serviceable or in reasonable condition for age of dwelling.

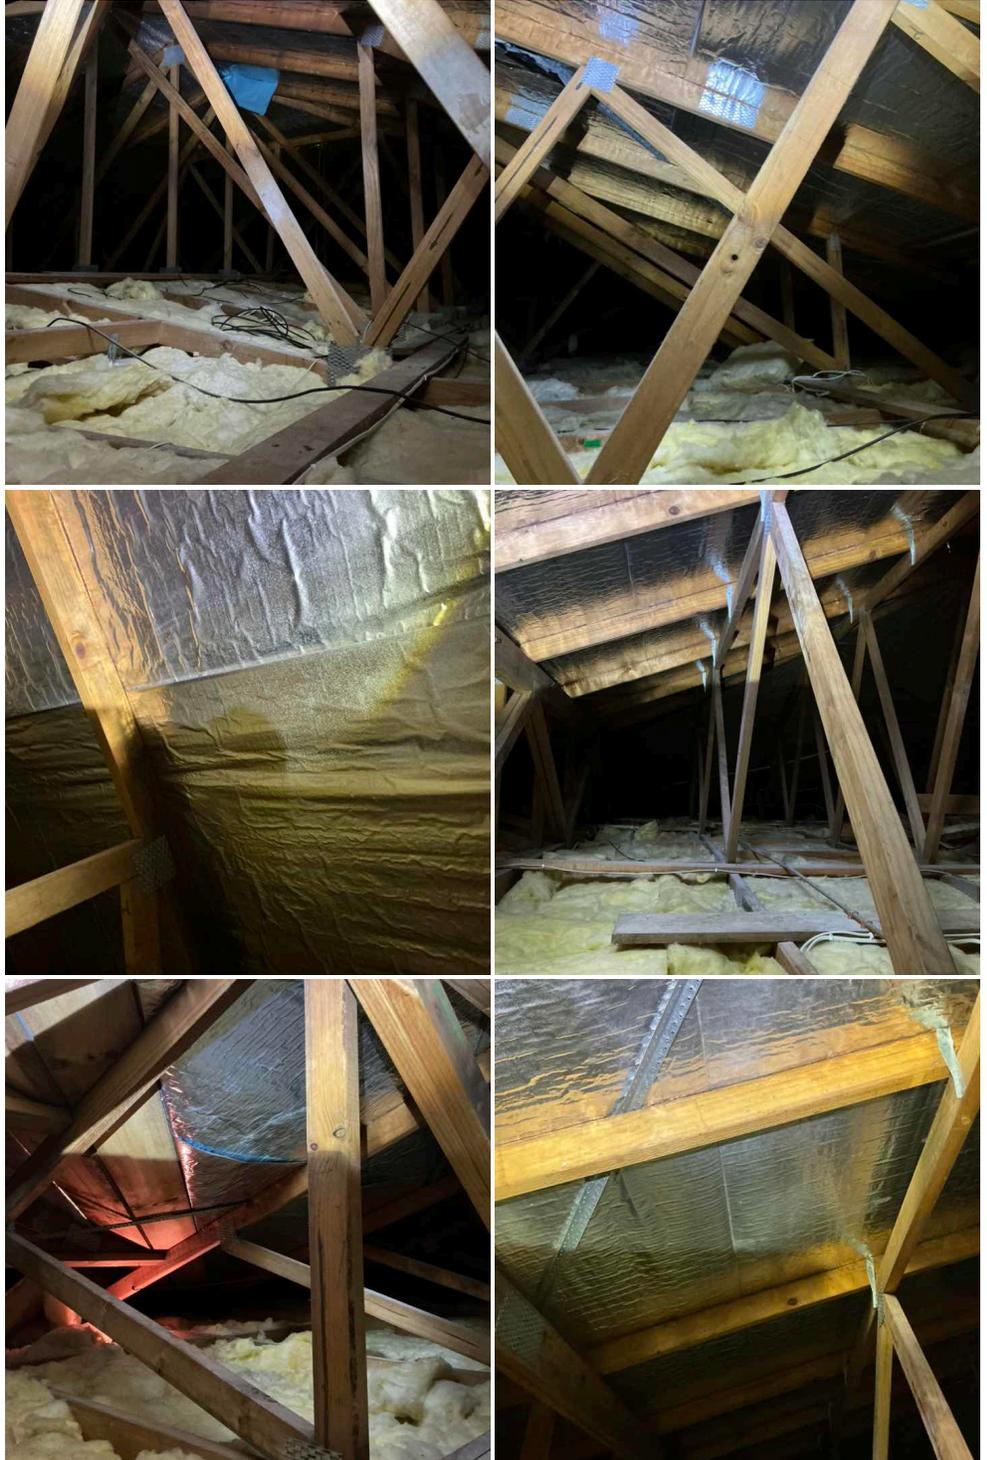
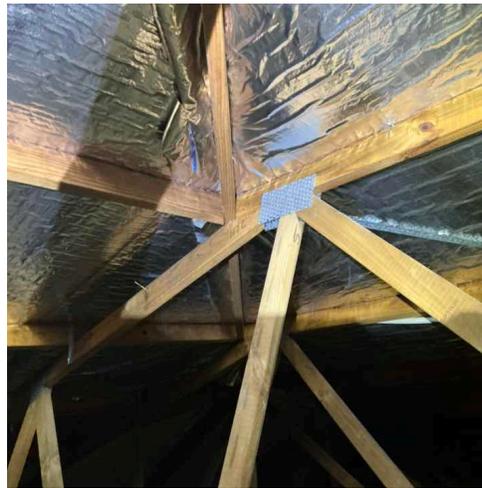
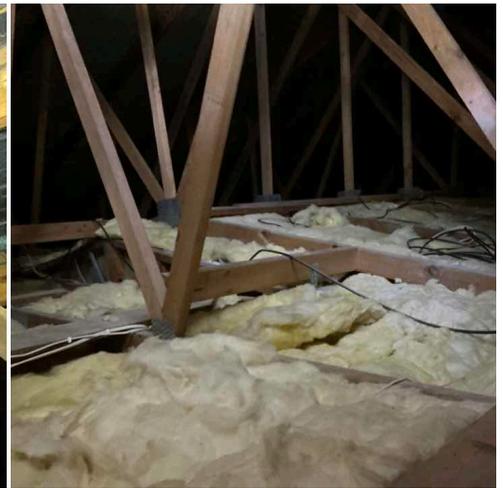
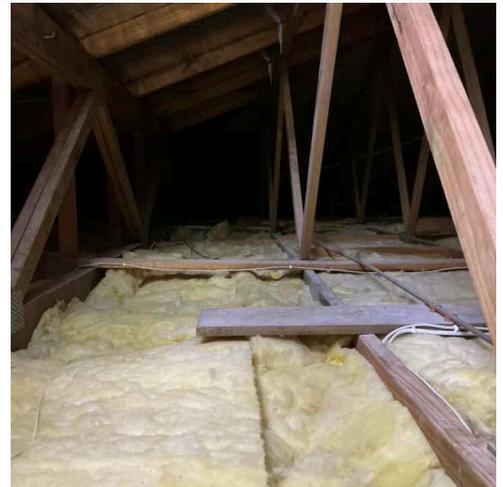
There is insulation present in the roof space/void. This is preventing a full inspection of ceiling joists from being undertaken. It is strongly recommended that full access be gained as it could be harbouring timber pest activity, damage or defects.

Visible sections of the roof void is in a serviceable condition for age of this dwelling.

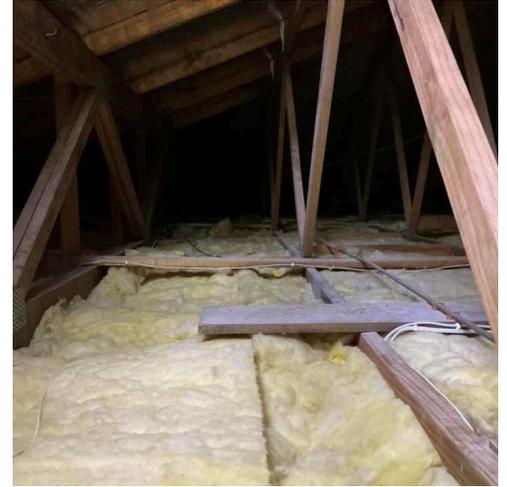
The roof space is insulated with fibreglass batts.

Where visible and accessible, the insulation appears to be in a serviceable condition.

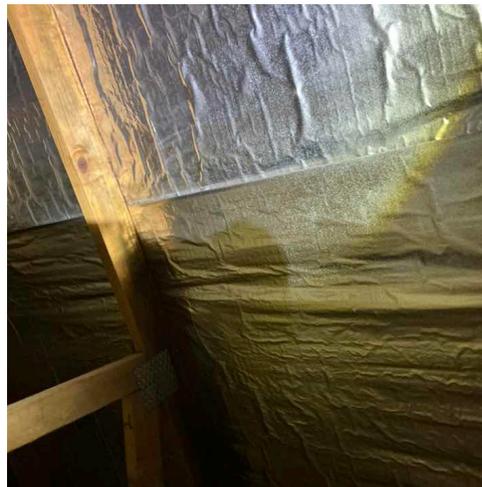
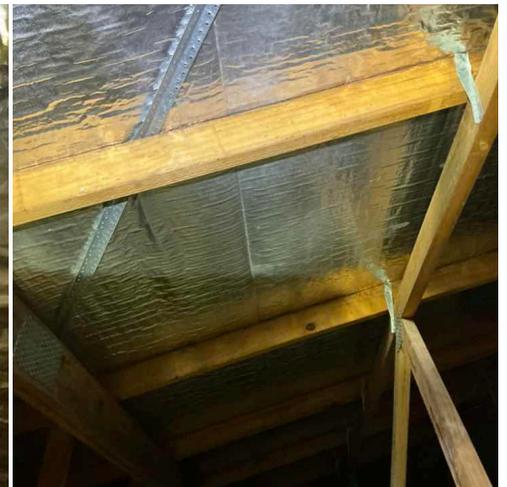
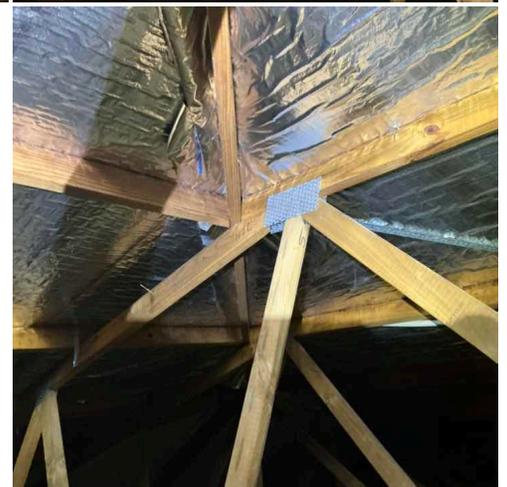
Sarking is installed.
