Building and Pest Report

1/20 Barrett Drive Lennox Head

Pest And Building Inspection

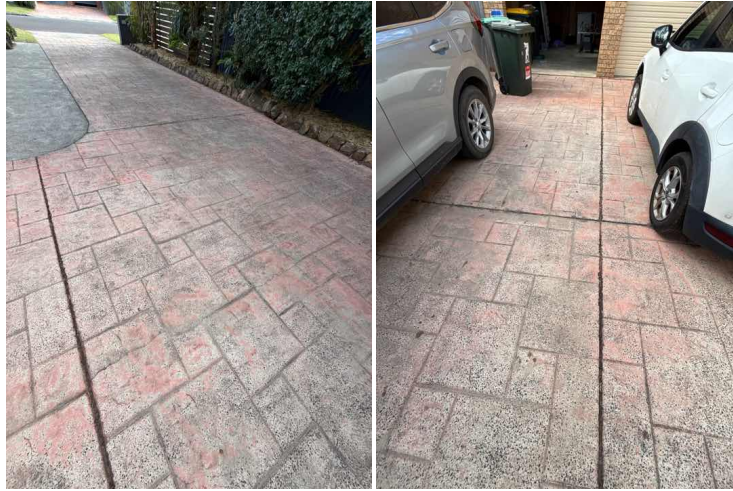
On visual inspection, the general condition of the driveway is serviceable.

Common cracks were observed on the driveway. Whilst these cracks appeared to be typical at the time of inspection, we strongly recommend you monitor these cracks and if worsening occurs contact a concreter for further advice.

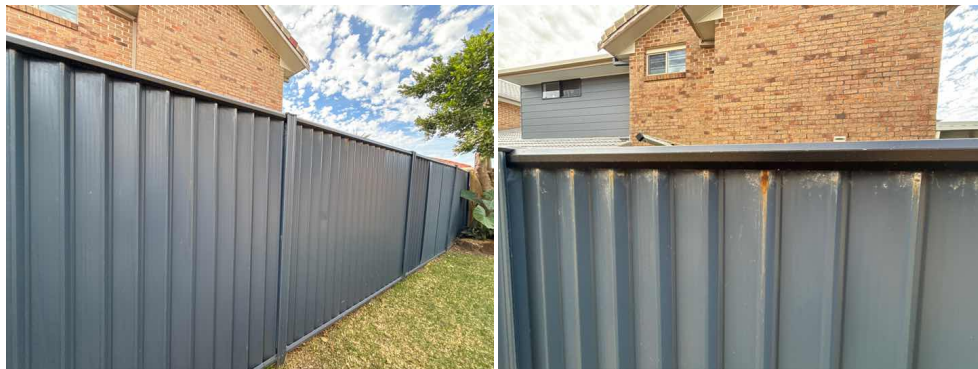
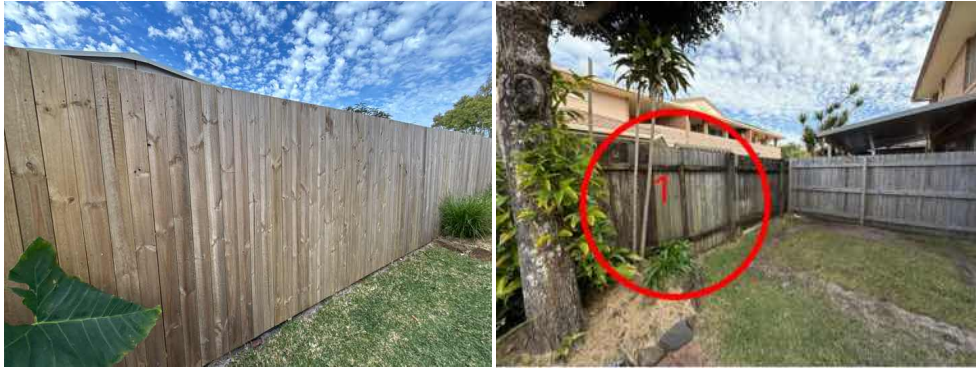
Of the visible areas, the general condition of the fences and gates is serviceable for the age of dwelling.

General age to fence components. General upkeep and maintenance required. A qualified fencing contractor should be engaged for repairs.

Fence rot/leaning. Repairs are required by a fencing contractor to avoid unsafe conditions.

General fence components have rot. Repairs are required by fencing contractor.

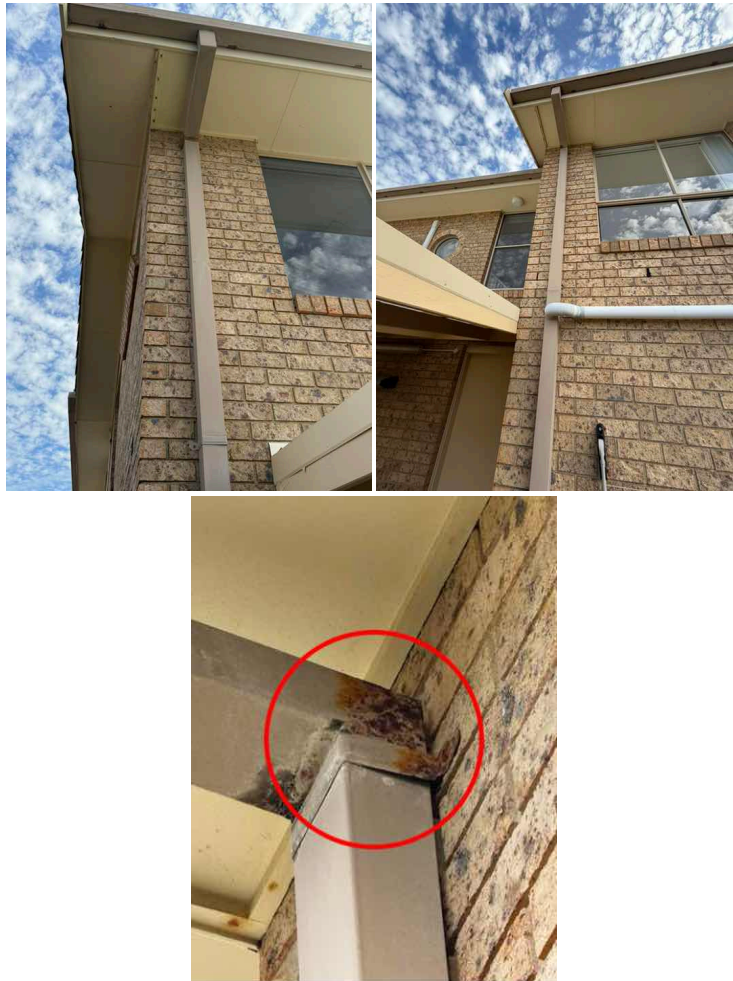
Leaking downpipe joints visible. This can be conducive to termite infestation and cause water damage to cladding over time. A qualified roof plumber should be engaged to repair.

Minor downpipe rust visible. A qualified plumber should be engaged for advice and recommendations.

Rusty clips

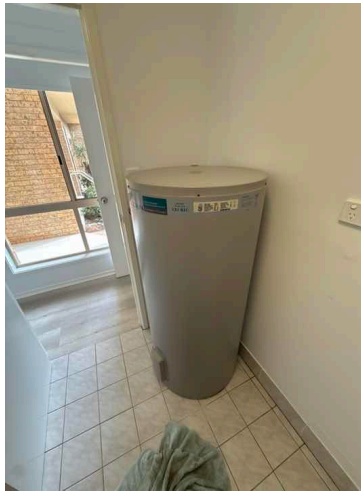
The hot water system appears to be in a serviceable condition. No specific tests other than running the hot water from a tap was carried out. No determination has been made as to the suitability or adequacy of the hot water system in relation to capacity or otherwise.

General rust deterioration was observed on the hot water unit casing. We recommend you replace the unit.

The make of the hot water unit is vulcan.

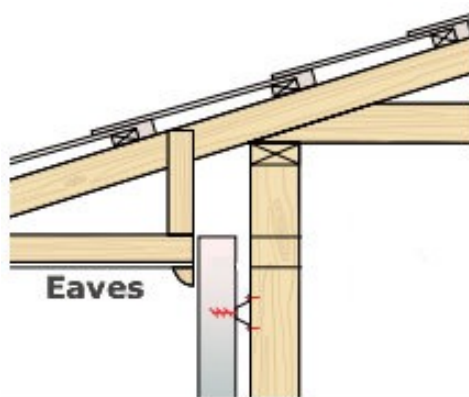
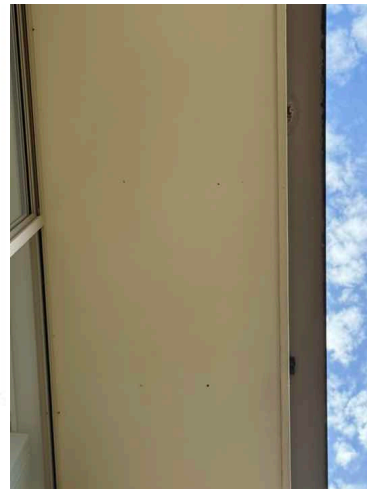
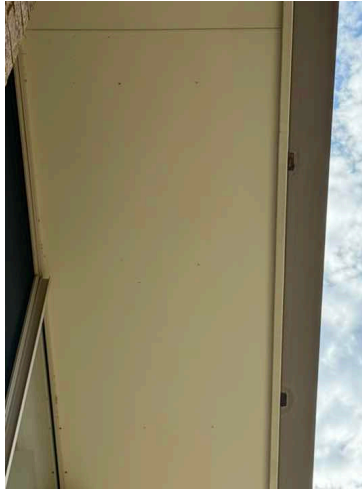
Upon visual inspection, several rusty fixings were identified, indicating potential structural weakness. It is recommended to replace all affected fixings with corrosion-resistant alternatives to ensure structural integrity. Additionally, inspect surrounding areas for further corrosion or damage. Engage a licensed tradesperson to assess and carry out necessary repairs, ensuring compliance with relevant building standards and safety regulations. Regular maintenance checks are advised to prevent future issues.

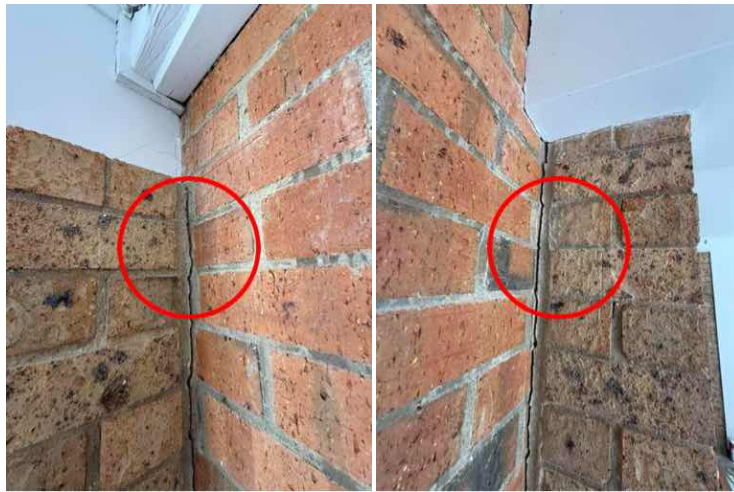
Upon visual inspection, a movement crack was observed on the engaged pier. This defect may compromise structural integrity if not addressed. It is recommended to engage a licensed masonry contractor to assess and repair the crack. Repairs may include repointing or reinforcing the affected area to prevent further deterioration and ensure stability. Regular monitoring is advised to detect any future movement.

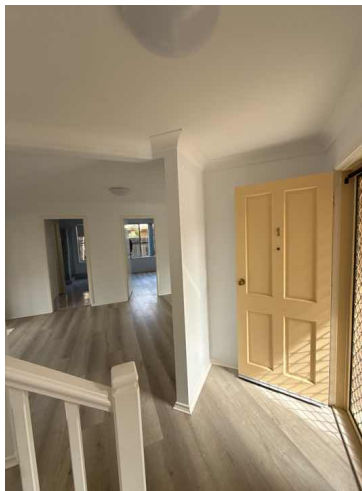
Typical cornice separation/detachment observed. I recommend you contact a qualified painter for repairs.

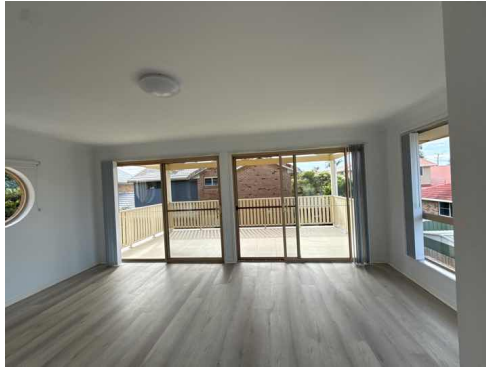
Settlement Cracks Noted. These are typical and generally patch and paint will suffice, however we recommend you monitor these cracks and if they become wider or longer, you will need to contact a structural engineers to assess.

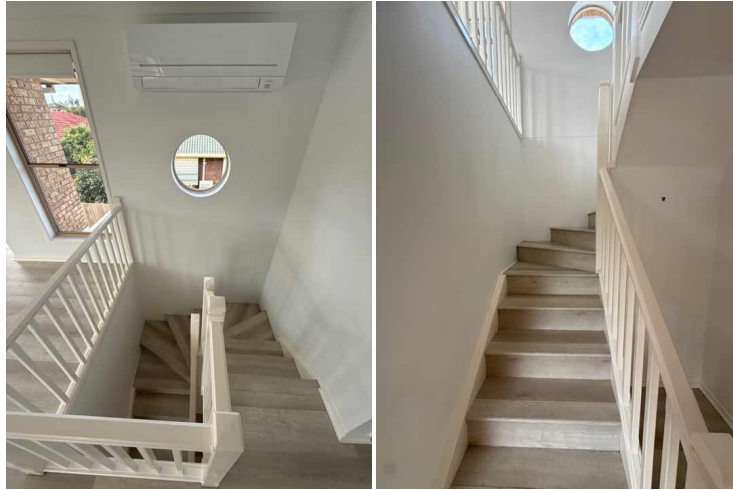
The internal staircase and components appear to be in a serviceable condition for the age with no notable defects sighted.

The handrails and or balustrades may not comply with the current standards. Although this report does not generally comment on items of compliance issues, as this is a safety issue it is included in this report. We recommend you further investigate this matter and repair/replace if necessary.

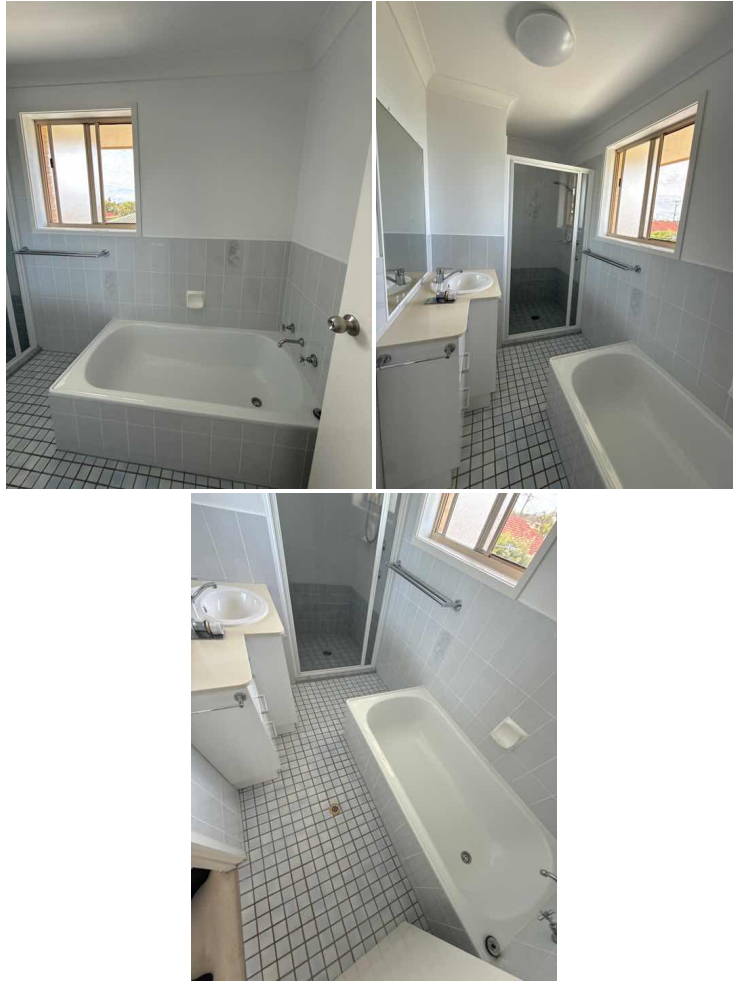
Door / frame deterioration - General age/damage has occurred to door frame, face or components.
 Recommendations: A qualified carpenter should be engaged for advice and recommendations.

Binding/out of square door frame - This can relate to some differential settlement in the footings, frame movement, age, expansion, shrinkage and the like. A qualified carpenter should be engaged for advice and recommendations.

Silicone sealant has been applied to the interface of the floor and walls in the bathroom in an apparent attempt to prevent water penetration to surrounding areas. This method of repair can only be considered to be temporary. Further waterproofing may be necessary.

Cracked tile/s noted. This can cause extensive floor and floor frame damage and is conducive to termite infestation if water is leaking through the cavity. A qualified tiler should be engaged for advice and recommendations.

No exhaust fan is installed - Recommend having one installed.

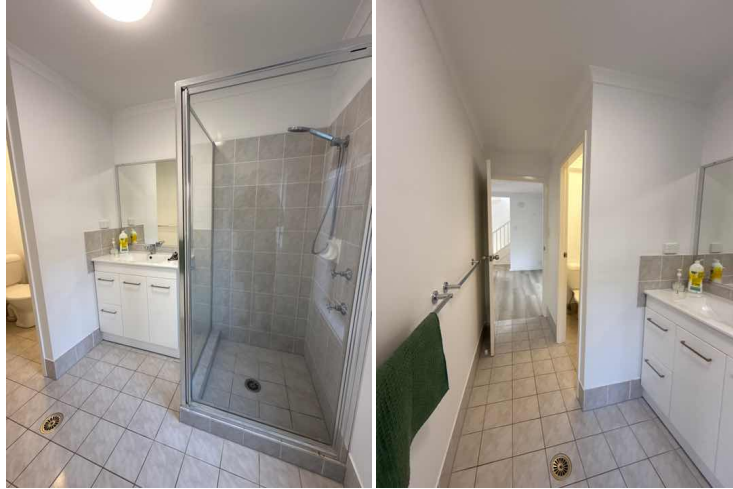
The shower screen door requires adjustment, maintenance or repair to operate properly.

No exhaust fan is installed - Recommend having one installed.

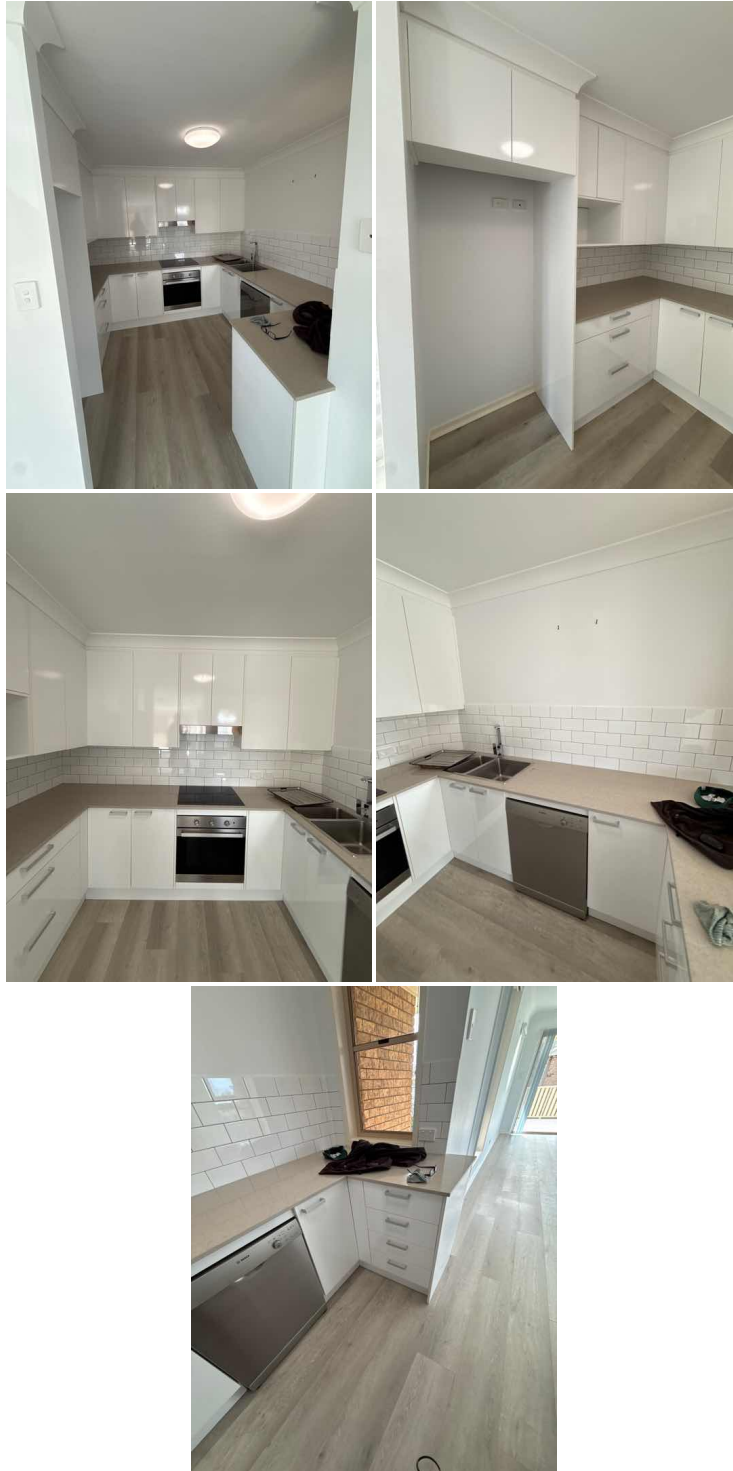
Adjustment to cabinet doors required, in some instance hinges may need to be replaced.

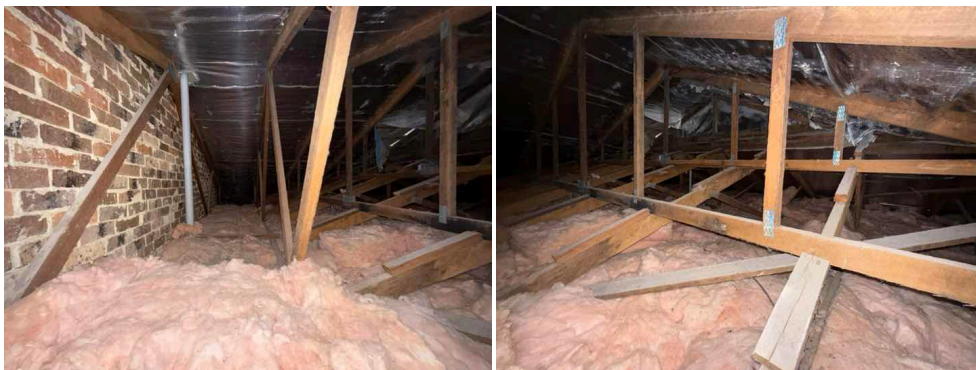
Sarking deteriorated/ damaged / aged in some sections. A qualified roofing contractor should be engaged for advice and recommendations.
