Building and Pest Report

8 Carnarvon Court Lennox Head

Pest And Building Inspection

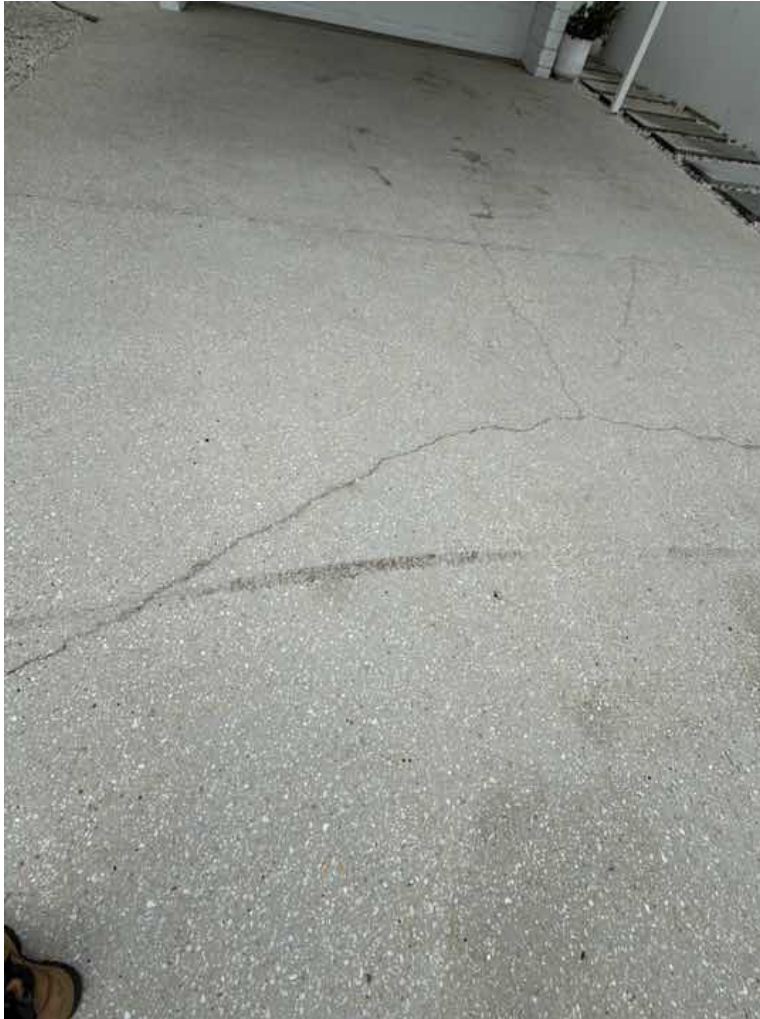
Driveway Condition

On visual inspection, the general condition of the driveway is serviceable.

Common cracks were observed on the driveway. Whilst these cracks appeared to be typical at the time of inspection, we strongly recommend you monitor these cracks and if worsening occurs contact a concreter for further advice.

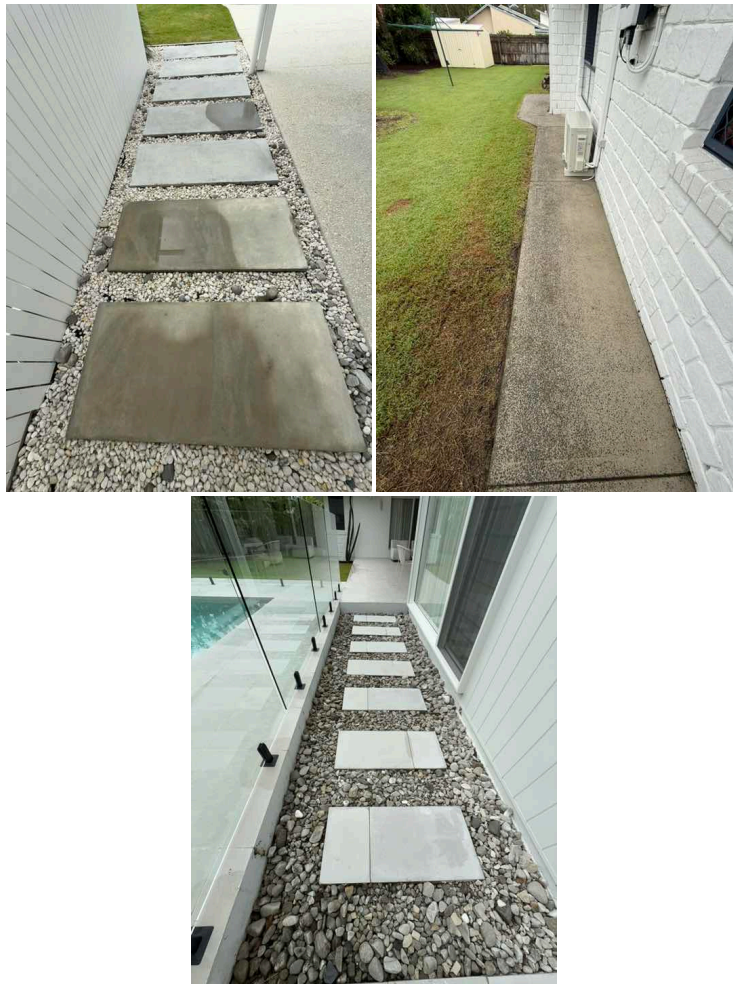
Pathways Condition

The paths around the home are in a serviceable condition for the age of this dwelling with no major defects visible.

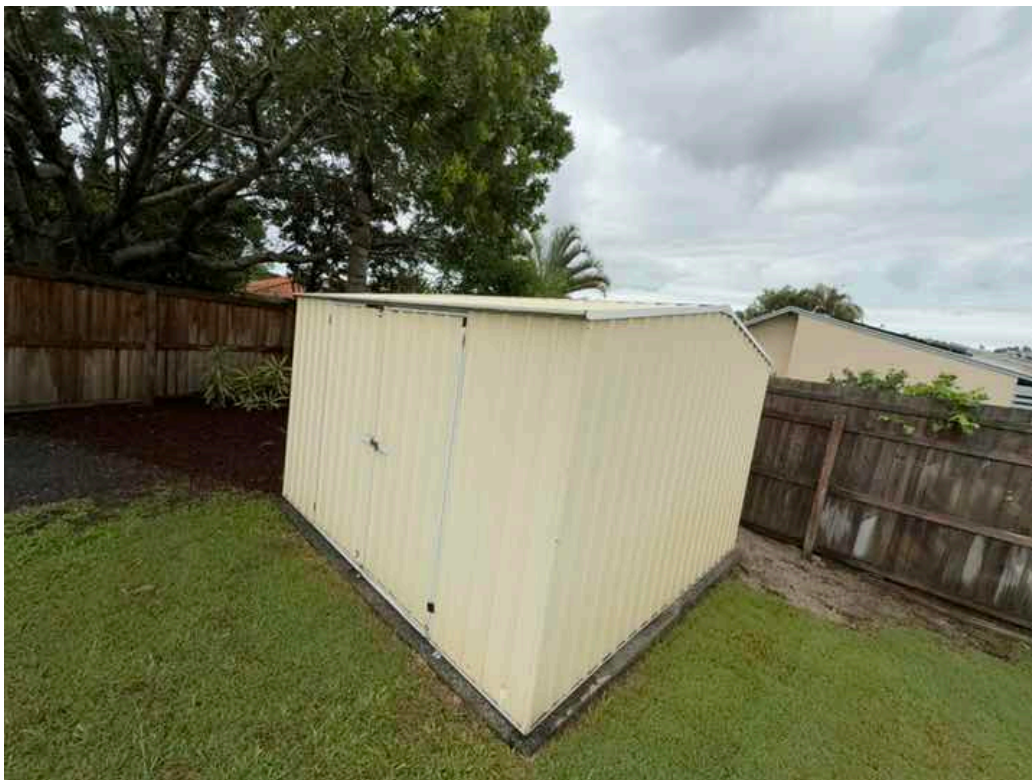
Shed Condition

The shed is in fair usable condition.

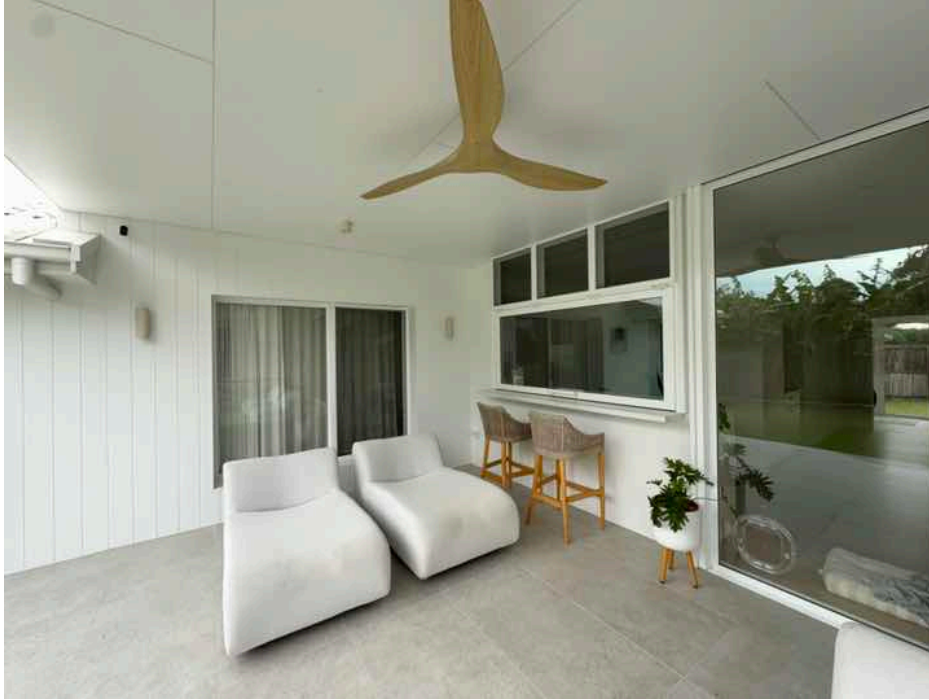
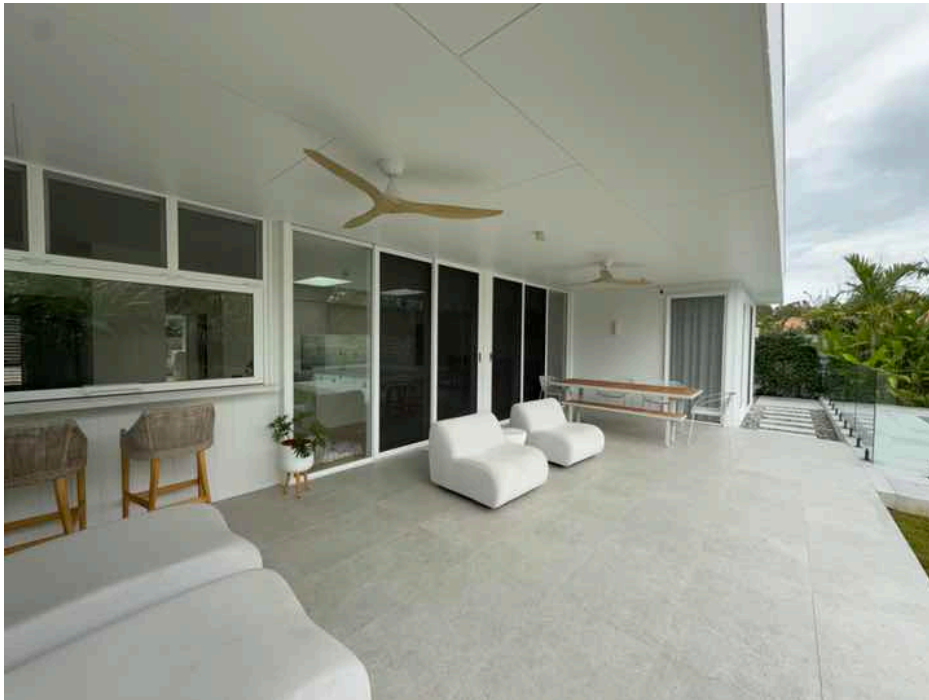
Visible sections of the Alfresco area are serviceable or in reasonable or condition for the age of this dwelling.

Drummy tiles

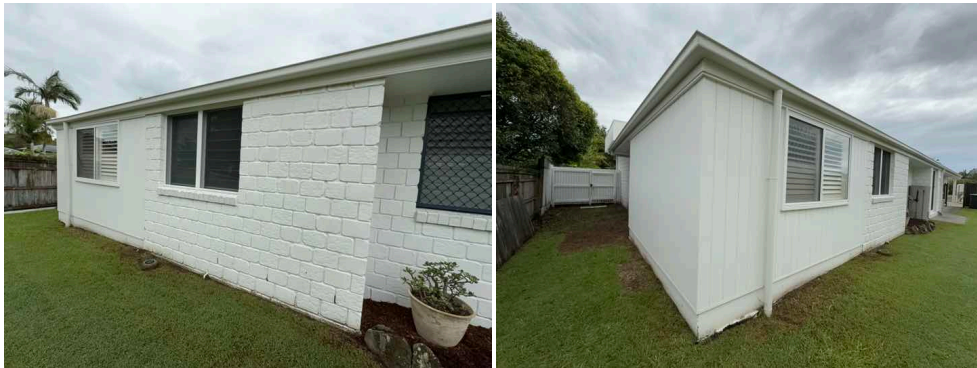
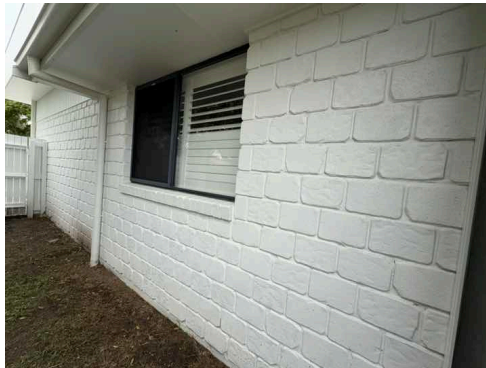
On visual inspection, the general condition of the exterior walls is serviceable for the age.

There appears to have been some settlement in the building which has caused some cracking to the walls. These cracks are categorized as 0 to 2. This can also cause some doors to bind or be out of square. In the inspectors opinion these cracks are due to settlement, usually due to ground movement and subsequent movement to building materials can be expected. Any cracks should be monitored and if cracks increase in size, further investigation should be carried out by a structural engineer.

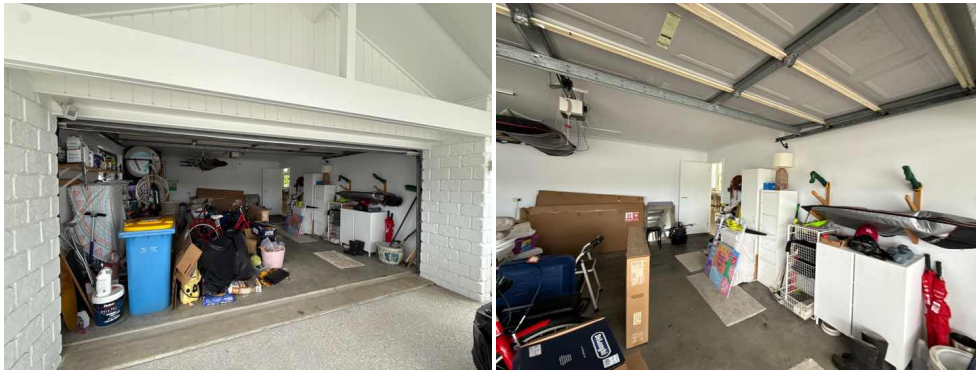
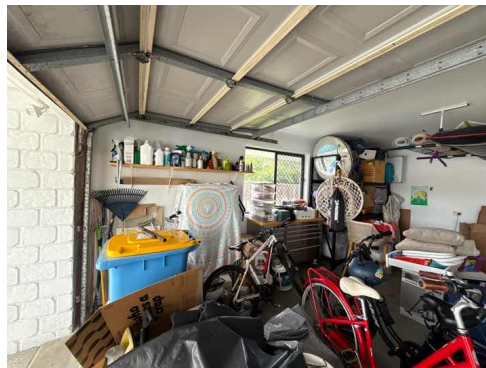
From the visible and accessible areas, the garage appears to be in a serviceable condition for the age of the property with no notable structural defects sighted.

Minor hairline slab cracks - Note. Whilst these cracks appeared to be minor at the time of inspection, we strongly recommend you monitor these cracks and if worsening occurs contact a qualified concreter for further advice.

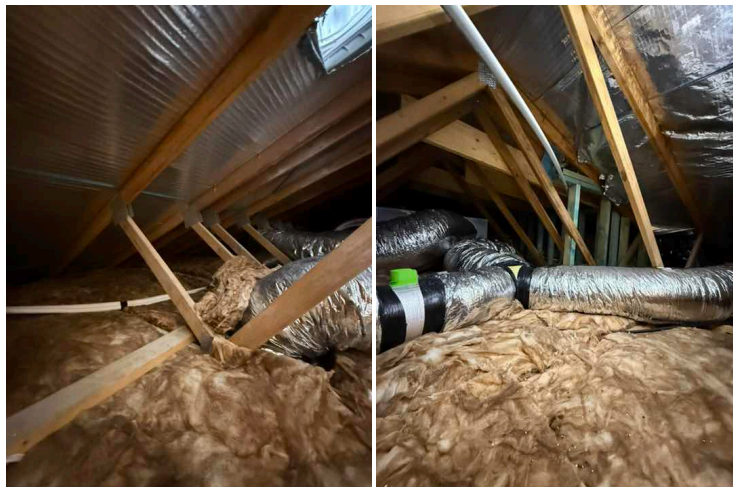
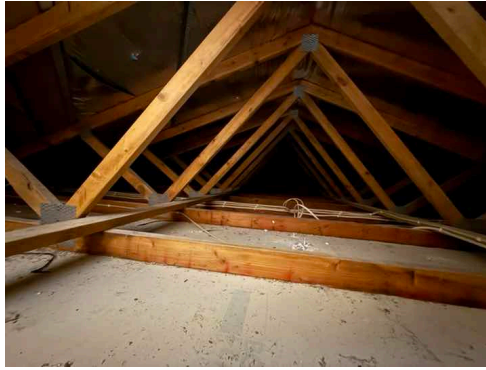
Visible sections of the roof void is in a serviceable condition for age of this dwelling.
