# Building and Pest Report

## 37 Alison Avenue, Lennox Head

| Report/Agreement # | 090326113621317 |
| Inspection Date: | 09 Mar 2026 |

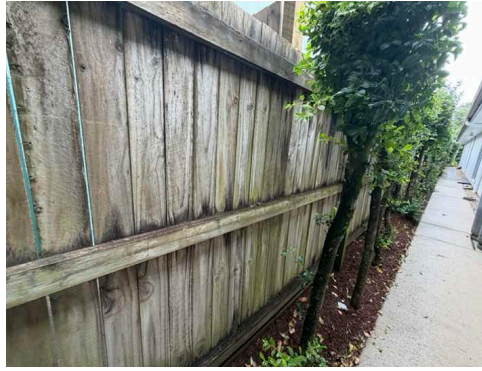
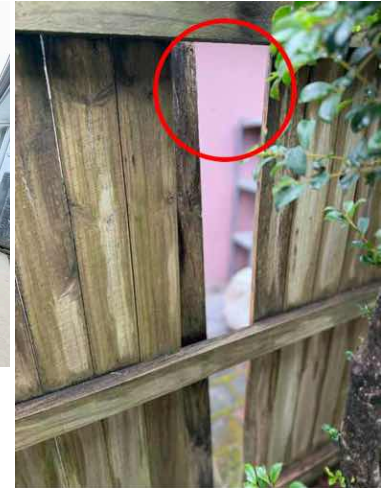
General age to fence components. General upkeep and maintenance required. A qualified fencing contractor should be engaged for repairs.

General age/damage/binding of gate/s components - Recommendations: A qualified fencing contractor should be engaged for advice and recommendations.

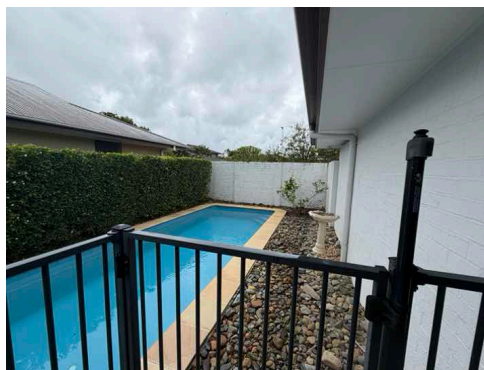
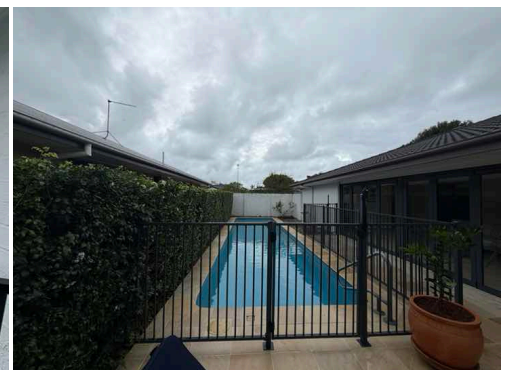
Pool fence and signage were sighted.

The appropriate warning signs do not appear to be present. You should check with your local council regarding the required signs.

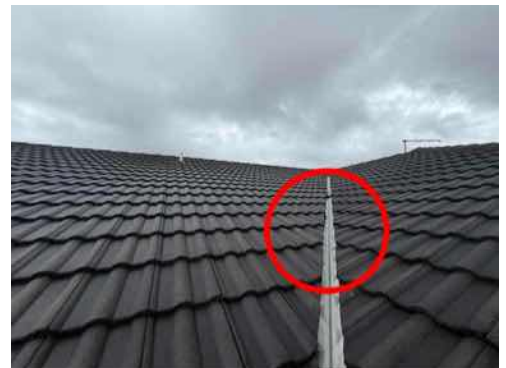
Visible section of The roof cladding appeared in a serviceable condition for the age of this dwelling. Annual maintenance inspection recommended. Cracked tile ends visible. A qualified roof tiling contractor should be engaged for advice and recommendations. Considered a minor defect but has the potential to become a Major defect if repairs aren't carried out immediately due to water ingress into the roof cavity.

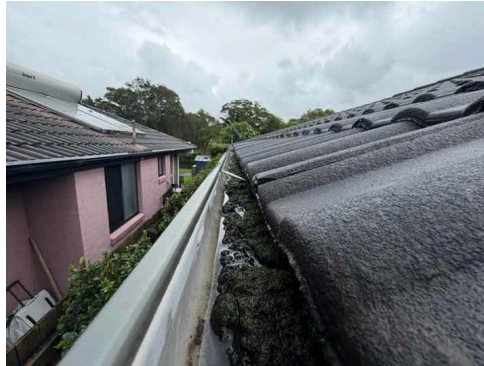
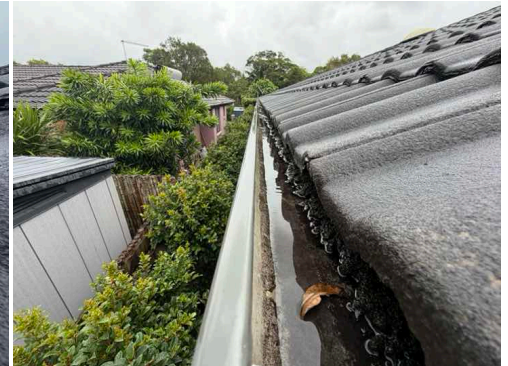
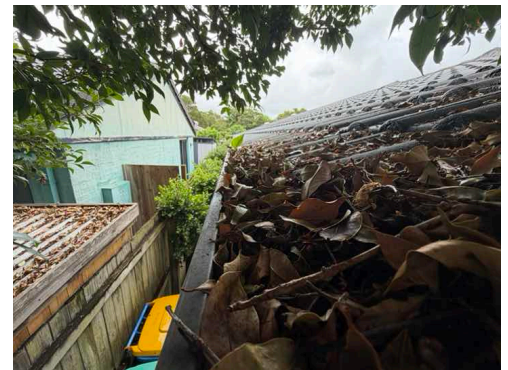
Debris in guttering areas- this requires cleaning out to prevent blocking of downpipes and leaking into eaves and fascia. Have gutters cleaned and assessed by a plumber for adequate fall. Regularly clean to prevent ponding. Ponding water will contribute to rust.

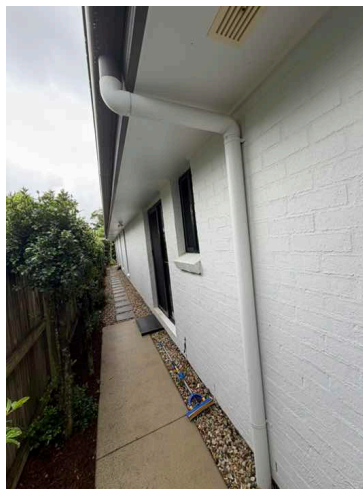
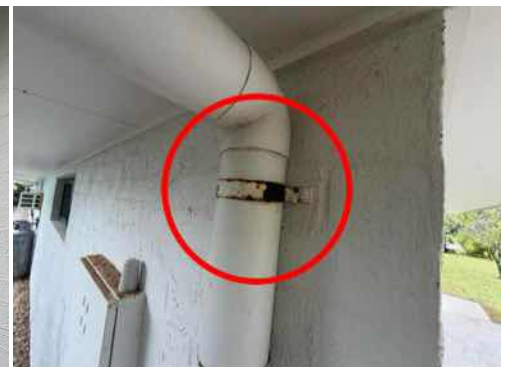
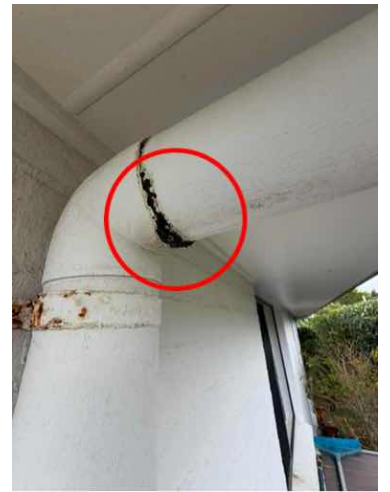
Leaking downpipe joints visible. This can be conducive to termite infestation and cause water damage to cladding over time. A qualified roof plumber should be engaged to repair.

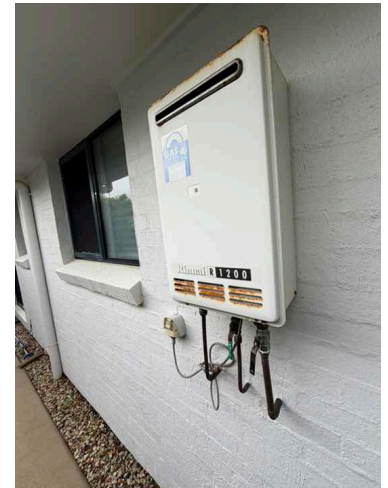
General rust deterioration was observed on the hot water unit casing. We recommend you replace the unit.

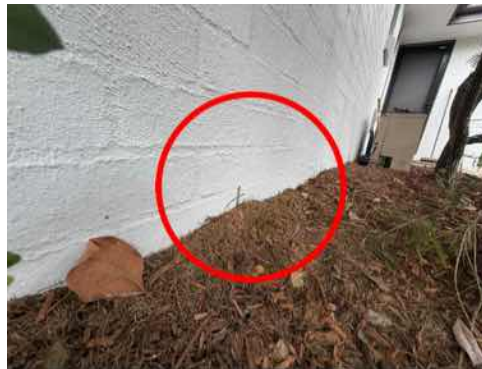
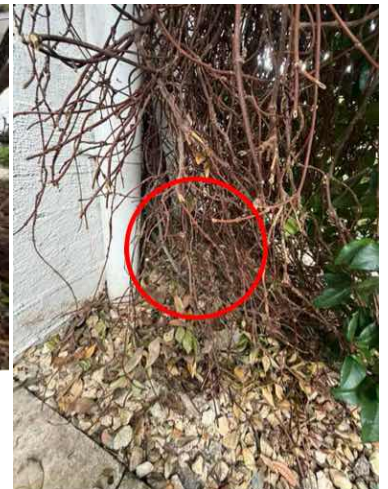
The weep holes are unobstructed .  
Vents are covered by soil/vegetation or have debris restricting ventilation to the sub floor  
Recommendations: Remove vegetation and or lower soil levels so that sub floor vents are unobstructed and allowing free flowing air.

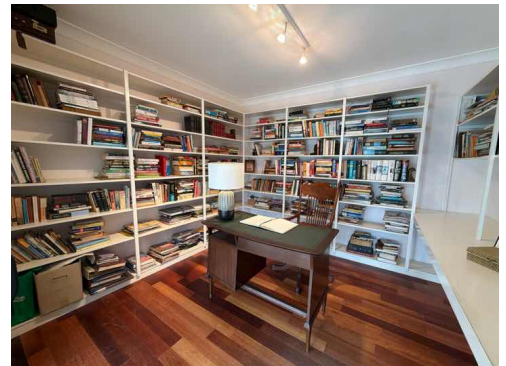
Settlement Cracks Noted. These are typical and generally patch and paint will suffice, however monitoring these cracks is advised for 12 months and if they become worse, further investigation by a suitably qualified professional is advised.

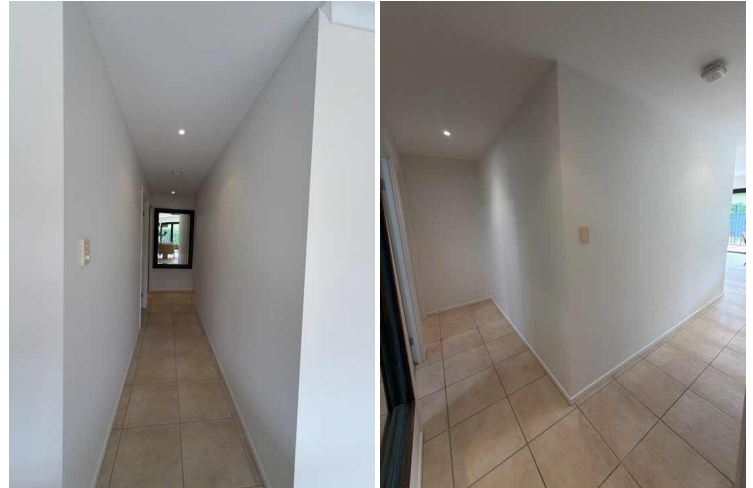
Settlement Cracks Noted. These are typical and generally patch and paint will suffice, however monitoring these cracks is advised for 12 months and if they become worse, further investigation by a suitably qualified professional is advised.

Typical cornice separation/detachment observed. I recommend you contact a qualified painter for repairs.

Drummy/loose tiles observed. Tile lift and further deterioration likely. Contact a qualified tiler for repairs.

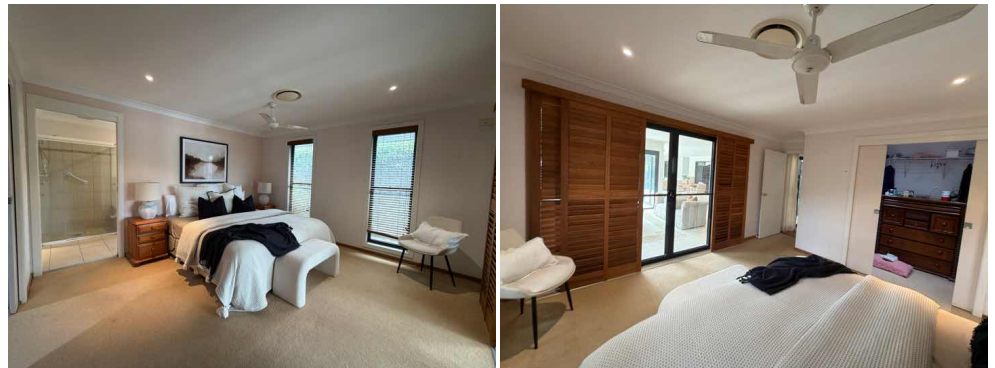
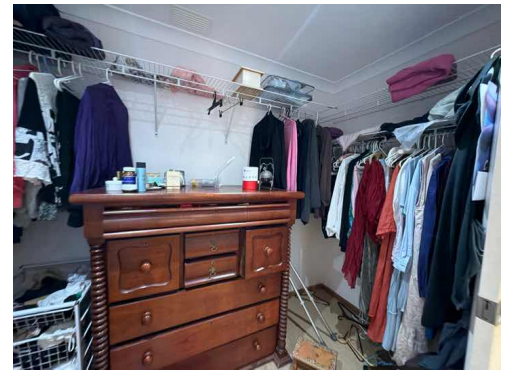
Settlement Cracks Noted. These are typical and generally patch and paint will suffice, however monitoring these cracks is advised for 12 months and if they become worse, further investigation by a suitably qualified professional is advised.

Drummy/loose tiles observed. Tile lift and further deterioration likely. Contact a qualified tiler for repairs.

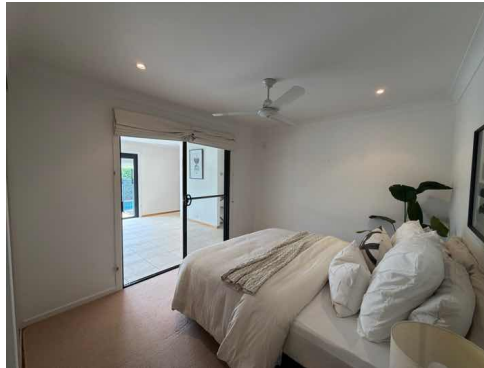
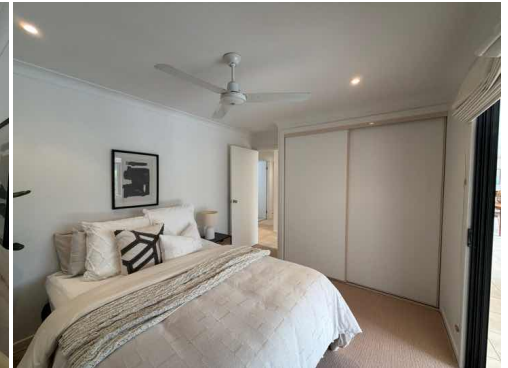
Typical cornice separation/detachment observed. I recommend you contact a qualified painter for repairs.

Stains observed - Steam cleaning may rectify stained areas but they appear entrenched.

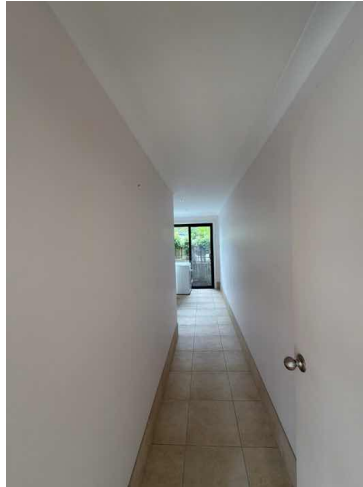
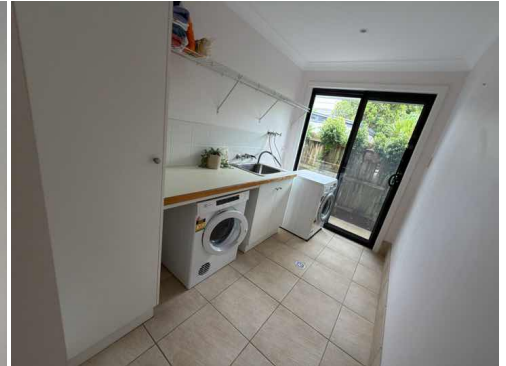
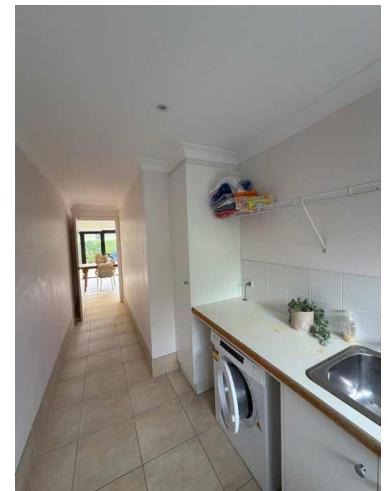
Adjustment to cabinet doors required, in some instance hinges may need to be replaced.
