# Building and Pest Report

## 32 Montwood Dr, Lennox Head

# Inspection Report

**32 Montwood Drive , Lennox Head , NSW , 2478**

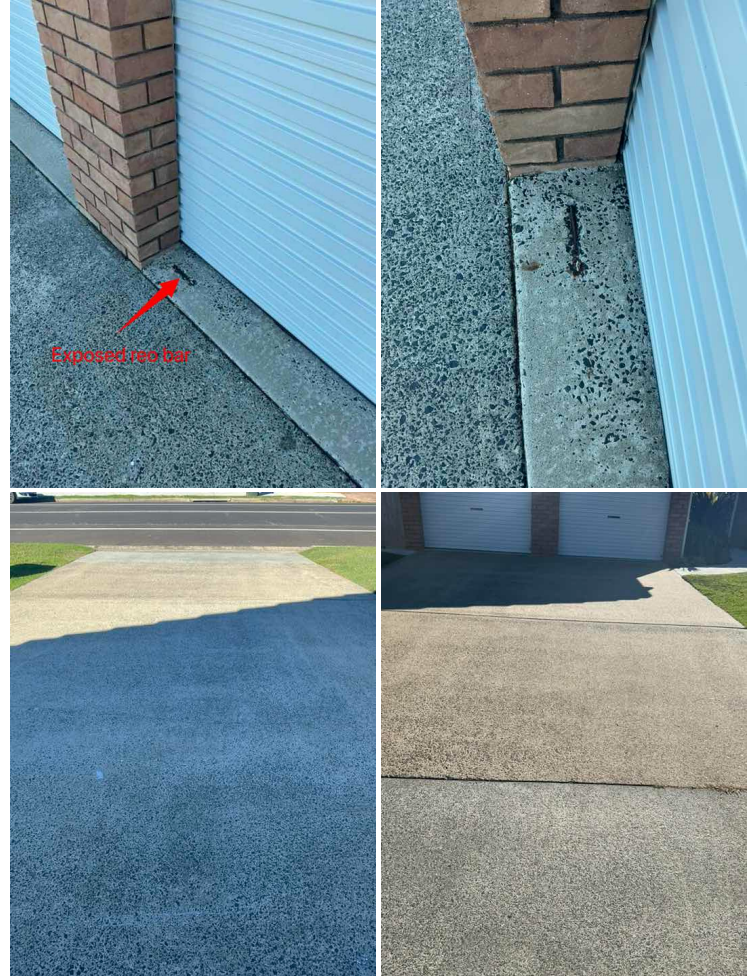
#1. Concrete spalling visible with corrosion to exposed steel reinforcement. Engage a qualified concreter for repairs to affected areas.

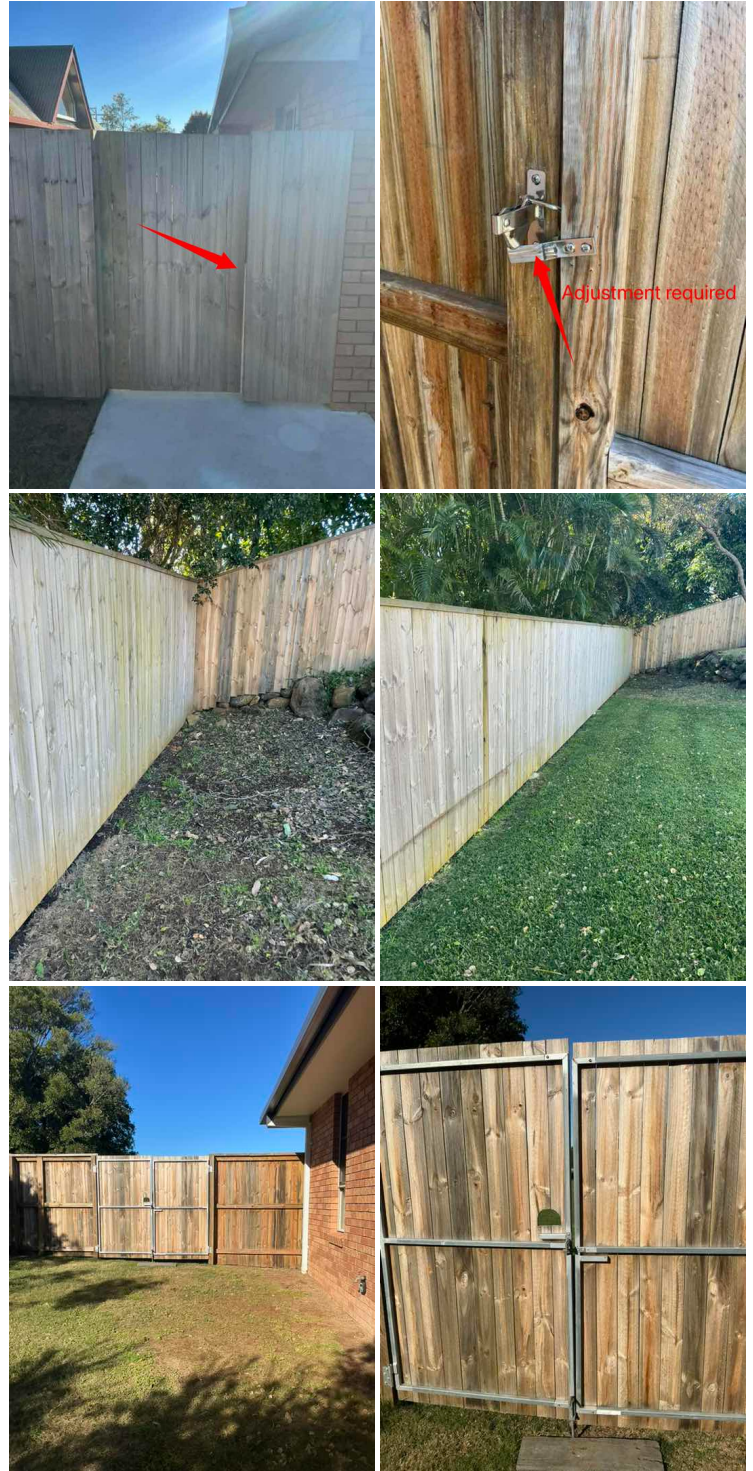
The gate does not latch. Have repaired by a qualified fencer.

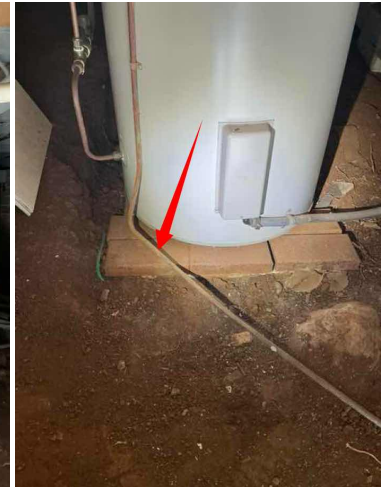
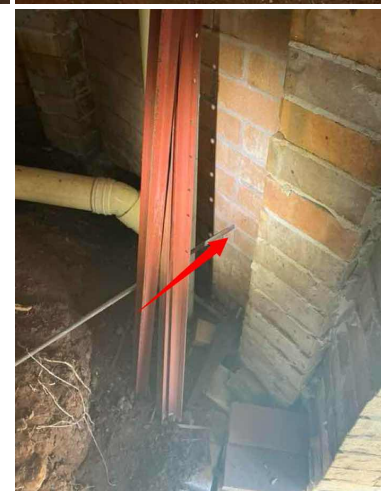
Yes. The hot water overflow does not drain to the perimeter of the building.

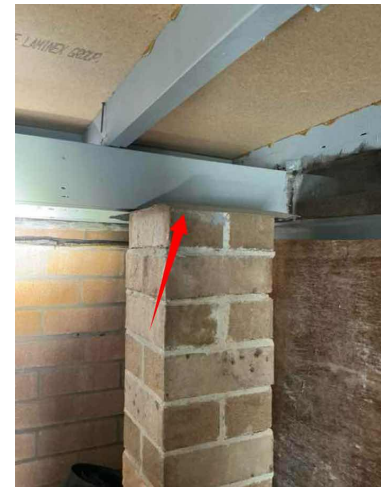
The ant capping is generally considered adequate.
