# Building and Pest Report

## 6 Seaward Street Lennox Head

| Report/Agreement # | 280126122333105 |
| Inspection Date: | 28 Jan 2026 |

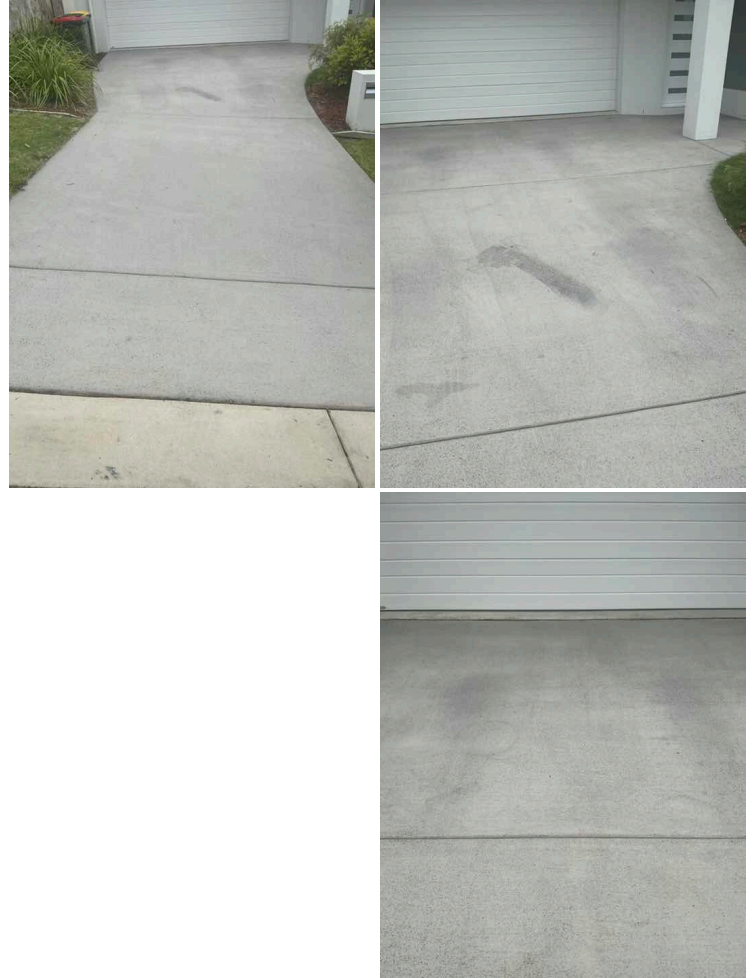
#### Driveway Condition

On visual inspection, the general condition of the driveway is serviceable.

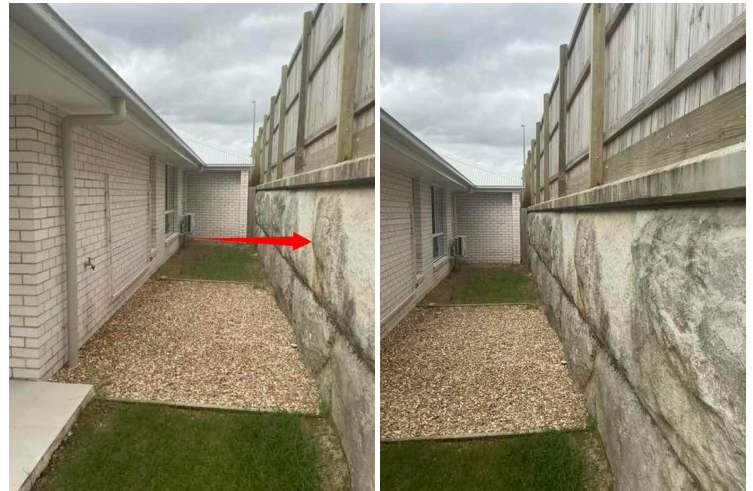
The retaining wall material is stone.

Of the visible areas, the general condition is serviceable or in reasonable condition for age of dwelling.

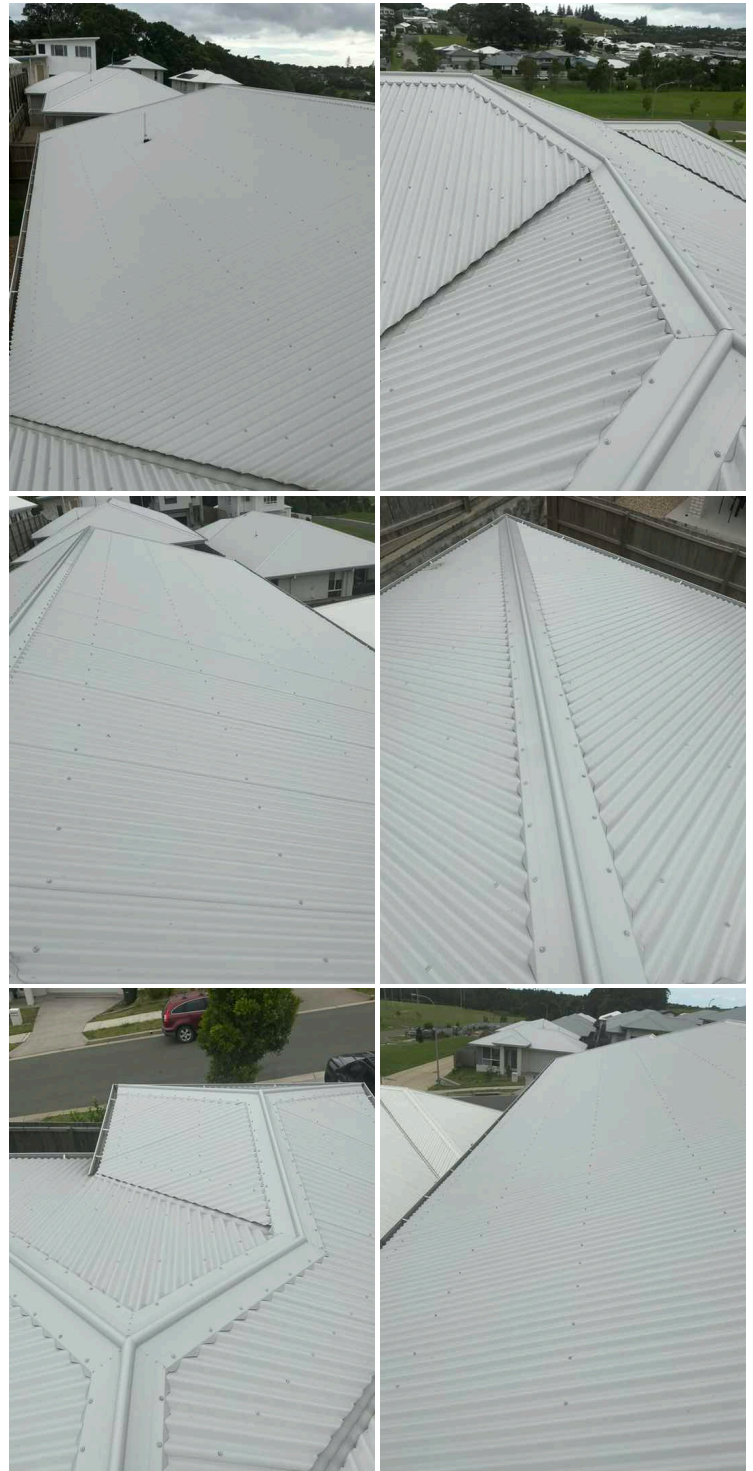
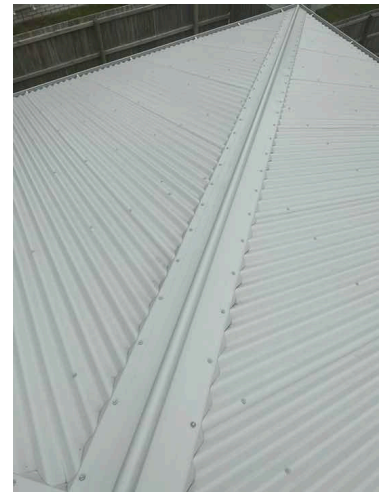
Of the visible areas, the general condition of the roof is in serviceable condition for the age.

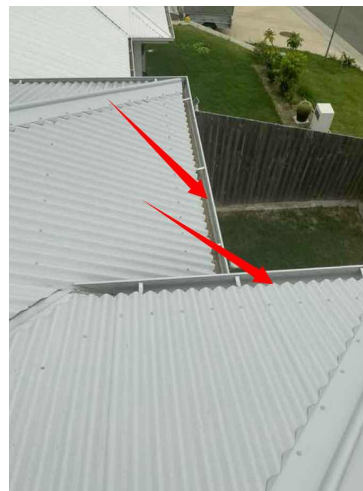
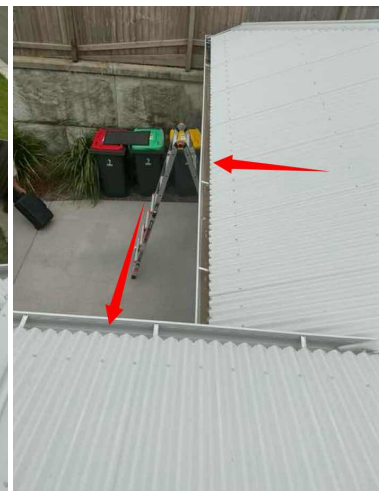
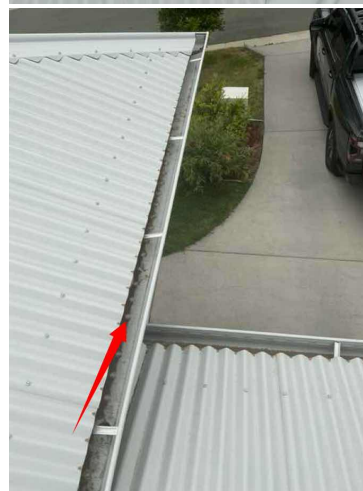
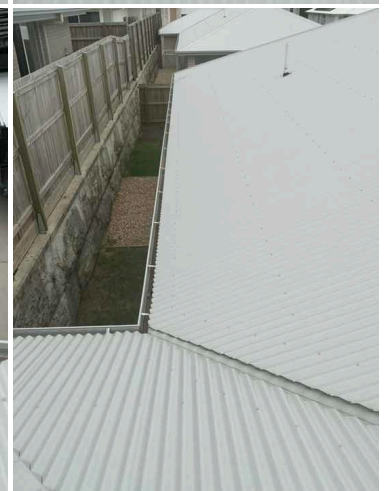
### **Gutter Findings**

All visible and accessible of the physical nature of the guttering system appears to be in a serviceable condition with no apparent defects at the time of inspection. In the absence of prolonged rain fall efficiency of the guttering can not be assessed and you may find that further investigation or repairs maybe required. Note: Periodic maintenance checks should be carried out for rust penetrations and leaks.

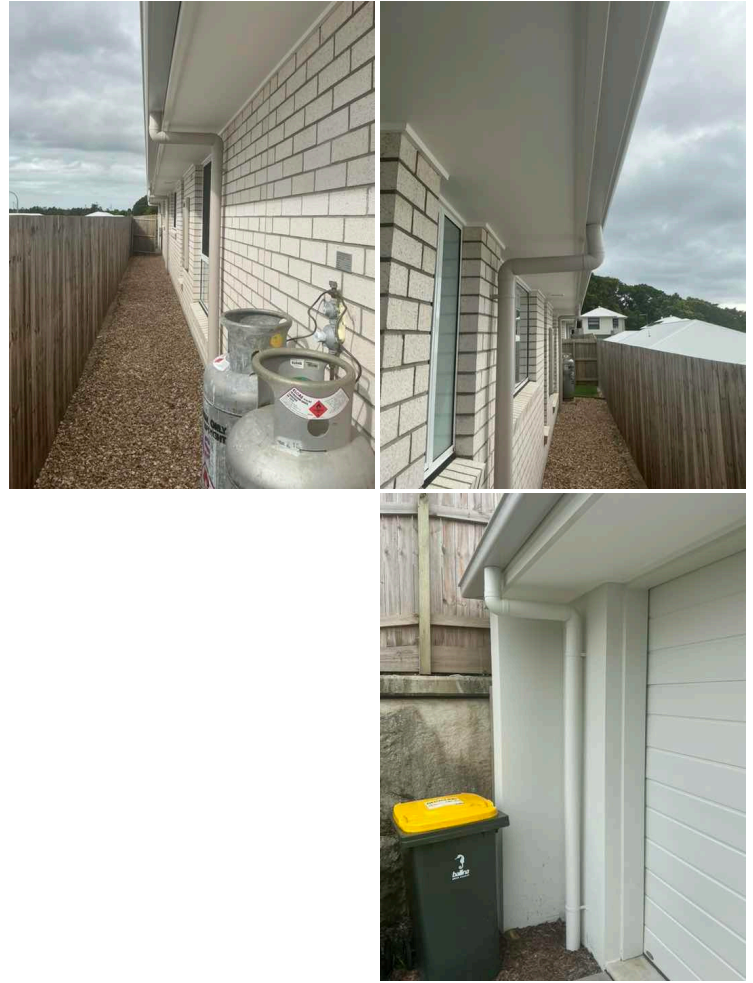
### **Downpipe Findings**

On visual inspection no apparent defects were noted to the down pipes and are considered serviceable, however no comment can be made with regard to blockages or connections to stormwater or functionality in the absence of rain. Note: Periodic maintenance checks should be carried out for rust penetrations and leaks.

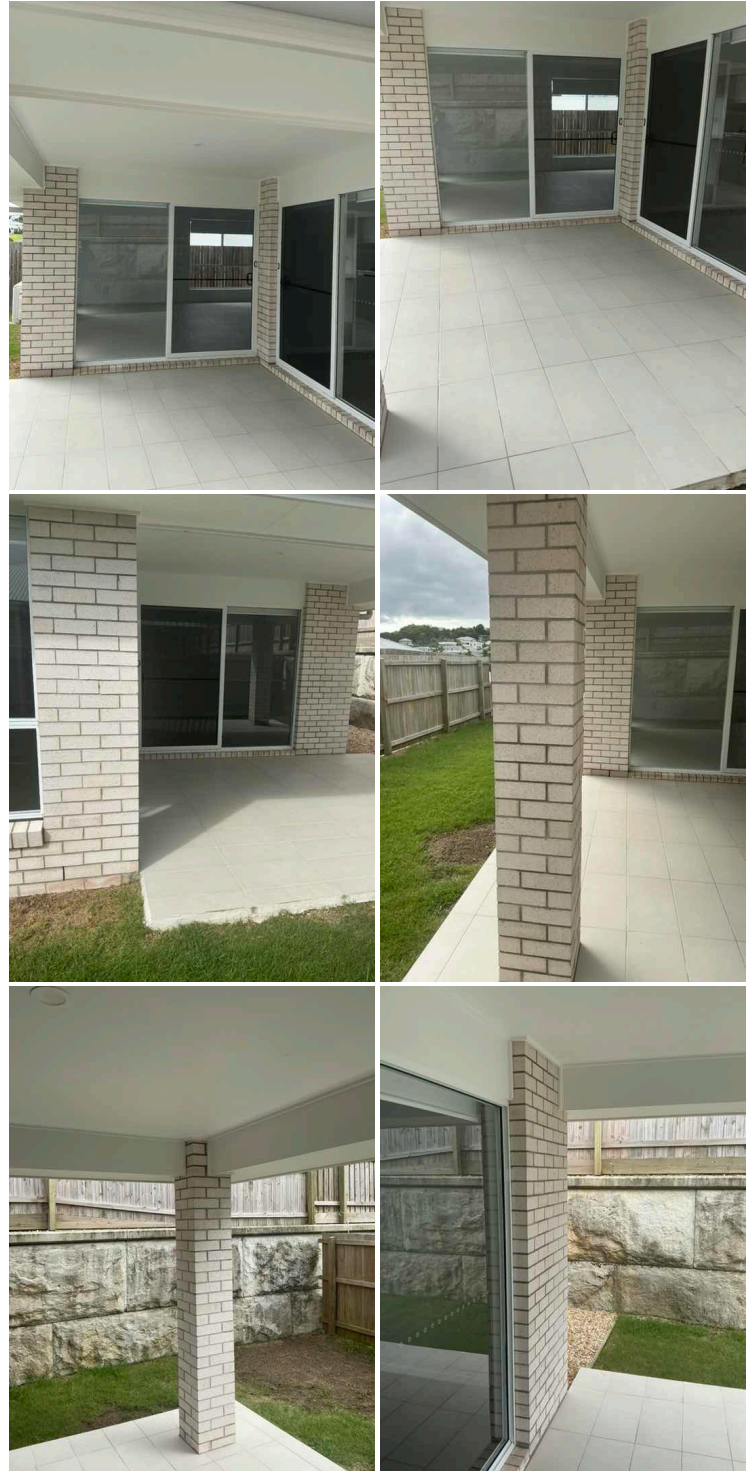
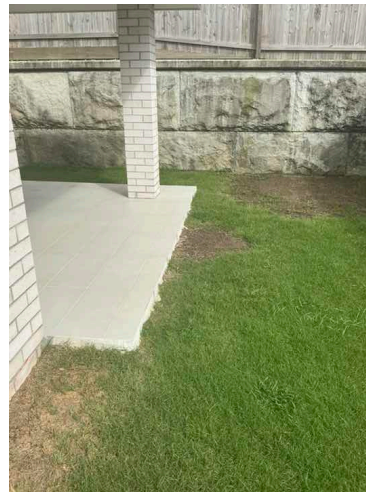
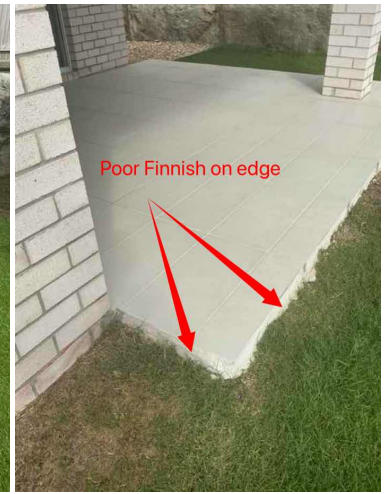
Visible sections of the Alfresco area are serviceable or in reasonable or condition for the age of this dwelling. Defects exist to an area or component/s requiring assessment by a specialised field. Please read below for details.

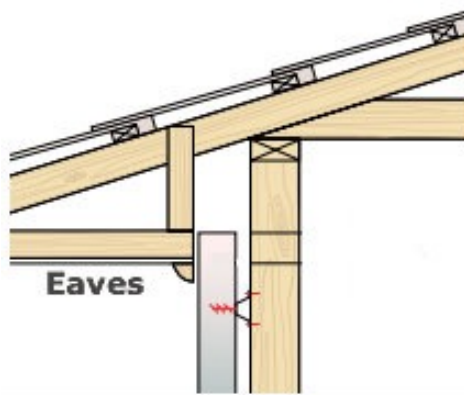
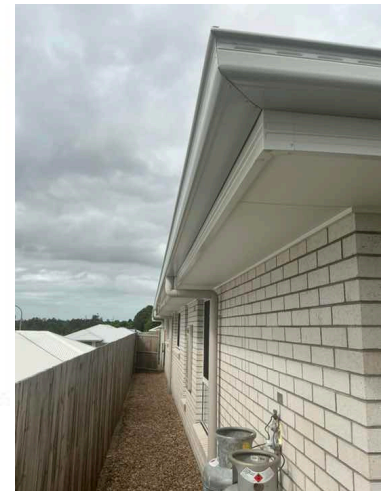
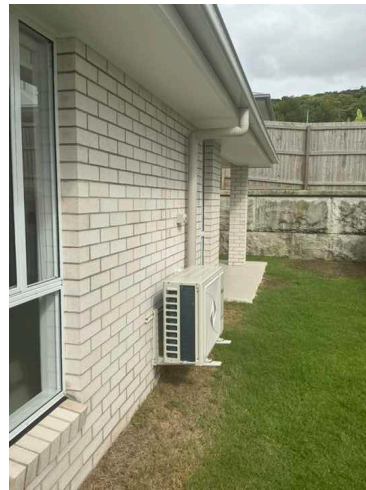
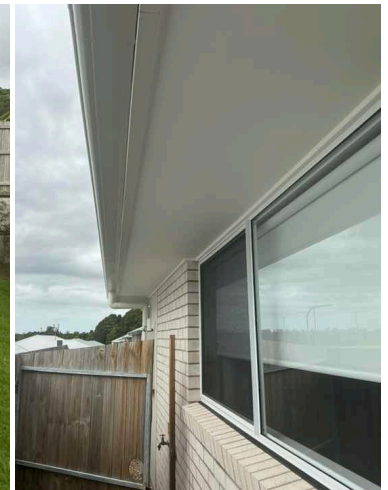
### Eave Condition

The soffit lining (eaves) are in a serviceable condition with no notable defects.

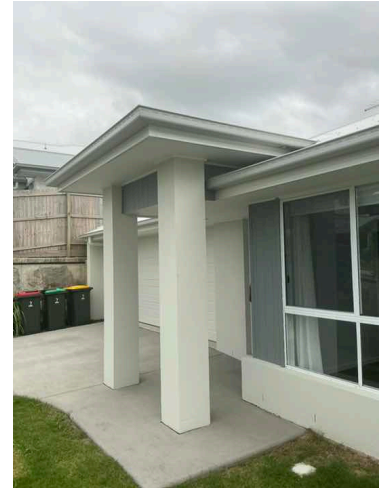
## Entry Porch Area

The entry porch serviceable or in reasonable or condition for the age of this dwelling.

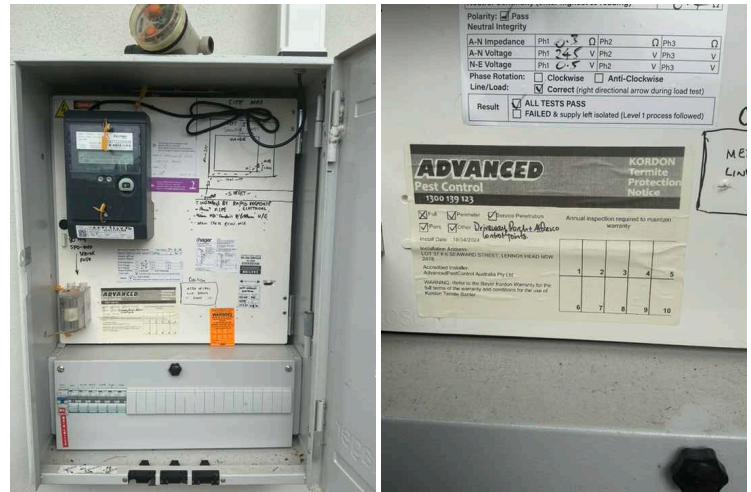
#### **Was a Treatment Notice Found**

Yes, a durable notice was found in the meter-box during the inspection.

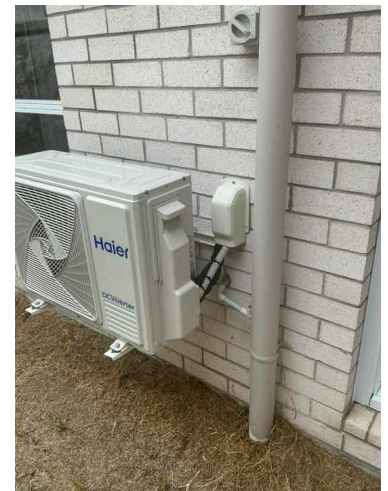
#### **Was the Air Conditioner Sufficiently Drained**

Yes. The overflow does not drain to the perimeter of the building.
