# Building and Pest Report

## 246 Martins Lane Knockrow

Report/Agreement #	101125084427120
Inspection Date:	10 Nov 2025
Inspection Time:	08:44 am

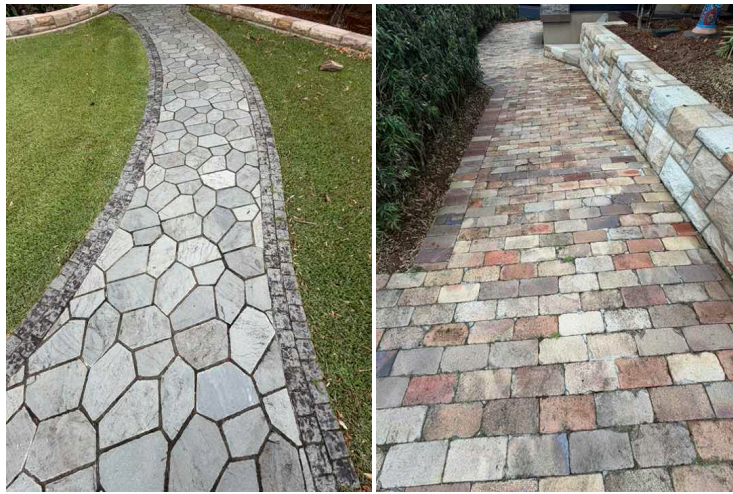
The paths around the home are in a serviceable condition for the age of this dwelling with no major defects visible.

Chipped tiles observed.

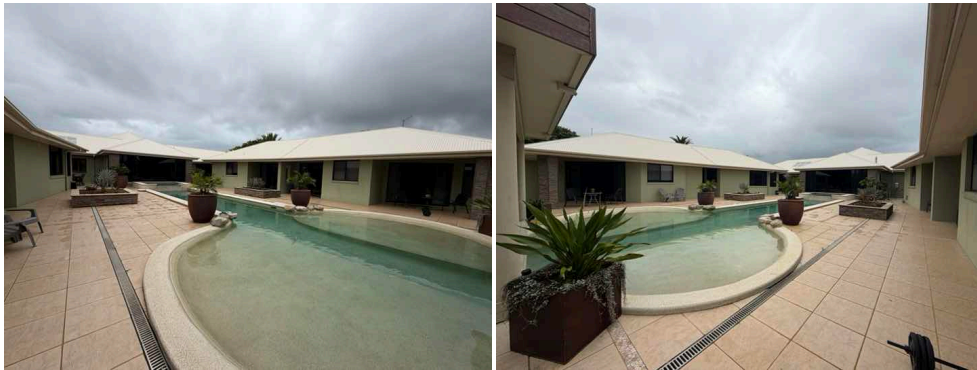
A swimming pool is present but the pool fence appears inadequate. The gate is not closing and latching as it should. This should be repaired. The pool fence should be checked for compliance with safety regulations.

Considered safety Hazard

The appropriate warning signs do not appear to be present. You should check with your local council regarding the required signs.

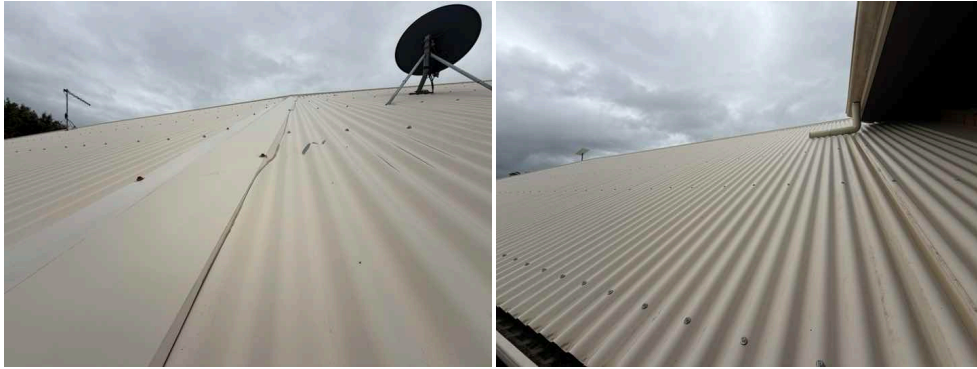
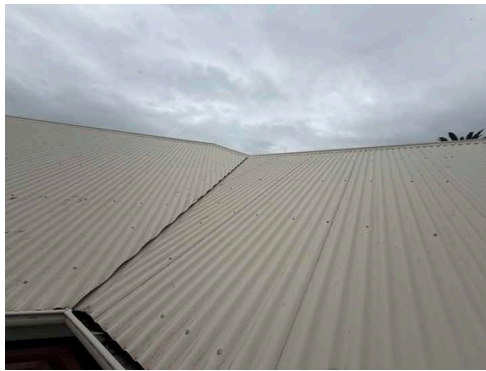
Of the visible areas, the general condition of the roof is in serviceable condition for the age.

Visible section of The roof cladding appeared in a serviceable condition for the age of this dwelling. Annual maintenance inspection recommended.

Corrosion noted to the screw fixings of the metal roof. Have these checked and replaced by qualified roofing contractor.

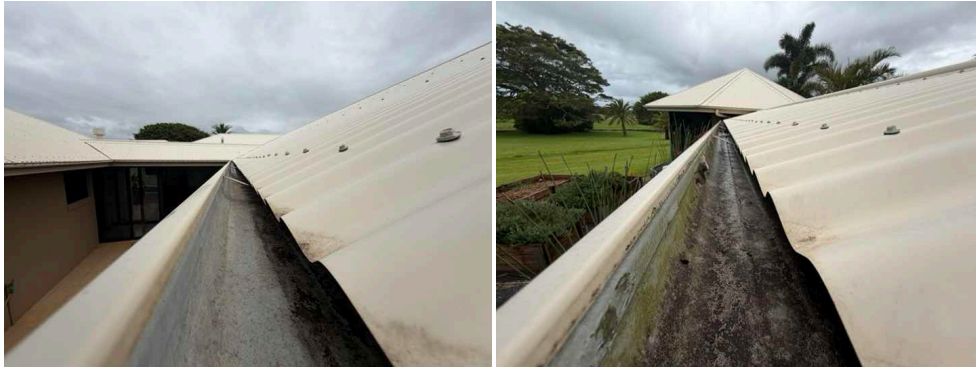
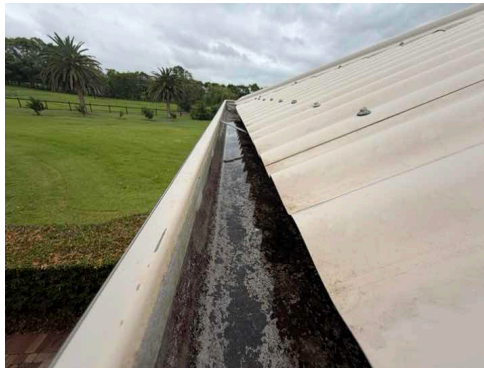
Gutter surface rust in sections- the rust is yet to penetrate and repairs/sealing may be an option. A qualified roof plumber should be engaged for advice and recommendations.

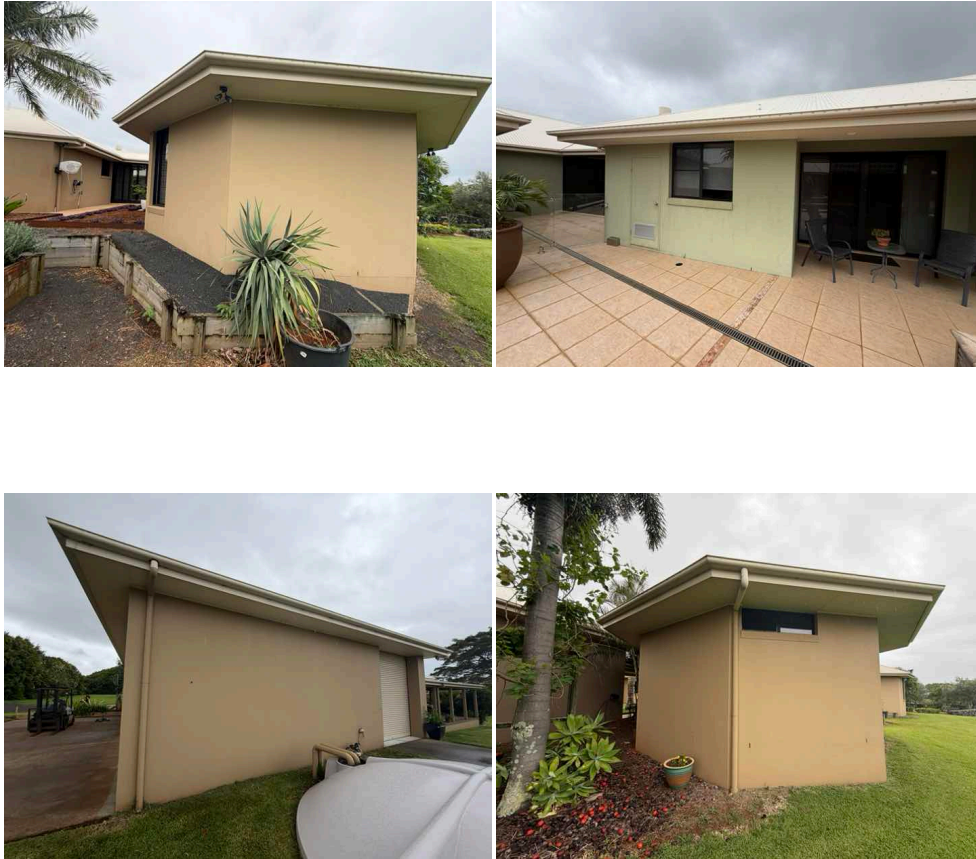
On visual inspection, the general condition of the exterior walls is serviceable for the age.

There appears to have been some settlement in the building which has caused some cracking to the walls. These cracks are categorized as 0 to 2. This can also cause some doors to bind or be out of square. In the inspectors opinion these cracks are due to settlement, usually due to ground movement and subsequent movement to building materials can be expected. Any cracks should be monitored and if cracks increase in size, further investigation should be carried out by a structural engineer.

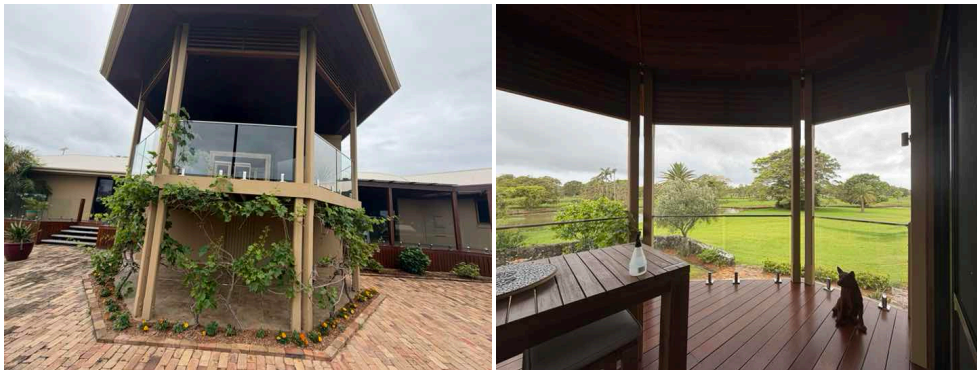
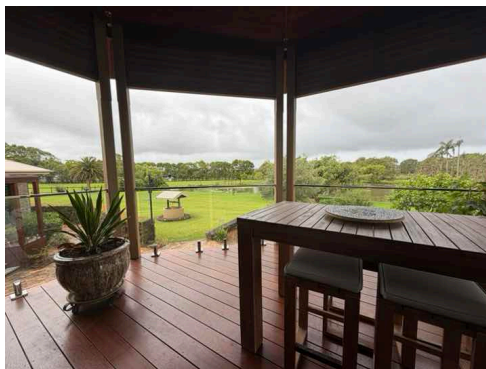
Though we are not structural engineers the veranda/s appear to be in a serviceable condition.

Upon visual inspection, several tiles were found to be chipped, compromising the surface integrity and aesthetic appeal. It is recommended to replace the damaged tiles to prevent further deterioration and potential safety hazards. A licensed tiler should be engaged to ensure proper removal and installation, matching the existing tile pattern and grout color for a seamless repair.

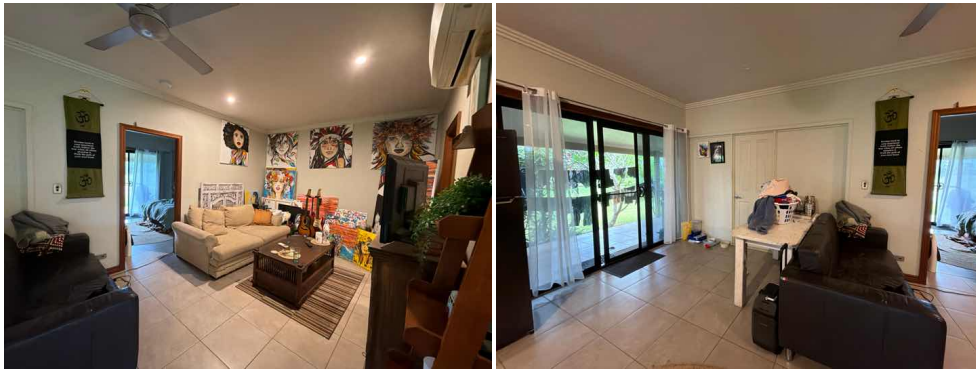
Ceiling stains - No moisture readings obtained. These may have been repaired however you will need to monitor after a prolonged period of rainfall. If leaking persists, a qualified plumber should be engaged for advice and recommendations. All water damaged plaster should be replaced.

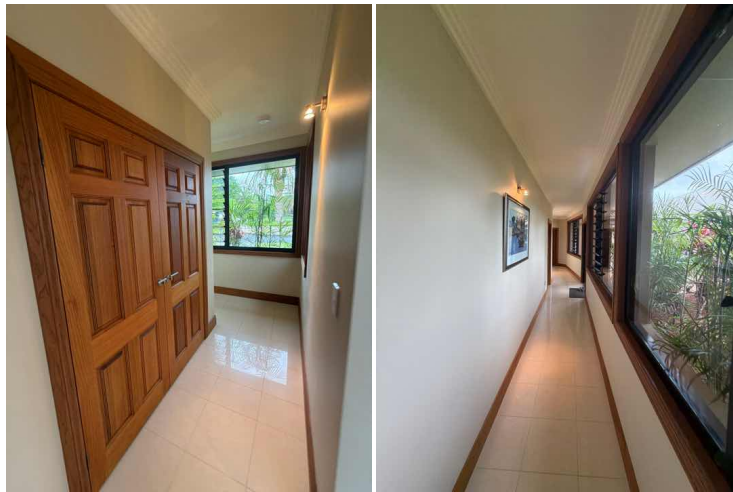
Settlement Cracks Noted. These are typical and generally patch and paint will suffice, however we recommend you monitor these cracks and if they become wider or longer, you will need to contact a structural engineers to assess.

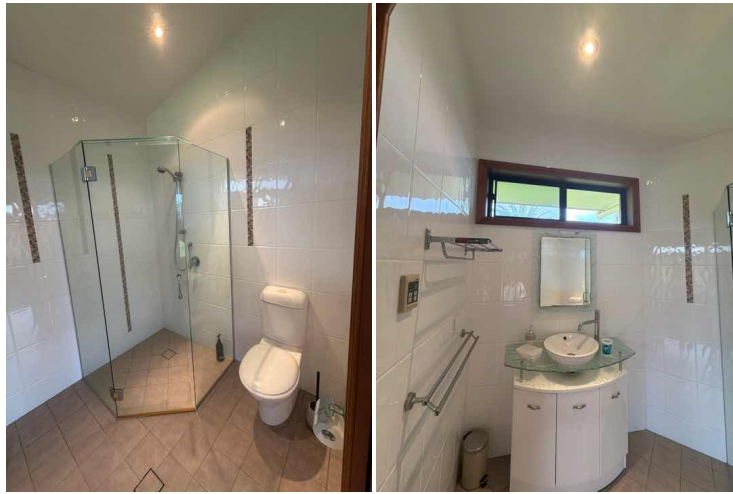
The vanity mirror is desilvering at edges. Replacement recommended.

Exhaust fan is installed but not operable. A qualified electrician should be engaged for advice and recommendations.

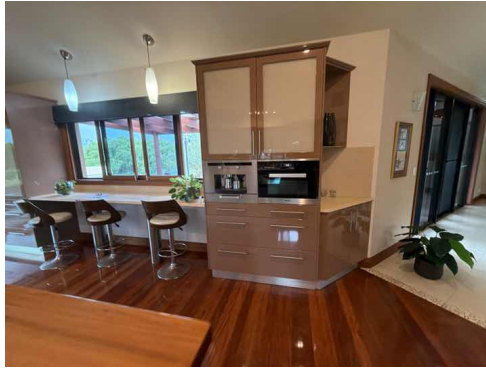
Adjustment to cabinet doors required, in some instance hinges may need to be replaced.
