Building and Pest Report

66 Stoneyhurst Drive Lennox Head

BPI BUILDING & PEST INSPECTIONS

66 Stoneyhurst Drive Lennox Head.

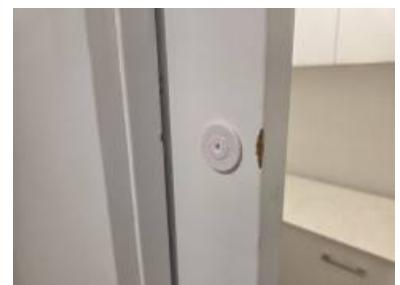
Doors

Minor paint touch ups to some doors.

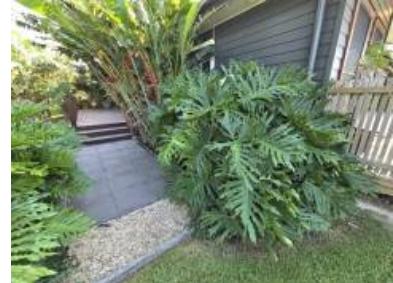
Inspection to areas and sections of the exterior was restricted due to the growth of foliage. Foliage should be removed as foliage may be concealing damage.

Further inspection of these areas is strongly recommended once access has been obtained.

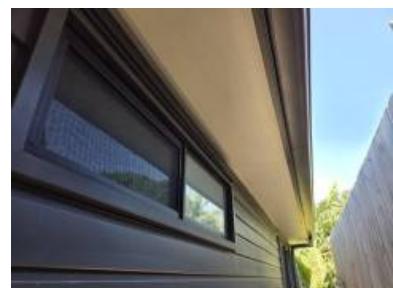
PAINTING

The external paintwork / finish to the external surfaces and timberwork is generally in good condition. There may be sections / areas that require touching up / repainting.

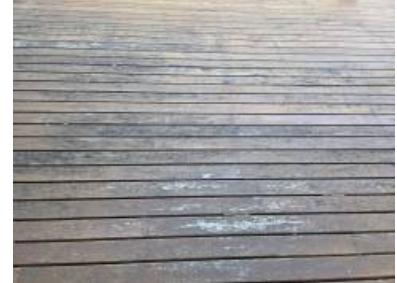
There is insufficient crawl space below the decking timbers due to the method of construction. There may be concealed defects where access cannot be achieved.

Various decking timbers require sealing / re-sealing to prevent weather damage.

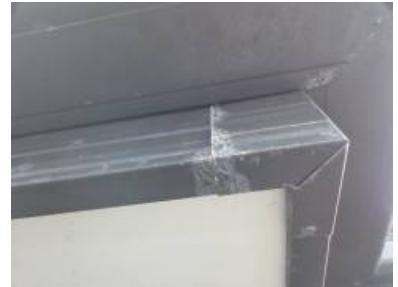
EAVES / FASCIAS / BARGES

Some metal fascia corners show signs of surface rust and require repair / painting with Killrust or better.

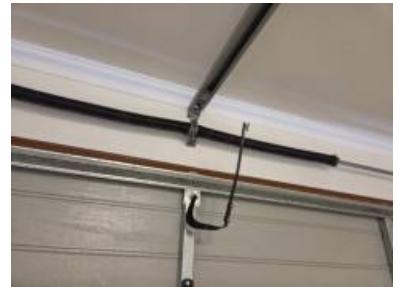
Panel door requires repair / adjustment. I recommend that a qualified Garage door technician be engaged for further investigation / maintenance.

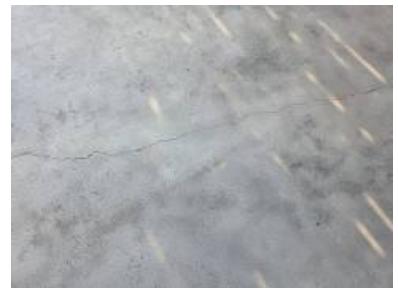
PATHS & DRIVEWAYS

Some surface cracks to concrete slabs.

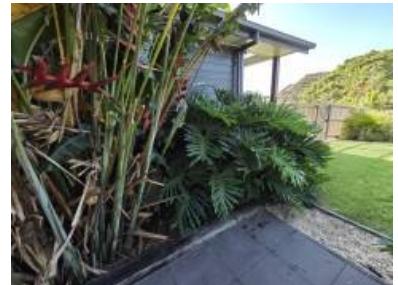
- We strongly recommend that all garden beds and vegetation close to or abutting the external walls of the structure be removed. Garden beds and vegetation can attract / allow concealed termite entry and should be removed.
