Building and Pest Report

5 Alexander
Circuit
Lennox Head

Inspection Report

East Coast Building Solutions

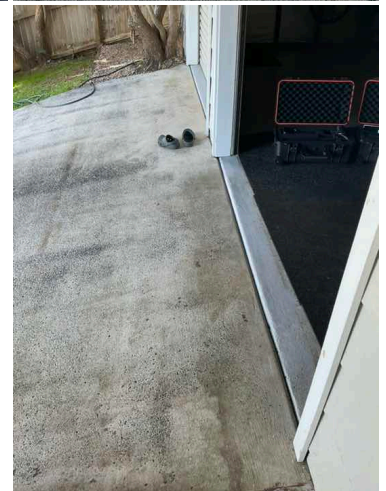
Driveway Condition

On visual inspection, the general condition of the driveway is serviceable.

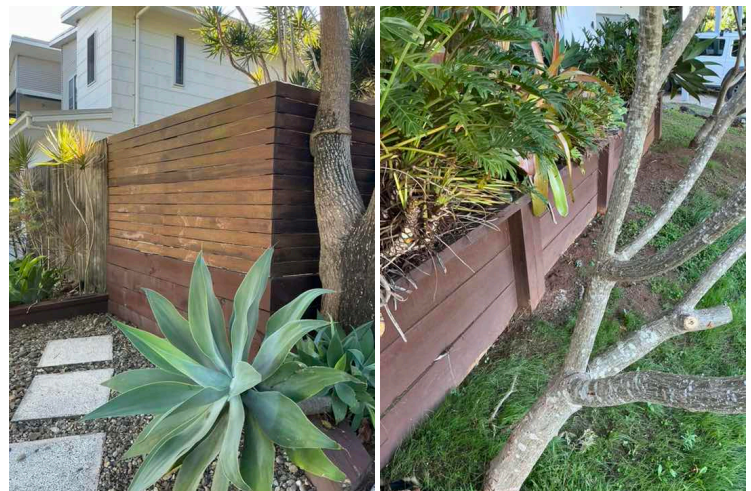
Overall Condition

Upon visual inspection, the timber appears cracked and weathered, likely due to moisture exposure and root pressure. Recommend replacing the damaged timber with treated wood to prevent future decay. Ensure proper drainage and clearance from tree roots to avoid similar issues. Consult a licensed tradesperson for assessment and repair.

Upon visual inspection, the wooden retaining wall shows signs of moisture exposure, indicated by discoloration and potential rot. Recommend sealing or replacing affected sections to prevent further deterioration. Ensure proper drainage to reduce moisture contact. Consult a licensed tradesperson for repair and maintenance.

#1. Upon visual inspection, the wooden retaining wall shows signs of moisture exposure, indicated by discoloration and potential rot at the base. Recommend sealing the wood with a waterproof sealant and ensuring proper drainage to prevent further moisture accumulation. Engage a licensed carpenter to assess and repair any structural weaknesses.

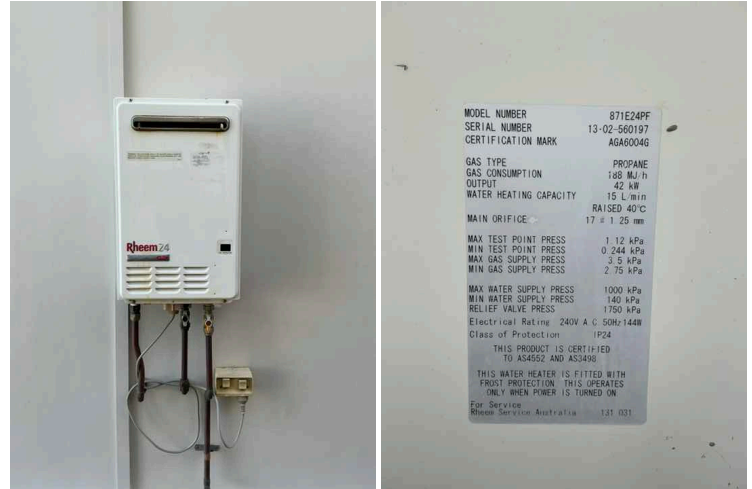
Hot Water Unit Findings

The hot water system appears to be in a serviceable condition. No specific tests other than running the hot water from a tap was carried out. No determination has been made as to the suitability or adequacy of the hot water system in relation to capacity or otherwise.

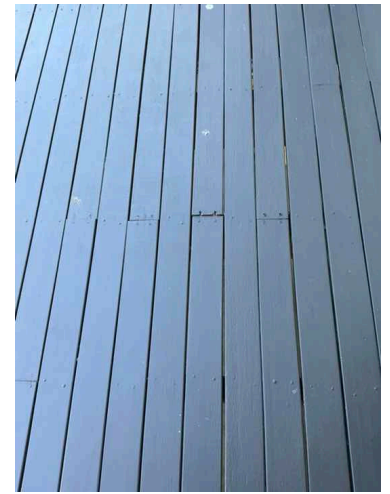
Deck Framework

Upon visual inspection, there is discoloration and potential water damage on the wooden beams. Recommend cleaning and sealing the wood to prevent further moisture intrusion. A licensed carpenter should assess for structural integrity and replace any compromised sections. Regular maintenance and inspection are advised to ensure longevity and safety.

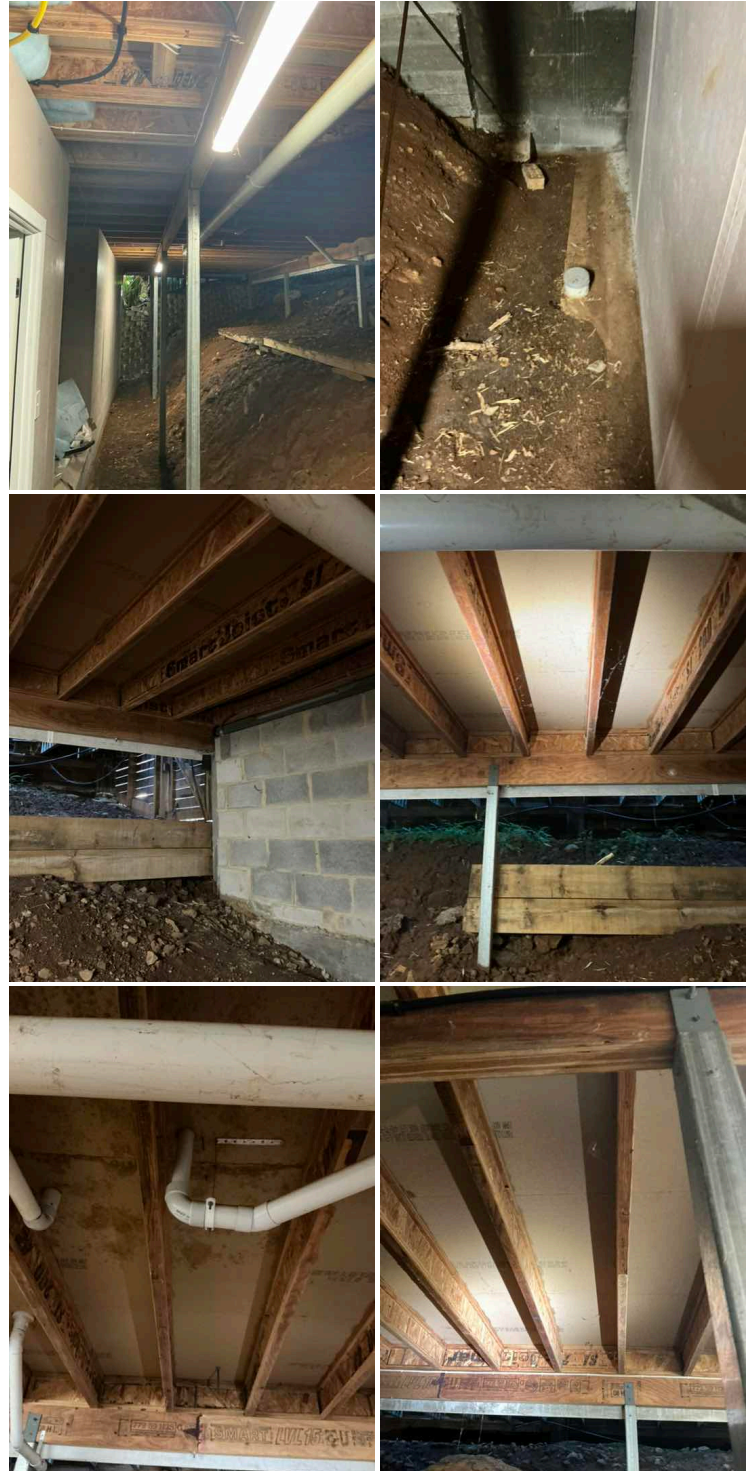
General Condition

Upon visual inspection, water stains and potential mold growth are visible on the ceiling. Recommend engaging a licensed plumber to inspect and repair any leaks. A licensed mold remediation specialist should assess and treat the affected areas to prevent further damage and ensure safety.

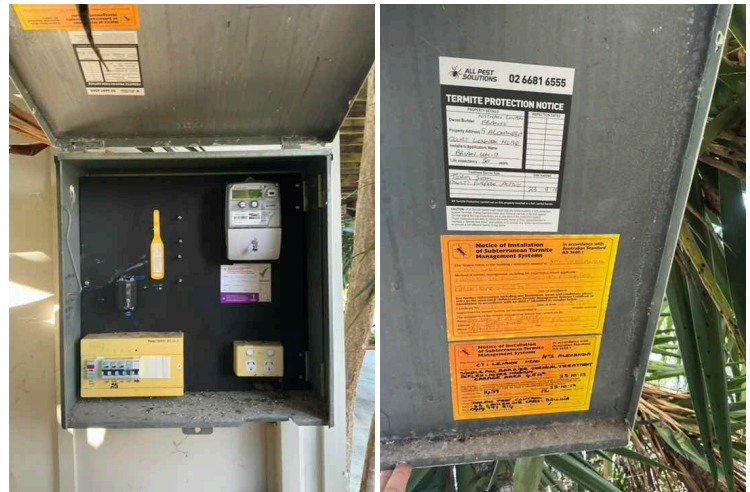
Was a Treatment Notice Found

Yes, a durable notice was found in the meter-box during the inspection.
