Building and Pest Report

**2/6 Kell Mather Dr
Lennox Head**

Pest And Building Inspection

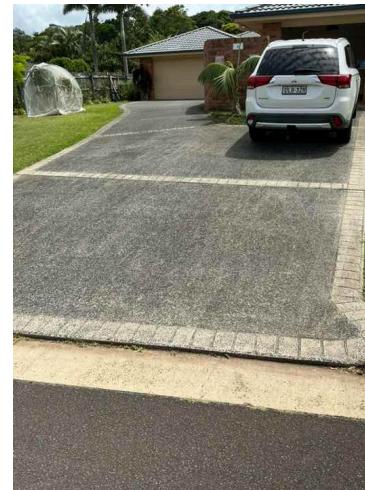
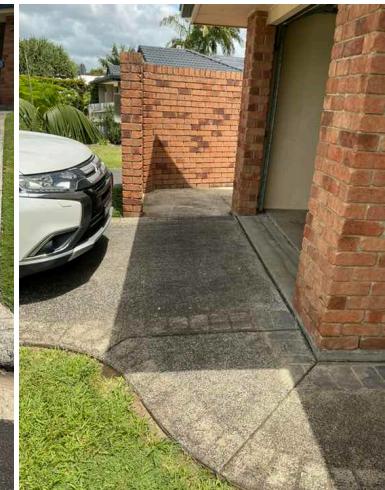
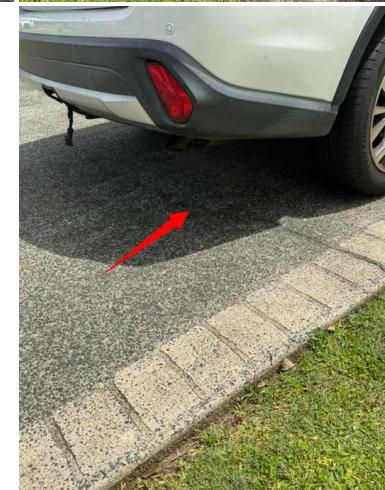
Driveway Condition

Common cracks were observed on the driveway. Whilst these cracks appeared to be typical at the time of inspection, we strongly recommend you monitor these cracks and if worsening occurs contact a concreter for further advice.

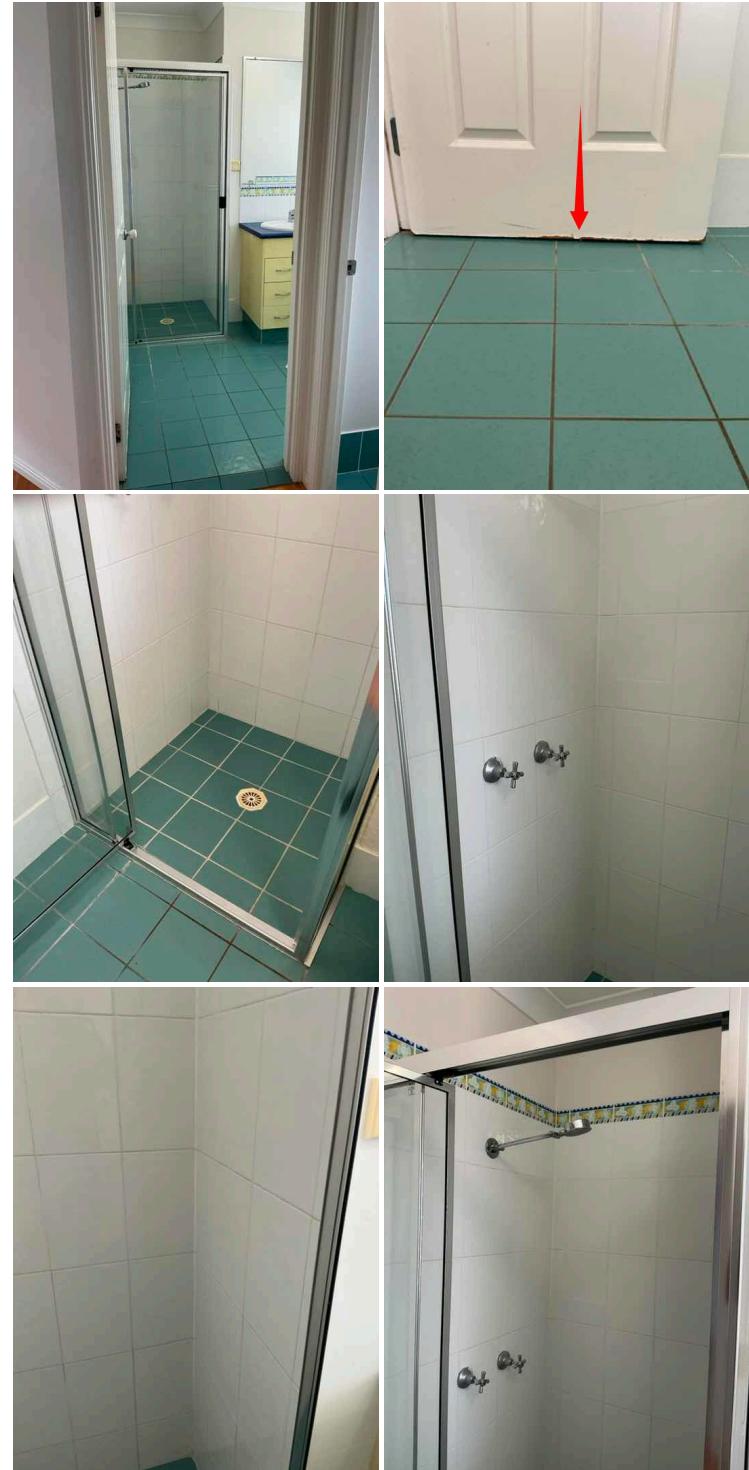
Upon visual inspection, the door shows signs of wear at the bottom edge, likely due to moisture exposure.

Recommend sanding the affected area and applying a water-resistant sealant. If the damage is extensive, consider replacing the door. Ensure proper ventilation to prevent future moisture-related issues.
