# PEST AND BUILDING PRE-PURCHASE REPORTS

# Inspection Report

**25 Ibis Place , Lennox Head, NSW, 2478**

### Pest And Building Inspection

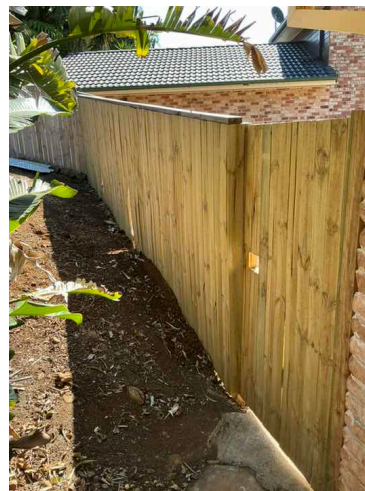
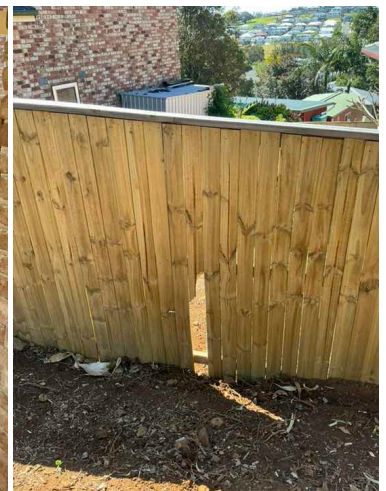
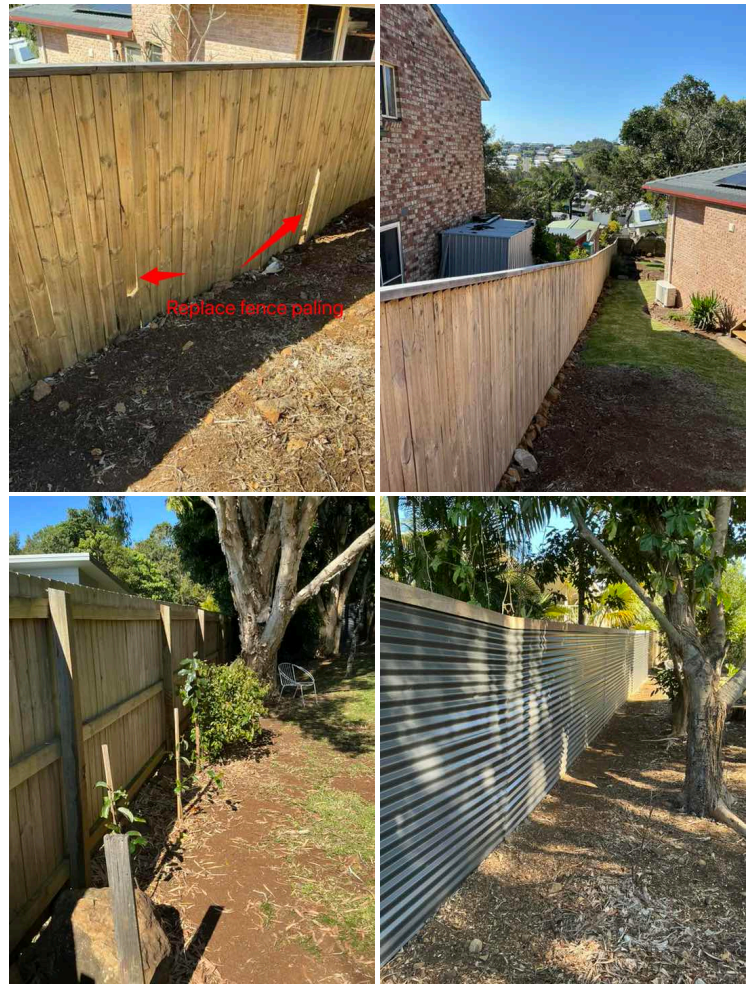
#1. Front fence Palings require replacement as per photo

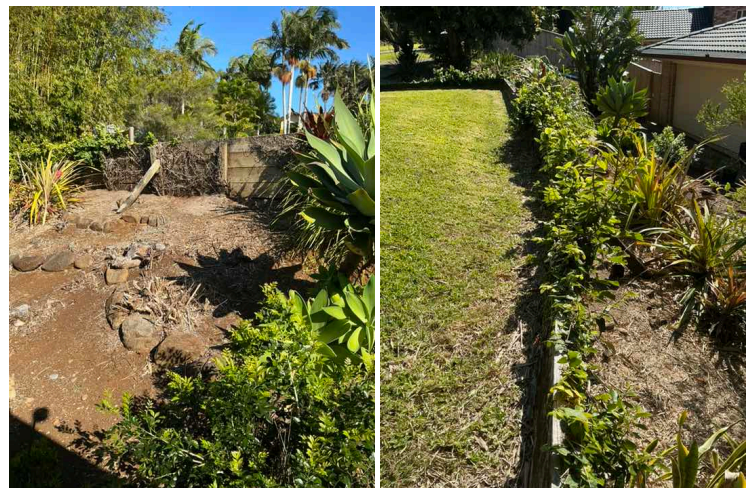
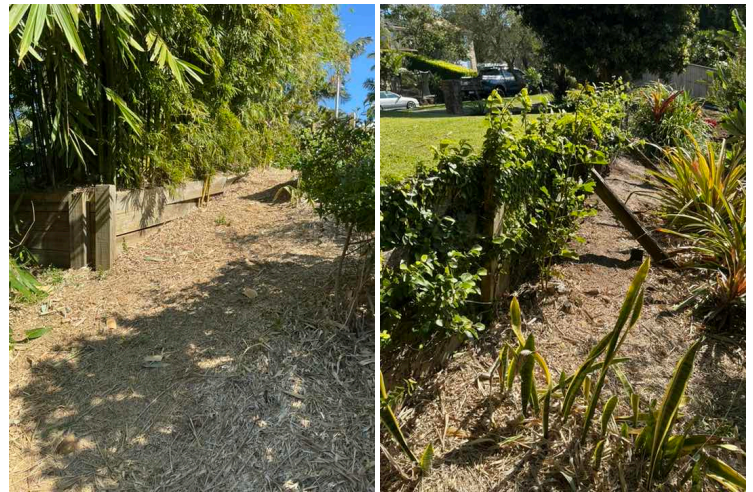
#2. Retaining wall leaning due to deterioration and age. A qualified brick layer should be engaged for advice and recommendations.

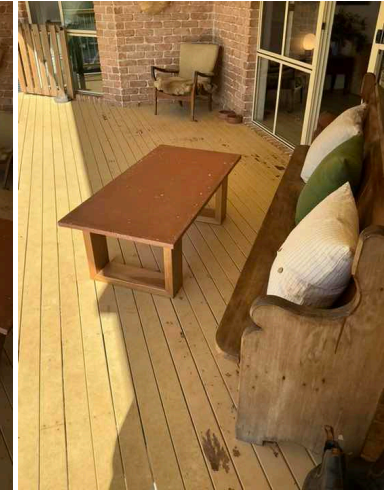
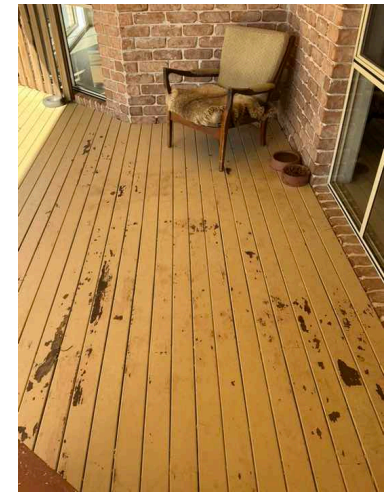
#3. Upon visual inspection, the deck shows signs of paint peeling and surface wear. It is recommended to sand the affected areas and apply a weather-resistant sealant or paint. Ensure proper drainage to prevent future deterioration. Consult a licensed tradesperson for a thorough assessment and repair to maintain structural integrity and appearance.

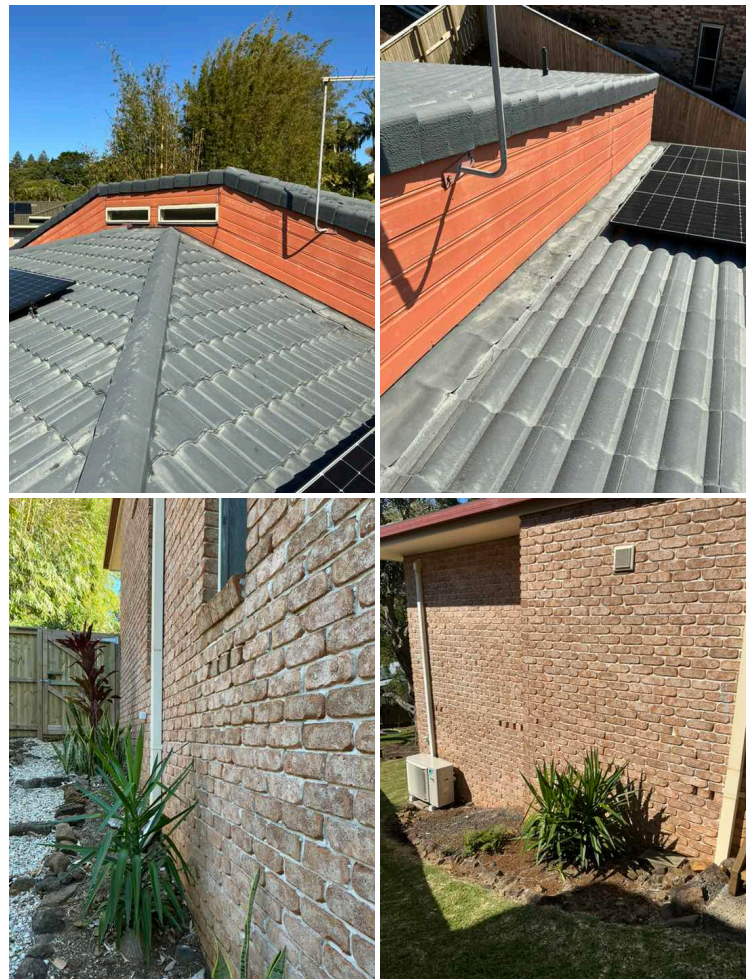
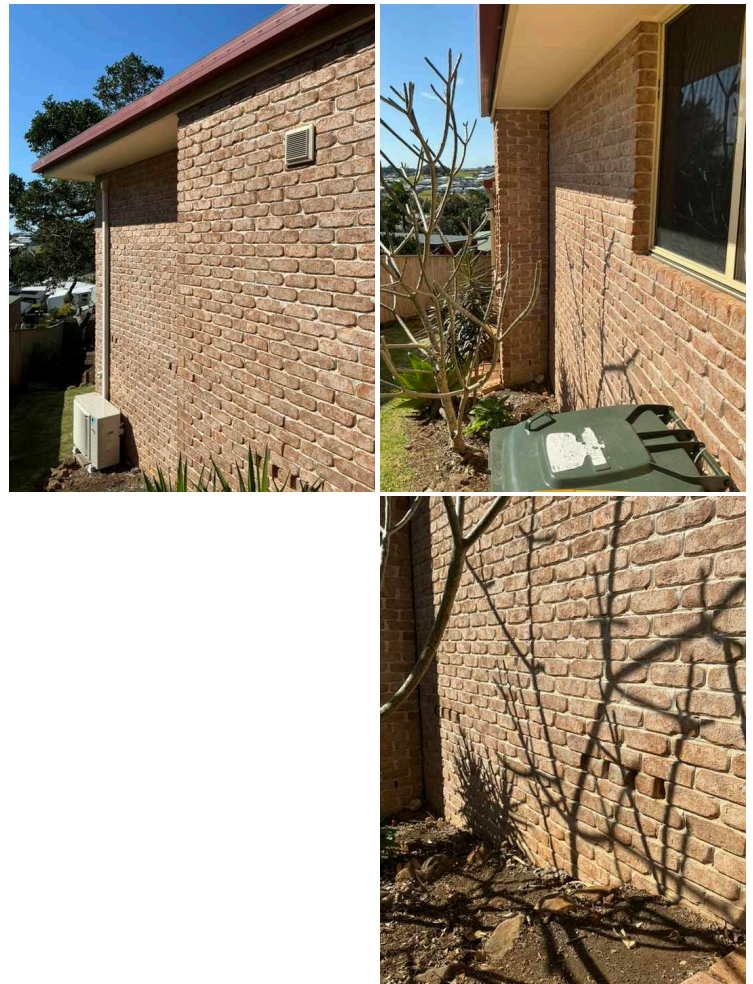
#4. Upon visual inspection, the brick wall appears intact with no visible structural defects. Ensure regular maintenance of the air conditioning unit and clear vegetation away from the wall to prevent moisture buildup. Engage a licensed tradesperson to inspect and maintain the drainage system to prevent water damage.

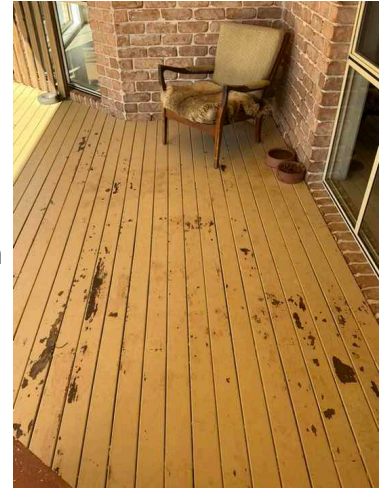
#5. Upon visual inspection, the deck shows signs of peeling paint and surface wear. It is recommended to sand and repaint the affected areas to protect the wood from further deterioration. Engage a licensed painter to ensure proper surface preparation and application of a suitable exterior-grade paint for durability and weather resistance.

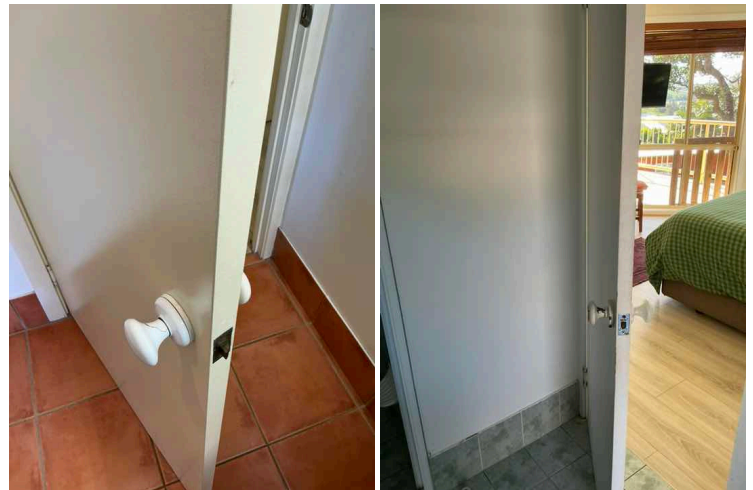
#6. The door lock was damaged/deteriorated -  
Recommendations: A locksmith should be engaged for advice and recommendations.

#7. Some internal door handles cracked on the inside and loose. Recommend qualified tradesperson replace and tighten

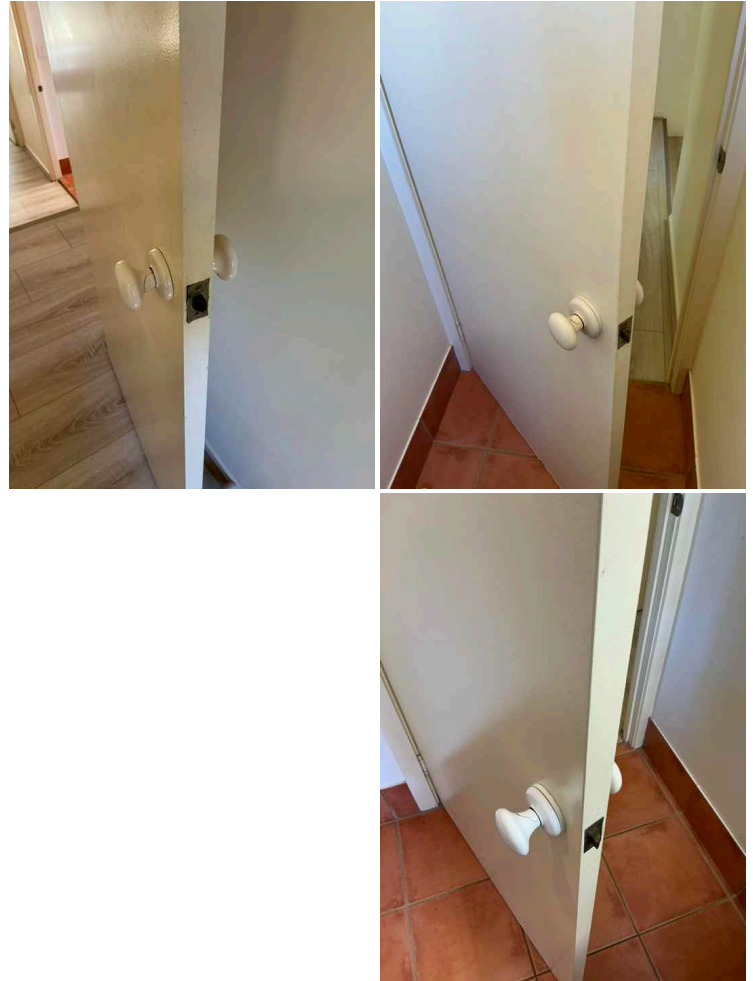
Door lock hardware is loose possibly damaged.  
Maintenance as required.

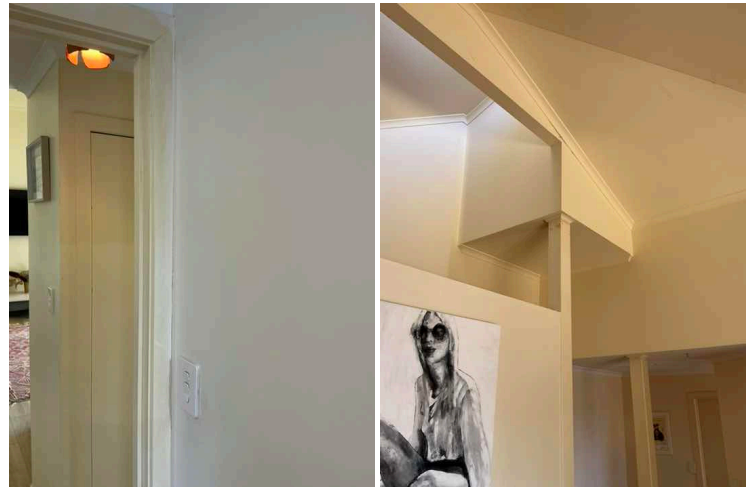
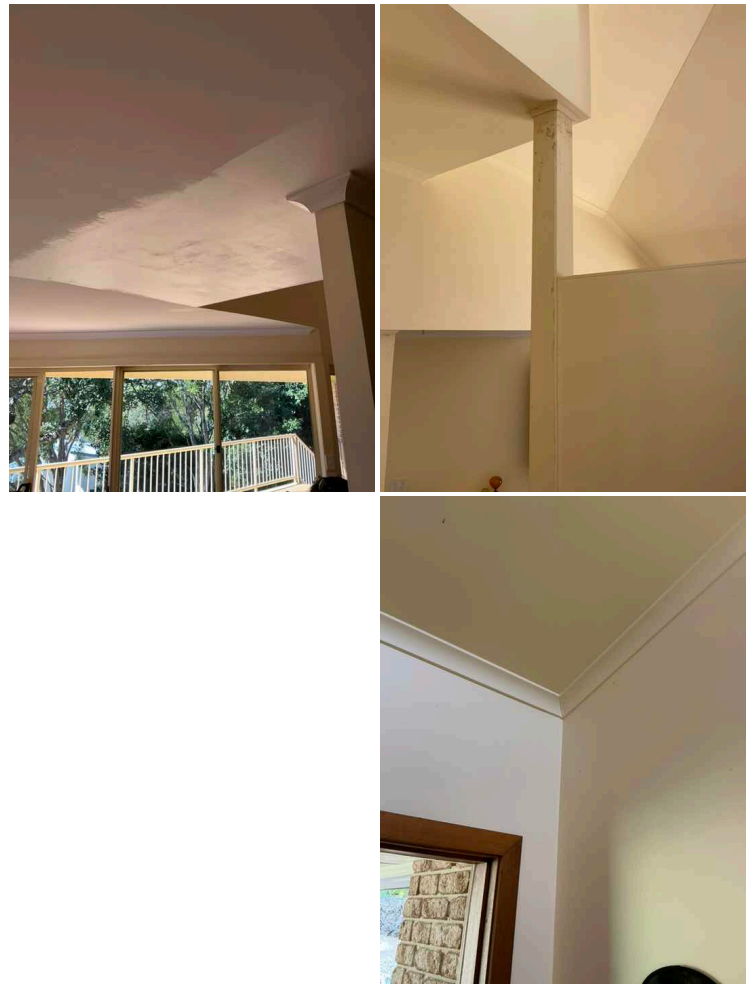
#9. Settlement Cracks Noted. These are typical and generally patch and paint will suffice, however monitoring these cracks is advised for 12 months and if they become worse, further investigation by a suitably qualified professional is advised.

#10. Typical cornice separation/detachment observed. I recommend you contact a qualified painter for repairs. Ceiling paint flake/deterioration is evident. Recommendations: General maintenance/painting as required.

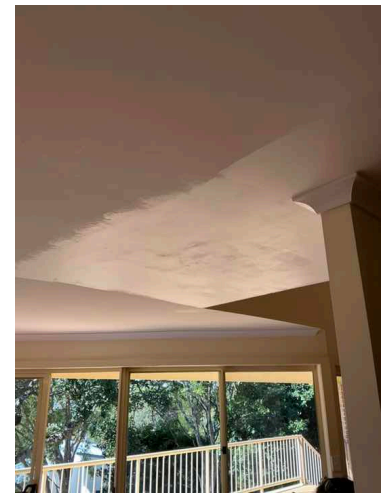
#13. General ageing and/or denting and/or wear and/or previous wall patching and the like is evident on wall linings - Recommendations: A qualified painter should be engaged to assess and repair as required.

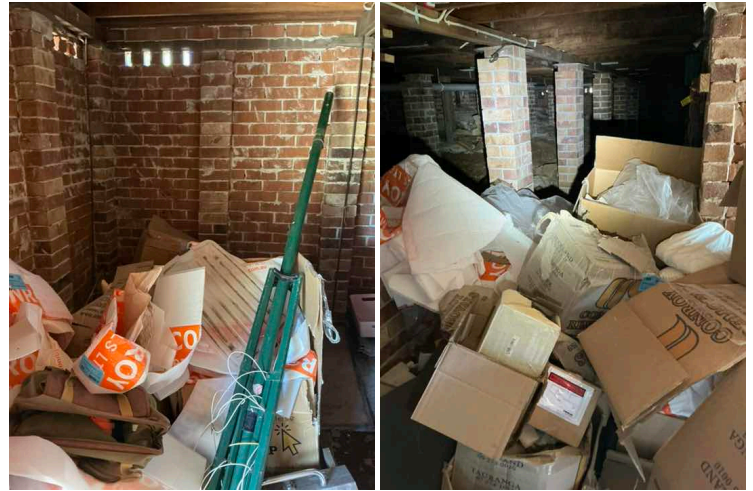
#15. There was debris and other material in the subfloor, we recommend cleaning these to aid with ventilation and reduce the likely hood of rodents and pests.

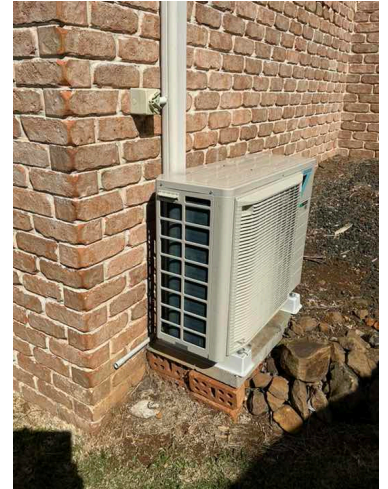
#18. Upon visual inspection, the air conditioning unit is elevated on bricks, which may not provide adequate stability. Recommend securing the unit on a proper concrete pad to ensure stability and prevent potential damage. Additionally, ensure the electrical connection is weatherproof and compliant with safety standards. Consult a licensed tradesperson for installation and safety compliance.
