# Building and Pest Report

91 Newrybar  
Swamp Road  
Kinvara

### Pest And Building Inspection

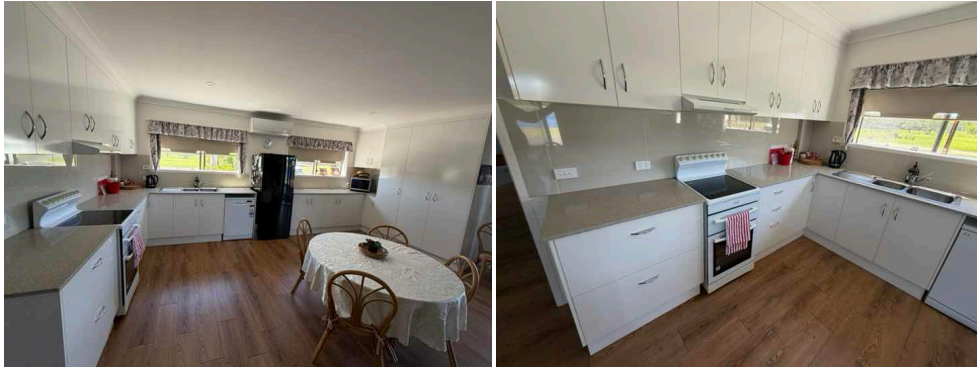
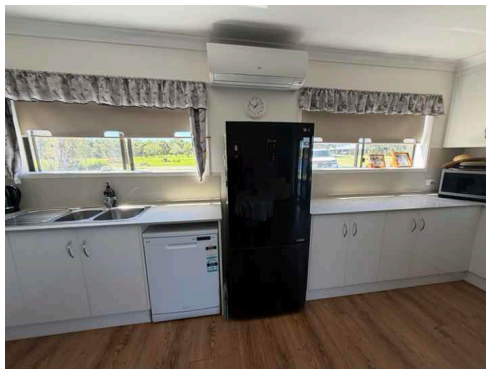
Settlement Cracks Noted. These are typical and generally patch and paint will suffice, however monitoring these cracks is advised for 12 months and if they become worse, further investigation by a suitably qualified professional is advised.

Settlement Cracks Noted. These are typical and generally patch and paint will suffice, however we recommend you monitor these cracks and if they become wider or longer, you will need to contact a structural engineers to assess.

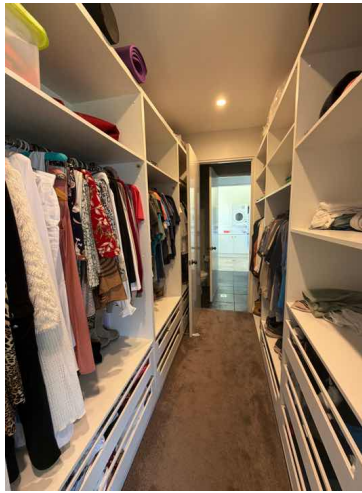
Settlement Cracks Noted. These are typical and generally patch and paint will suffice, however monitoring these cracks is advised for 12 months and if they become worse, further investigation by a suitably qualified professional is advised.

Settlement Cracks Noted. These are typical and generally patch and paint will suffice, however we recommend monitor these cracks and if become wider or longer, you will need to contact a structural engineers to assess.

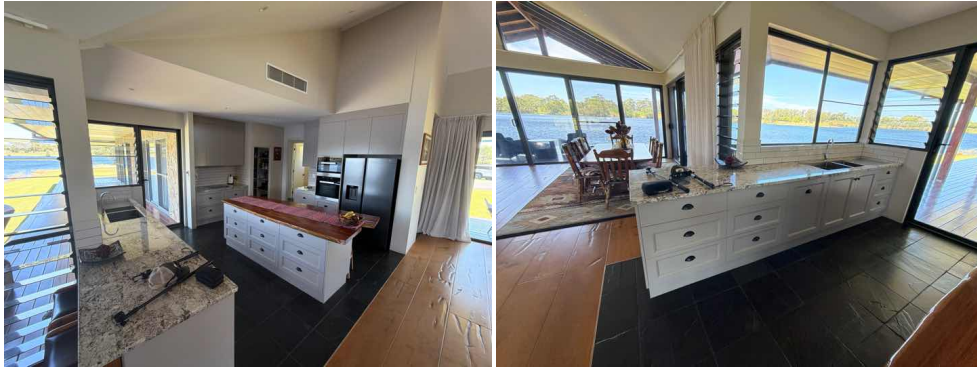
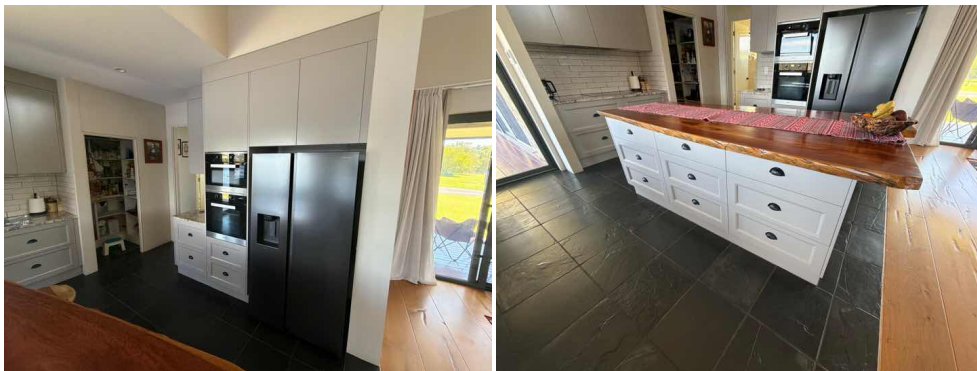
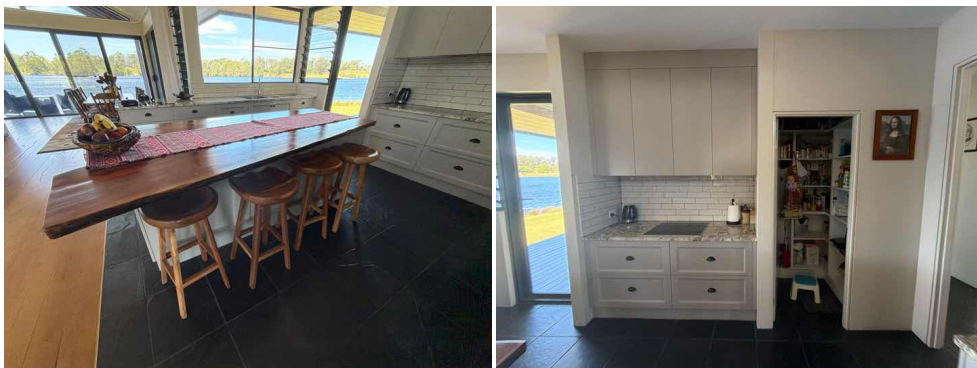
Minor cornice cracks - Minor cornice cracks visible. Recommendations: I recommend you contact a licensed plasterer for further advice and recommendations.

Adjustment to cabinet doors required, in some instance hinges may need to be replaced.

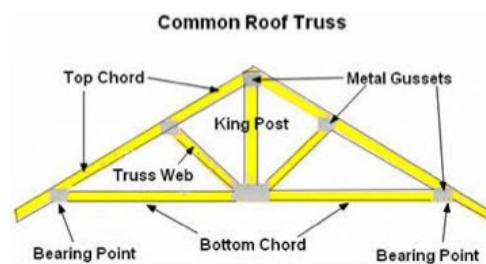
Cathedral/Raked ceiling design - No crawl space. It is strongly recommended that full access be gained as it could be harbouring timber pest activity, damage or defects.

There is insulation present in the roof space/void. This is preventing a full inspection of ceiling joists from being undertaken. It is strongly recommended that full access be gained as it could be harbouring timber pest activity, damage or defects.

There is sarking present in the roof space/void. This is preventing a full inspection from being undertaken. It is strongly recommended that full access be gained as it could be harbouring timber pest activity, damage or defects.

Cathedral/Raked Design - There is no crawl space in this ceiling design.
