# Building and Pest Report

## 5 Susan Place Skennars Head

| Report/Agreement # | 17112511273777 |
| Inspection Date: | 17 Nov 2025 |

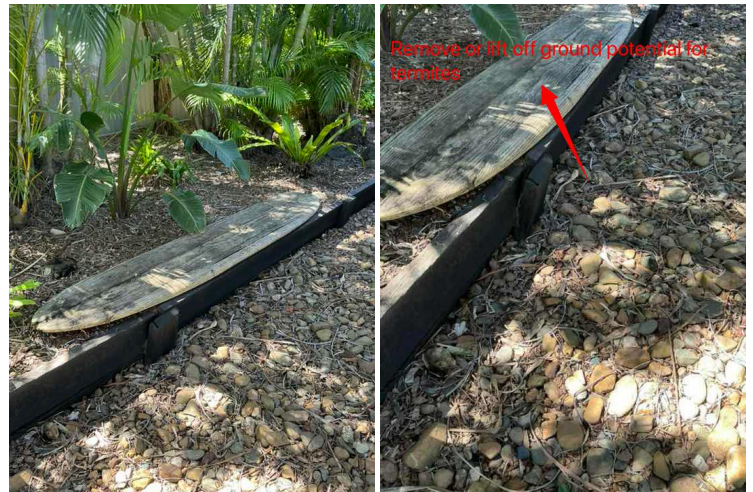
Upon visual inspection, the wooden retaining structure shows signs of warping and potential decay. Recommend replacing damaged sections with treated timber to prevent further deterioration. Ensure proper drainage to reduce moisture accumulation. Consult a licensed tradesperson for assessment and repair to maintain structural integrity.

#1. Retaining wall leaning due to deterioration and age.

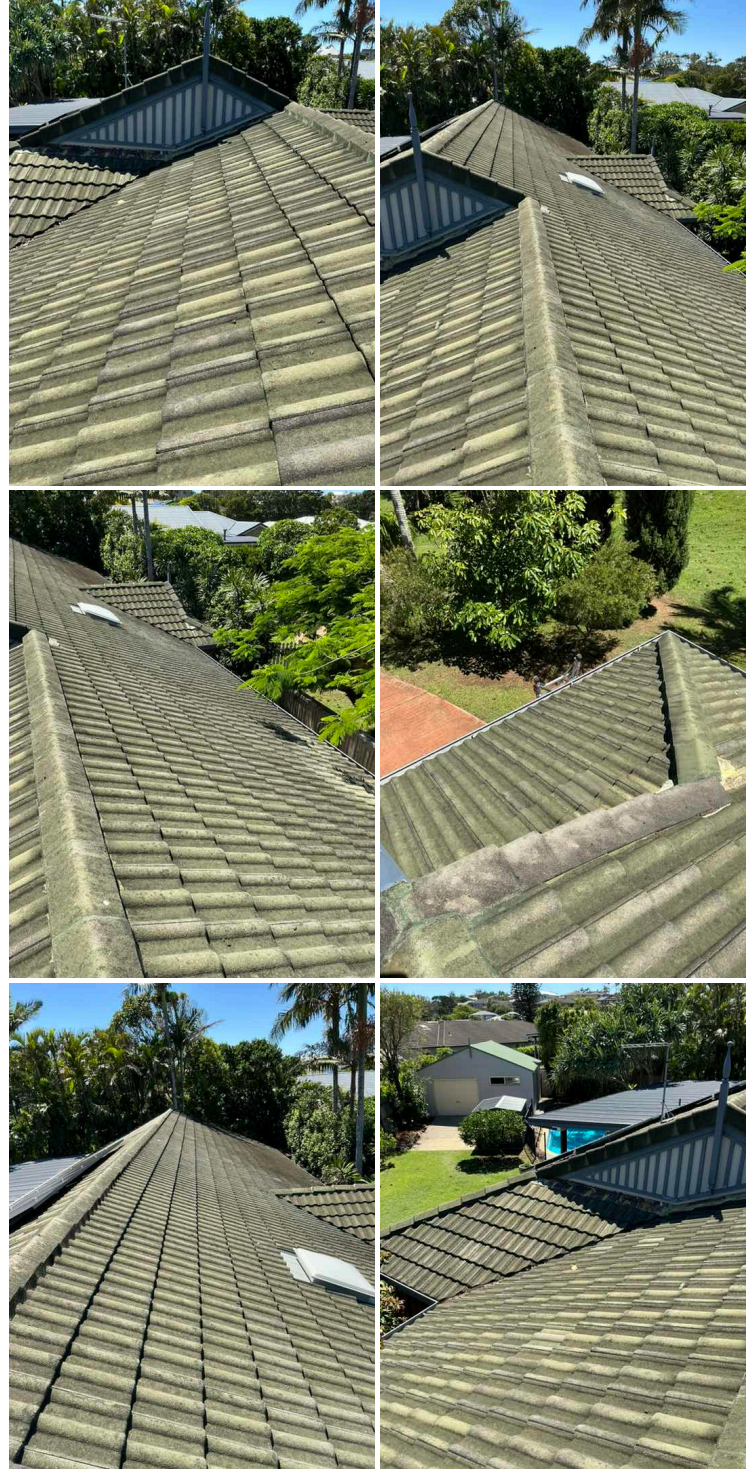
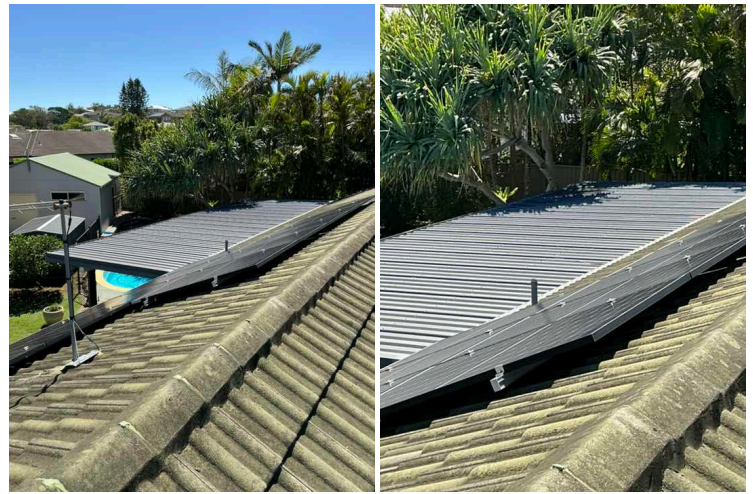
Upon visual inspection, the roof tiles appear weathered with signs of moss growth, indicating potential moisture retention. It is recommended to clean the tiles and apply a protective sealant to prevent further deterioration. Engage a licensed roofer to assess and address any underlying issues to ensure the roof's integrity and longevity.

On inspection, defects were noted that may require further assessment and recommendations by licensed roofer.

#2. Moss has built up on the tiles over time. It is preferable to have removed / cleaned to prevent deterioration. Recommendations: A qualified roof restoration contractor should be engaged for advice and recommendations.

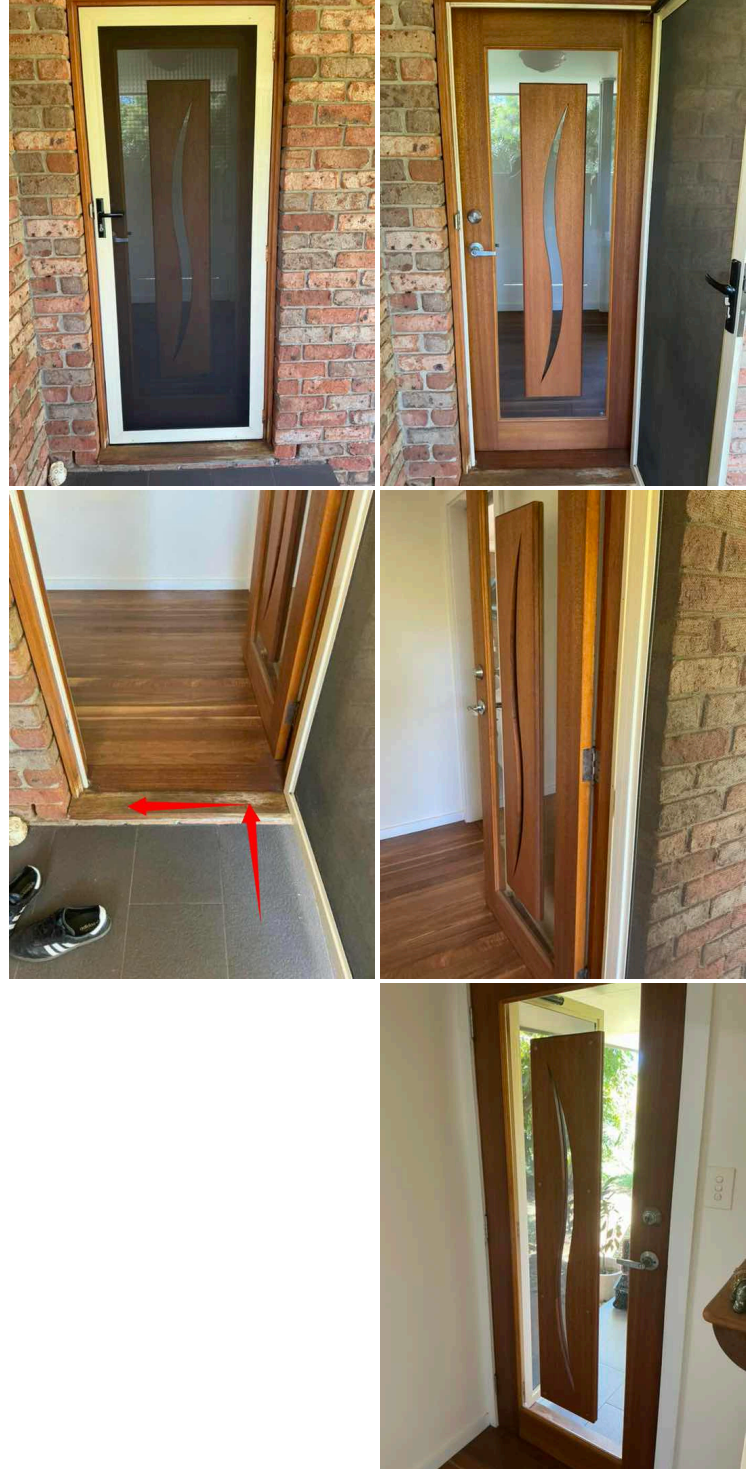
Upon visual inspection, the door frame shows signs of wear and possible water damage. Recommend sanding and refinishing the affected areas. Ensure proper sealing to prevent future moisture intrusion. Consult a licensed carpenter for repair and maintenance to restore structural integrity and appearance.

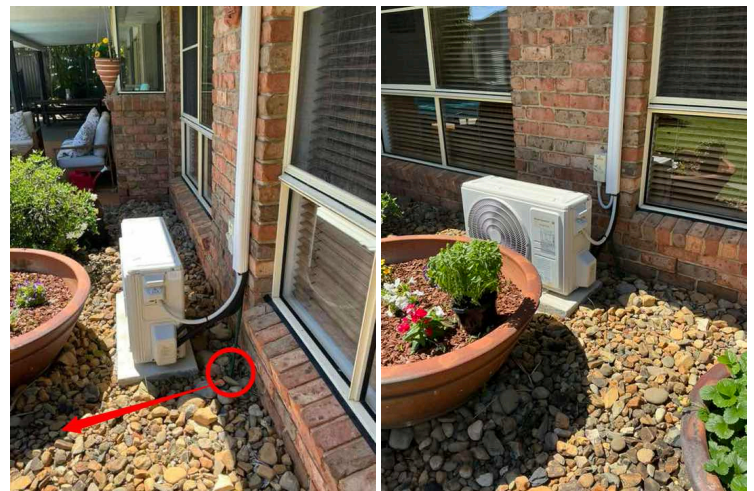
No - Divert A/C overflow away from the building perimeter.
