# Building and Pest Report

## 493 Friday Hut Rd Brooklet

Report/Agreement #	291121104631
Agreement signed on:	23 Nov 2021
Inspection Date:	25 Jul 2025
Inspection Time:	09:00 am

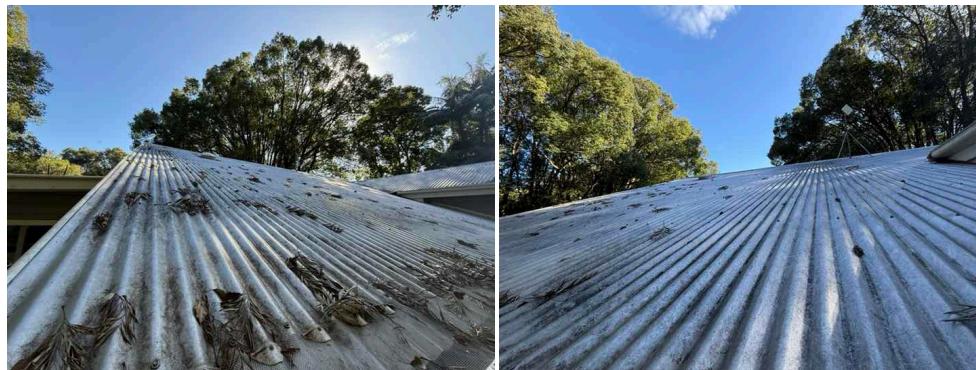
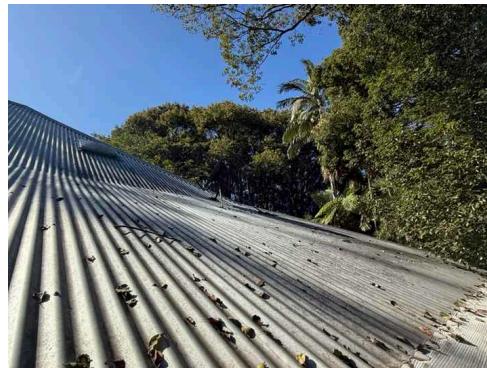
Corrosion noted to the screw fixings of the metal roof. Have these checked and replaced by qualified roofing contractor.

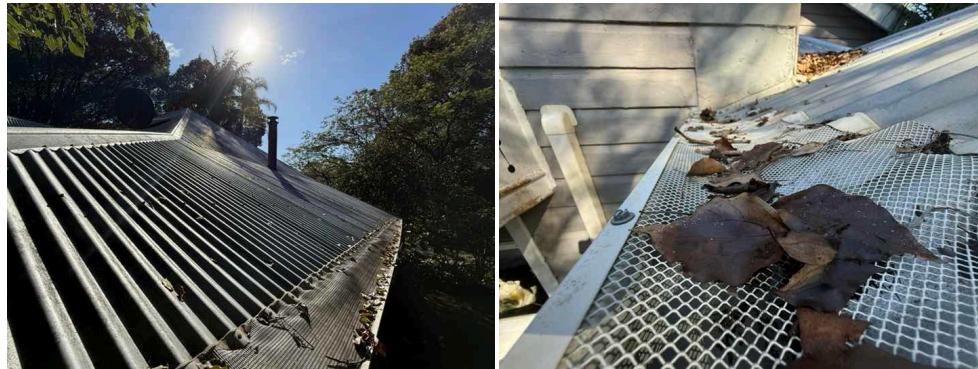
Debris in guttering areas- this requires cleaning out to prevent blocking of downpipes and leaking into eaves and fascia. Have gutters cleaned and assessed by a plumber for adequate fall. Regularly clean to prevent ponding. Ponding water will contribute to rust.

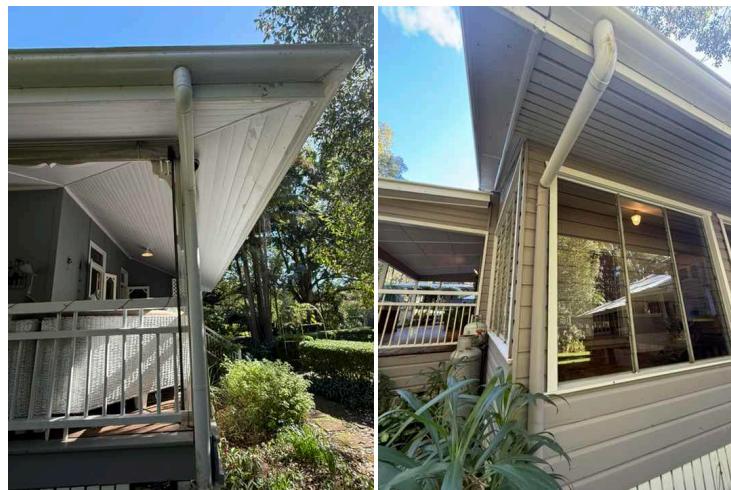
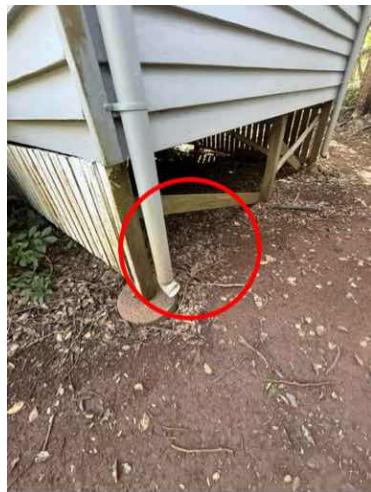
Downpipe/s not connected to storm water discharge - Downpipes not connected to storm water have the potential to cause differential settlement to the footings, cause rising damp and is also conducive to termite infestation. A qualified roof plumber should be engaged for advice and recommendations.

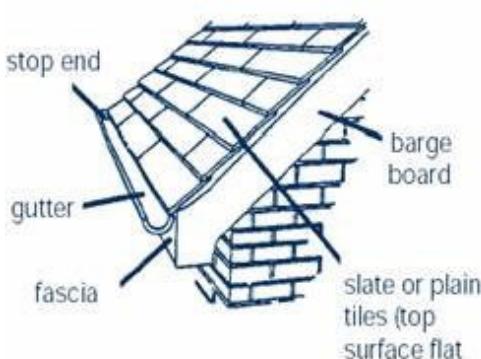
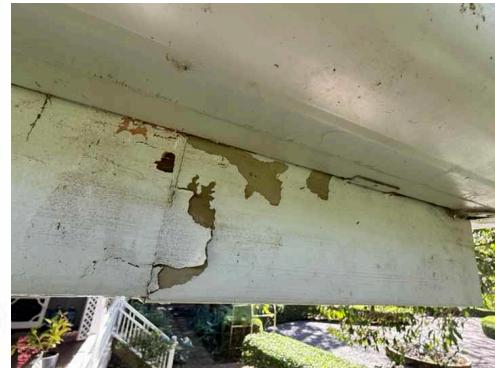
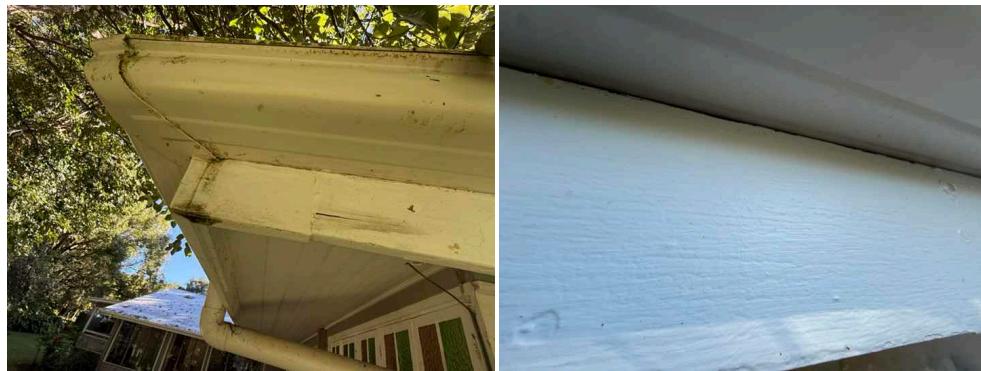
Minor deterioration & ageing evident. Recommendations: Maintenance works, general upkeep should be carried out.

Paint / finish was deteriorated in areas and is in need of maintenance - Sanding back affected areas and painting required.

Timber fungal decay (rot) visible. Recommendations: A qualified carpenter should be engaged to replace all affected timbers.

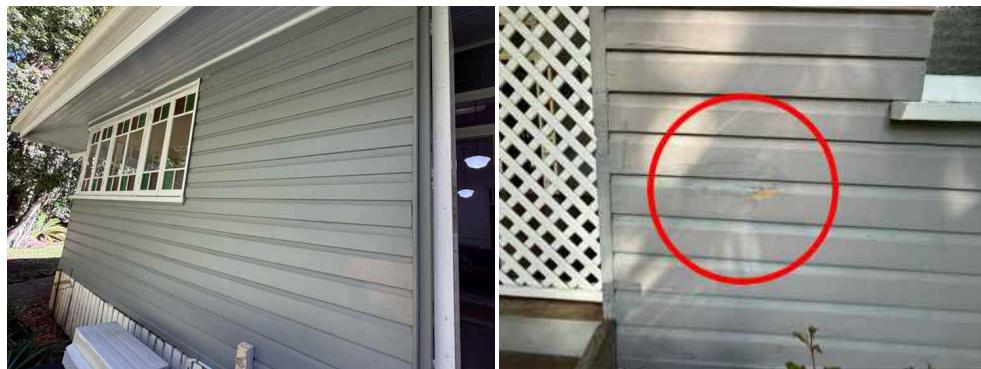
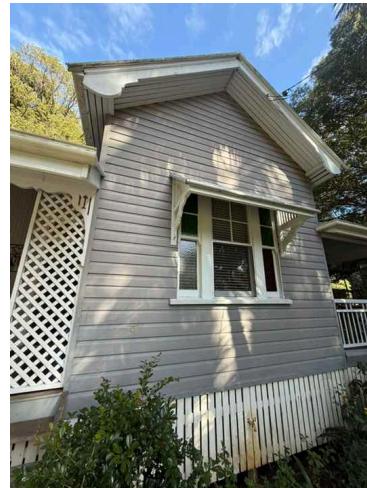
Minor decay was noted to the external wall lining. We recommend replacement of all affected timbers.

Minor cladding damage observed. This should be repaired so as to avoid moisture ingress and pests entry.

The external paint has deteriorated . External wall paint preserves and protects the building elements. Contact a qualified painter for repairs.

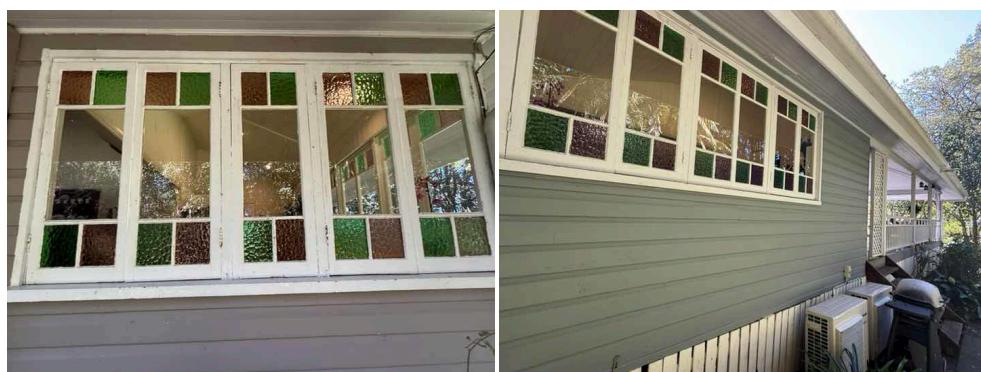
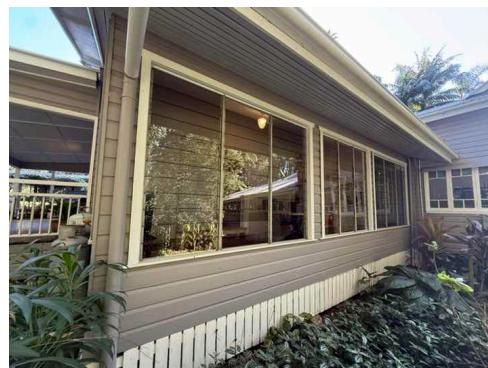
General age/damage has occurred to window components. Recommendations: Restoration work recommended. A qualified carpenter should be engaged for advice and recommendations.

Cracked window pane. A qualified glazier should be engaged to repair.

Surface rust is evident in sections of the louvre window framework.

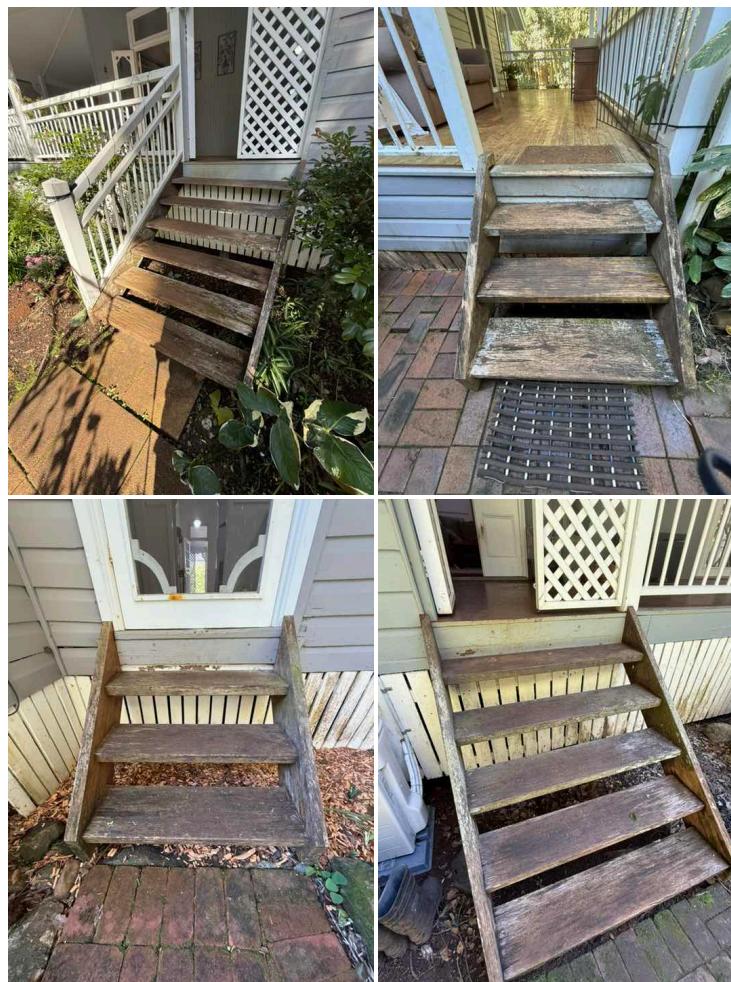
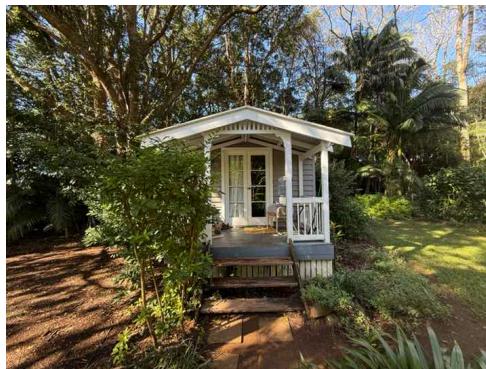
Timber fungal decay in sections. This is a safety hazard and repair is required - Recommendations: A qualified carpenter should be engaged for advice and recommendations.

Timber fungal decay in sections of stair treads. This is a safety hazard and repair is required. A qualified carpenter should be engaged for advice and recommendations.

There are no rails on the stairs. This presents a fall risk. Have repaired immediately.

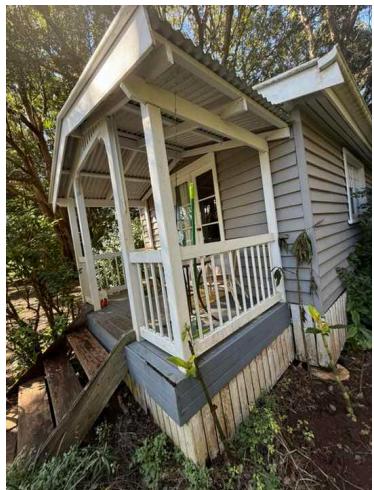
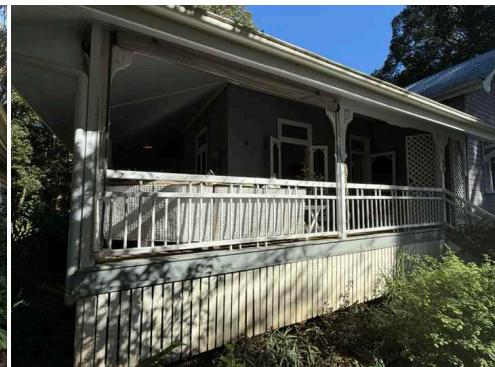
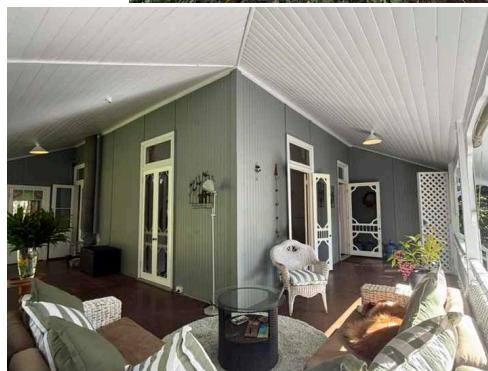
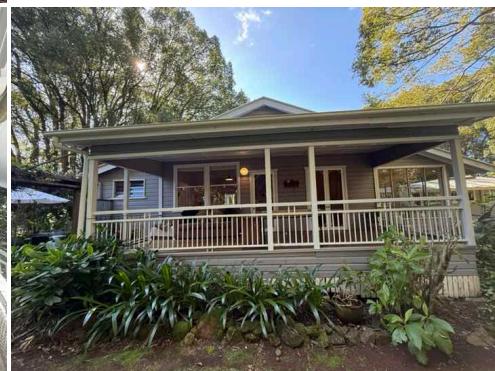
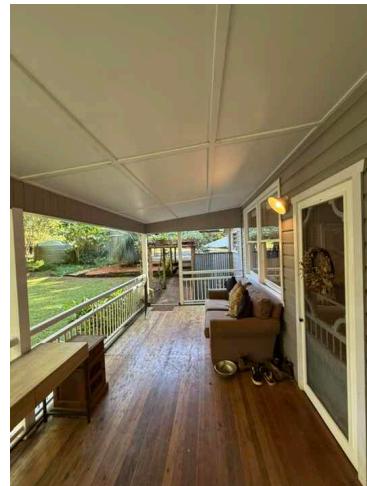
Baluster rail height - Should be 1 m in height from deck/balcony/patio floor. In some circumstances this regulation was non-existent dependent on the age of the dwelling and technically there is no requirement to rectify. Recommendations: We strongly advise you rectify to comply for safety concerns.

Timber decay evident on rails / balustrade - Recommendations: A qualified carpenter should be engaged to replace all affected timbers prior to a decision to purchase.

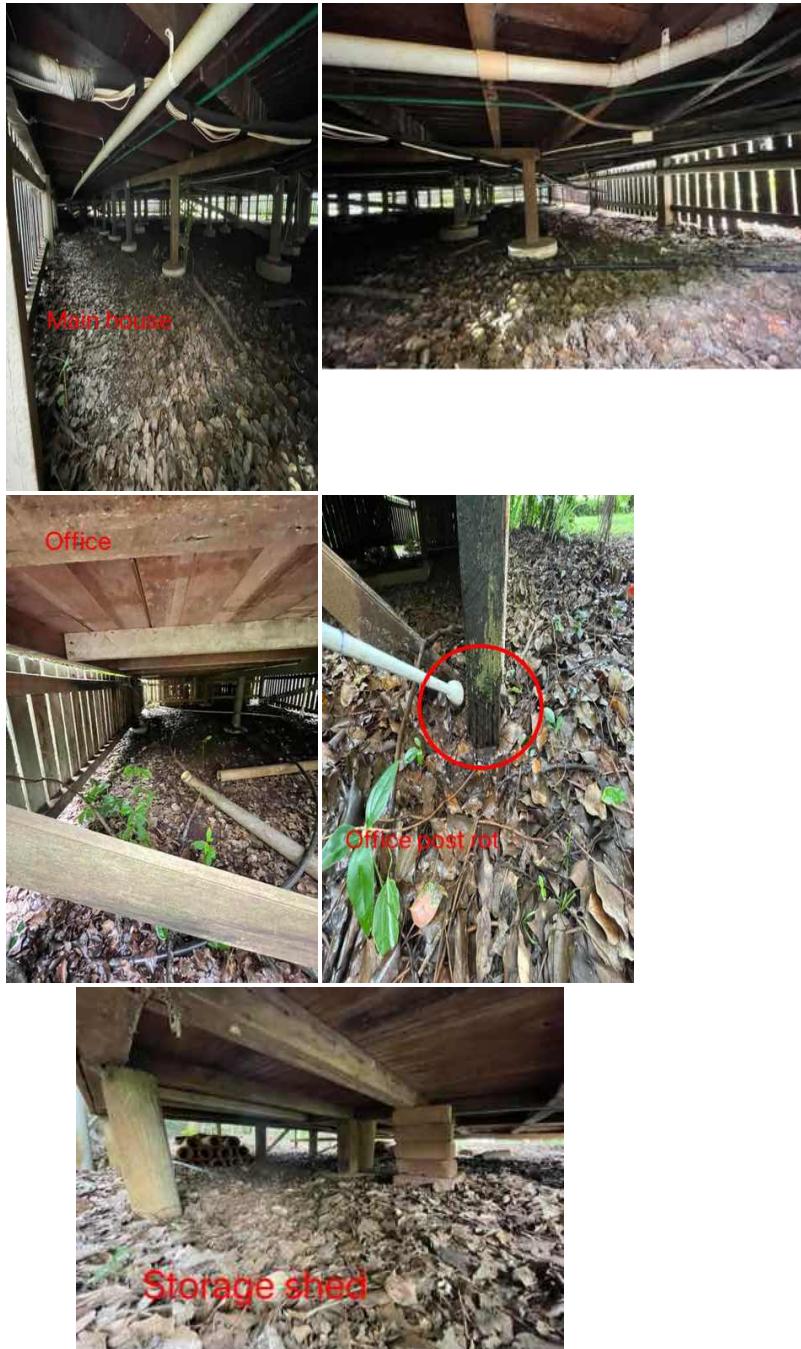
Timber fungal decay evident in stumps. Recommendations: A qualified re-stumping contractor should be engaged for advice and recommendations.
