Inspection Report

13 Loedna Pl, Lennox Head, NSW, 2478

Report/Agreement #	041024091314471
Inspection Date:	04 Oct 2024
Inspection Time:	09:13 AM

Pest And Building Inspection

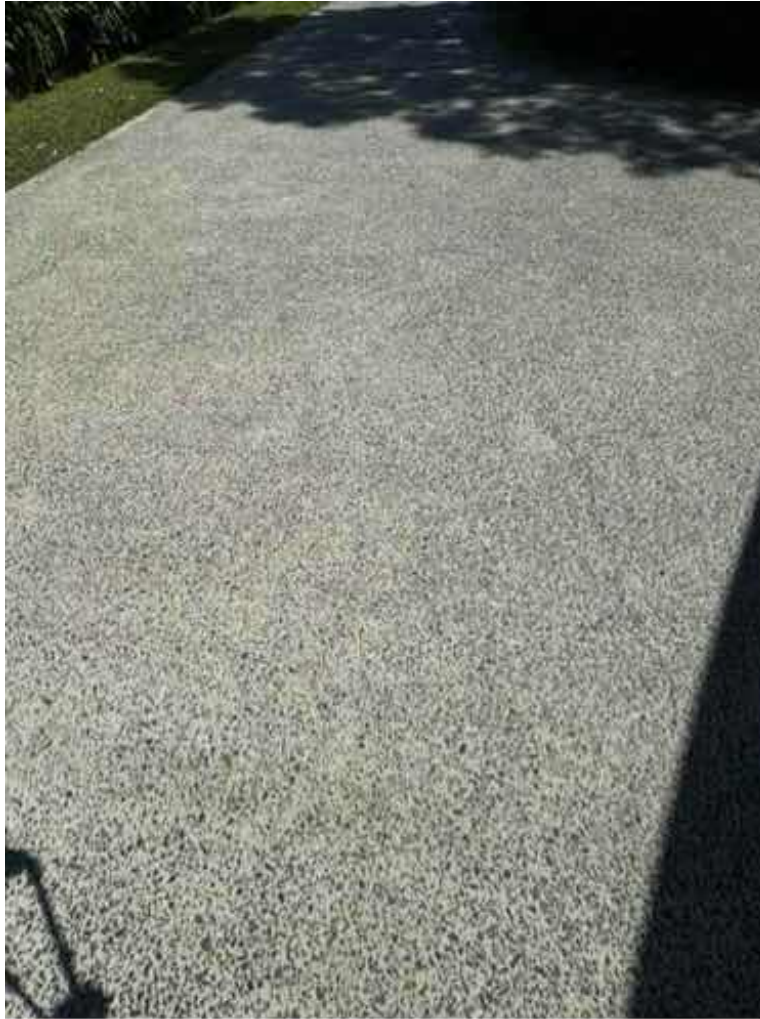
Common cracks were observed on the driveway. Whilst these cracks appeared to be typical at the time of inspection, we strongly recommend you monitor these cracks and if worsening occurs contact a concreter for further advice.

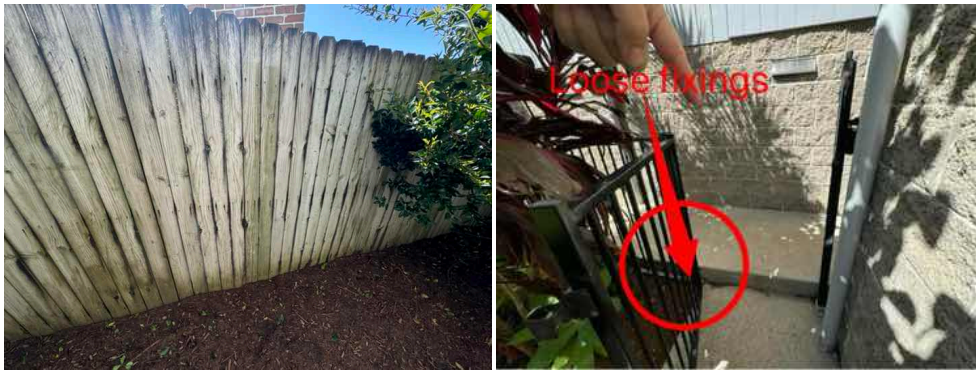
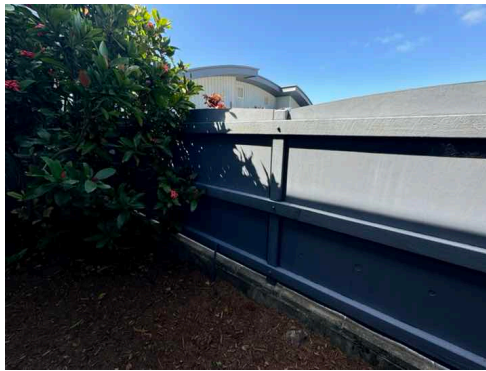
The gate does not latch. Have repaired by a qualified fencer.

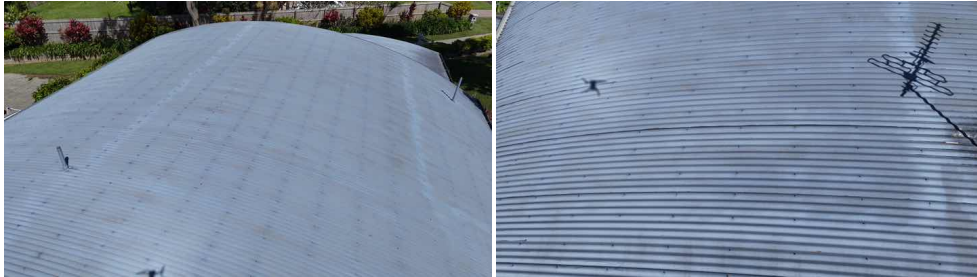
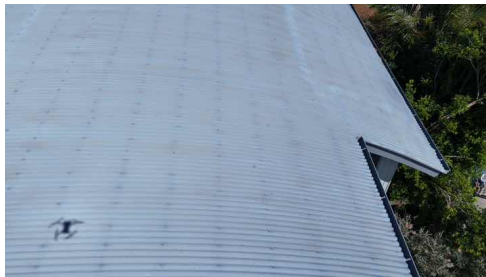
Corrosion noted to the screw fixings of the metal roof. Have these checked and replaced by qualified roofing contractor.

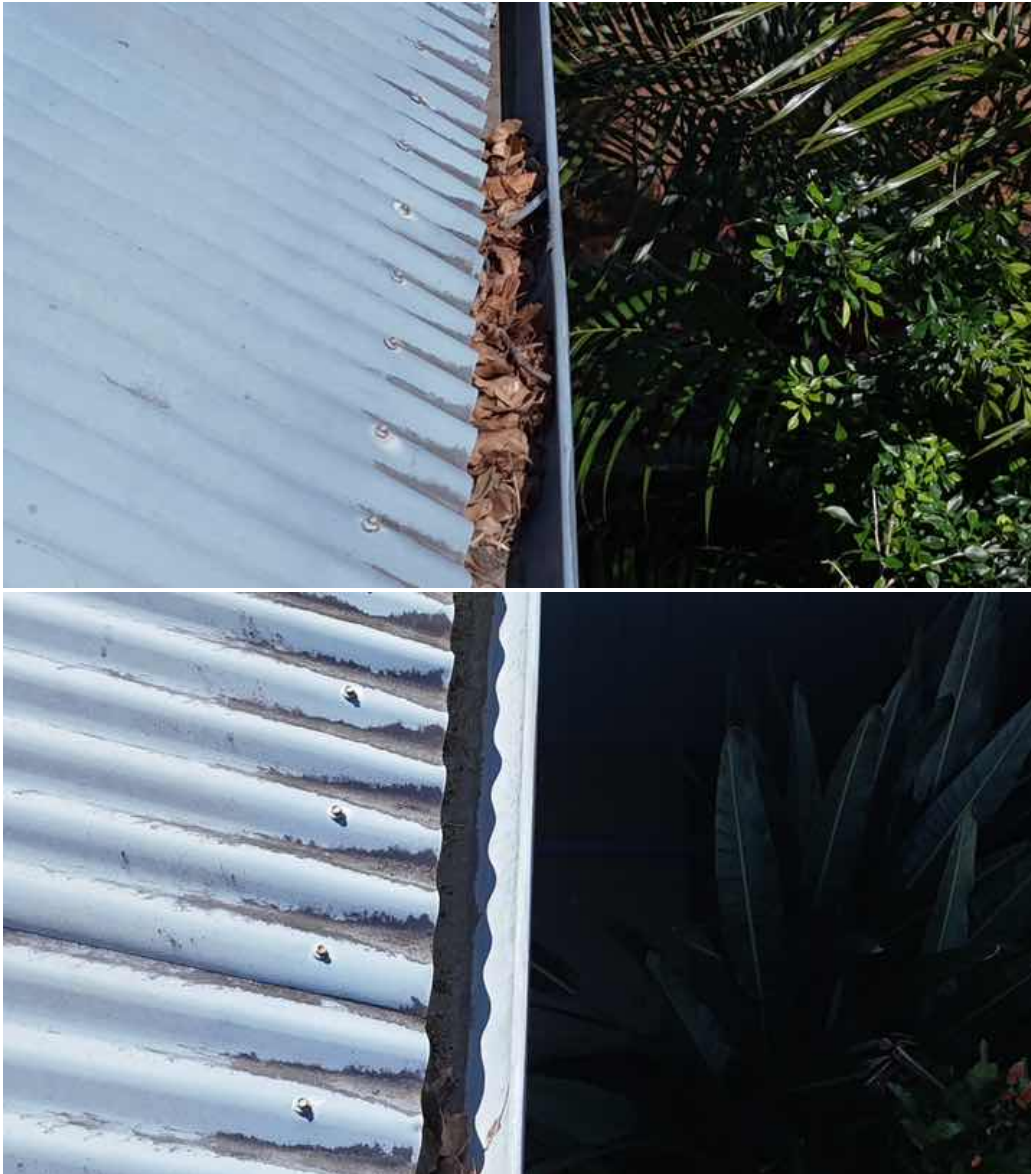
Debris in guttering areas- this requires cleaning out to prevent blocking of downpipes and leaking into eaves and fascia. Have gutters cleaned and assessed by a plumber for adequate fall. Regularly clean to prevent ponding. Ponding water will contribute to rust.

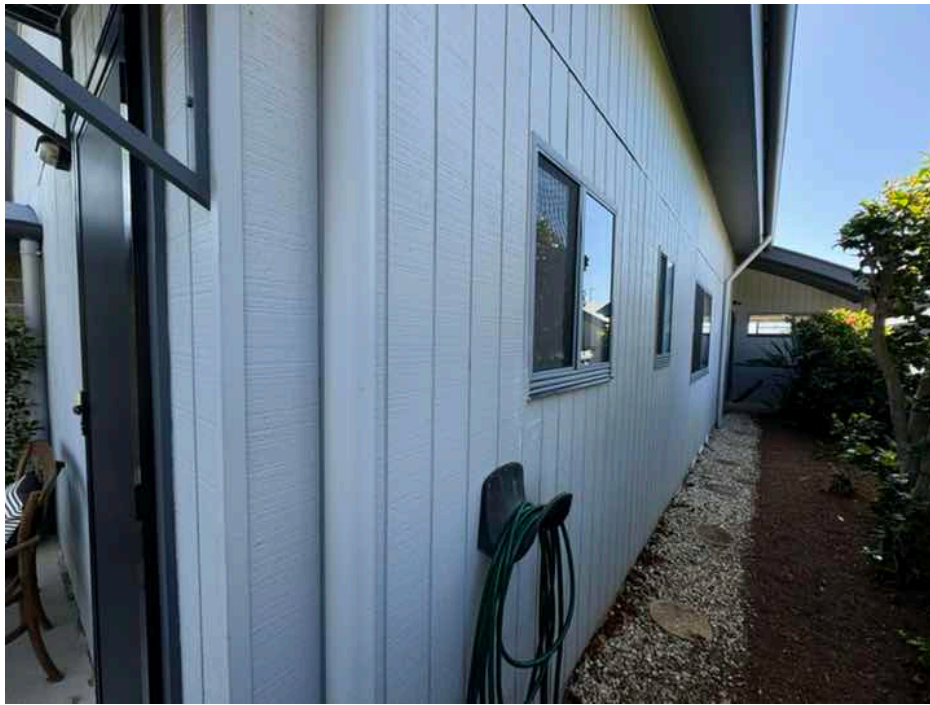
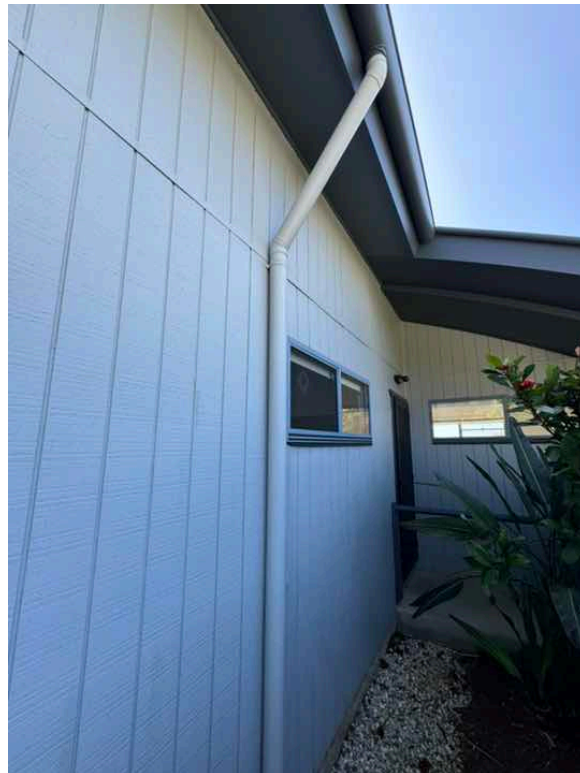
The downpipe/s wall clips is detached or missing. Although minor and easily rectifiable, we recommend a licensed roof plumber be engaged for repairs.

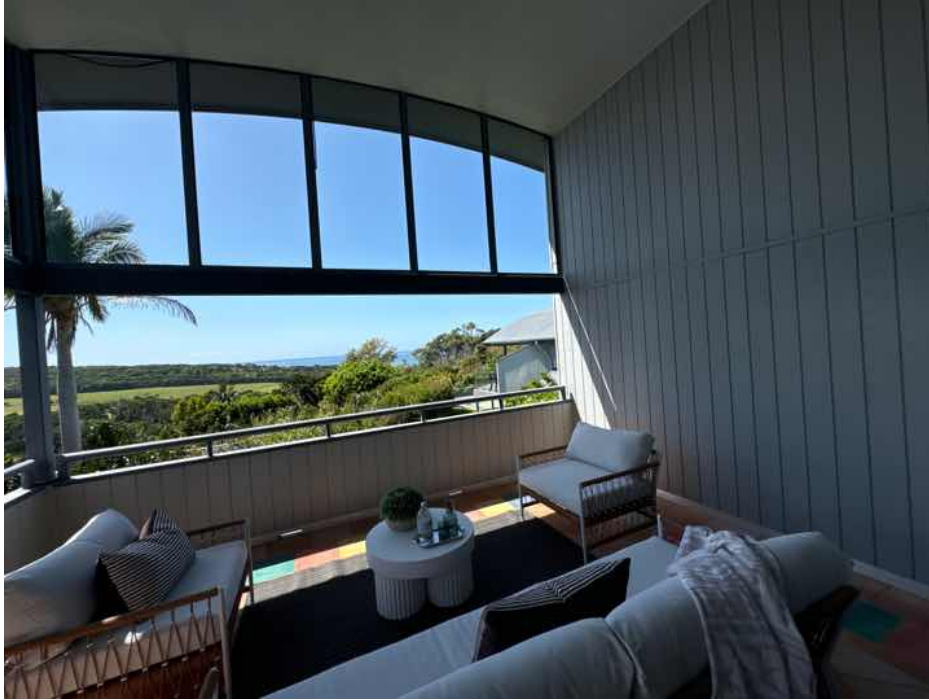
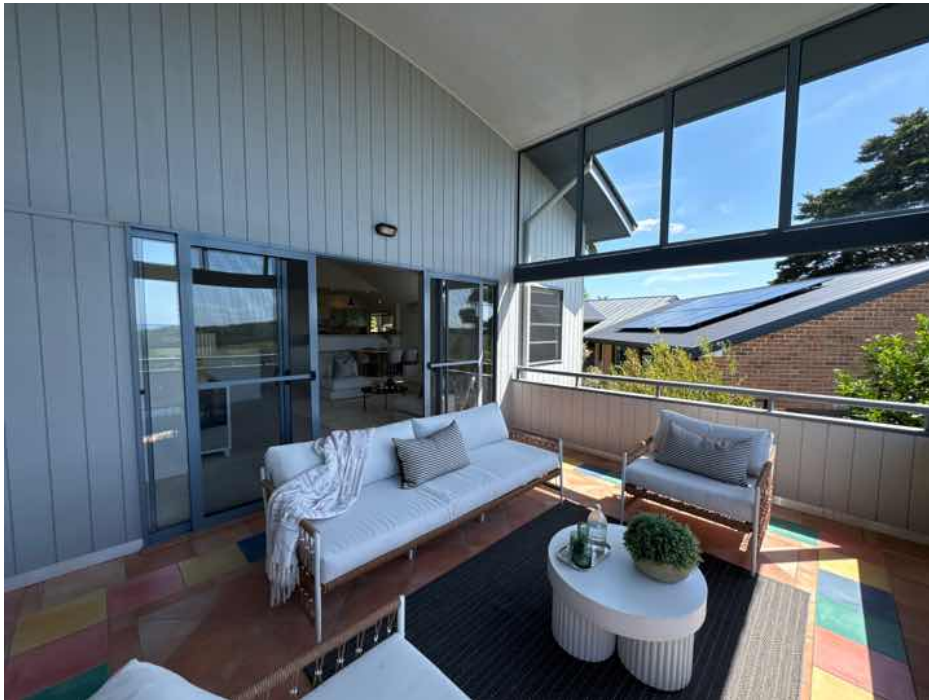
Tile cracks evident. Engage a qualified tiling contractor to repair.

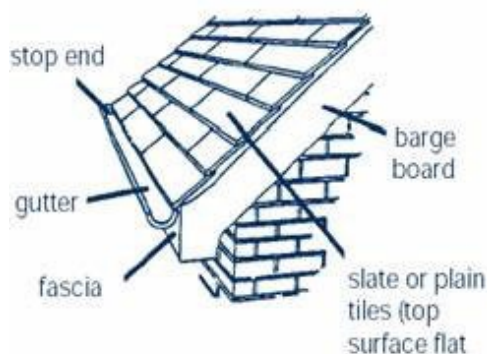
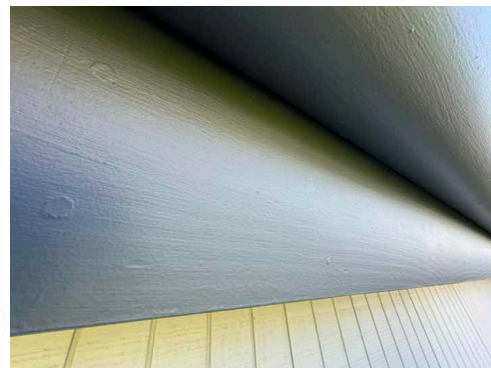
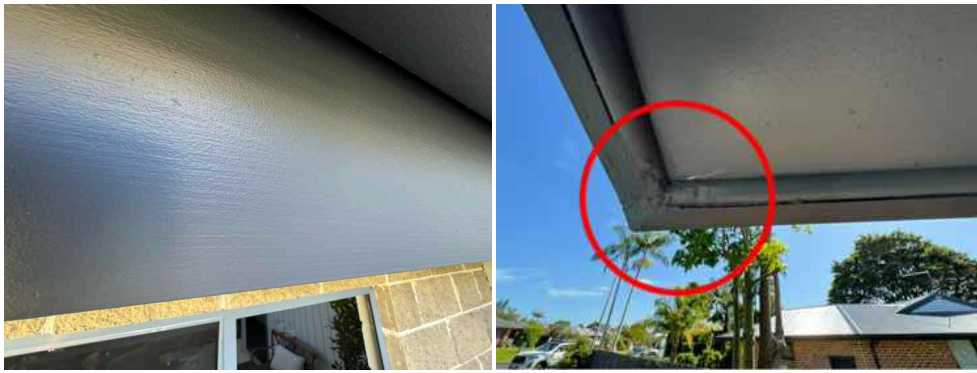
Timber fungal decay (rot) visible. Recommendations: A qualified carpenter should be engaged to replace all affected timbers.

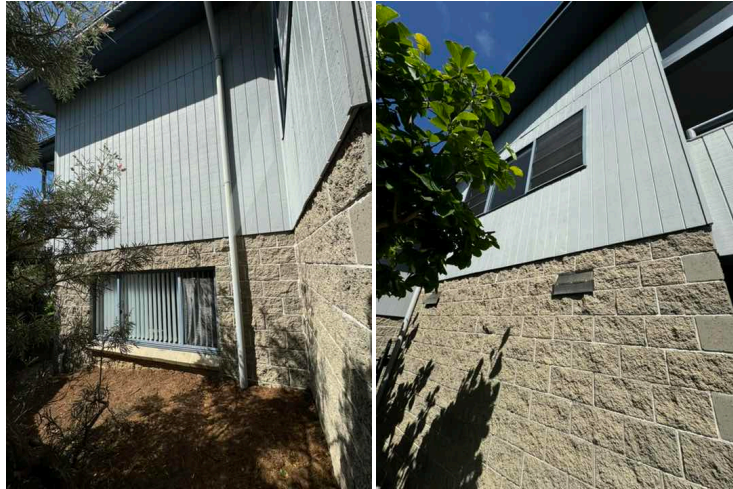
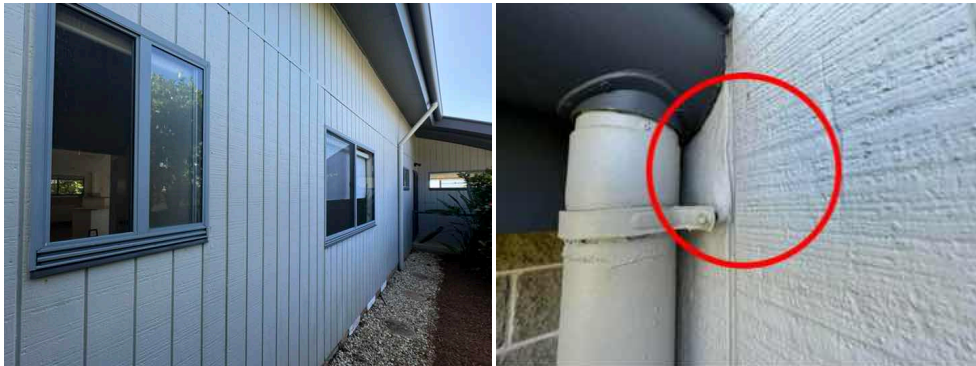
Minor decay was noted to the external wall lining. We recommend replacement of all affected timbers.

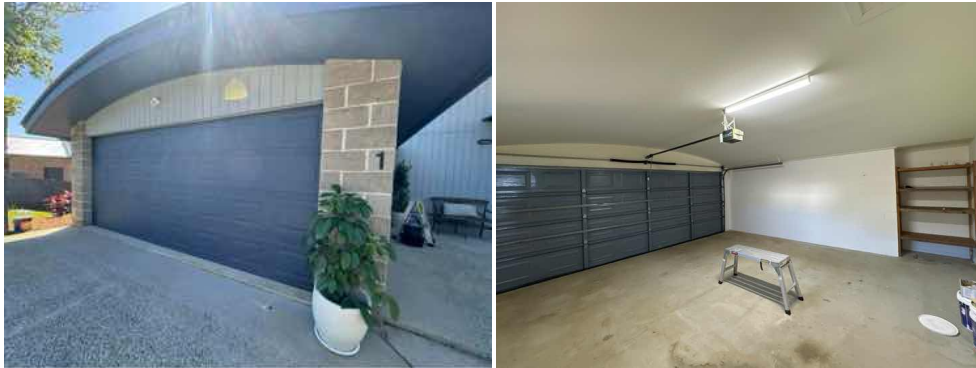
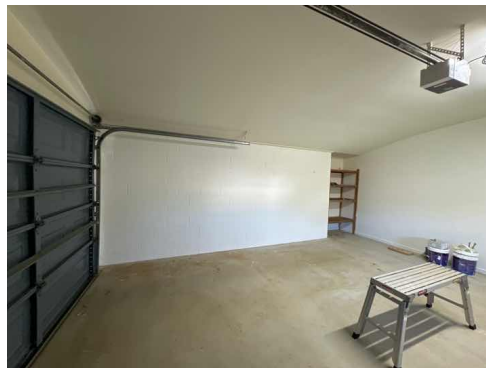
Rust in garage door frame noted - General repair required.

Settlement Cracks Noted . These are typical and generally patch and paint will suffice, however Monitoring these cracks advised for 12 months and if become wider or longer, you will need to contact a structural engineers to assess.

Minor hairline slab cracks - Note. Whilst these cracks appeared to be minor at the time of inspection, we strongly recommend you monitor these cracks and if worsening occurs contact a qualified concreter for further advice.

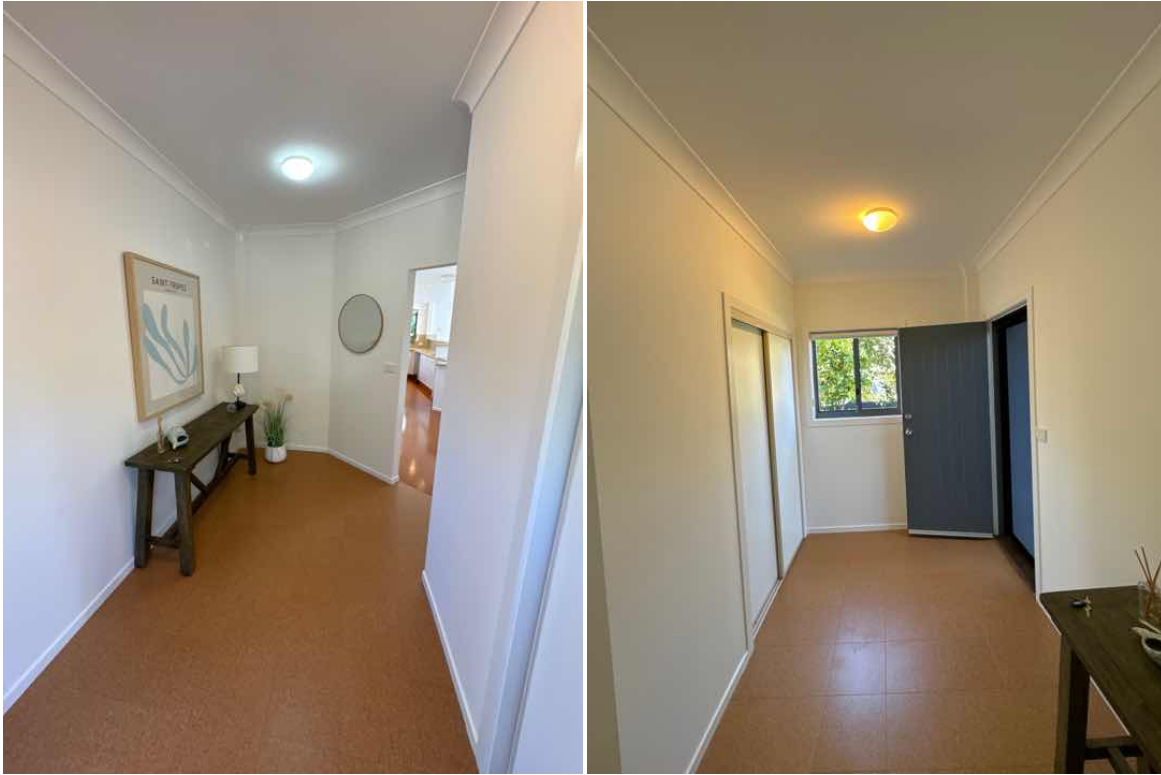
Impact damage to wall from door handle. Repairs and installation of a door stop recommended

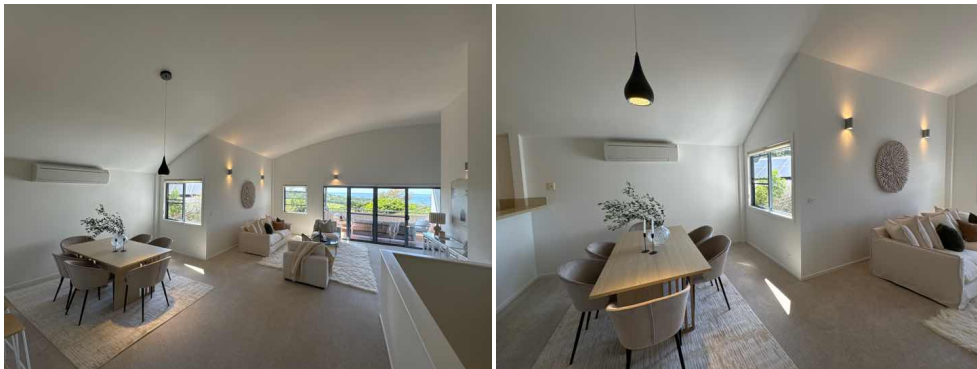
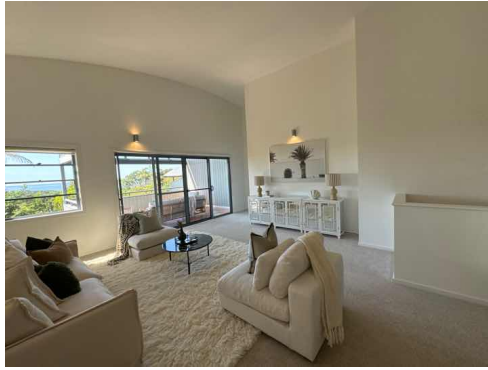
Settlement Cracks Noted. These are typical and generally patch and paint will suffice, however monitoring these cracks is advised for 12 months and if they become worse, further investigation by a suitably qualified professional is advised.

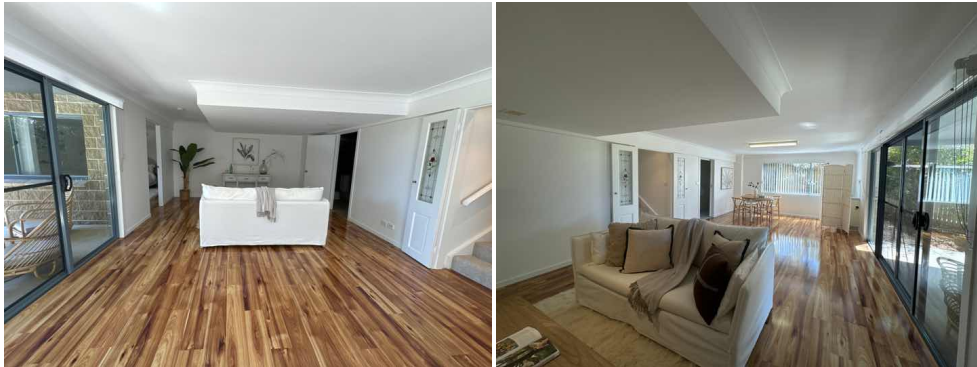
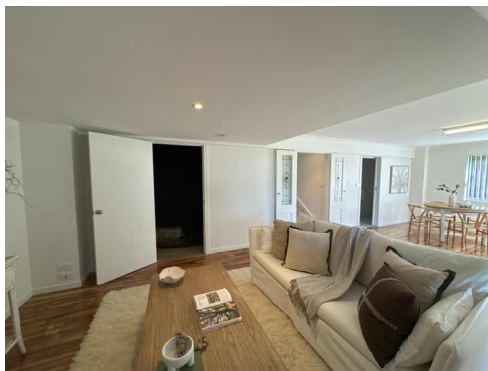
Door stop should be fitted - Wall damage from door handle impacting wall lining has occurred. I recommend you contact a qualified painter for repairs.

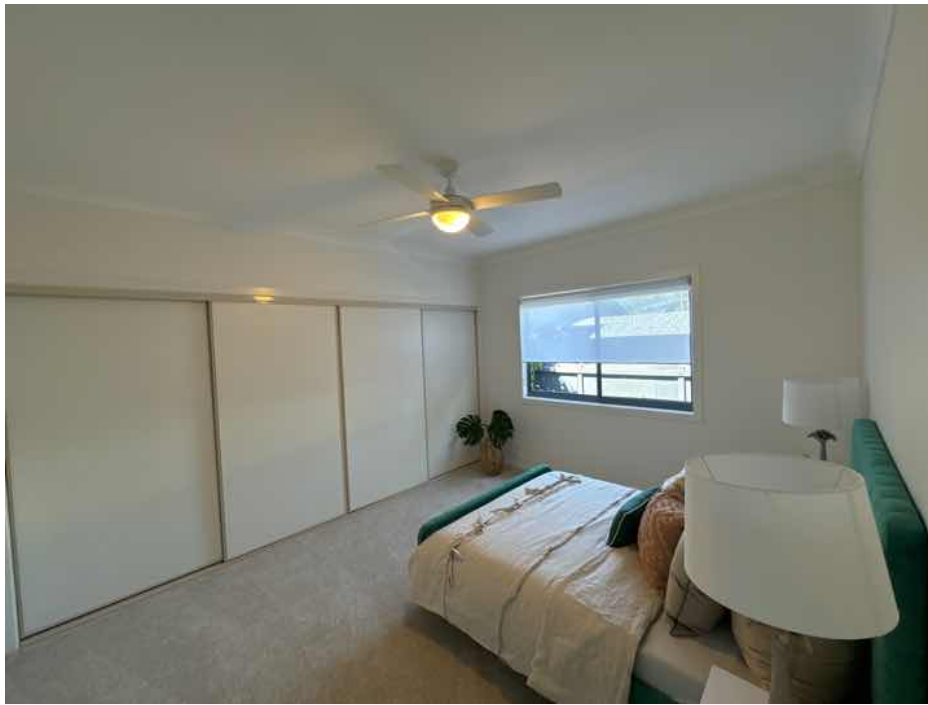
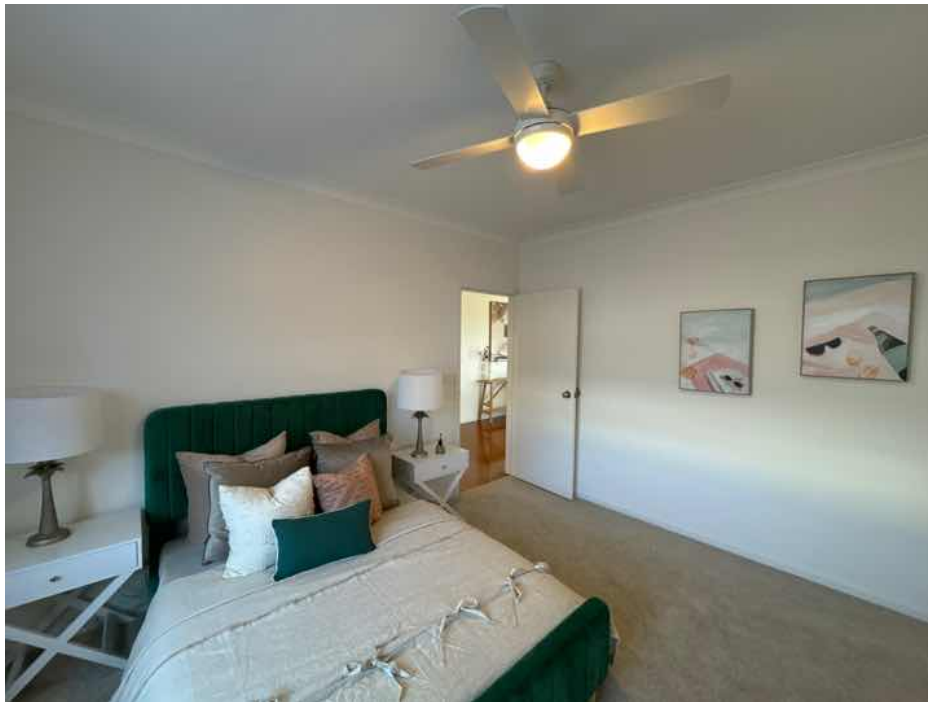
Door
Door stop should be fitted - Wall damage from door handle impacting wall lining has occurred. I recommend you contact a qualified painter for repairs.

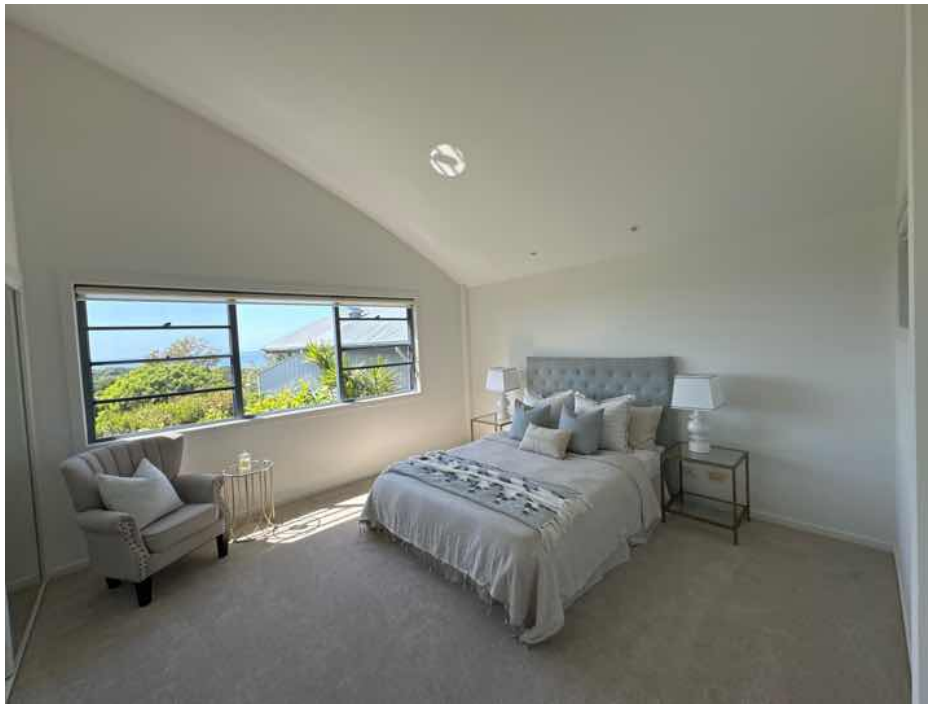
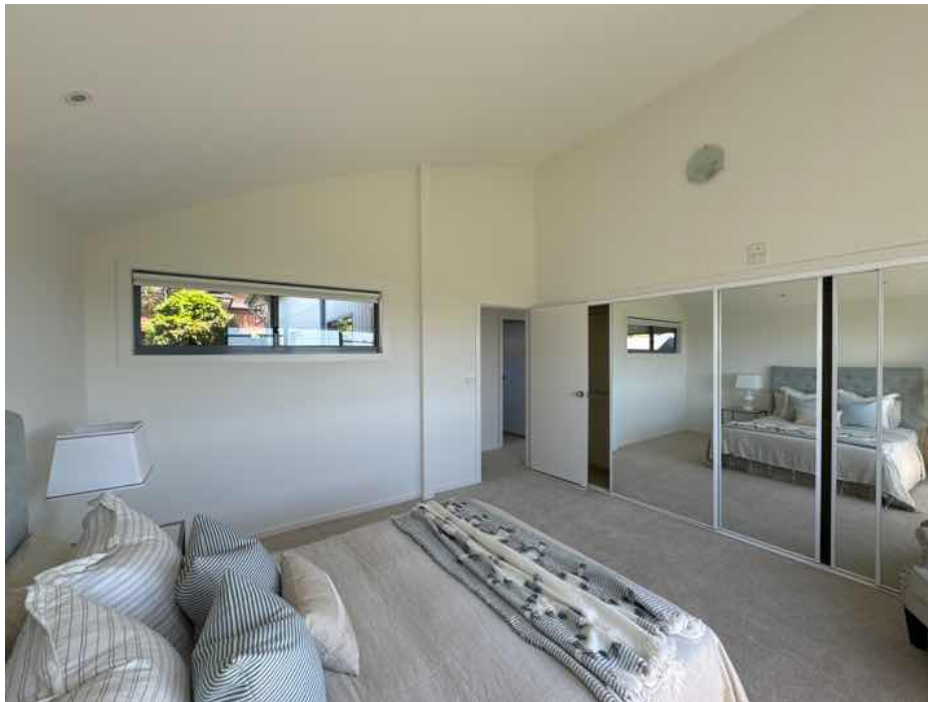
Door
Door stop should be fitted - Wall damage from door handle impacting wall lining has occurred. I recommend you contact a qualified painter for repairs.

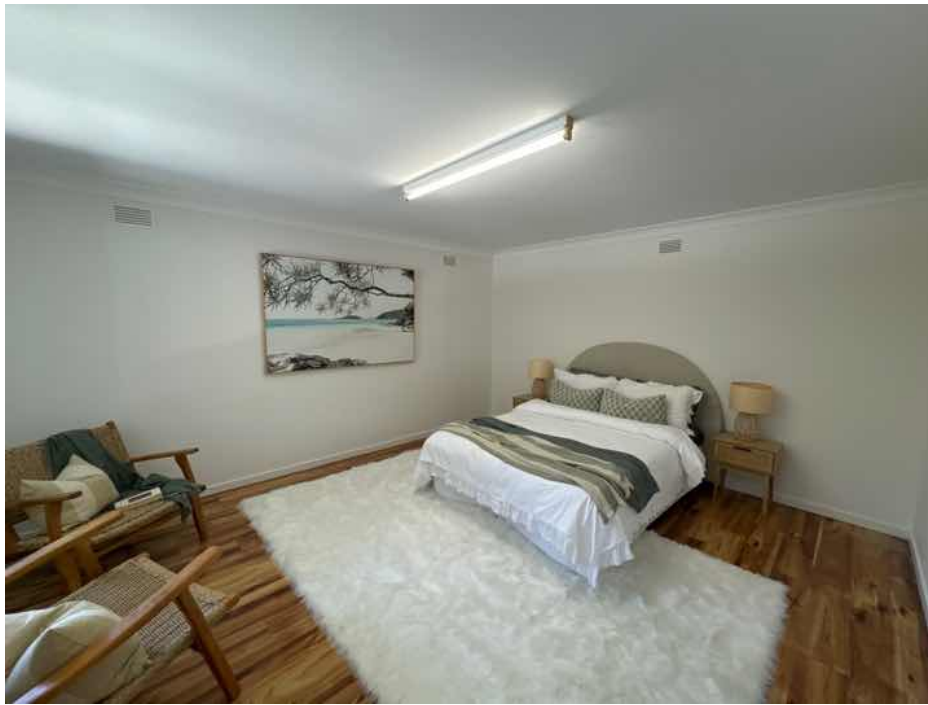
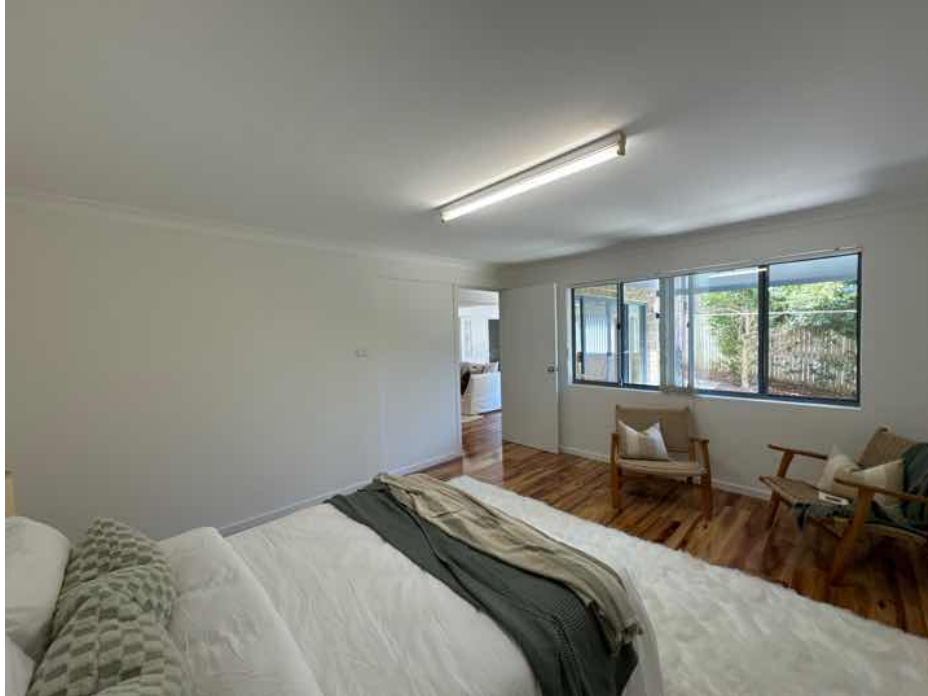
Door stop should be fitted - Wall damage from door handle impacting wall lining has occurred. I recommend you contact a qualified painter for repairs.

Typical cornice separation/detachment observed. I recommend you contact a qualified painter for repairs.

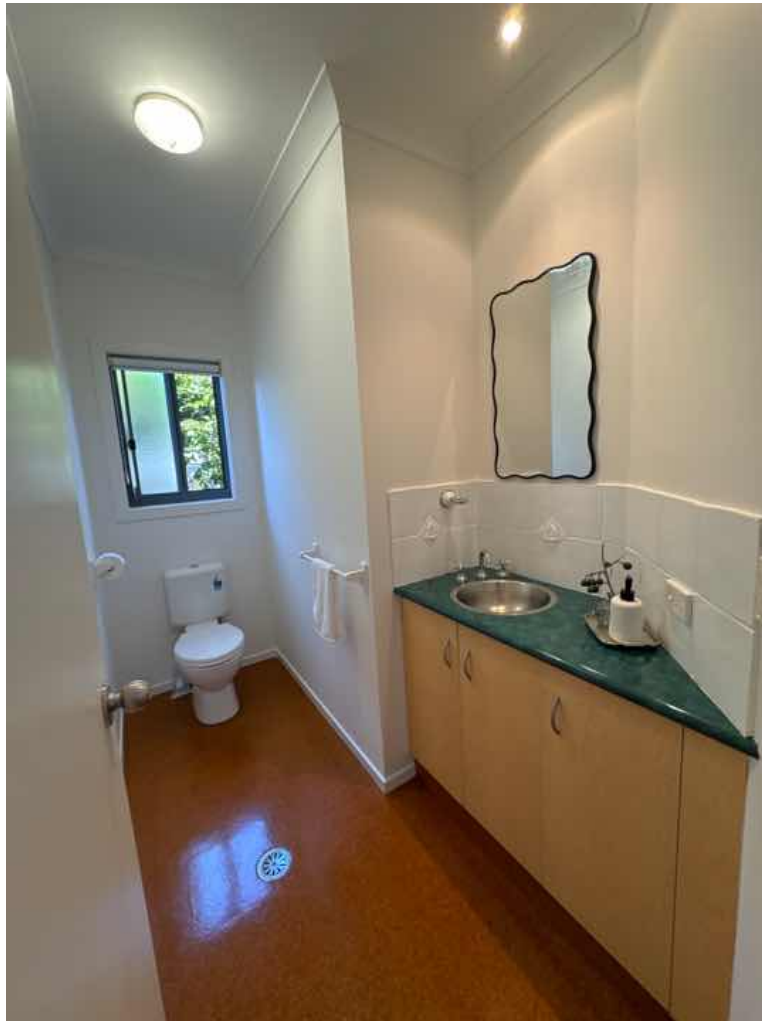
No exhaust fan is installed - Recommend having one installed.

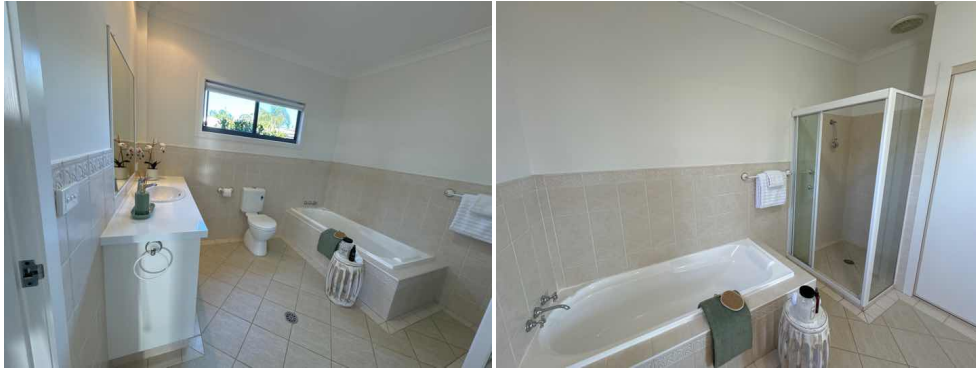
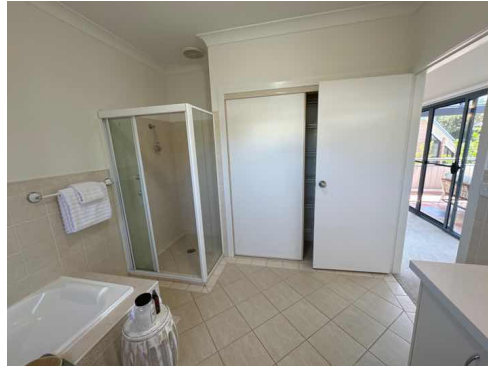
Door stop should be fitted - Wall damage from door handle impacting wall lining has occurred.
Recommendations: A qualified carpenter should be engaged for advice and recommendations.

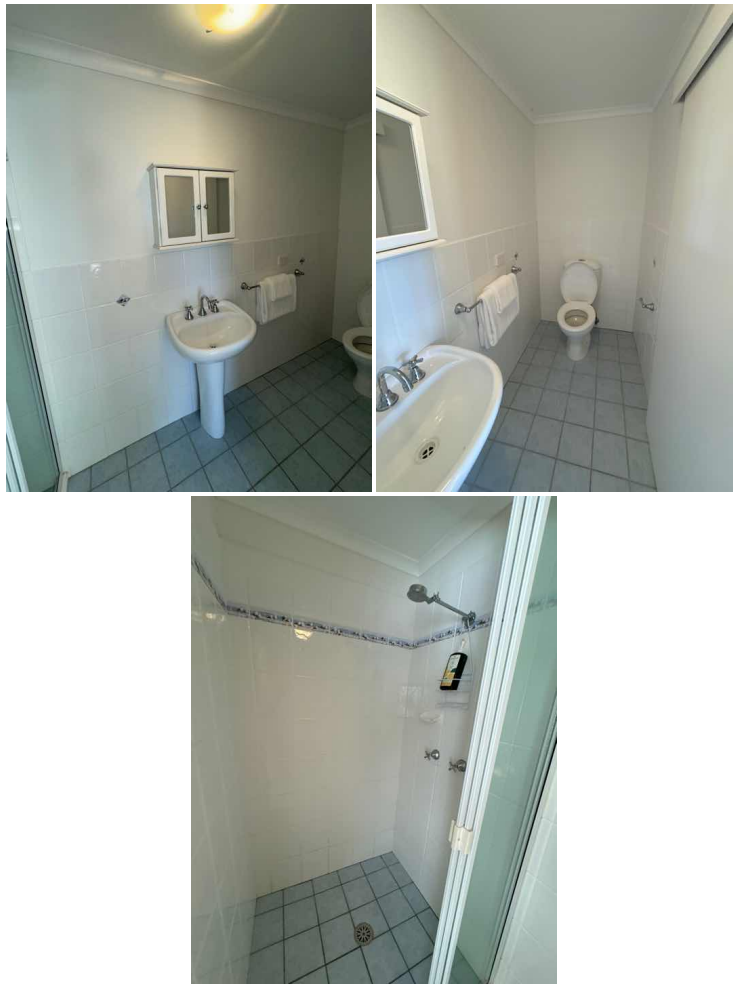
Cornice separation. I recommend you contact a licensed plasterer for repairs.

Drummy tiles noted. This needs to be repaired at the earliest as this has the potential to lead to many related issues such as damp, water ingress to other areas and cracked tiles. Contact a qualified tiler for repairs and recommendation

Shower head is leaking. Replacement recommended.

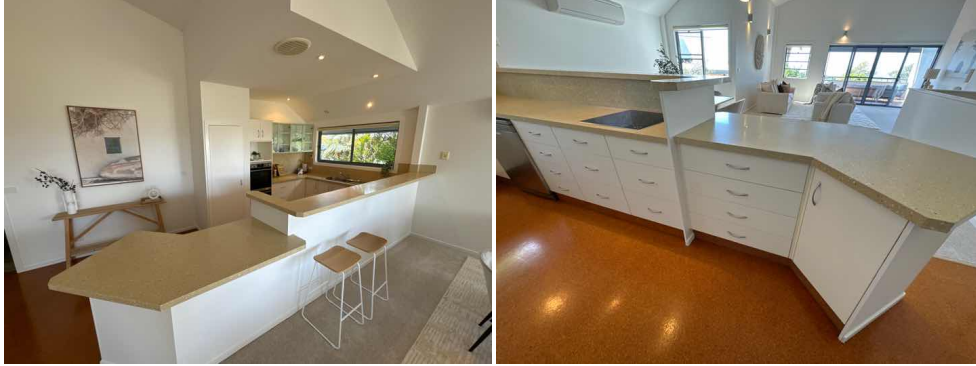
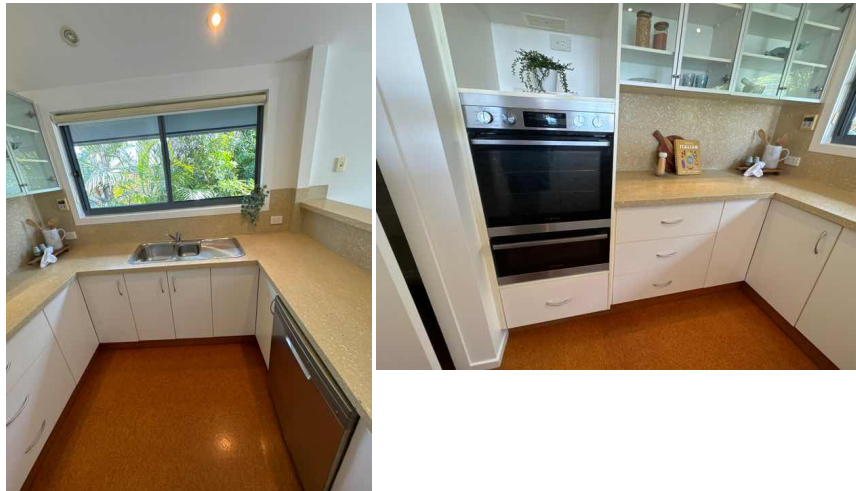
Ceiling stains - No moisture readings obtained from same. Recommendations: These may have been repaired, however, you will need to monitor after a prolonged period of rainfall - If leaking persists, a qualified plumber should be engaged for advice and recommendations. Essentially, it is preferable to have all water damaged plaster replaced by a qualified plasterer due to potential detachment or collapse.

Adjustment to cabinet doors required, in some instance hinges may need to be replaced.

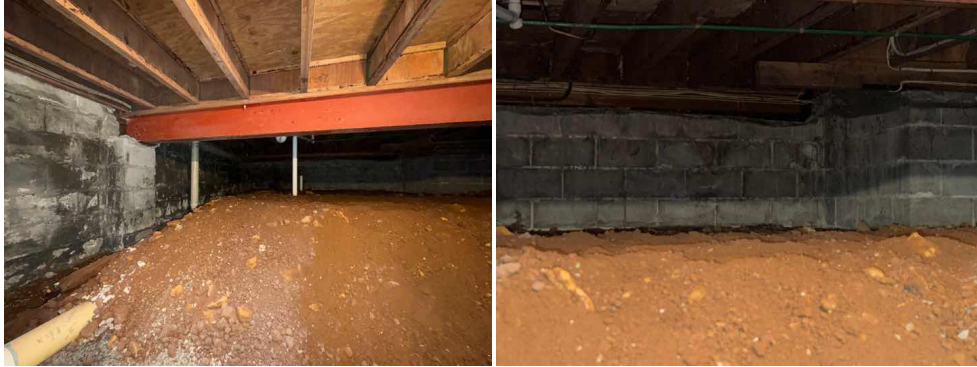
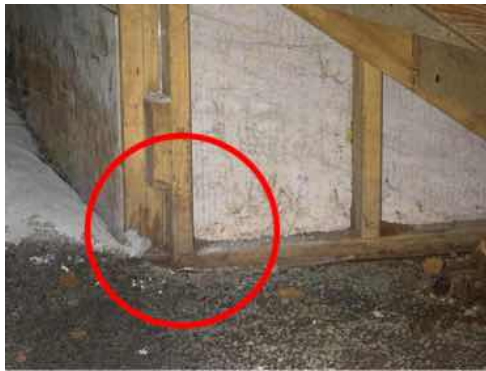
Sub floor soil against timbers

Dampness in sub floor soil. Damp sub floor soil should be avoided as it can cause fungal decay, mould and possibly footings problems. Recommendations: A qualified drainage plumber should be engaged for advice and recommendations.
