Inspection Report

Naraic Building & Pest Inspections Pty Ltd

36 Gibbon St, Lennox Head, NSW, 2478

Pest And Building Inspection

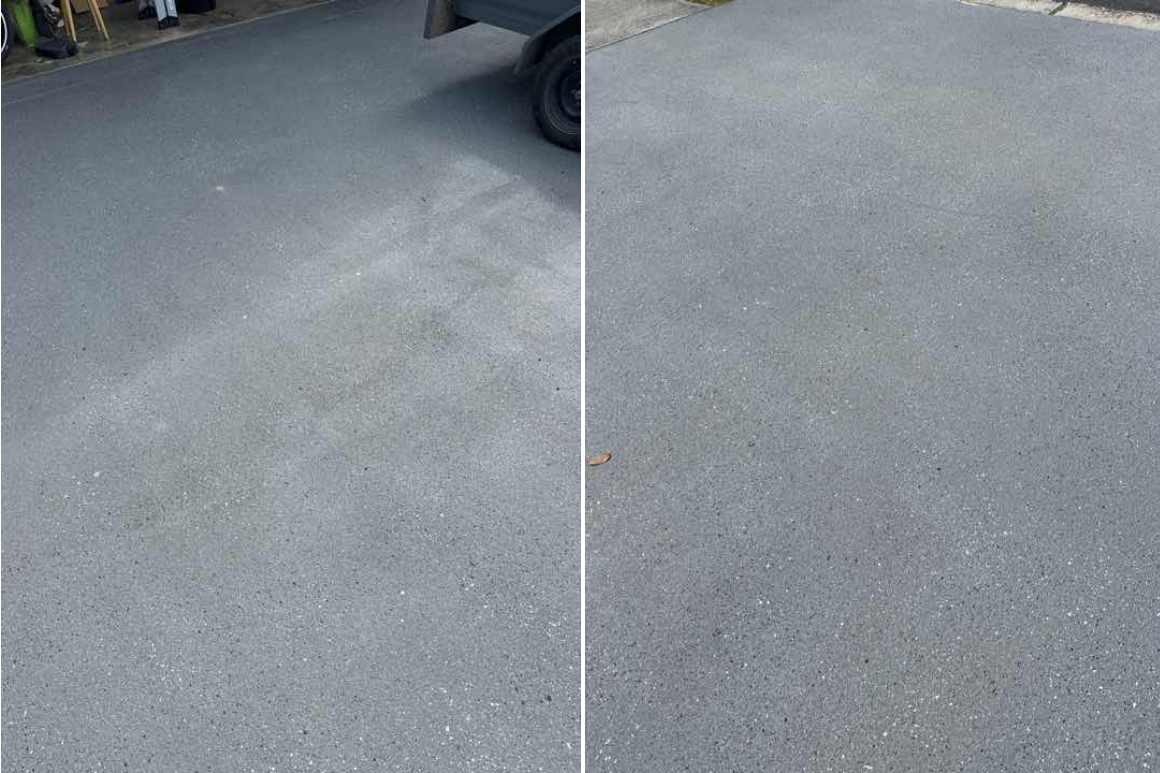
Driveway Condition

On visual inspection, the general condition of the driveway is serviceable.

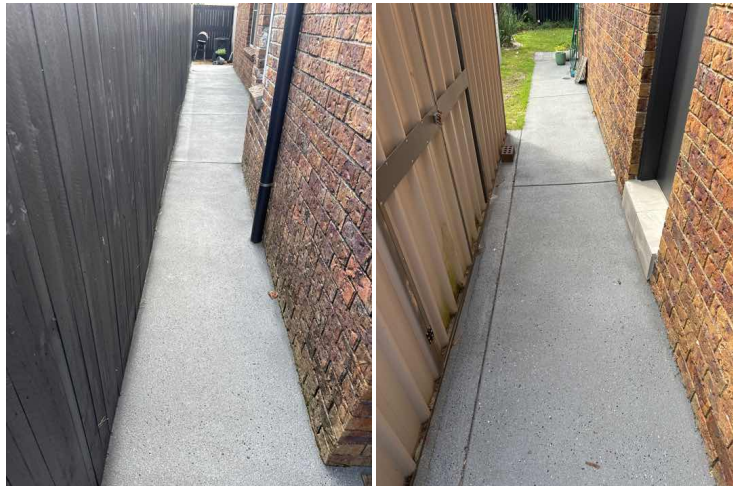
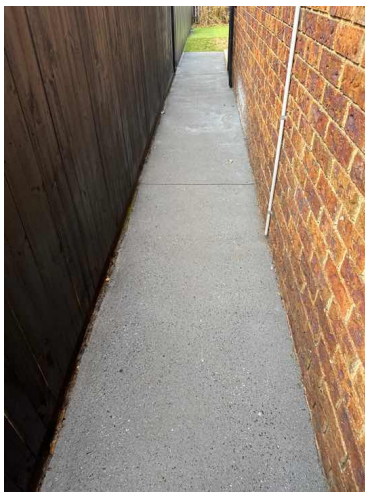
Pathways Condition

The paths around the home are in a serviceable condition for the age of this dwelling with no major defects visible.

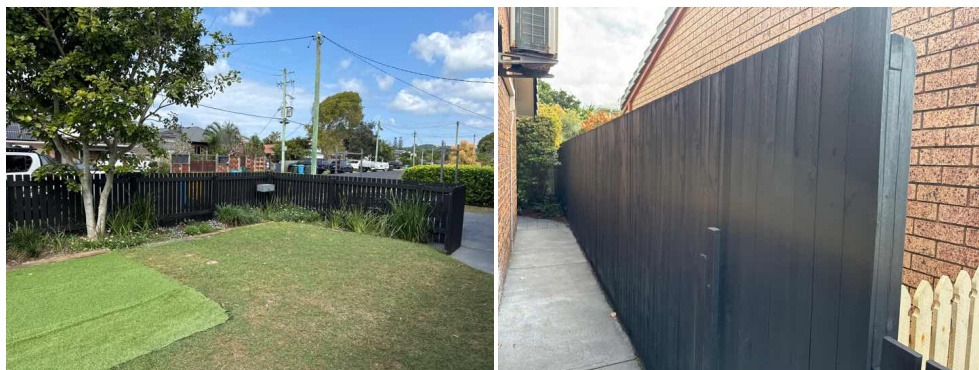
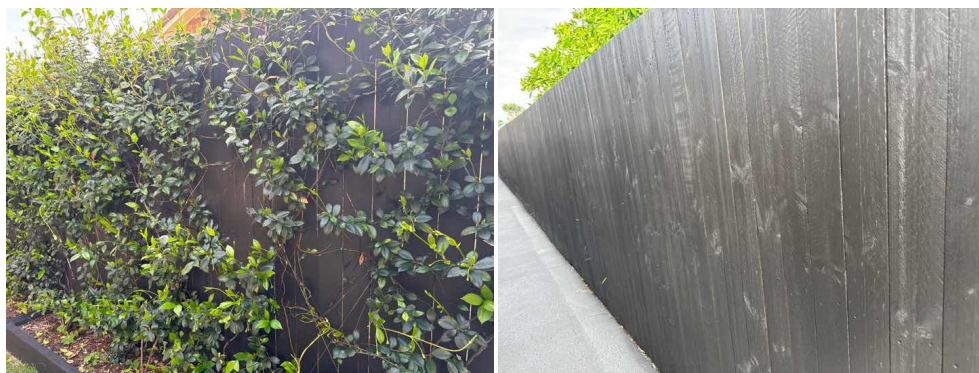
Fences & Gates

Of the visible areas, the general condition of the fences and gates is serviceable for the age of dwelling.

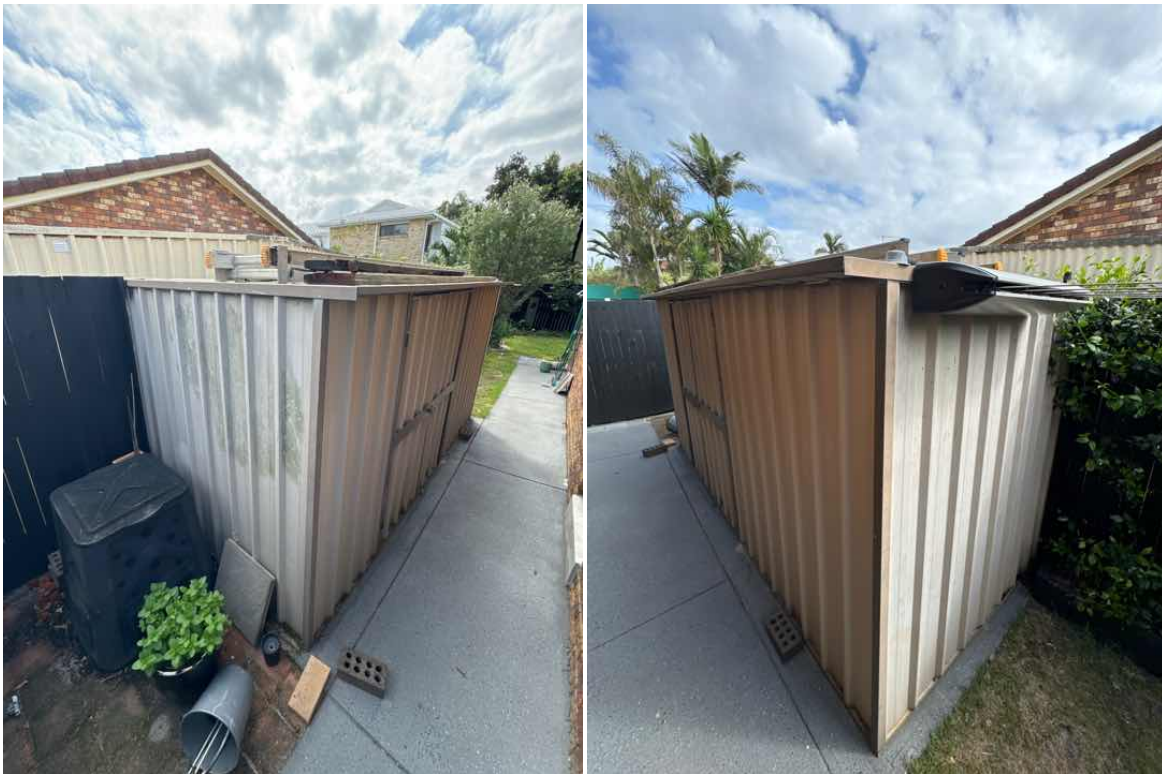
Shed Condition

The shed is in fair usable condition.

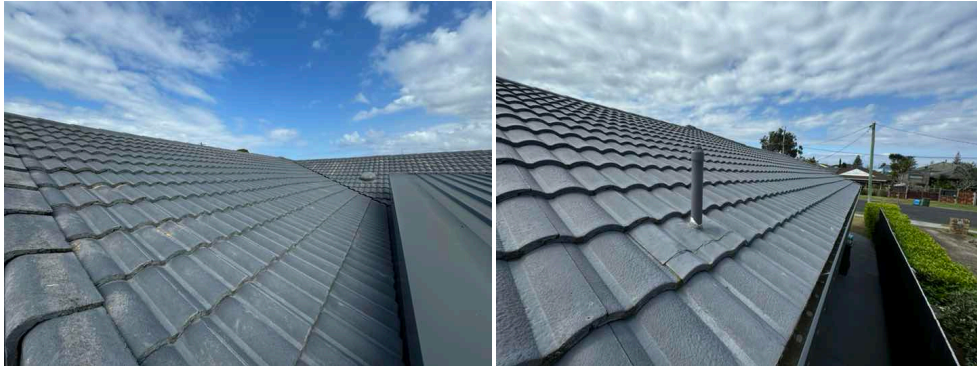
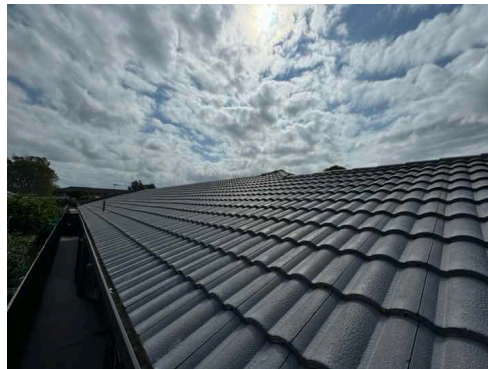
Of the visible areas, the general condition of the roof is in serviceable condition for the age.

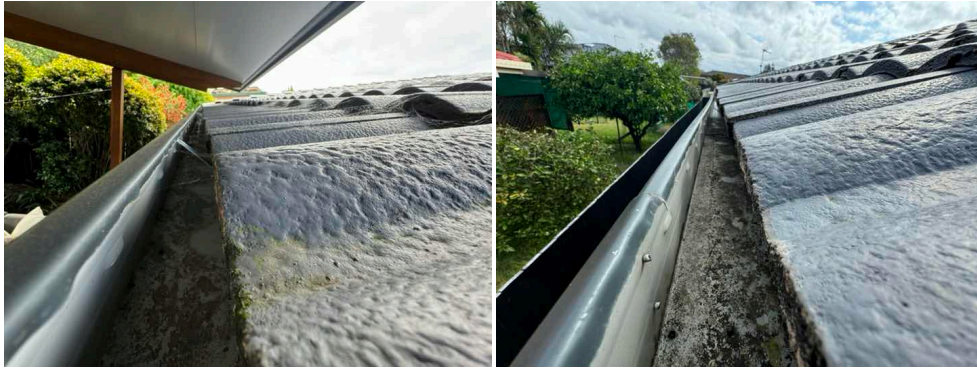
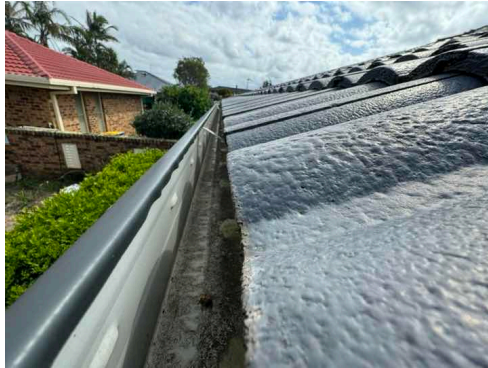
All visible and accessible of the physical nature of the guttering system appears to be in a serviceable condition with no apparent defects at the time of inspection. In the absence of prolonged rain fall efficiency of the guttering can not be assessed and you may find that further investigation or repairs maybe required. Note: Periodic maintenance checks should be carried out for rust penetrations and leaks.

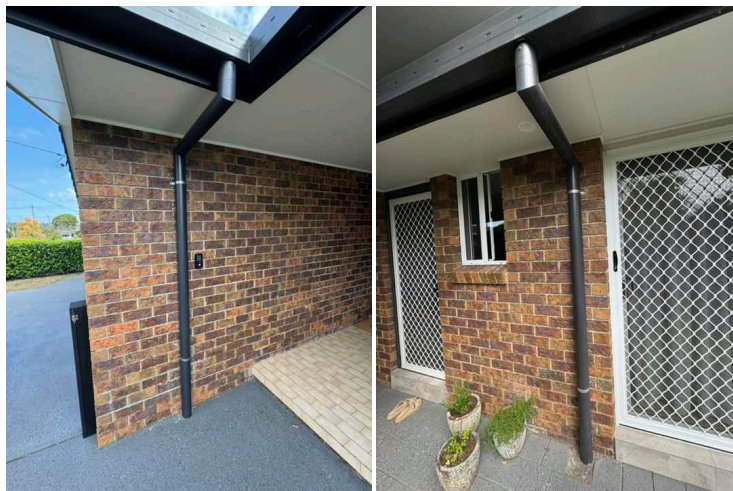
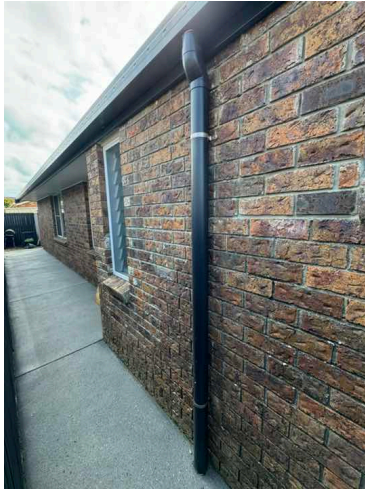
On visual inspection no apparent defects were noted to the down pipes and are considered serviceable, however no comment can be made with regard to blockages or connections to stormwater or functionality in the absence of rain. Note: Periodic maintenance checks should be carried out for rust penetrations and leaks.

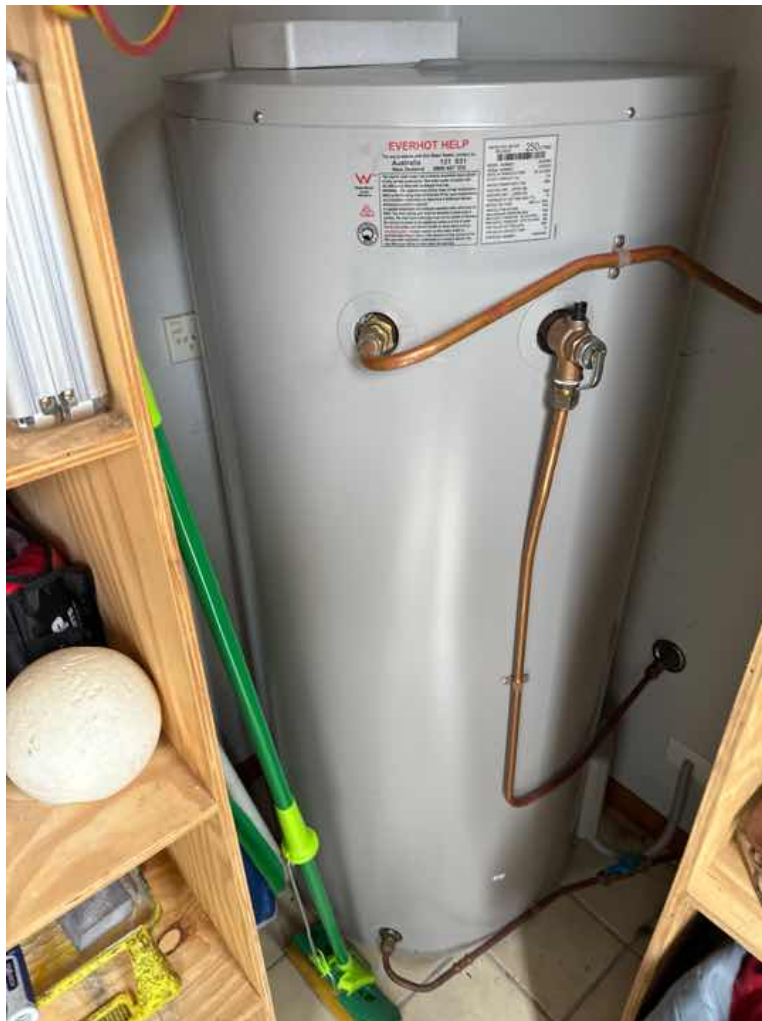
The hot water system appears to be in a serviceable condition. No specific tests other than running the hot water from a tap was carried out. No determination has been made as to the suitability or adequacy of the hot water system in relation to capacity or otherwise.

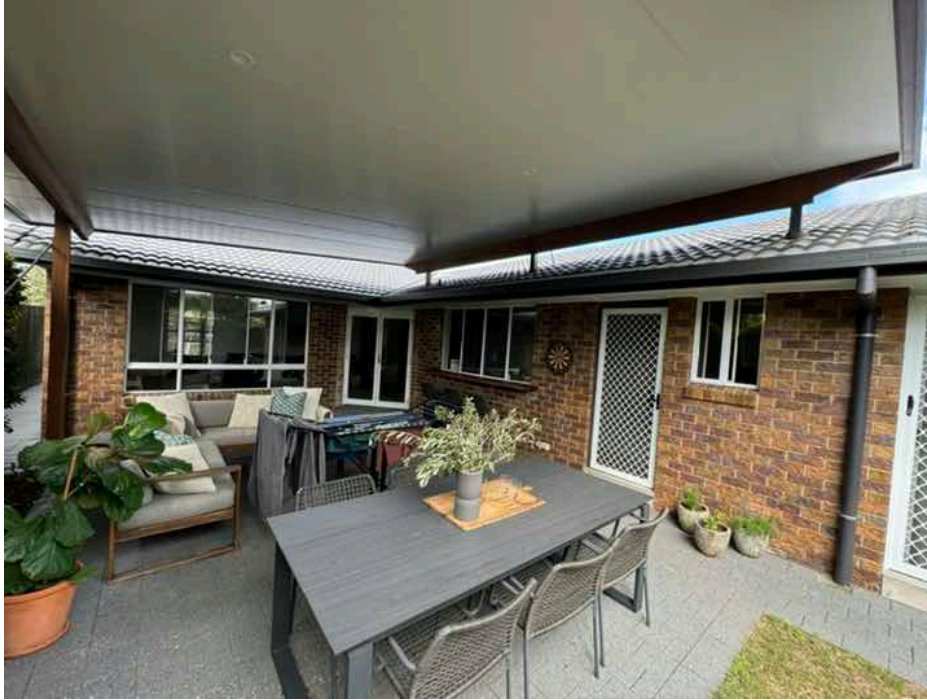
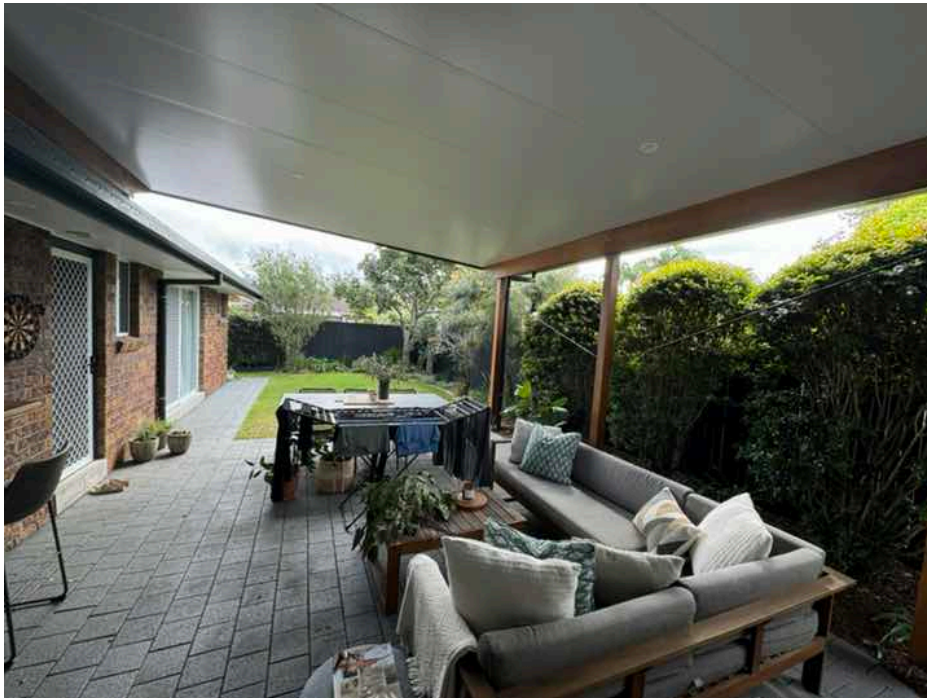
Visible sections of the Alfresco area are serviceable or in reasonable or condition for the age of this dwelling.

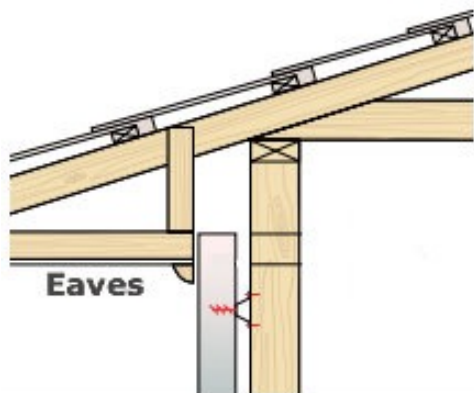
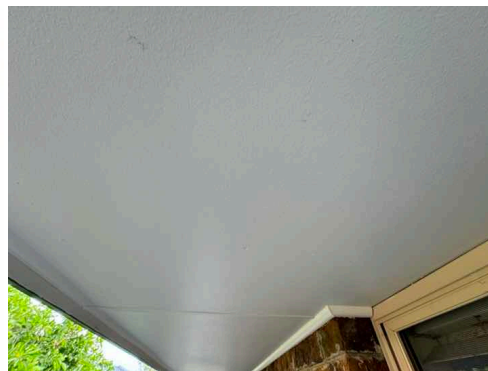
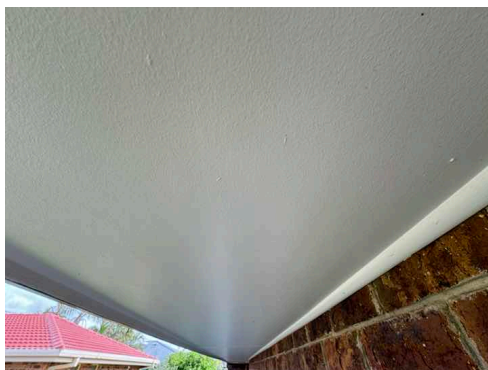
Eaves

Eave lining damage visible. Recommendations: A qualified carpenter should be engaged for repairs.

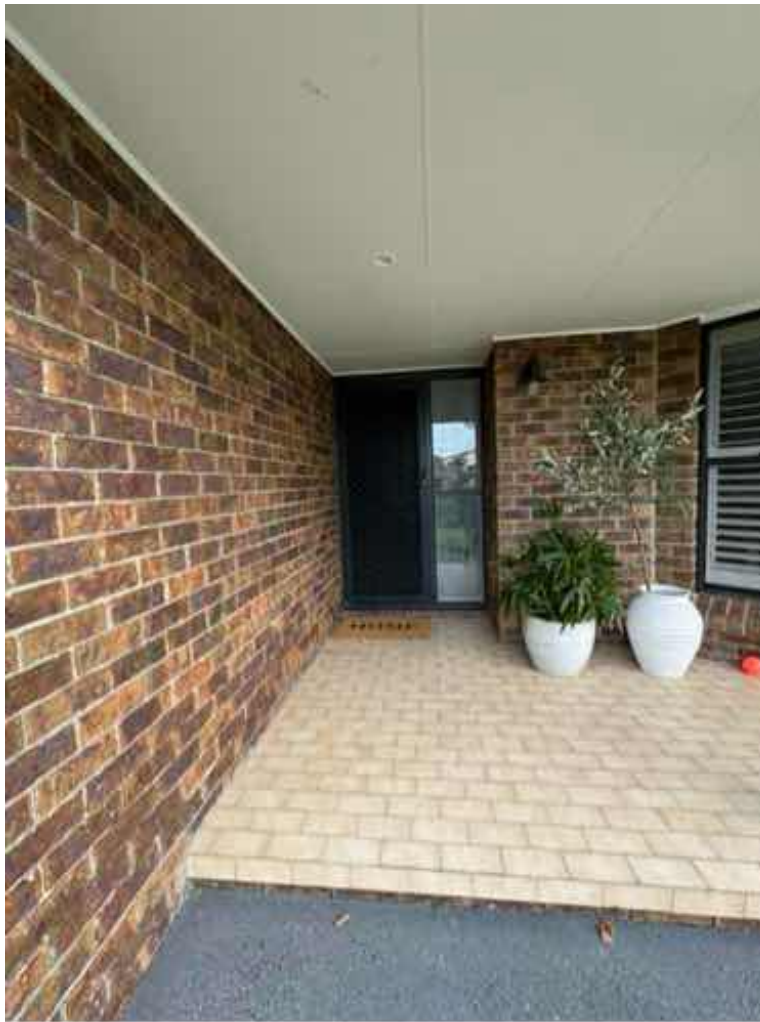
The entry porch serviceable or in reasonable or condition for the age of this dwelling.

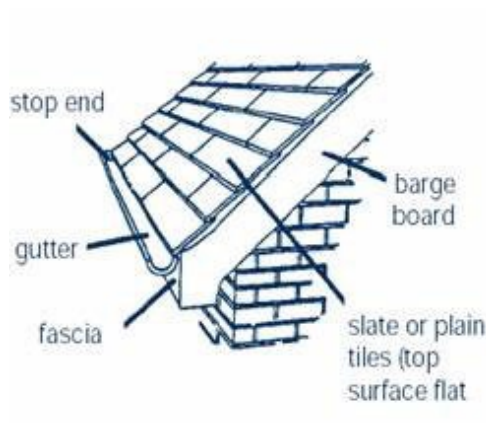
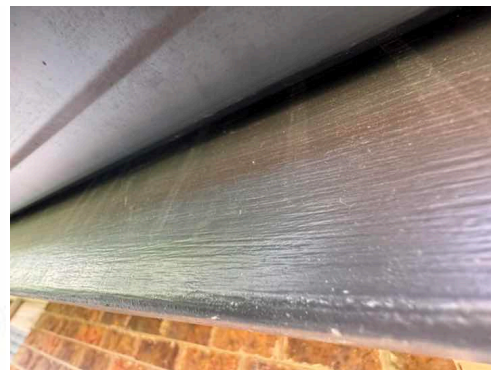
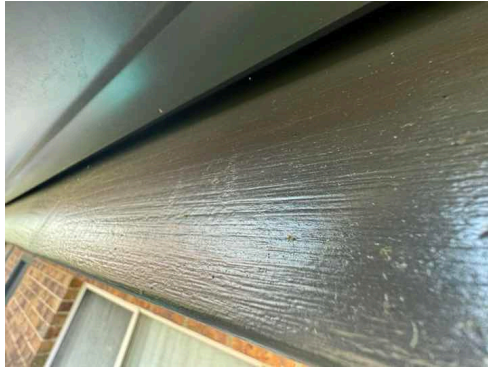
On visual inspection, the general condition of the fascia/barge boards is serviceable.

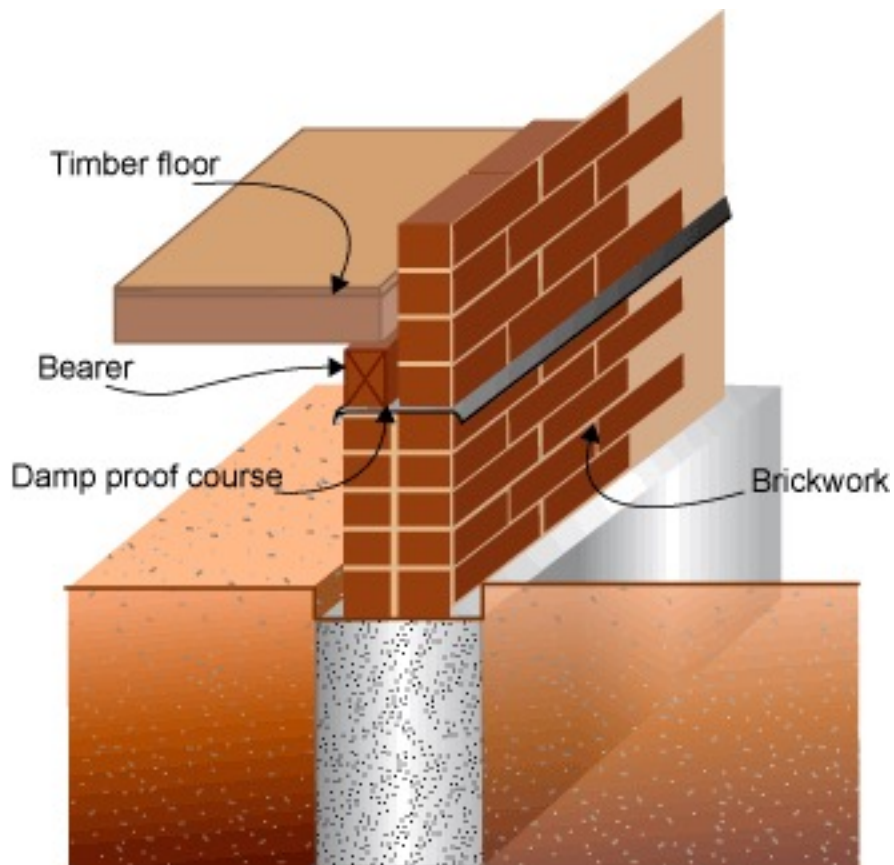
A damp proof course (DPC) was noted.

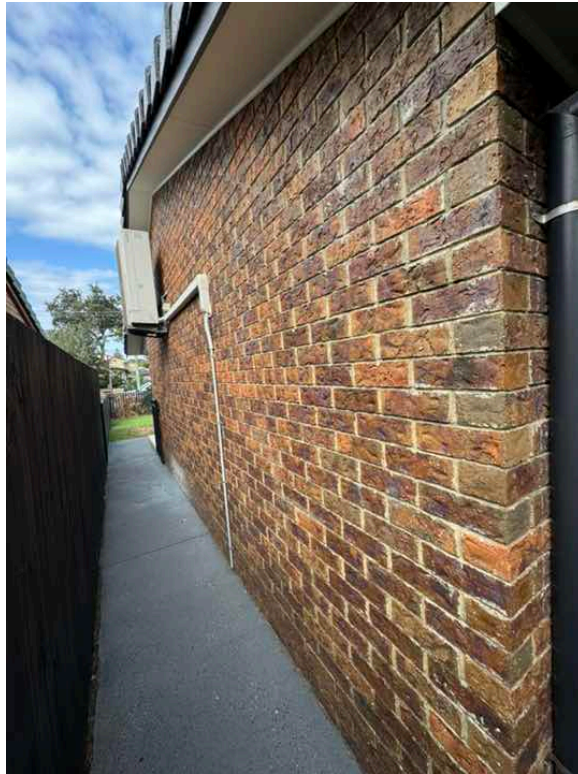
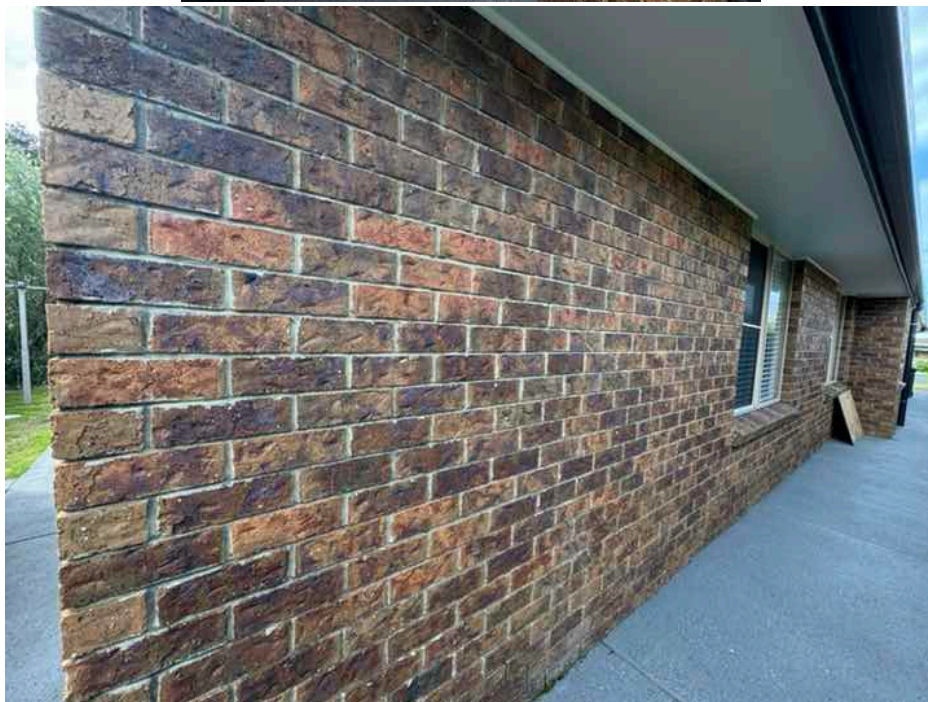
On visual inspection, the general condition of the exterior walls is serviceable for the age.

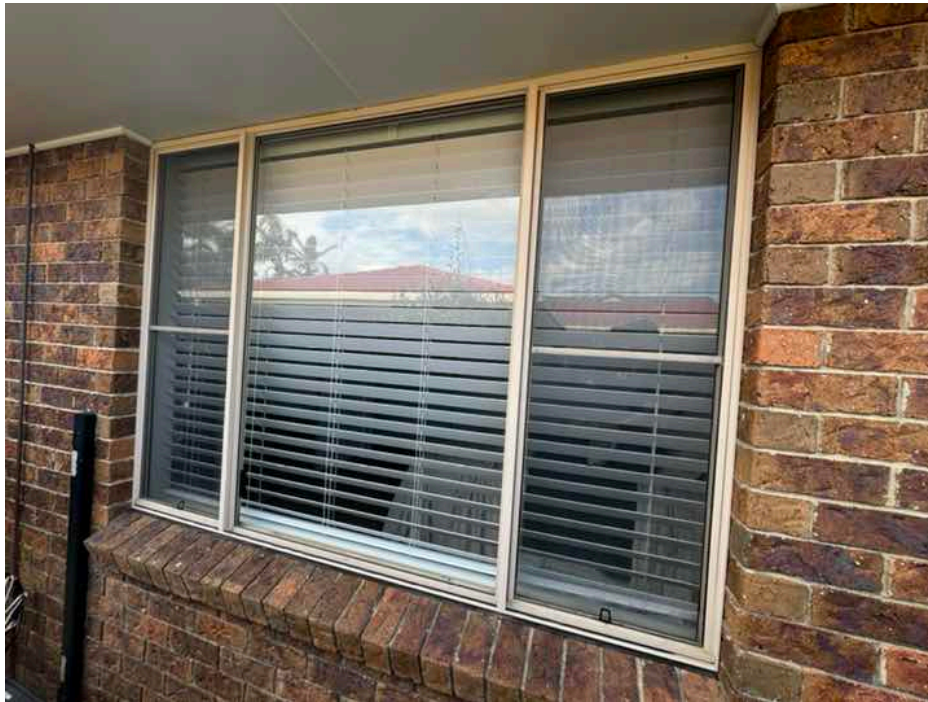
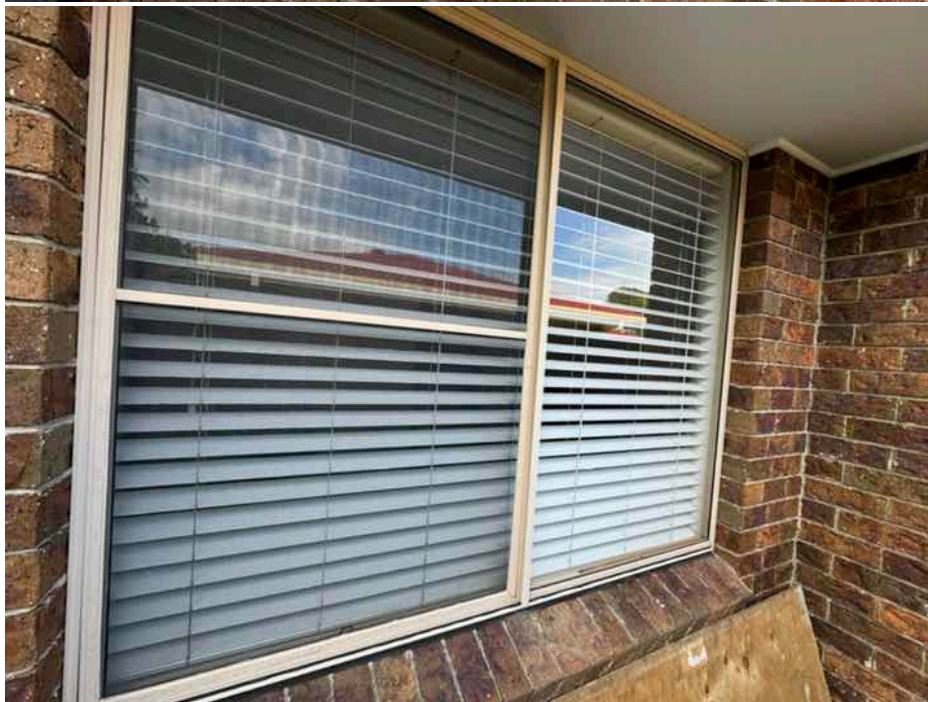
On visual inspection, the general condition of the windows is serviceable for the age.

Damaged fly screen/s replace as required.

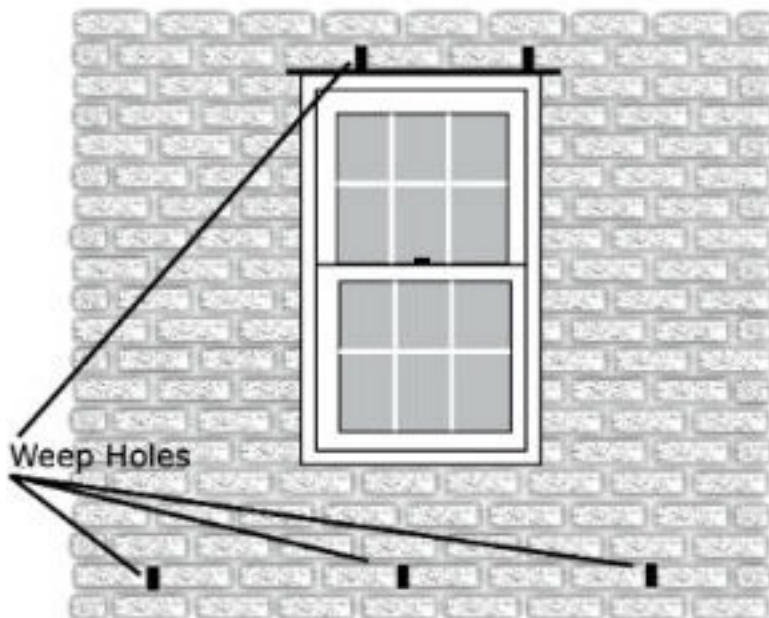
The weep holes are unobstructed .

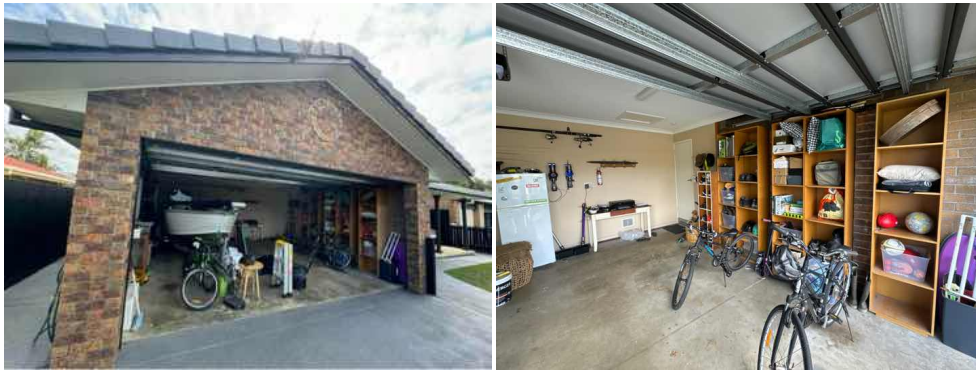
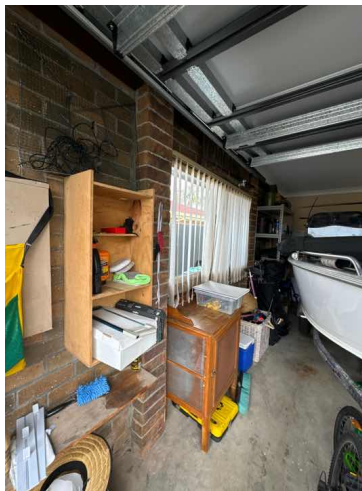
From the visible and accessible areas, the garage appears to be in a serviceable condition for the age of the property with no notable structural defects sighted.

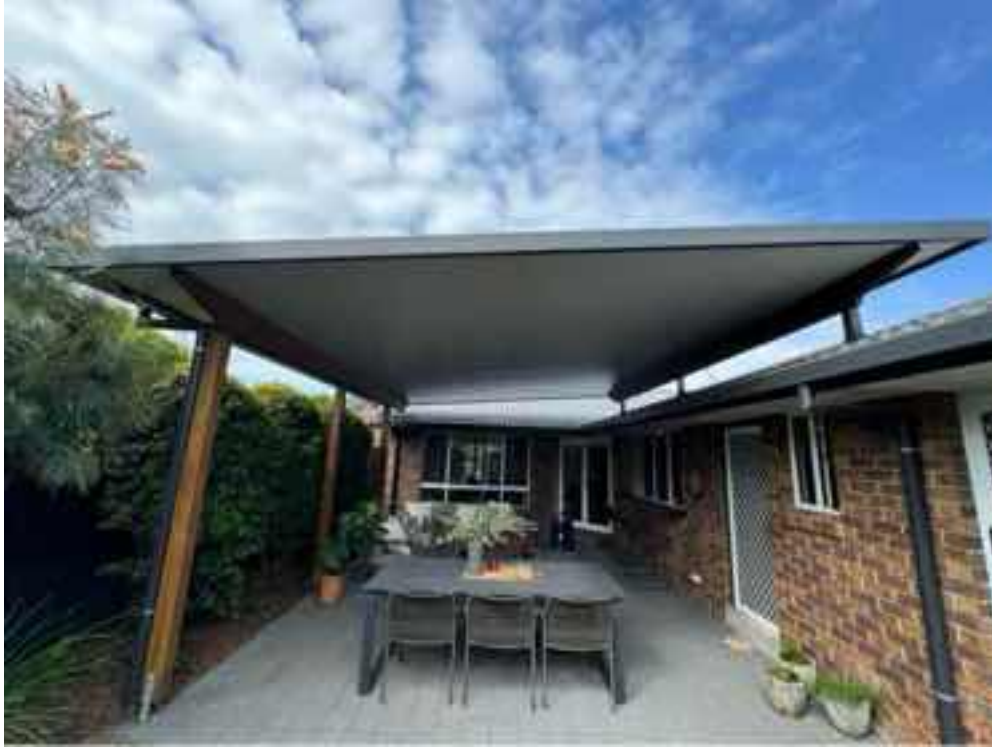
The Pergola is in a serviceable condition with no notable defects sighted.

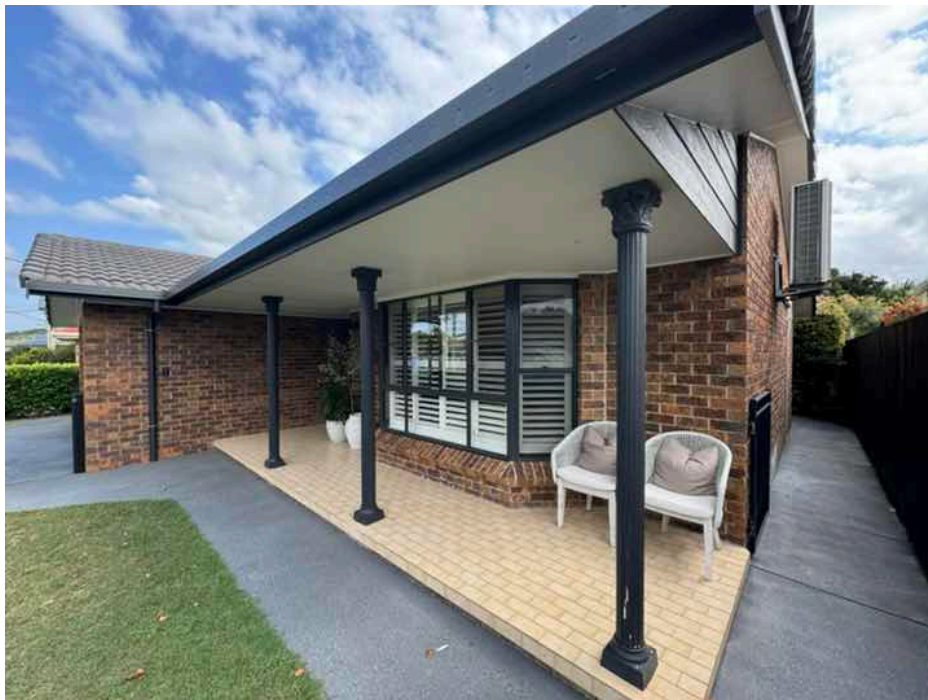
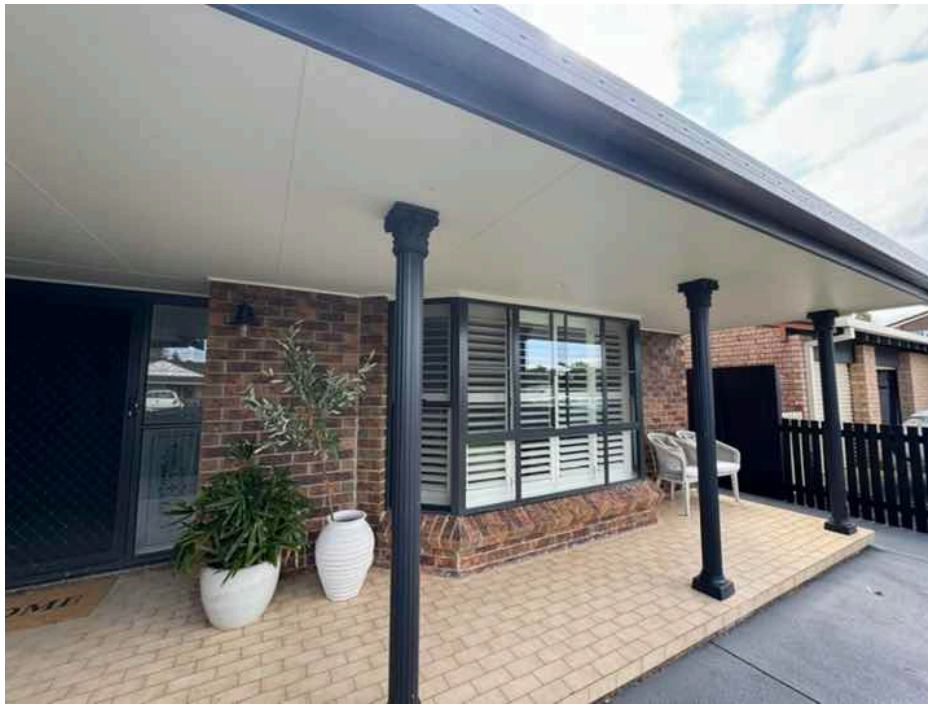
Though we are not structural engineers the balcony/s appear to be in a serviceable condition.

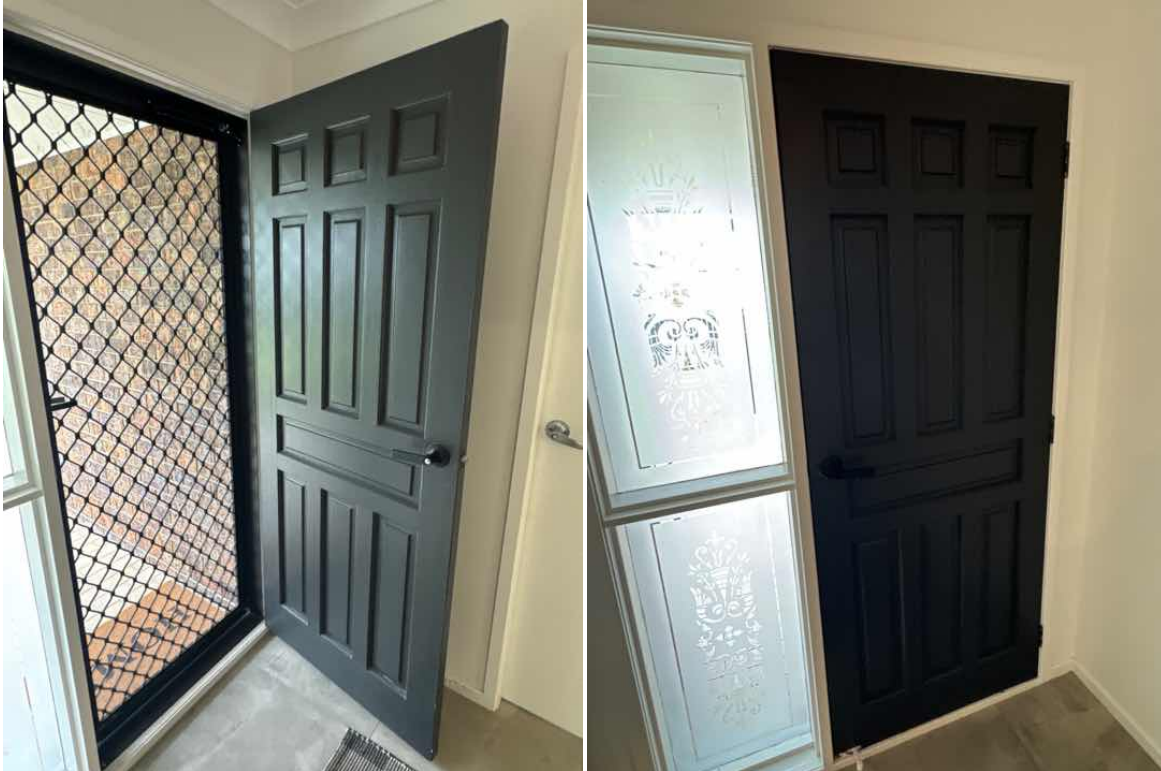
The doors are in serviceable condition with no notable defects observed.

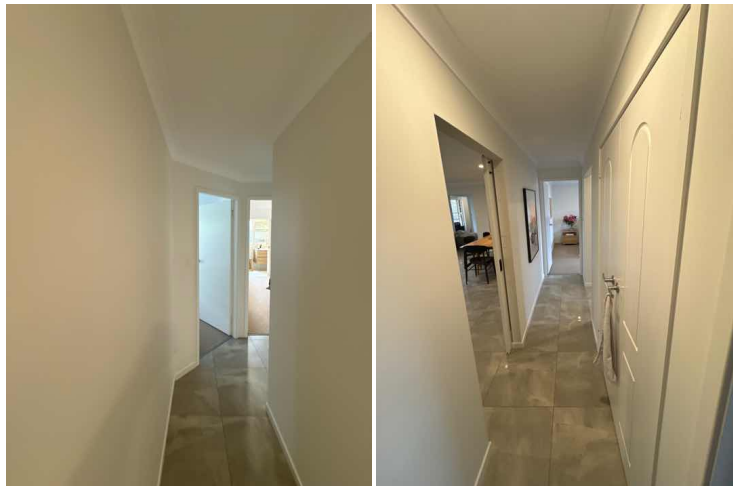
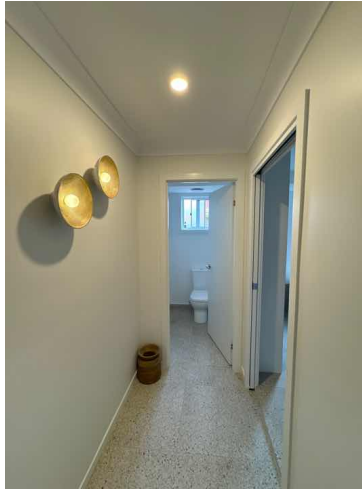
From the visible and accessible areas, the hallway/ appears to be in a serviceable condition for the age of the property with no notable structural defects sighted.

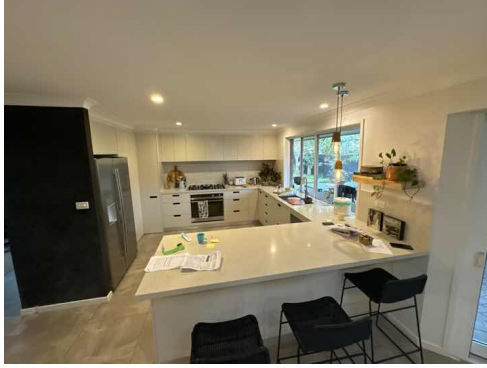
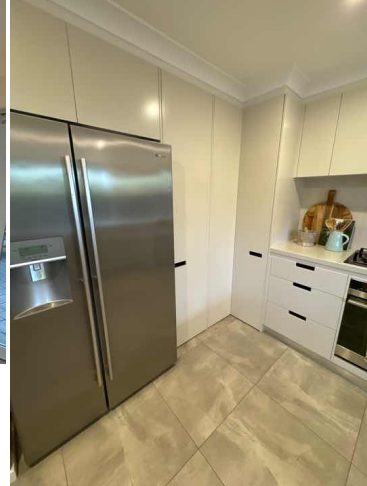
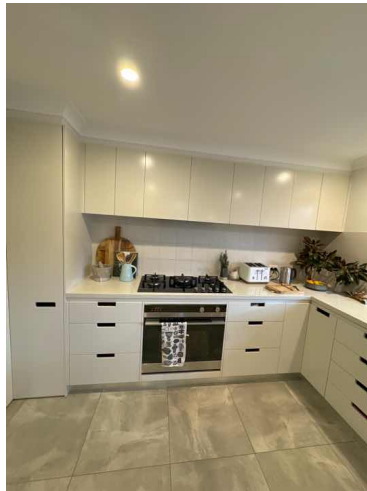
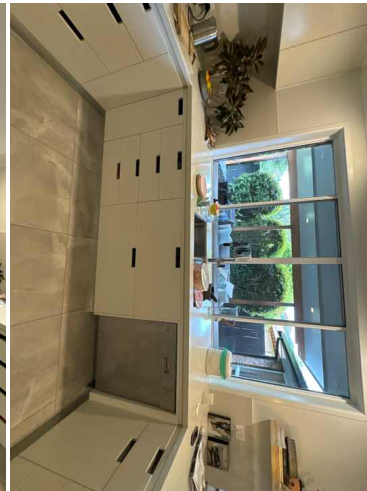
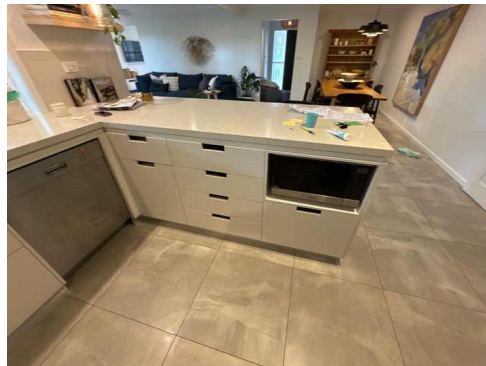
Of the visible areas, the general condition of the kitchen and pantry is serviceable or in reasonable condition for age of dwelling.

Adjustment to cabinet doors required, in some instance hinges may need to be replaced.

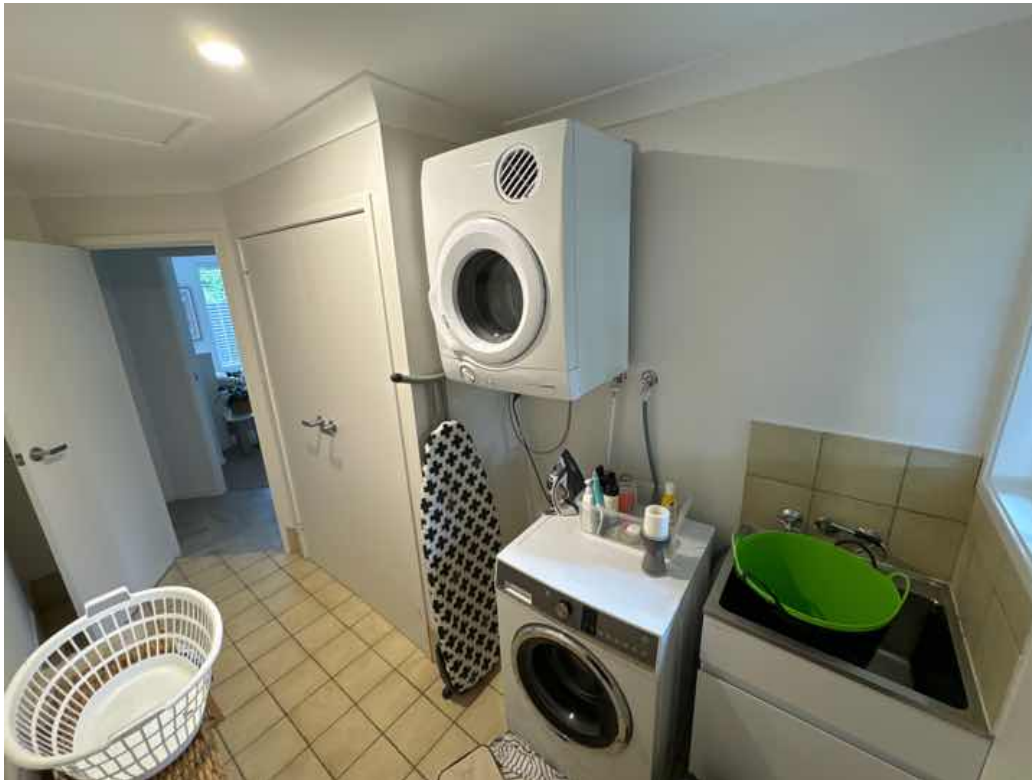
Of the visible areas, the general condition of the laundry is serviceable or in reasonable condition for age of dwelling.

Minor cracks floor tiles. A qualified tiler should be engaged for repairs.

Drummy tiles noted. This needs to be repaired at the earliest as this has the potential to lead to many related issues such as damp, water ingress to other areas and cracked tiles. Contact a qualified tiler for repairs and recommendation.

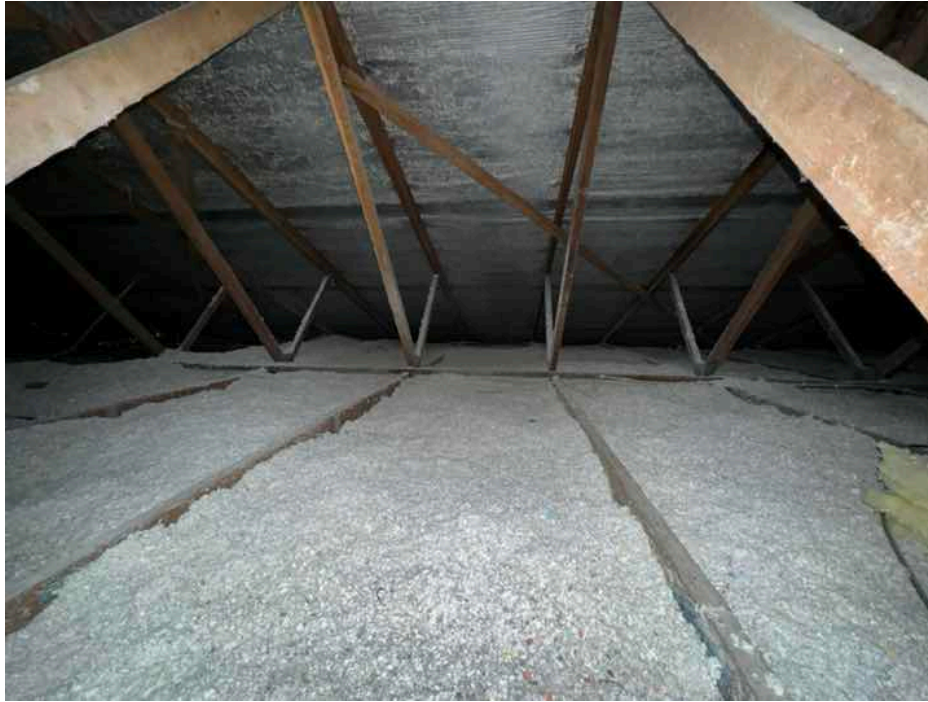
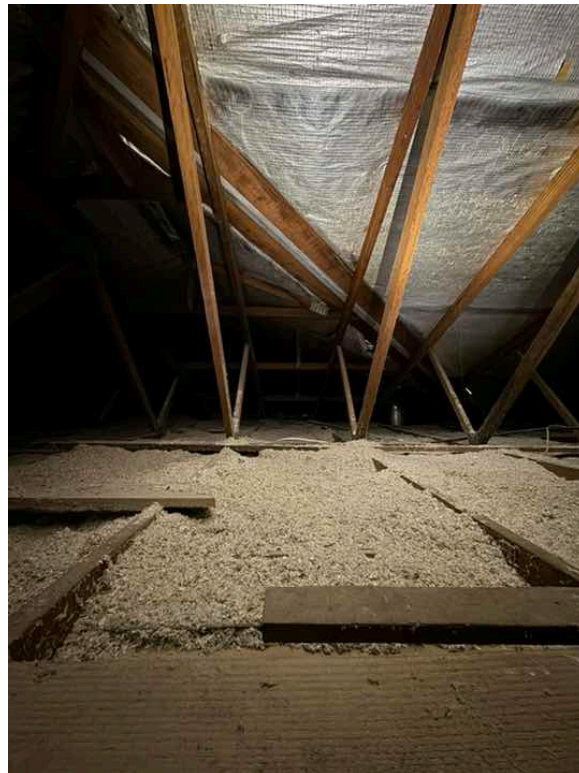
Visible sections of the roof void is in a serviceable condition for age of this dwelling.

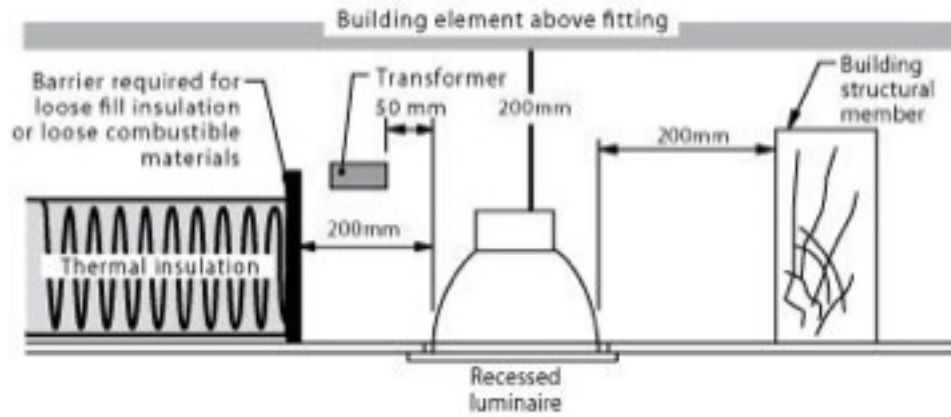
Where visible and accessible, the insulation appears to be in a serviceable condition.

Insufficient spacing between insulation and down lights. This poses a fire risk. Contact a qualified electrician for further advice and recommendations prior to a decision to purchase.
