Building and Pest Report

53B Stoneyhurst Drive Lennox Head

BUILDING & PEST INSPECTIONS

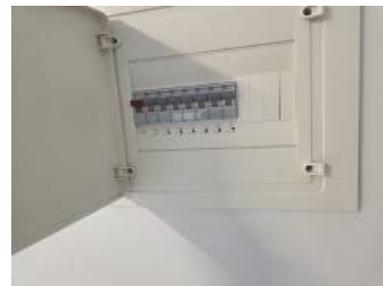
ELECTRICAL SAFETY SWITCH:

Whilst not an electrician, it appears that an electrical safety switch is present.

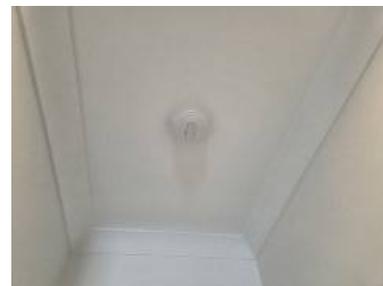
Present - Hall.

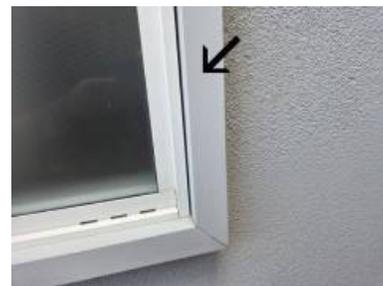
WINDOWS / DOORS / FLASHINGS / MOULDINGS / SILLS

Some window frame / cladding joints require resealing with a suitable sealant.
Architrave joins.

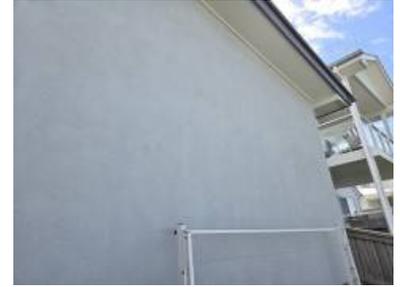
PAINTING

The external paintwork / finish to the external surfaces and timberwork is generally satisfactory. There are some sections / areas that require touching up / repainting.

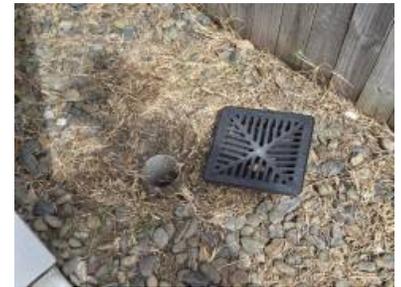
SURFACE WATER DRAINAGE

Whilst not a plumber it appears that at the time of the inspection, drainage seems generally adequate.
1 drain lid needs reinstalling.

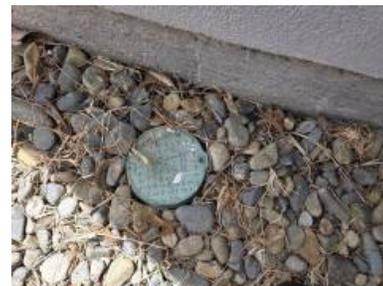
PHYSICAL EVIDENCE:

It appears that a termite reticulation system may be present to the residence. We strongly recommend that you attempt to verify any treatment information and obtain copies of all relevant documentation.
