PEST AND BUILDING PRE-PURCHASE REPORTS

Inspection Report

28 Tamar St, Ballina, NSW, 2478

Pest And Building Inspection

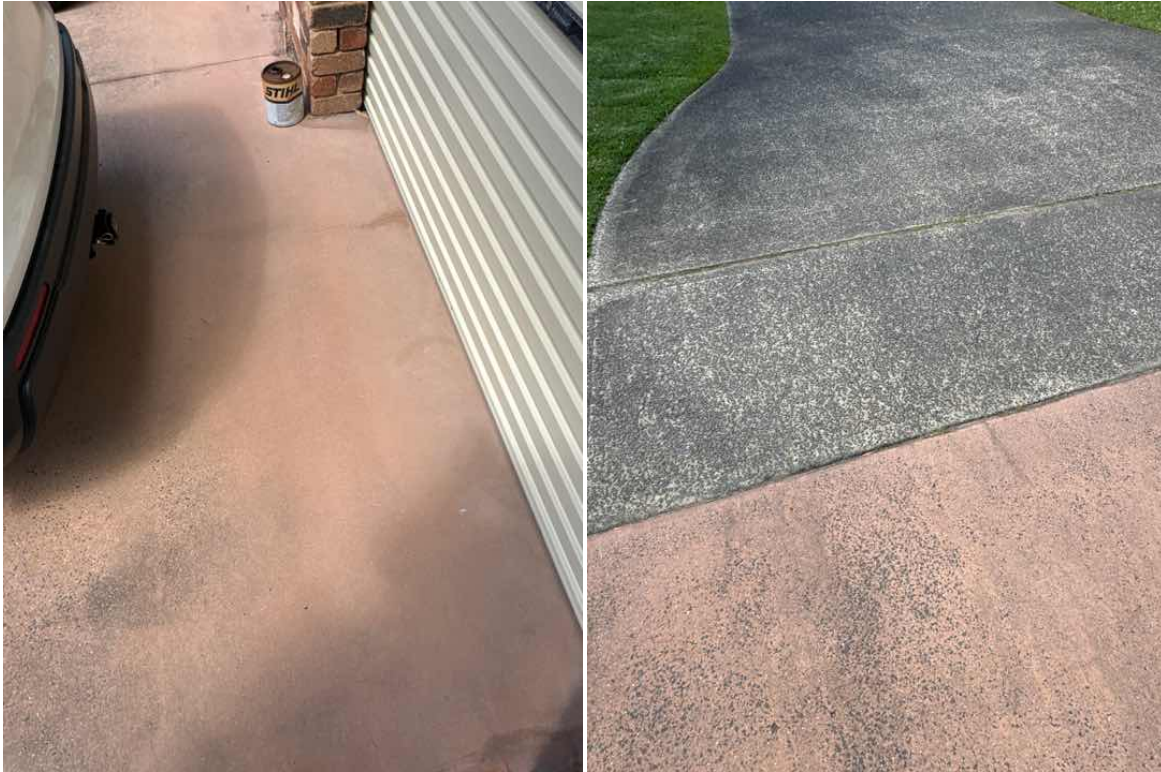
Driveway Condition

On visual inspection, the general condition of the driveway is serviceable.

Common cracks were observed on the driveway. Whilst these cracks appeared to be typical at the time of inspection, we strongly recommend you monitor these cracks and if worsening occurs contact a concreter for further advice.

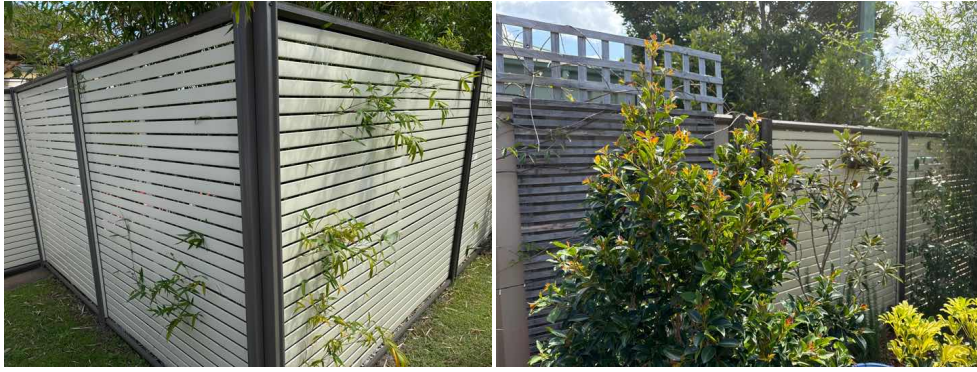
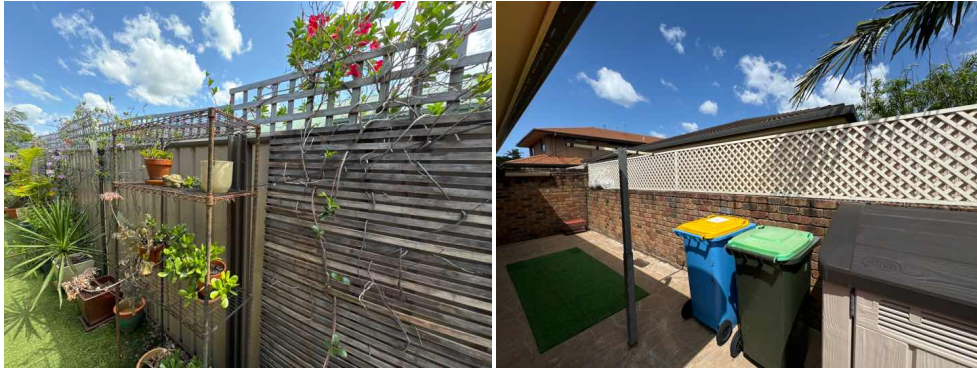
Overall Condition

Of the visible areas, the general condition of the fences and gates is serviceable for the age of dwelling.

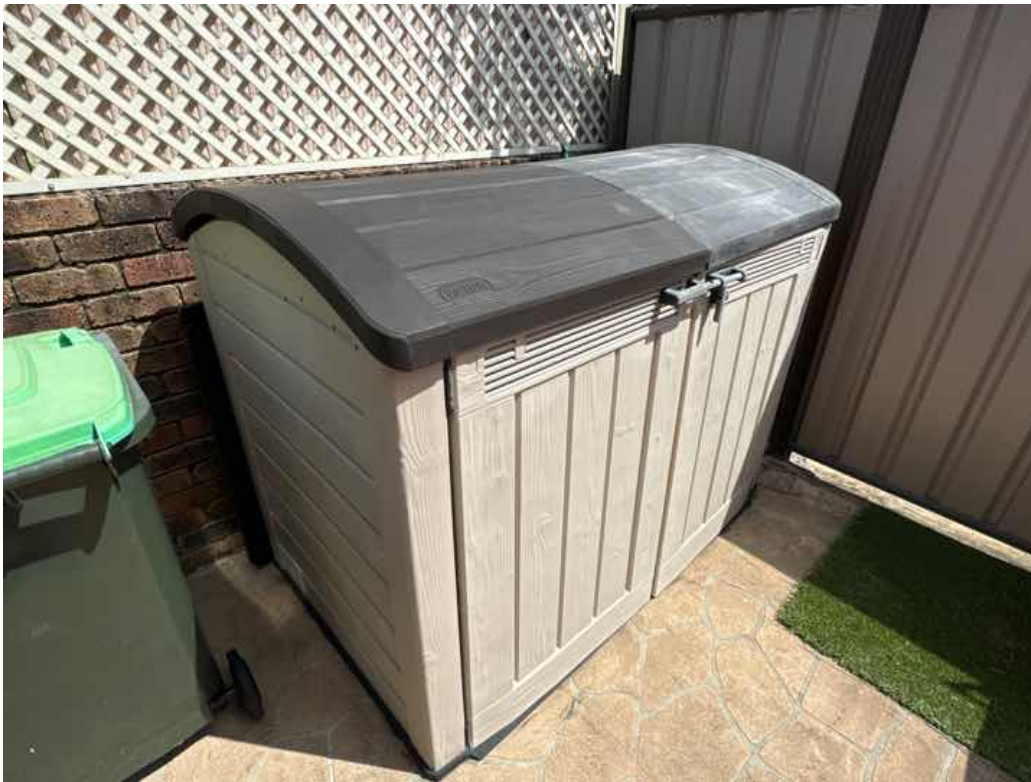
Shed Condition

The shed is in fair usable condition.

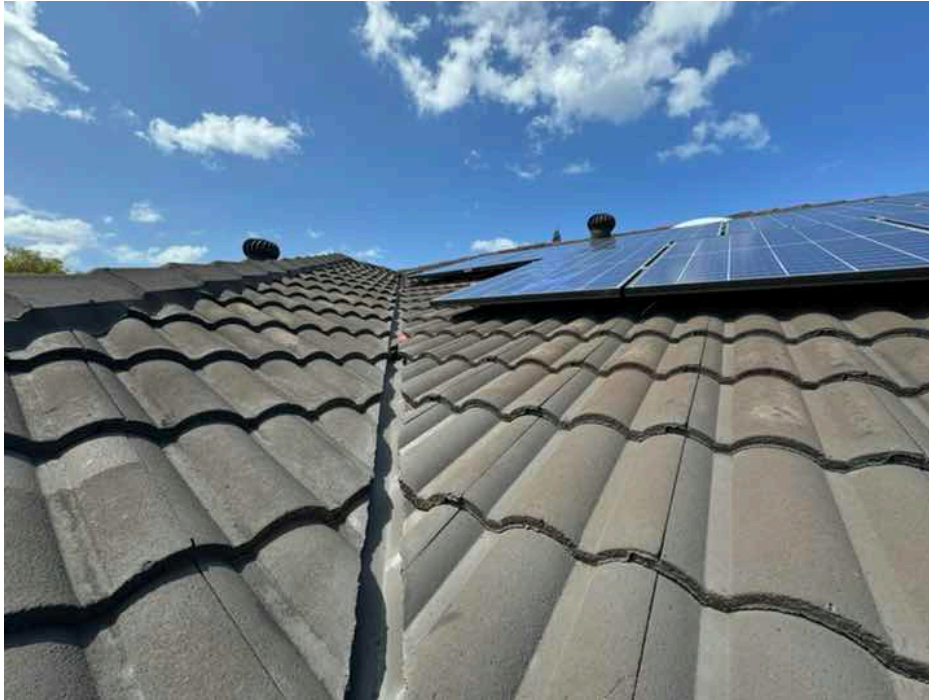
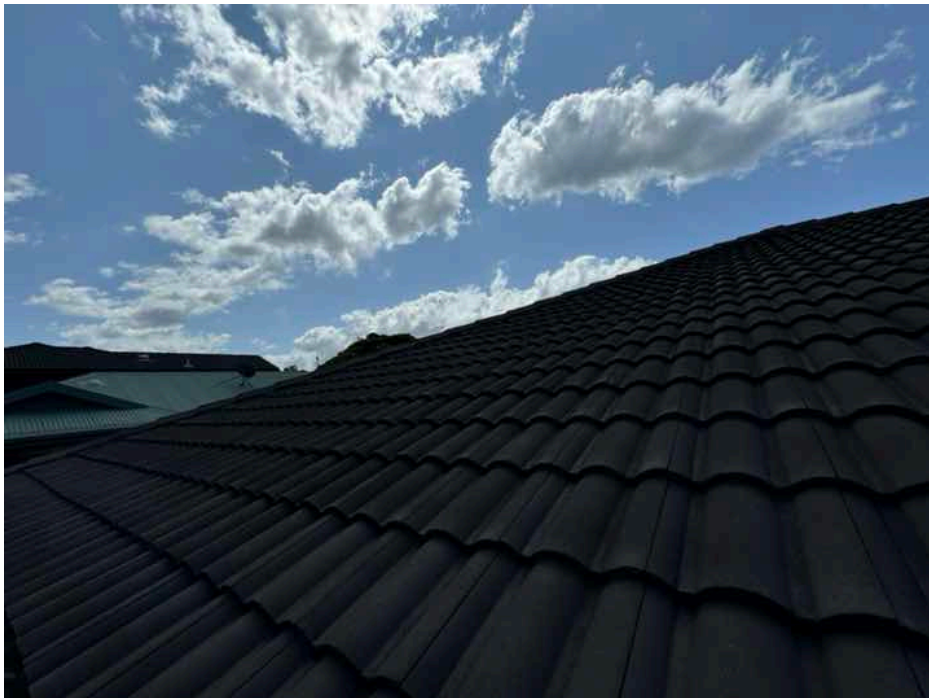
Overall Condition

Of the visible areas, the general condition of the roof is in serviceable condition for the age.
Note: In the absence of rainfall there is no guarantee that the roof won't leak.

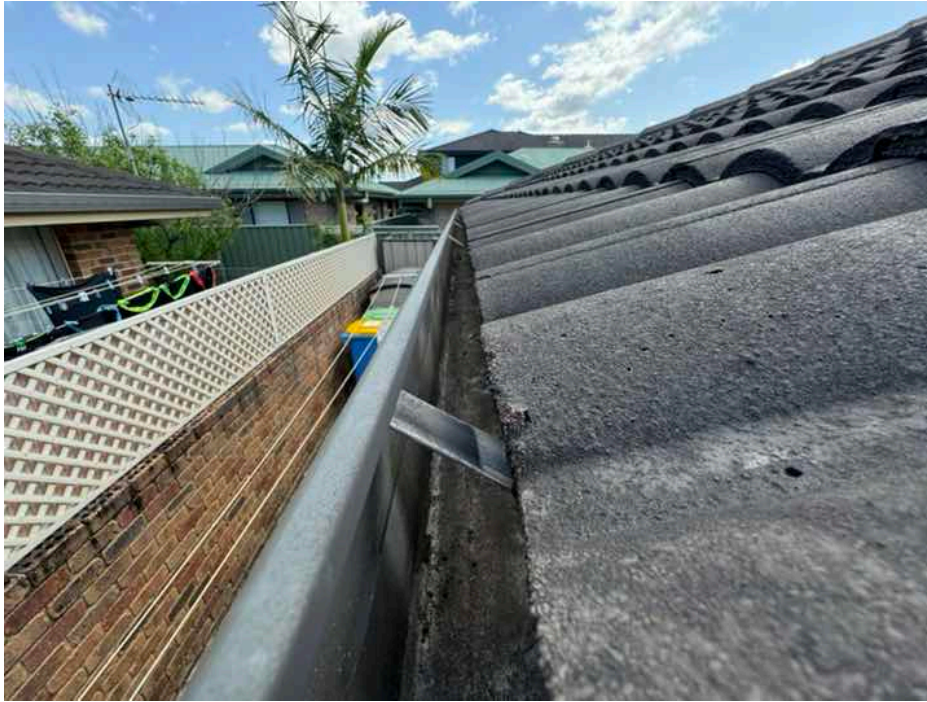
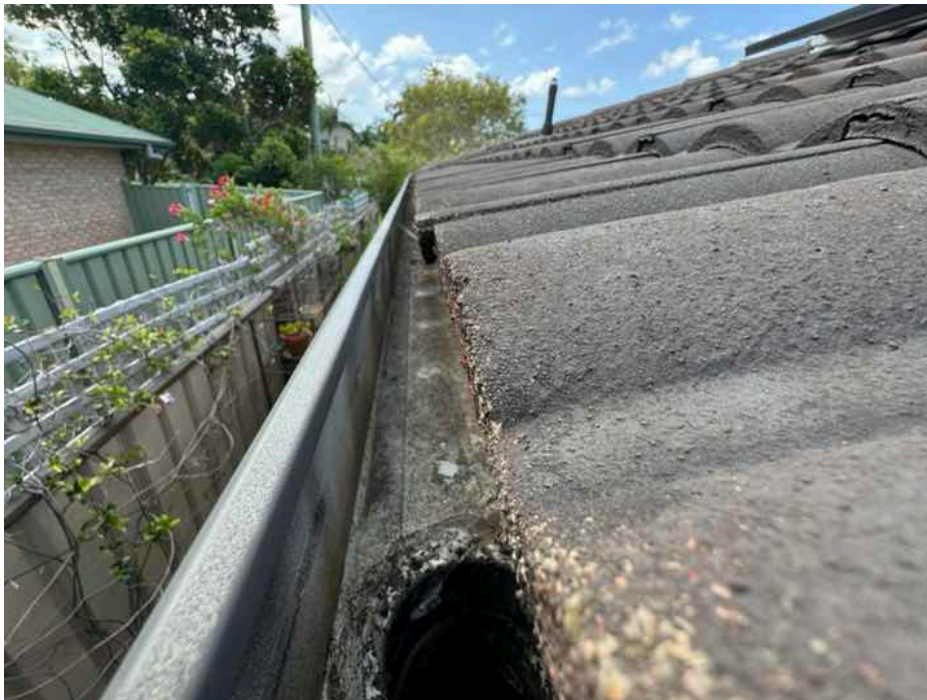
Guttering

All visible and accessible of the physical nature of the guttering system appears to be in a serviceable condition with no apparent defects at the time of inspection. In the absence of prolonged rain fall efficiency of the guttering can not be assessed and you may find that further investigation or repairs maybe required. Note: Periodic maintenance checks should be carried out for rust penetrations and leaks.

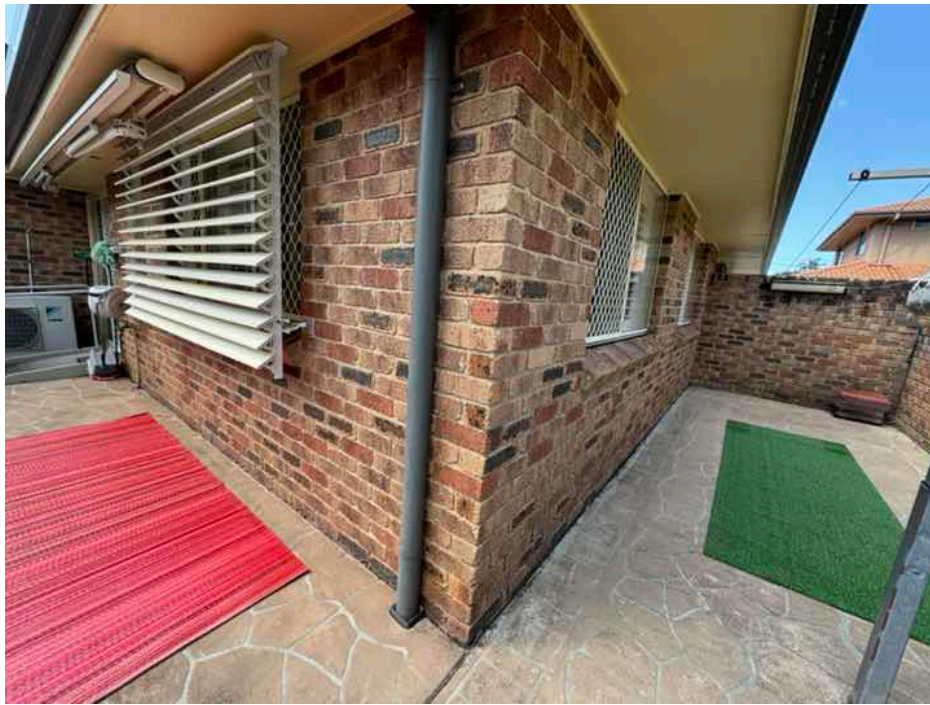
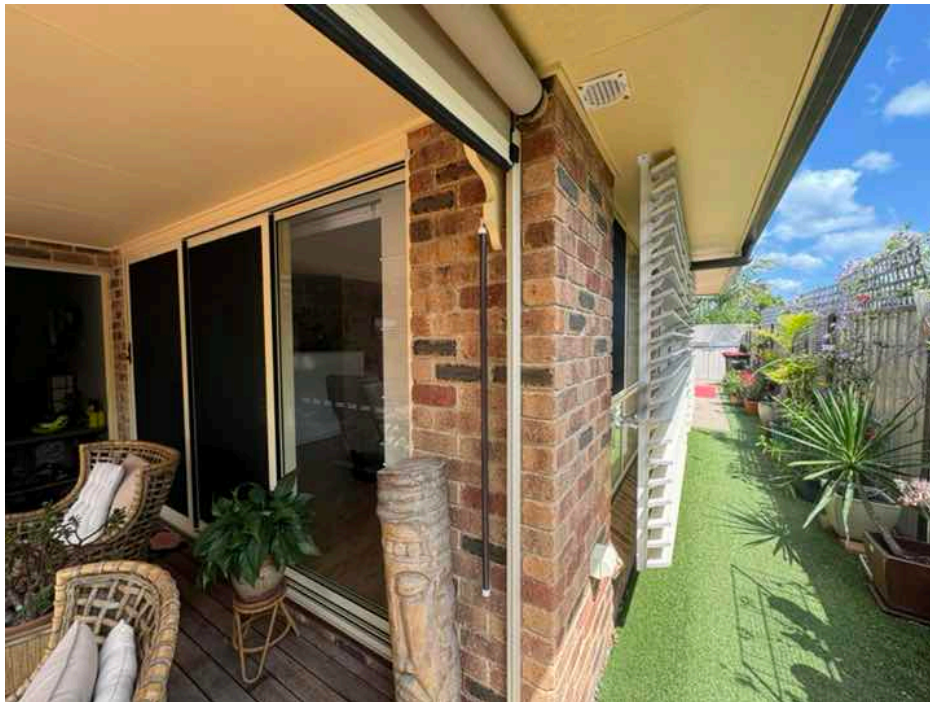
Downpipes

On visual inspection no apparent defects were noted to the down pipes and are considered serviceable, however no comment can be made with regard to blockages or connections to stormwater or functionality in the absence of rain. Note: Periodic maintenance checks should be carried out for rust penetrations and leaks.

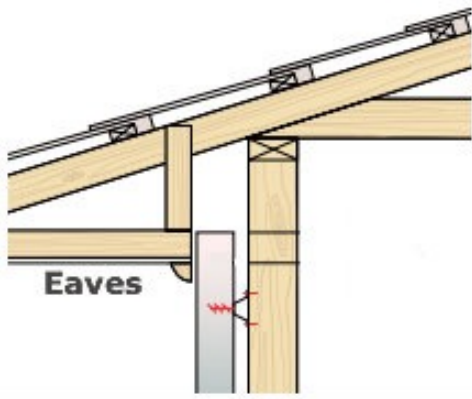
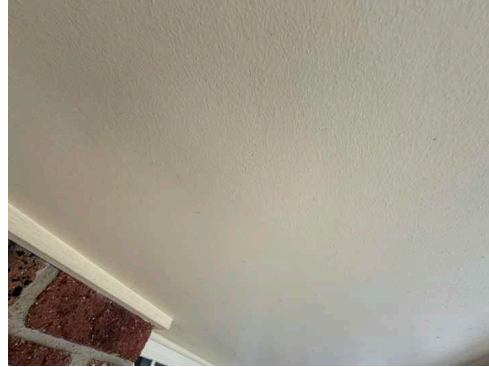
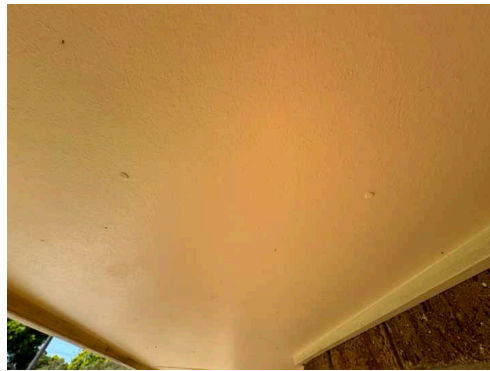
Eave Condition

The soffit lining (eaves) are in a serviceable condition with no notable defects.

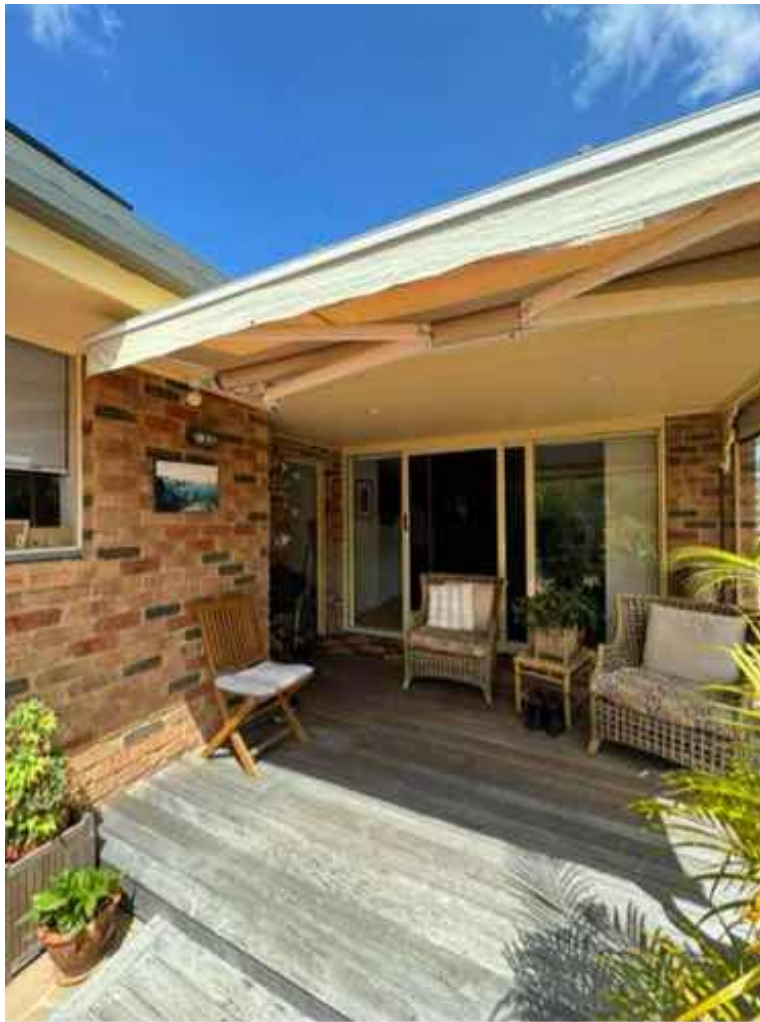
Entry Porch Area

The entry porch serviceable or in reasonable or condition for the age of this dwelling.

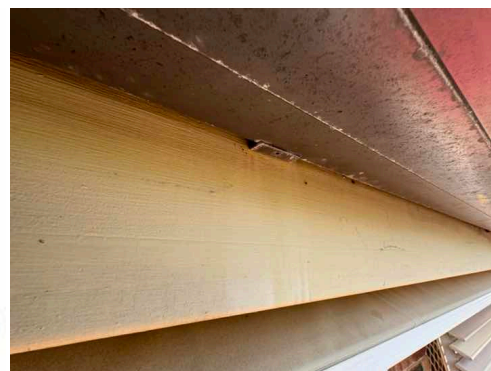
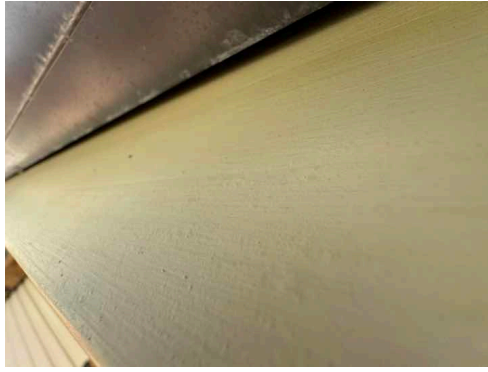
On visual inspection, the general condition of the fascia/barge boards is serviceable.

Rusty fixing

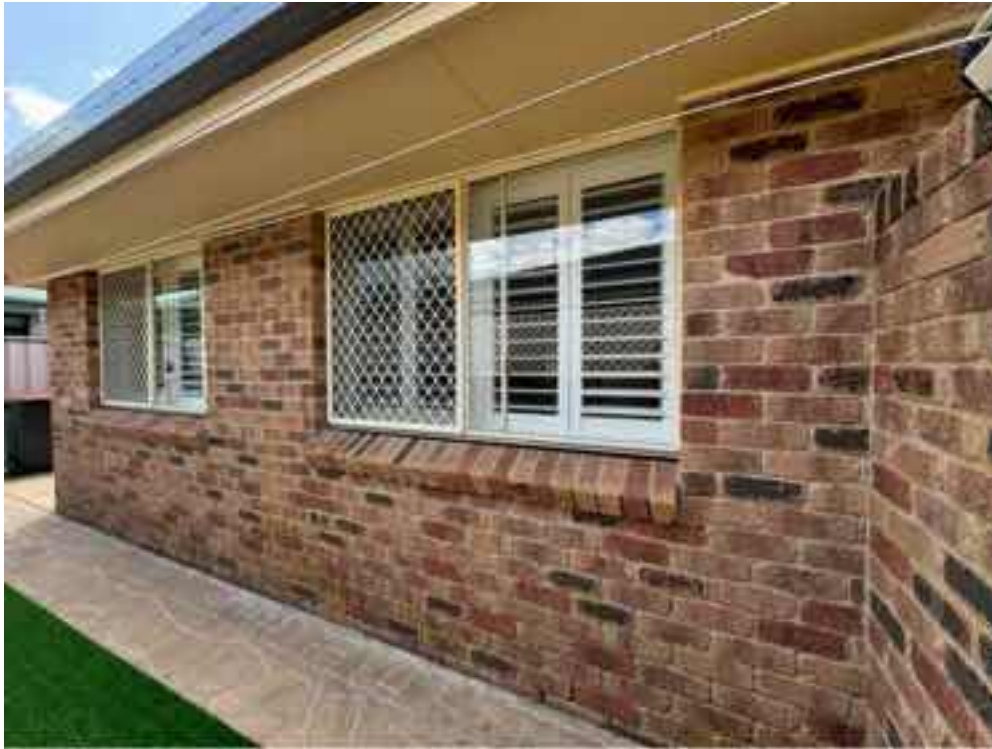
On visual inspection, the general condition of the exterior walls is serviceable for the age.

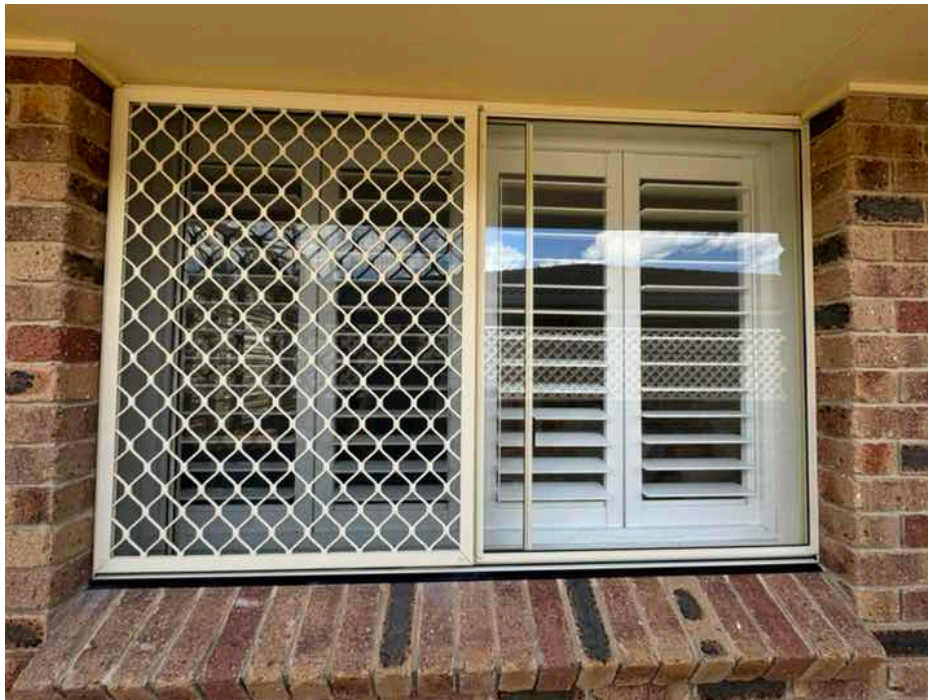
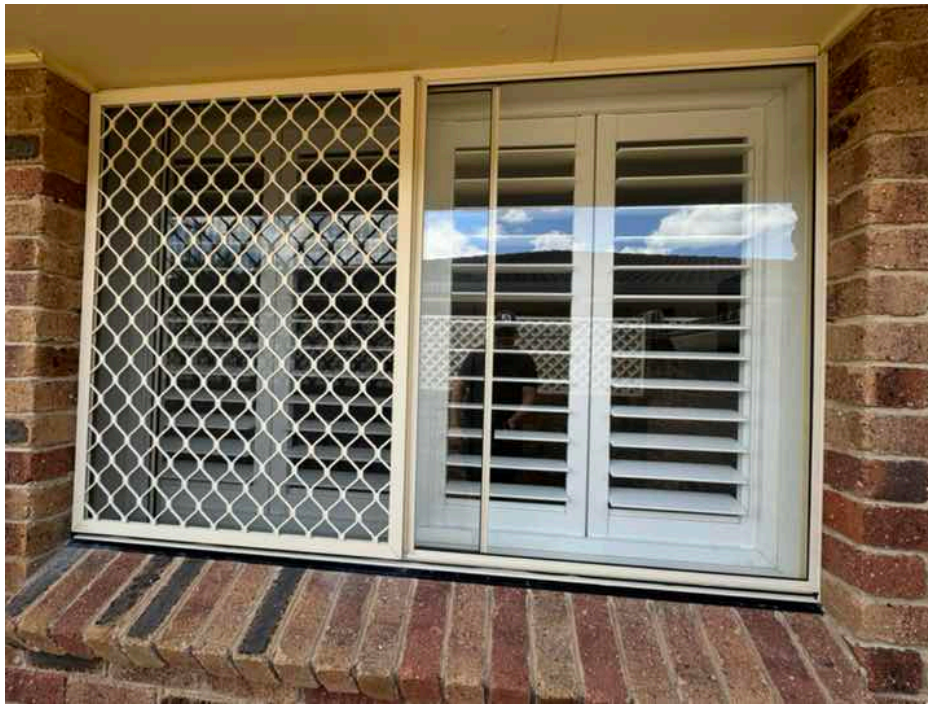
Windows

On visual inspection, the general condition of the windows is serviceable for the age.

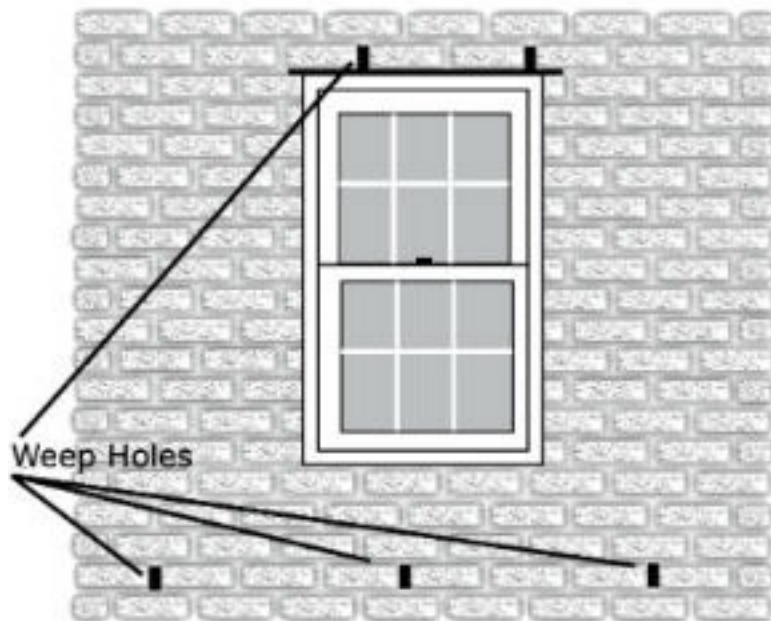
Weep Holes and Ventilation

The weep holes are unobstructed .

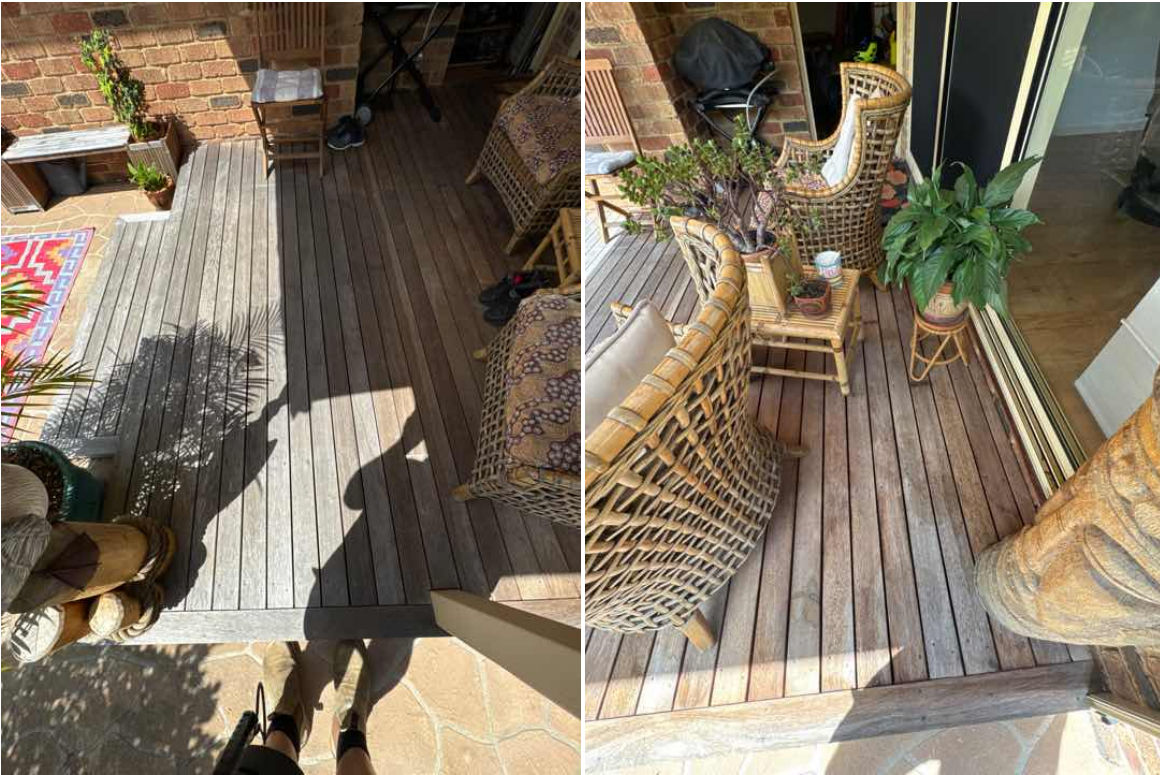
Of areas visible, the decking appears to be in a serviceable condition.

Of areas visible, minor defects and/or maintenance issues were visible. These will require assessment and subsequent repairs by a licensed tradesperson. Please read below for details. Please note that the inspector believes these to be of a minor nature relative to the age of the dwelling and or lack of proper and continual maintenance. Others, including other inspectors may differ in their opinions.

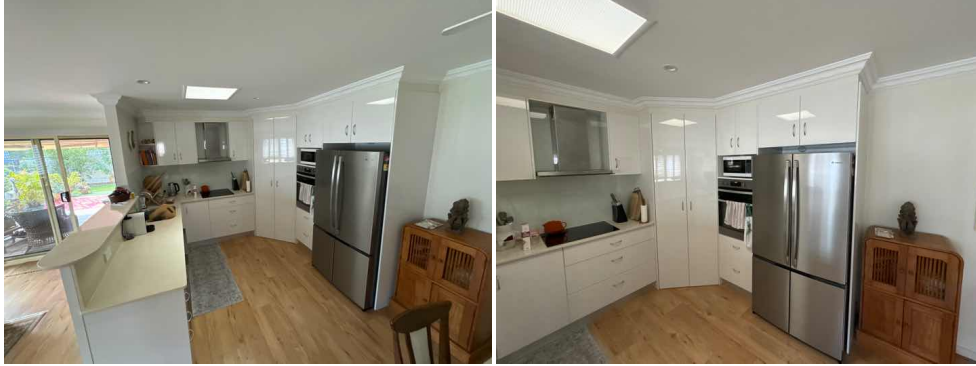
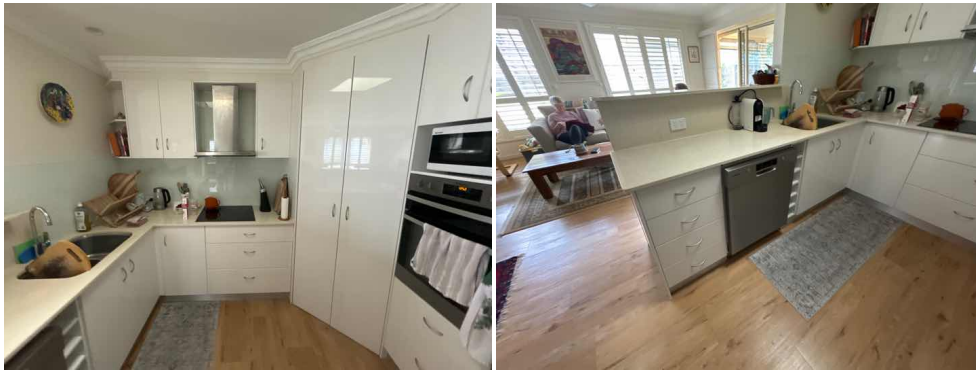
Of the visible areas, the general condition of the kitchen and pantry is serviceable or in reasonable condition for age of dwelling.

Adjustment to cabinet doors required, in some instance hinges may need to be replaced.

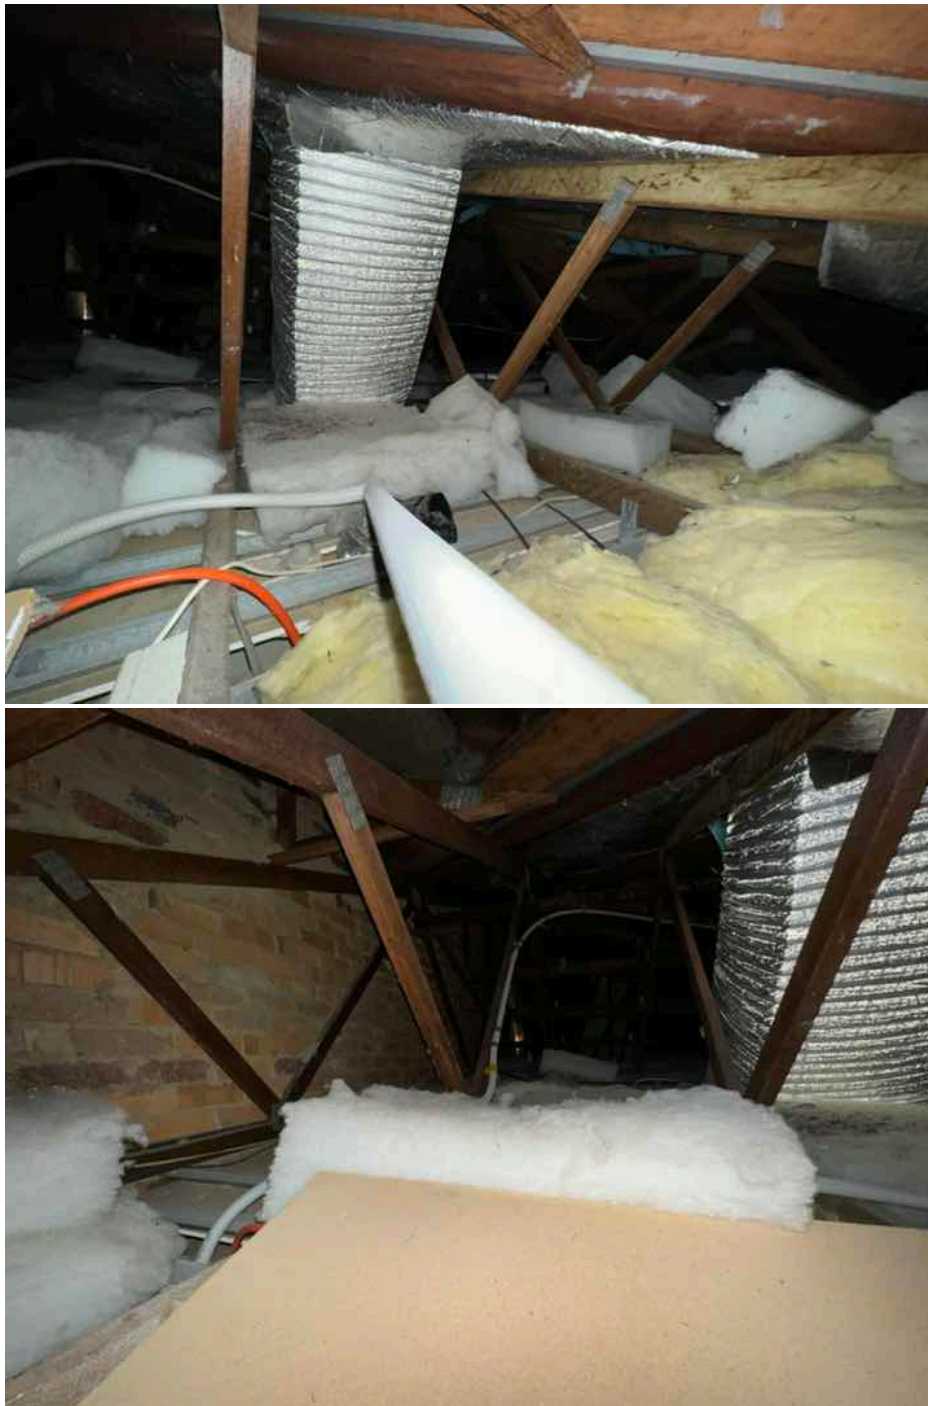
Visible sections of the roof void is in a serviceable condition for age of this dwelling.
