# Building and Pest Report

## 5 Fern Street Lennox Head

### Pest And Building Inspection

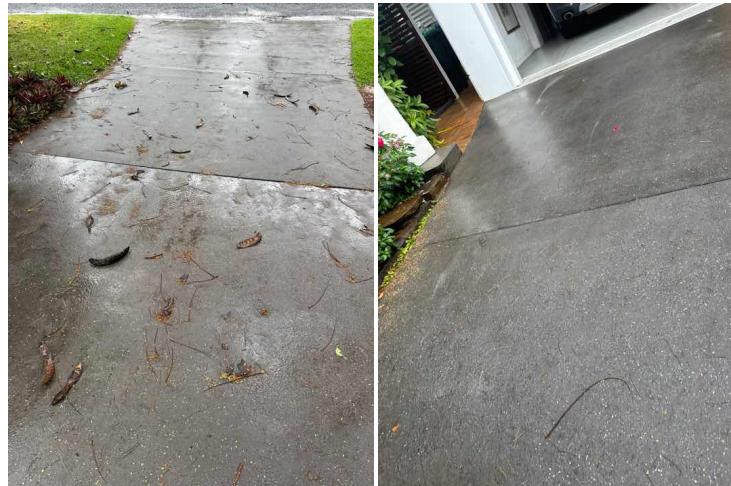
On visual inspection, the general condition of the driveway is serviceable.

Common cracks were observed on the driveway. Whilst these cracks appeared to be typical at the time of inspection, we strongly recommend you monitor these cracks and if worsening occurs contact a concreter for further advice.

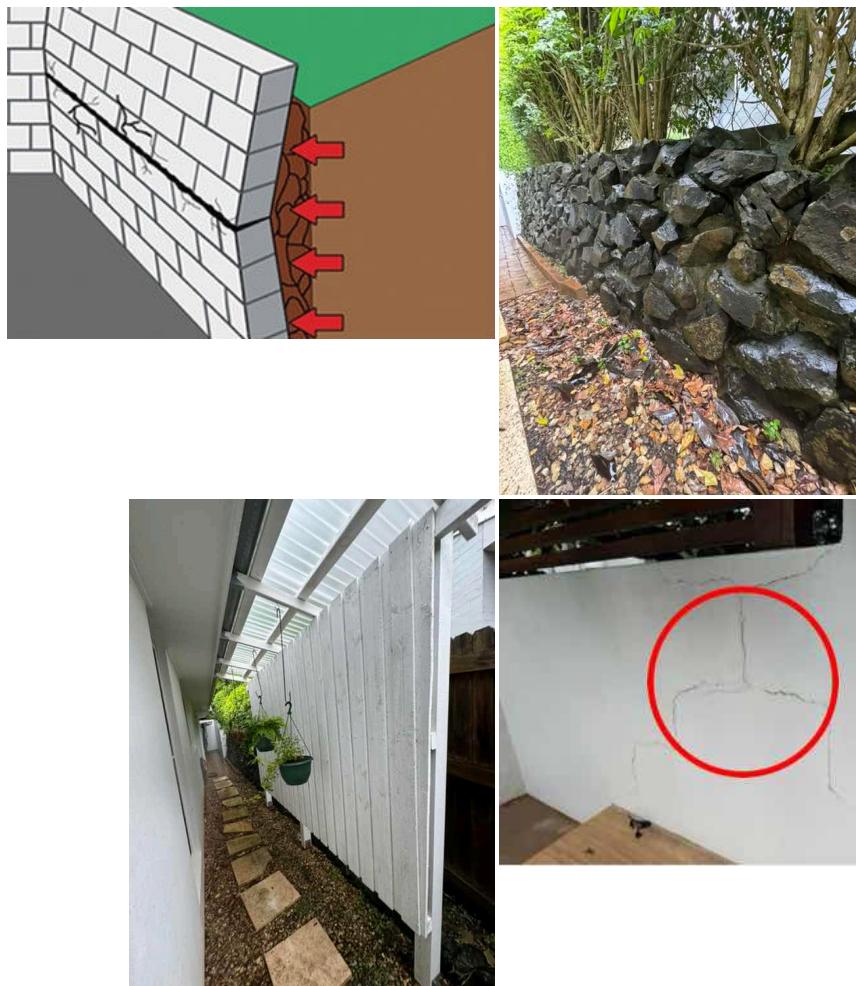
Of the visible areas, the general condition is serviceable or in reasonable condition for age of dwelling.

Retaining wall cracking. Normally this occurs if adequate drainage has not been provided (Ag Line) or a poor footing system or a combination of reasons. A qualified brick layer should be engaged for advice and recommendations.

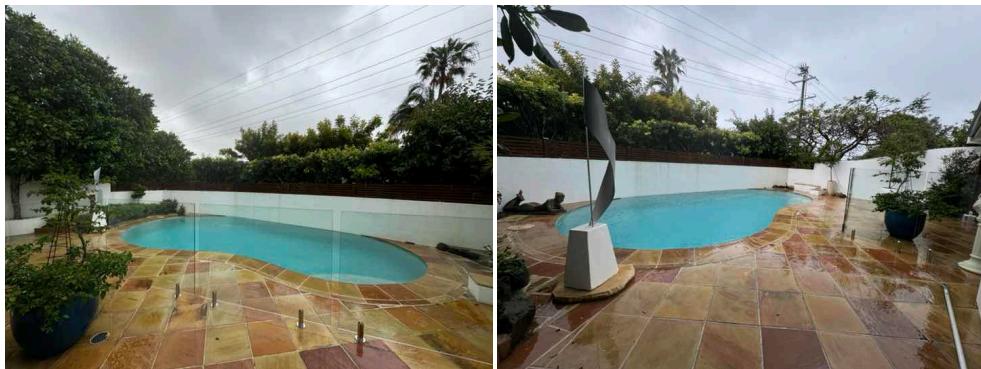
Pool fence and signage were sighted.

The appropriate warning signs do not appear to be present. You should check with your local council regarding the required signs.

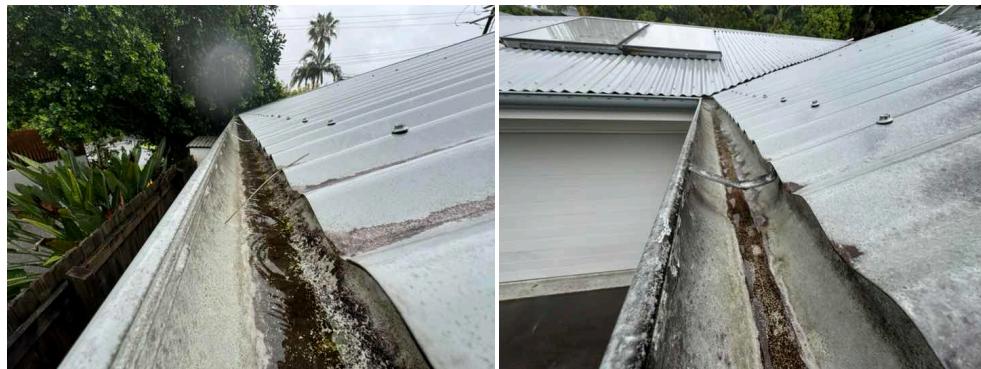
Debris in guttering areas- this requires cleaning out to prevent blocking of downpipes and leaking into eaves and fascia. Have gutters cleaned and assessed by a plumber for adequate fall. Regularly clean to prevent ponding. Ponding water will contribute to rust.

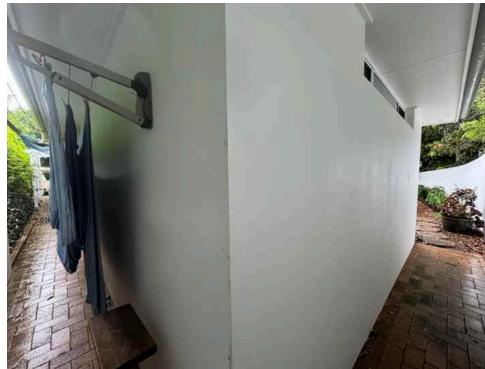
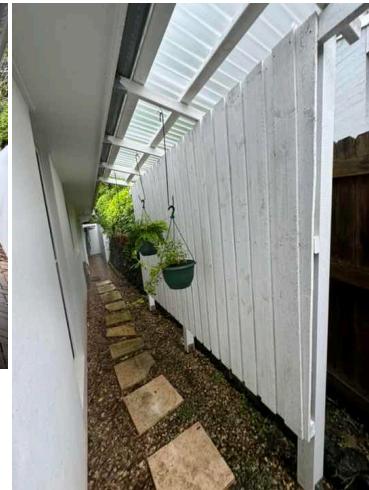
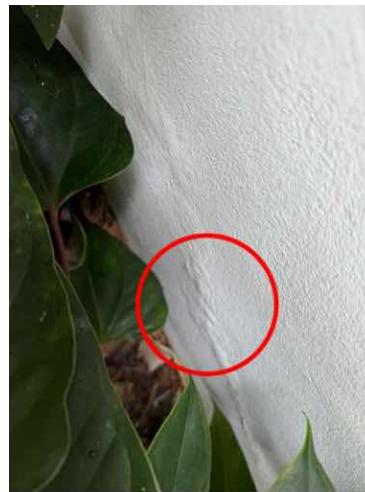
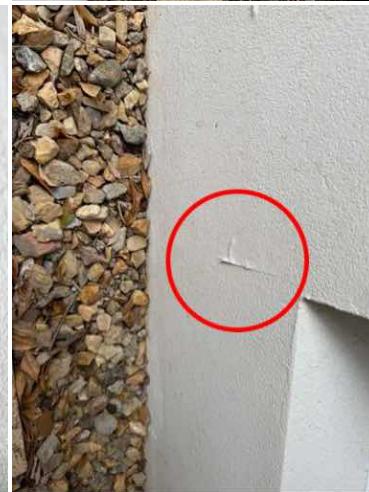
On visual inspection, the general condition of the exterior walls is serviceable for the age.

There appears to have been some settlement in the building which has caused some cracking to the walls. These cracks are categorized as 0 to 2. This can also cause some doors to bind or be out of square. In the inspectors opinion these cracks are due to settlement, usually due to ground movement and subsequent movement to building materials can be expected. Any cracks should be monitored and if cracks increase in size, further investigation should be carried out by a structural engineer.

Rising damp detected. A qualified damp proof specialist should be engaged for advice and recommendations. Accurate diagnosis of the cause and extent of the damp problem is very important. It is strongly advised that you have this issue assessed prior to purchasing the dwelling as can be quite costly if a damp proof course has to be reinstated.

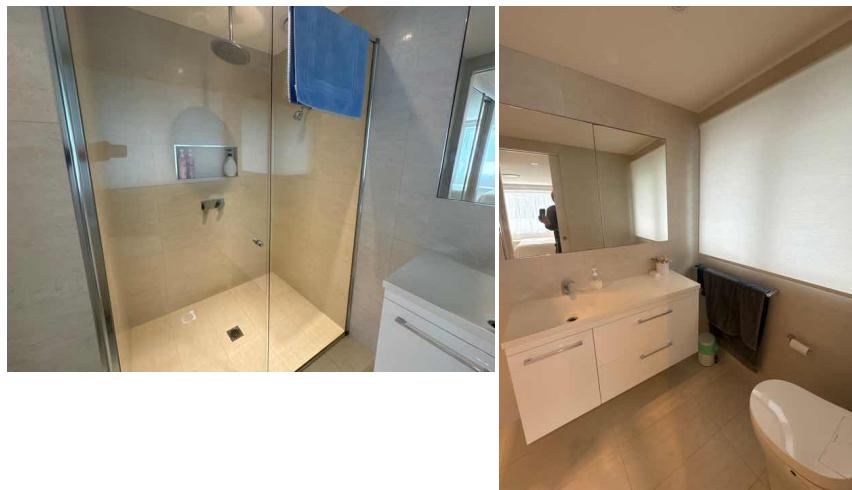
Settlement Cracks Noted. These are typical and generally patch and paint will suffice, however monitoring these cracks advised for 12 months and if become wider or longer, you will need to contact a structural engineers to assess.

The vanity mirror is desilvering at edges. Replacement recommended.
