# Pre Purchase Building & Pest Inspection 970 Coolamon Scenic Dr

Property Address: 970 Coolamon Scenic Drive Coorabell 2479

Inspection Date: 5 Mar 2026

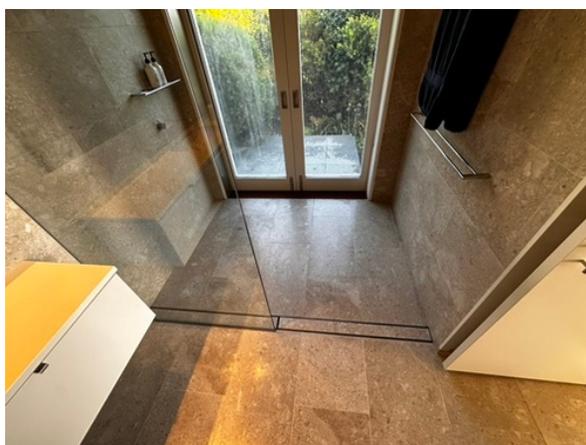
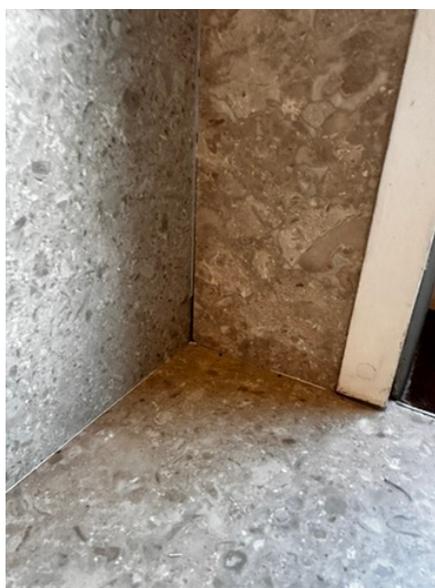
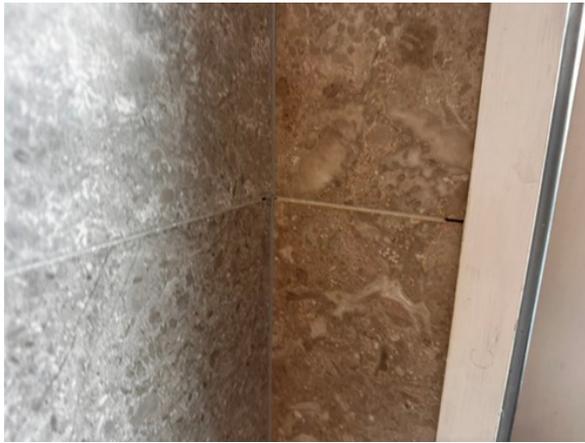
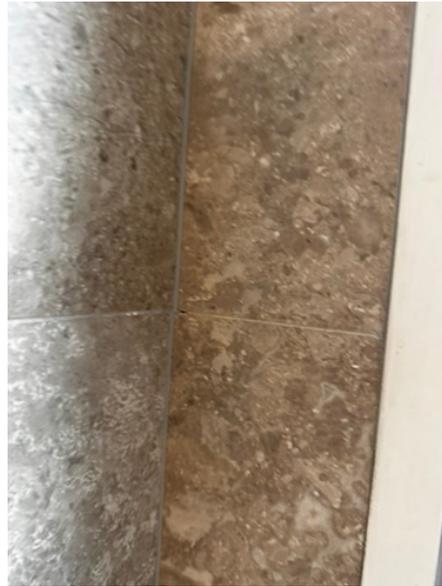
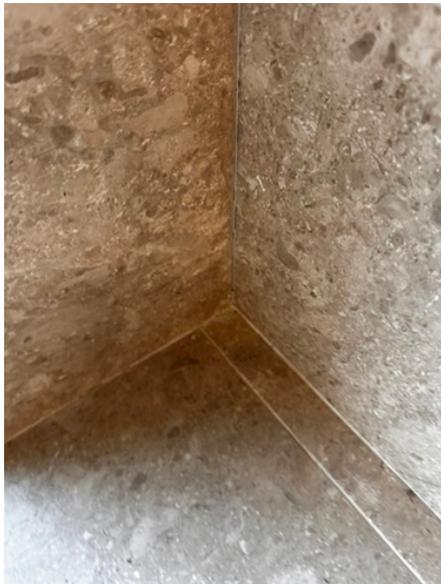
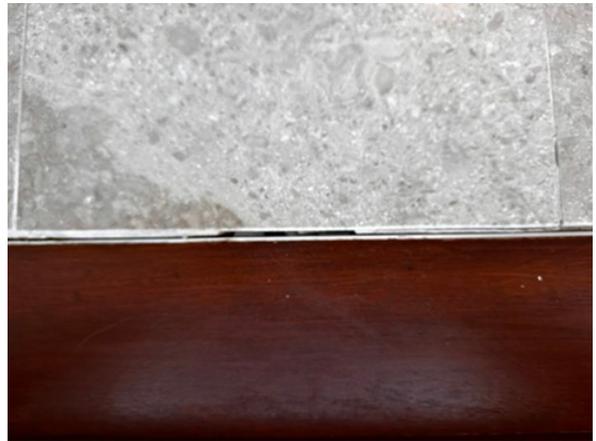
### Minor Defect 1.01

**Location:** Bathroom One

**Finding:** In Bathroom One, I've noticed that some grout and silicone are missing around the tiles. While no moisture issues are apparent right now, it's vital to address this to prevent any potential future problems. I'd recommend reapplying grout and silicone where needed to ensure everything stays nice and watertight. It's a straightforward fix that'll keep the bathroom looking sharp and functioning well.

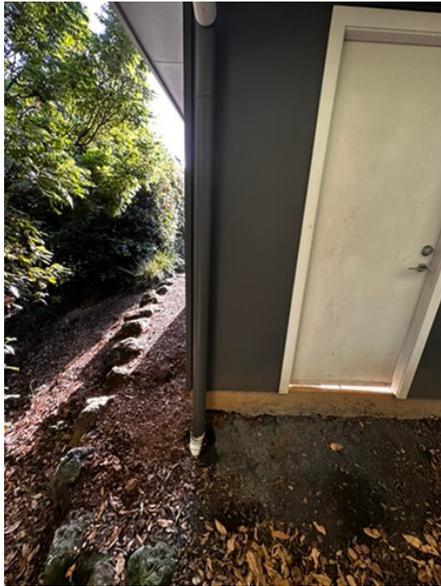
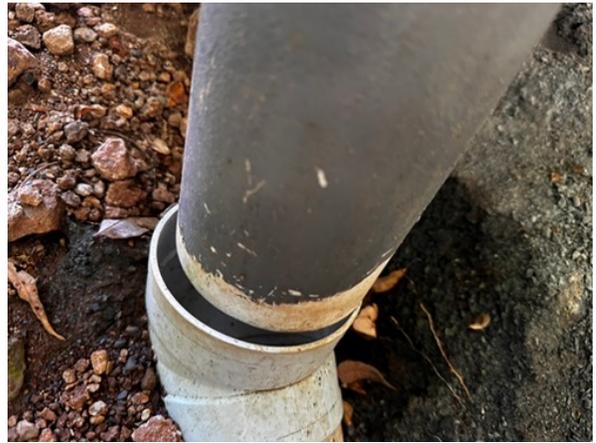
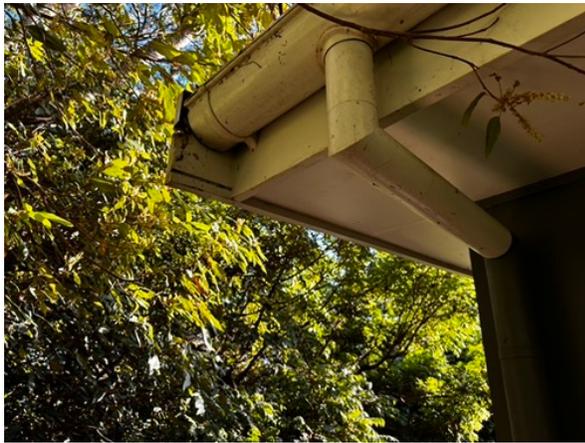
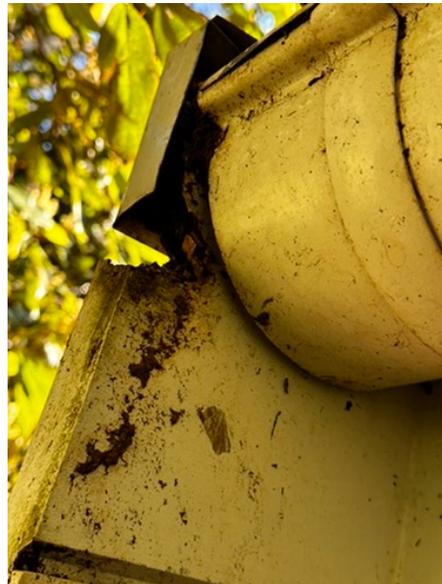
## Minor Defect 1.02

**Location:** Landscaping Hunt

**Finding:** In Landscaping Hunt, we found a downpipe that's not properly connected and a timber fascia starting to show signs of rot. This could lead to water damage if left unaddressed. It would be wise to reconnect the downpipe securely and repair or replace the affected fascia section. Addressing this promptly can prevent further deterioration and maintain the property's structural integrity.

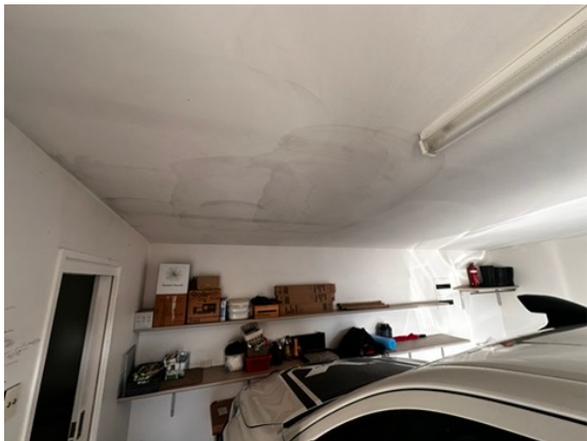
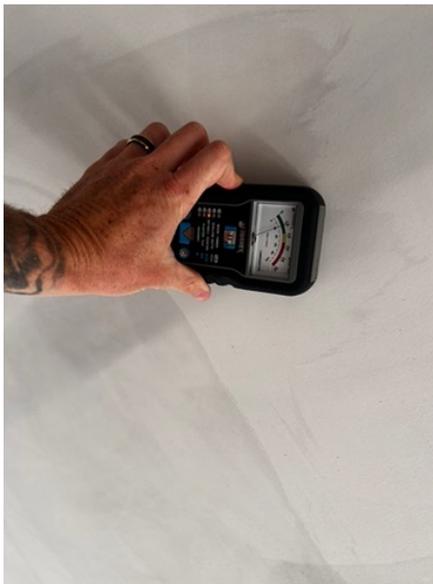
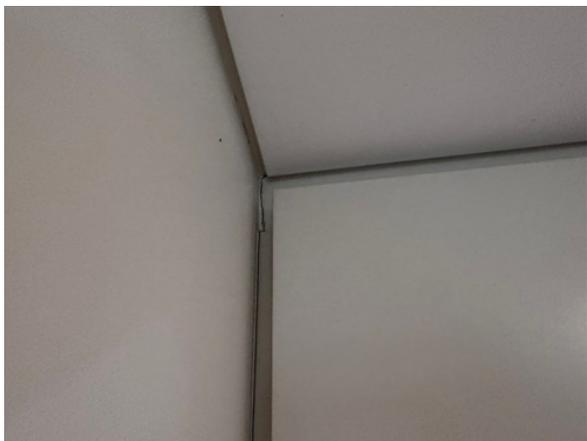
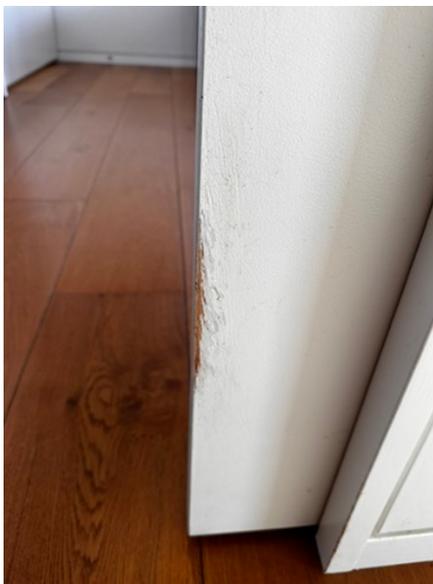
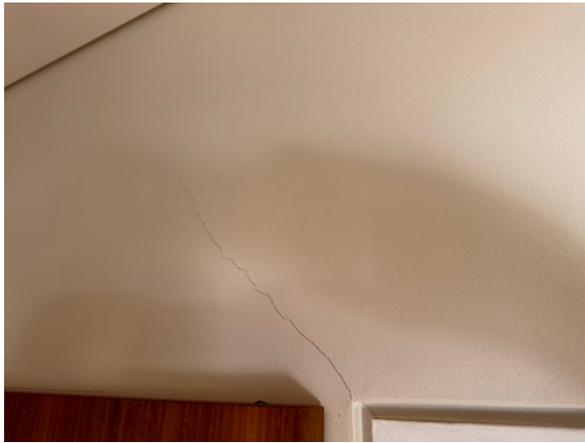
**Location:** Various Internal Areas, Including Garage

**Finding:** In a few spots around the house, including the garage, there's some minor cracking and a few stains on one of the walls. While there's no moisture or structural issues involved, these areas could use a bit of TLC. It's mostly a case of routine maintenance to keep everything looking and functioning at its best. A good clean and some patchwork or repainting should do the trick to get everything back in top shape. Keeping an eye on these areas and addressing any changes promptly will ensure the overall integrity and aesthetics of the home are maintained.

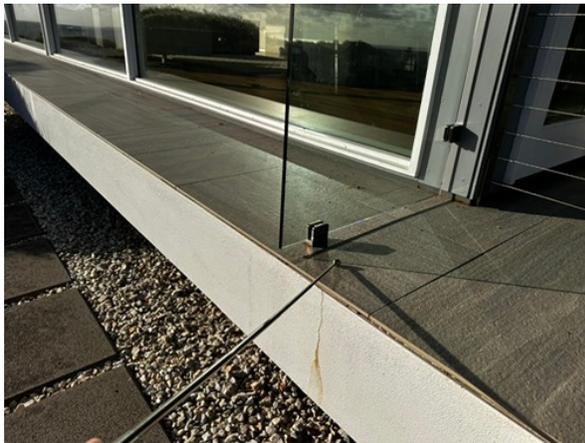
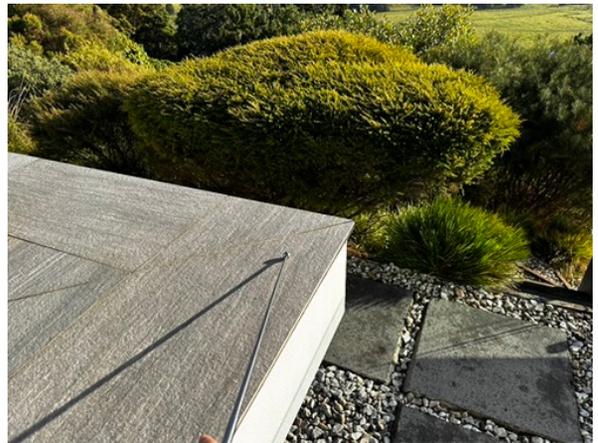
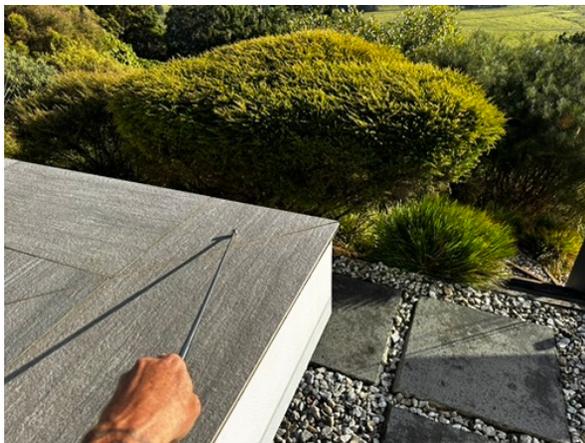
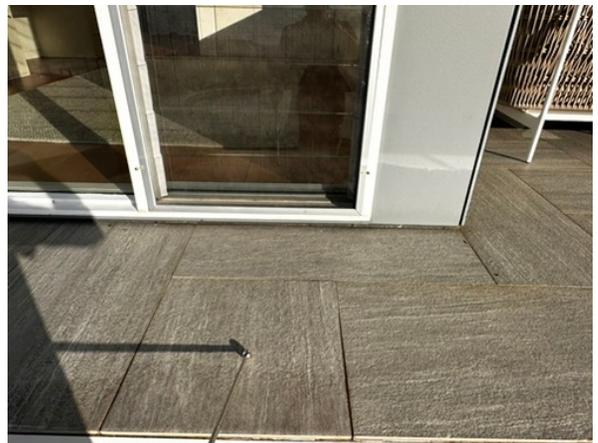
## For your information 2.02

**Location:** External Tiles

**Finding:** The external tiles show areas where they sound hollow, or "drummy," likely due to moisture seeping underneath. This is common with exterior tiles and doesn't necessarily need immediate fixing, as it can recur. To prevent further issues, consider applying a waterproof membrane beneath the tiles and re-securing them with a flexible adhesive to accommodate any movement or moisture changes. Regular maintenance checks are advisable to monitor and manage any potential water ingress.
