# Pest & Building Report

**54 Tuckeroo Avenue,  
Mullumbimby**

# Pre Purchase Building & Pest Inspection 54 Tuckeroo Av

Property Address: 54 Tuckeroo Avenue Mullumbimby 2482

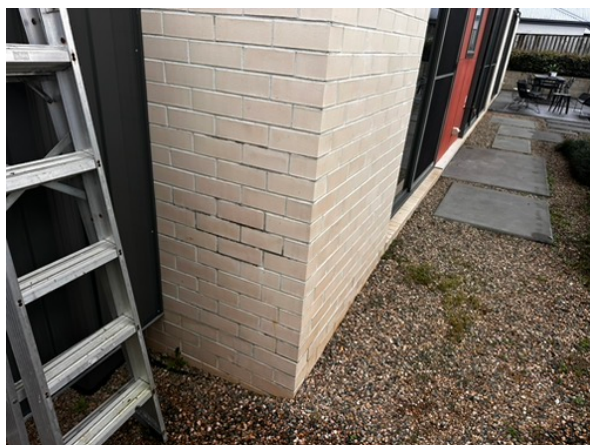
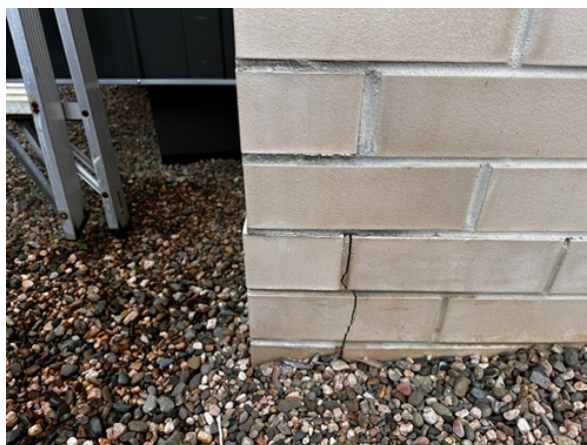
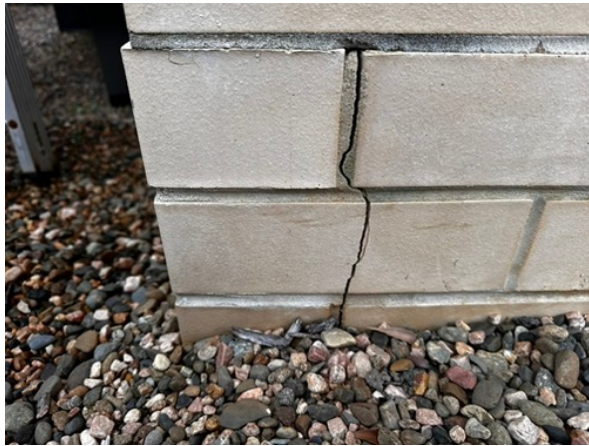
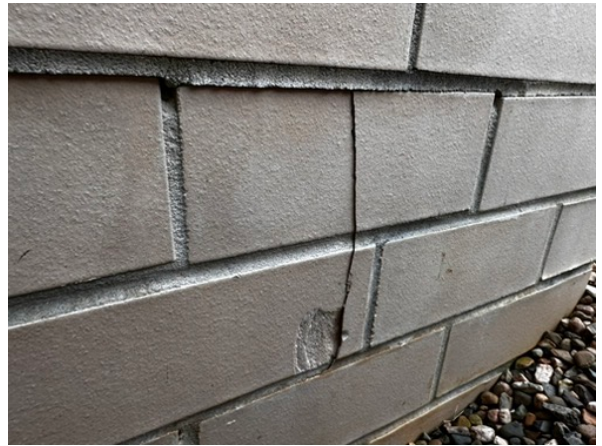
**Location:** Back Right Of Dwelling

**Finding:** At the back right of the dwelling, there's 2 minor cracks in the brickwork likely due to some load pressure. It's not immediately worrying, but it's wise to keep an eye on it over time. To prevent any future issues, consider having a bricklayer replace the cracked bricks. This simple fix should keep things in check and maintain the integrity of the structure.

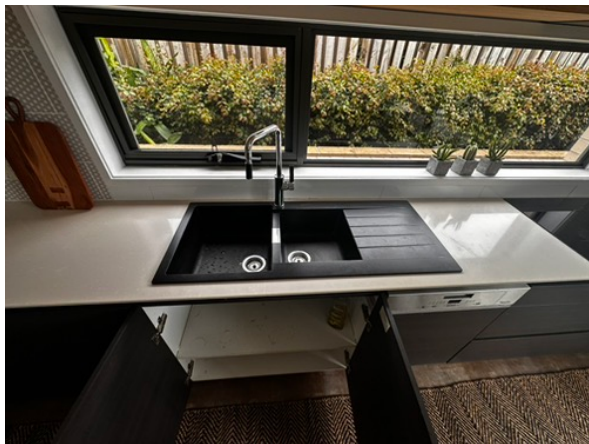
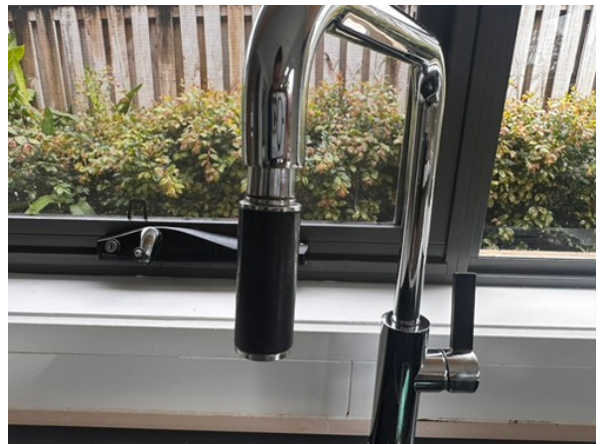
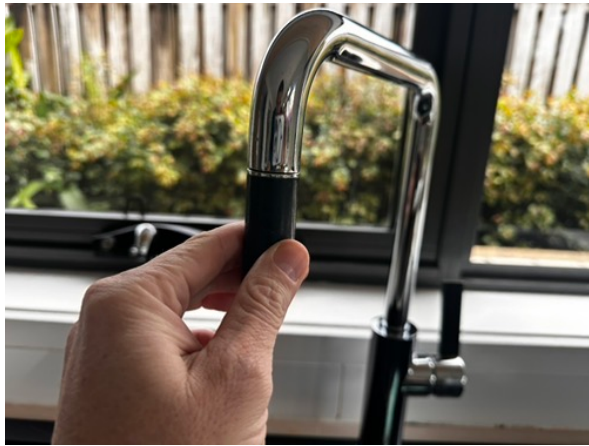
**Location:** Kitchen Sink Tap

**Finding:** The kitchen sink tap has an issue where the tap head doesn't retract properly into the fitting. This might be due to wear and tear or a minor defect in the mechanism. To address this, I recommend replacing the tap head or the retracting mechanism to ensure smooth operation. Regular maintenance checks can also help prevent similar issues in the future.

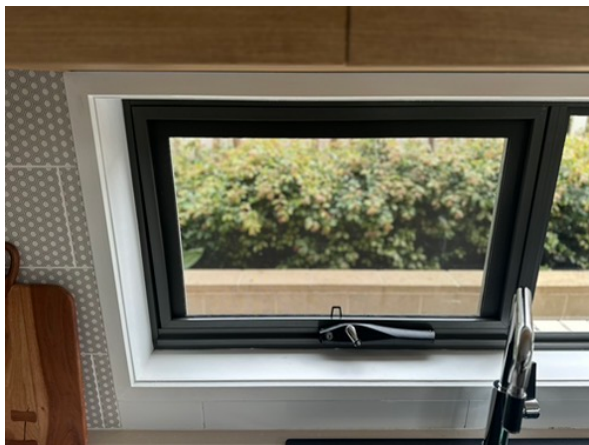
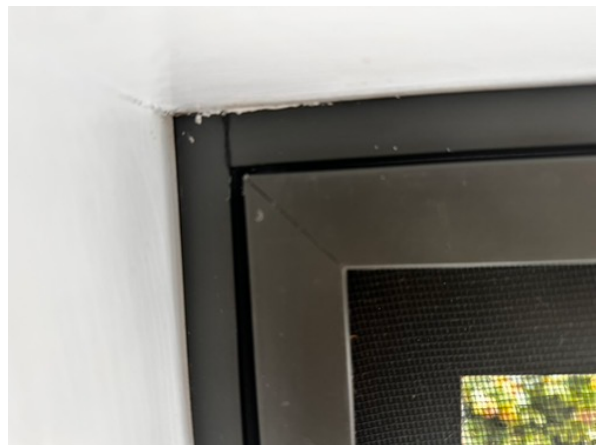
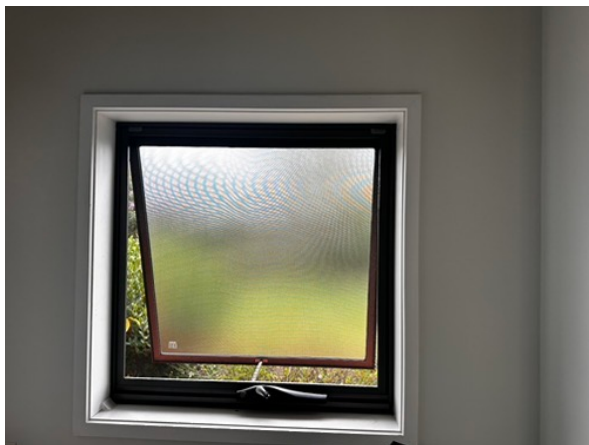
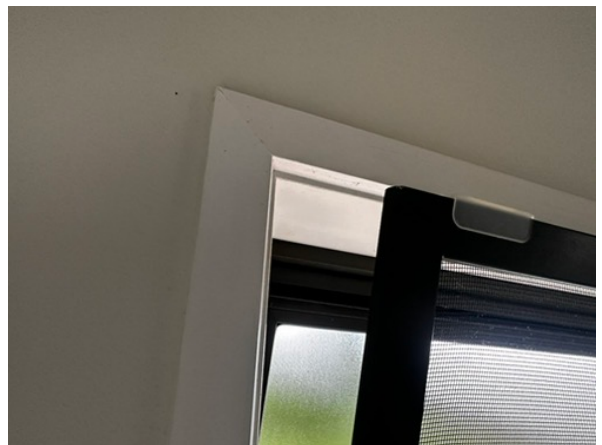
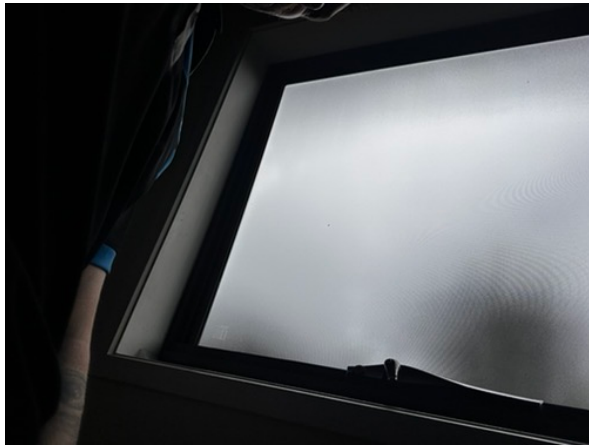
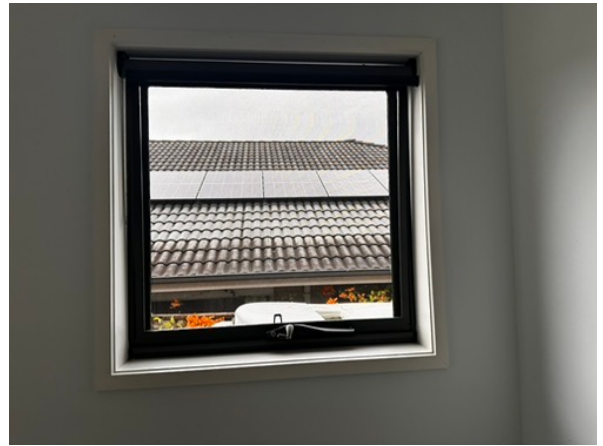
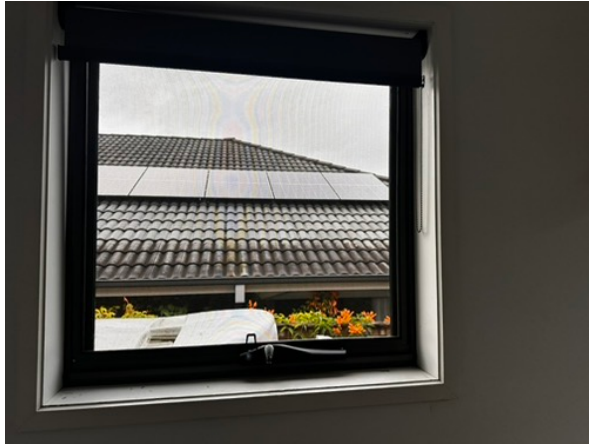
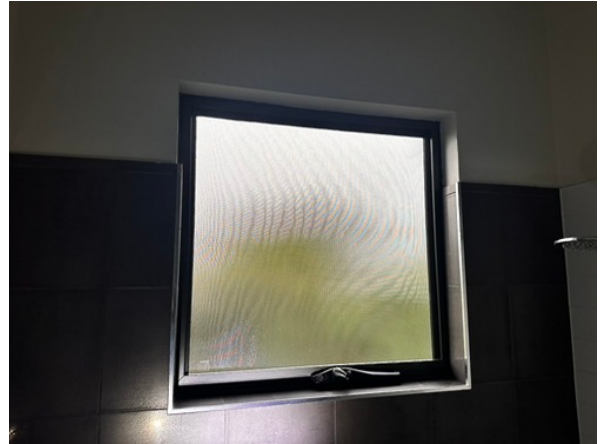
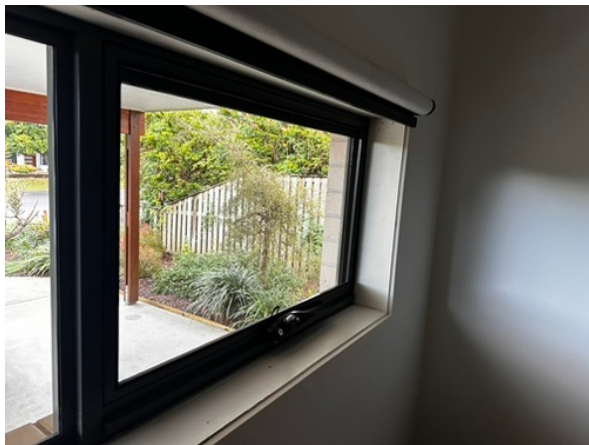
**Location:** Various Window Screens

**Finding:** The window screens in several areas are quite loose and pose a risk of falling out. It looks like they need a bit of love! A good solution would be to secure them with silicone or pop rivets to ensure they stay in place safely. Addressing this promptly will help prevent potential damage and enhance the security and functionality of the screens.

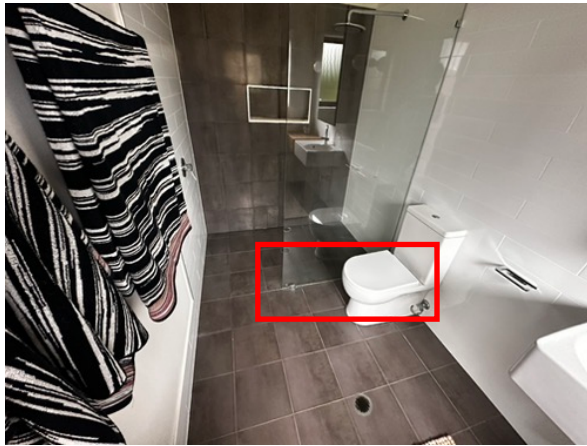
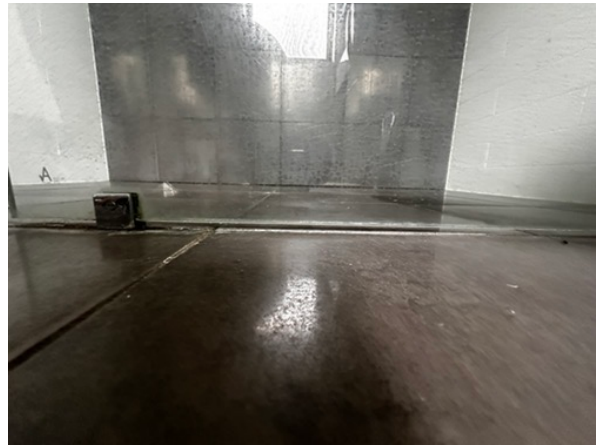
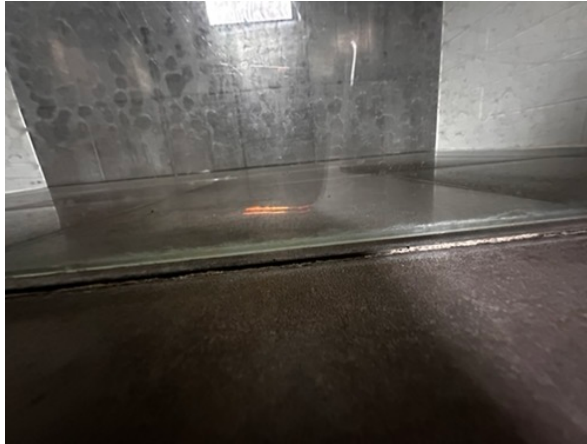
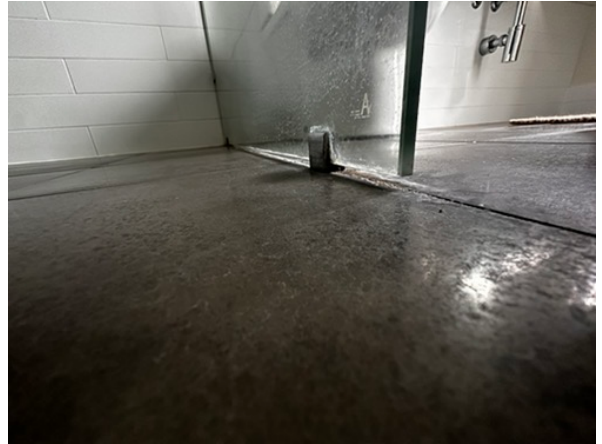
**Location:** Ensuite

**Finding:** The ensuite shower screen is missing silicon at the base, which can lead to water escaping onto the bathroom floor. This could potentially cause water damage over time. To prevent this, it's suggested to apply a good quality waterproof silicon sealant along the bottom edge of the shower screen. This will help keep the water contained where it belongs and protect your bathroom floor from unnecessary moisture.

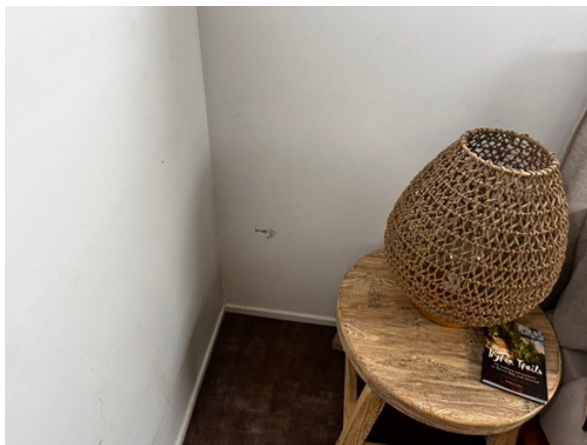
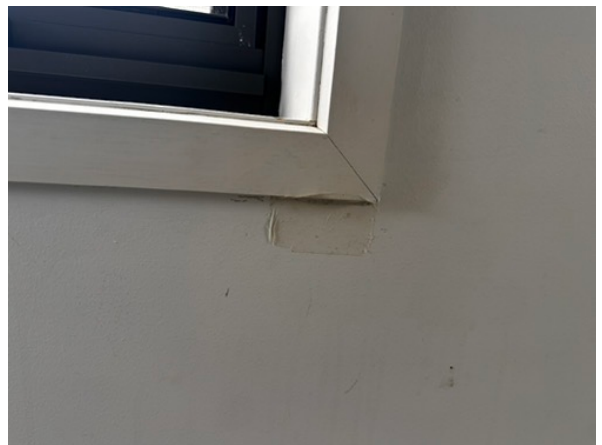
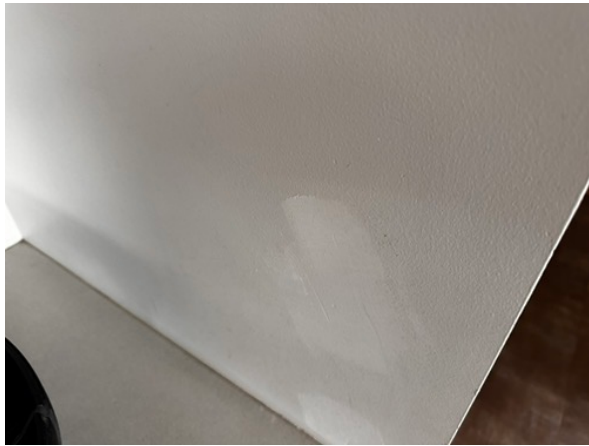
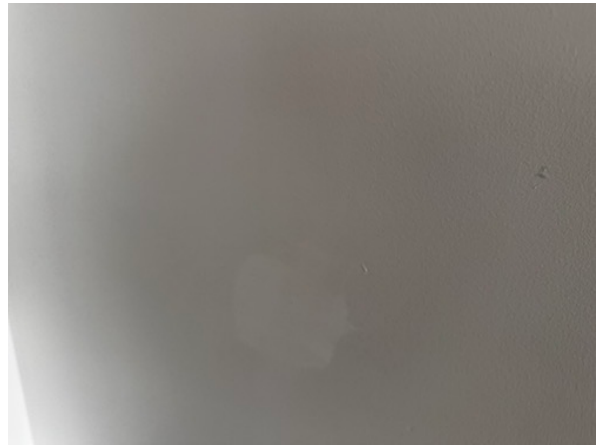
The interior walls in various areas show signs of patch and paint work that could use a bit of TLC. The patches are visible and the paint finish is uneven, which affects the overall look of the space. To improve the aesthetics, it's recommended to sand these areas smoothly and reapply matching paint for a seamless blend. A little attention to detail will certainly make a big difference in freshening up the interior.

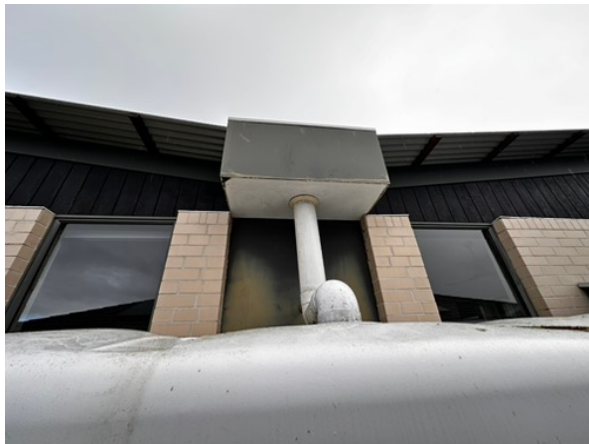
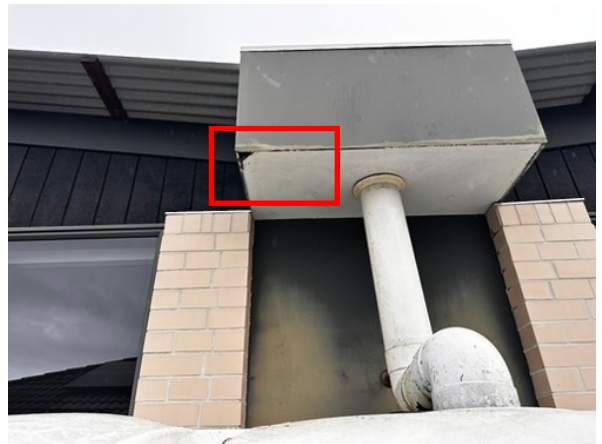
**Location:** Right Hand Side Of Dwelling

**Finding:** The box gutter exterior covering on the right-hand side of the dwelling is clearly showing signs of rot and age-related wear. It's definitely time for a replacement to prevent any potential water damage or leaks. I'd recommend having a professional contractor assess and replace the damaged section with more durable materials to ensure longevity and prevent future issues. Keeping an eye on it will be a good idea to avoid any surprises later on.

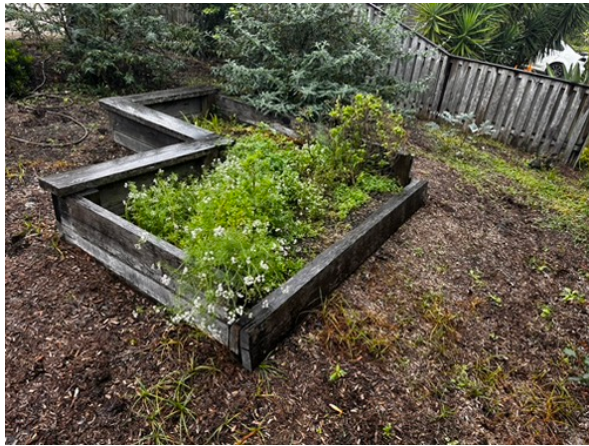
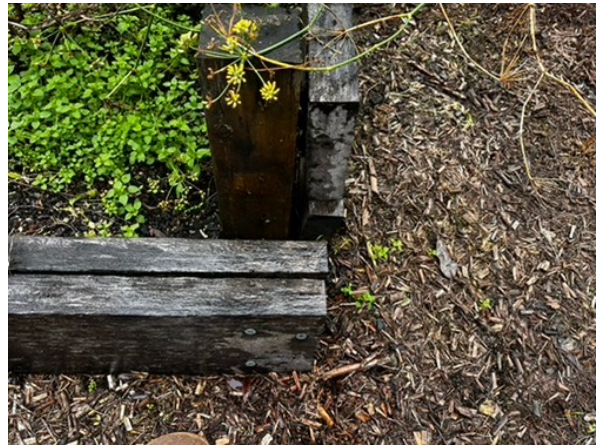
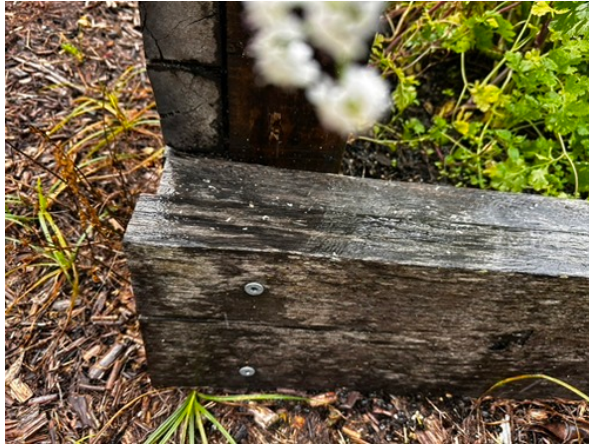
**Location:** Front Yard

**Finding:** Upon inspection, the planter box in the front yard appears to have come loose from its original position. The misaligned timber sections suggest a few screws might need re-tightening to secure it properly. This simple fix will not only restore the box's functionality but also enhance its visual appeal. I recommend re-screwing the boards to the main frame to ensure the structure remains stable and avoids further movement. Regular checks in the future will help maintain its condition.

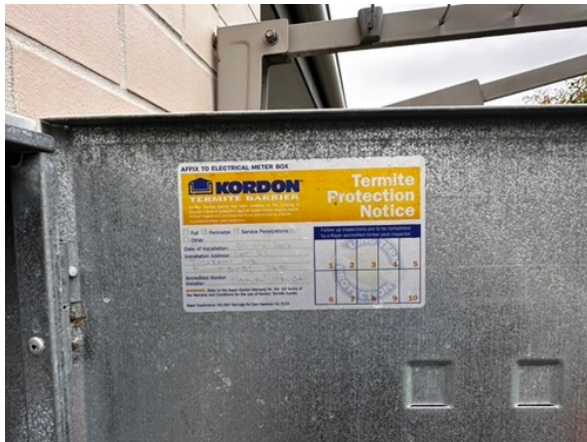
**Location:** All areas

**Finding:** This property had a termite protection system installed during its construction in 2014 at all the necessary points. Fortunately, there are no signs of termites at the moment. However, to keep things that way, it's crucial to schedule a termite check-up roughly every six months. Regular inspections will ensure any potential issues are caught early. If any concerns do arise, I suggest consulting a professional to assess and address them promptly. This approach will give you peace of mind and keep your home safe from any termite mischief!
