PEST AND BUILDING PRE-PURCHASE REPORTS

Visual Timber Pest Inspection and Report in Accordance with AS 4349.3-2010

Property Address: 4-6 George Street Bangalow 2479

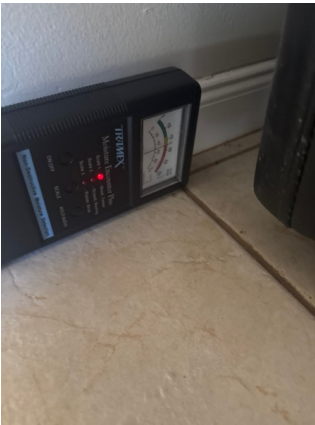
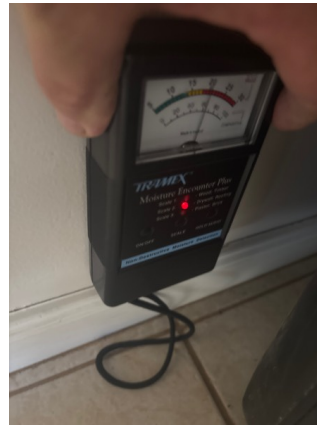
Moisture Present
Moisture present behind main bathroom refer to building inspection

Moisture behind main shower

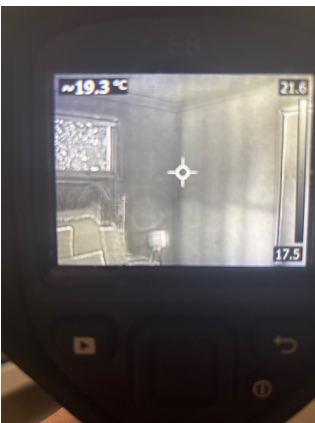
Thermal imaging of internal wall with no abnormalities

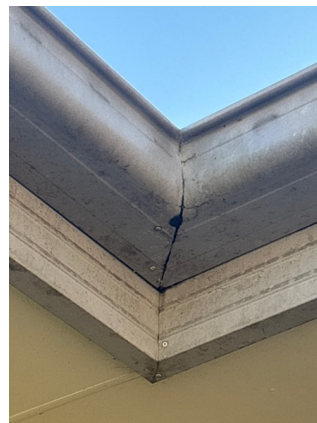
Leaking gutter join

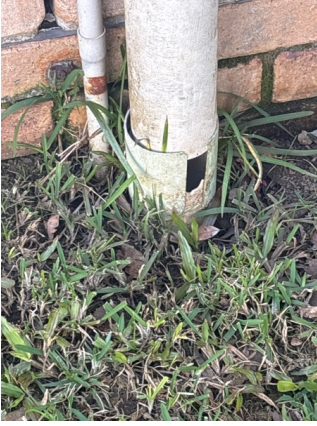
Broken down pipe

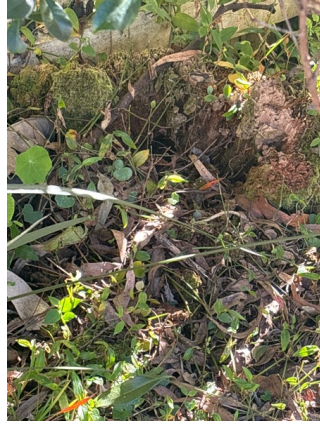
Stump in front garden

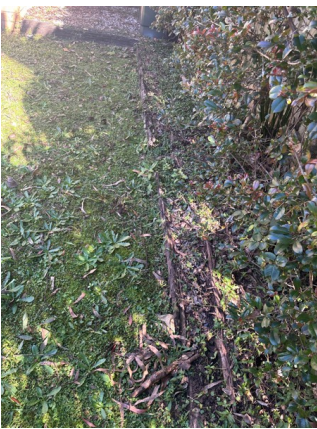
Non termite resistant garden edging

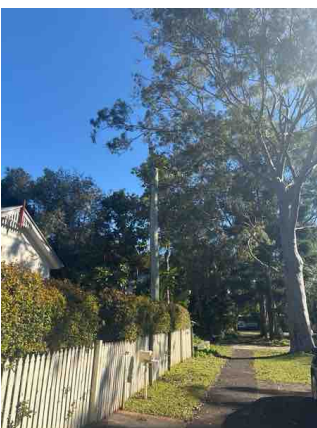
Wooded areas

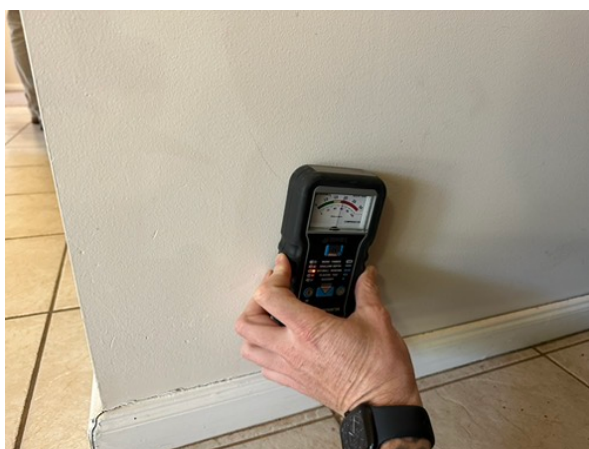
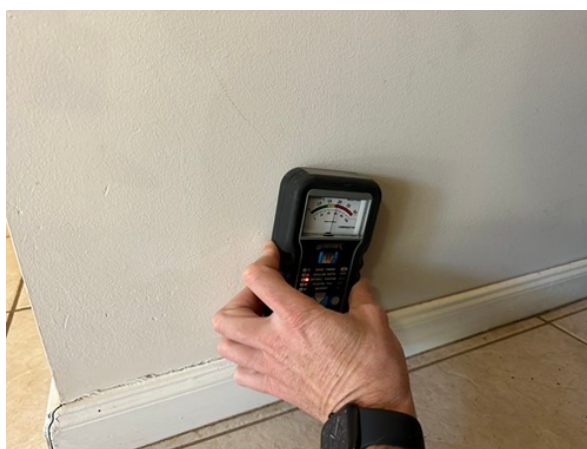
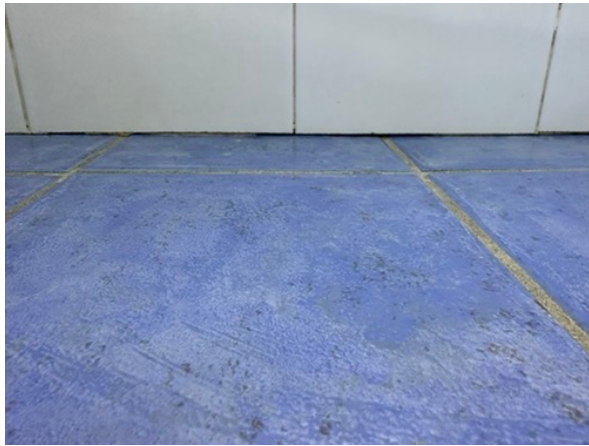
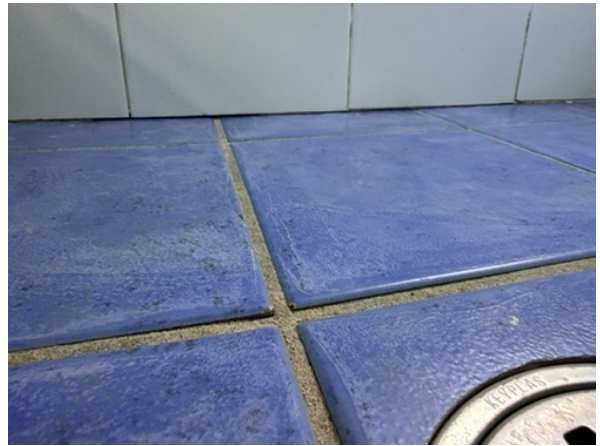
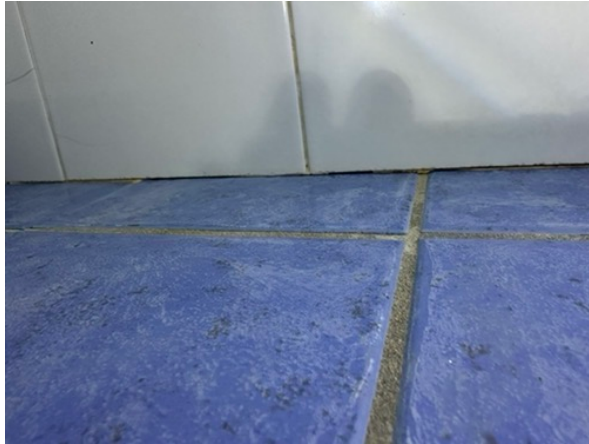
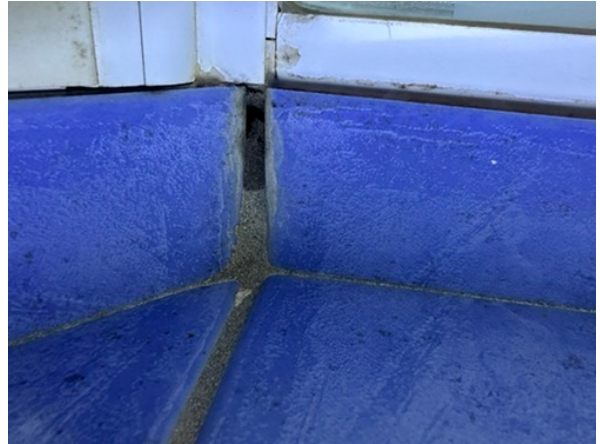
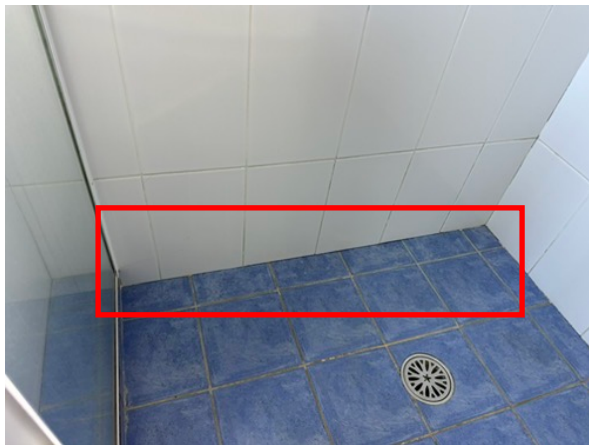
Minor Defect 1.01

Finding: Moisture has been detected in the wall behind the shower, indicating a need for resealing. The issue appears to stem from compromised sealant, allowing water to penetrate the wall. Reapplying sealant around the shower area is recommended to prevent further moisture intrusion and potential damage. This is a straightforward fix that should resolve the problem efficiently.

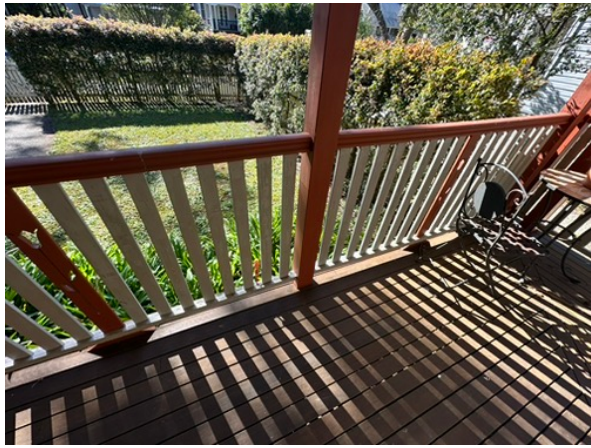
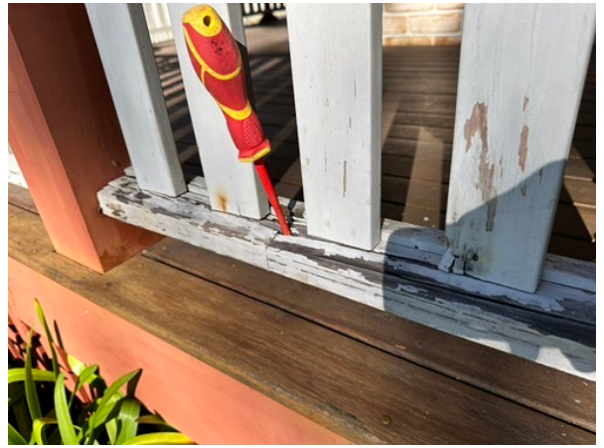
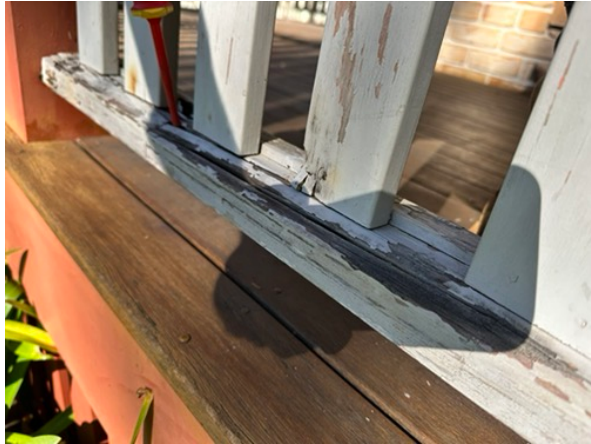
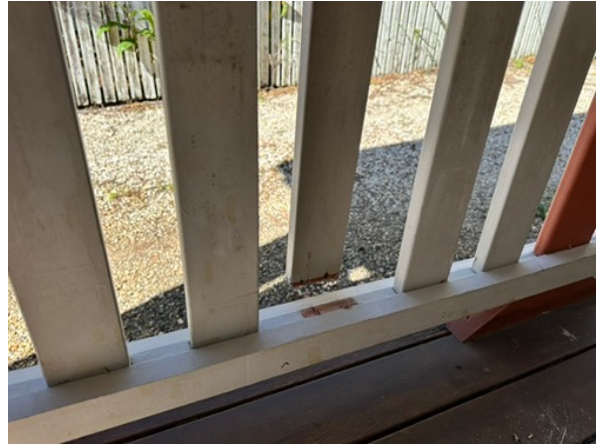
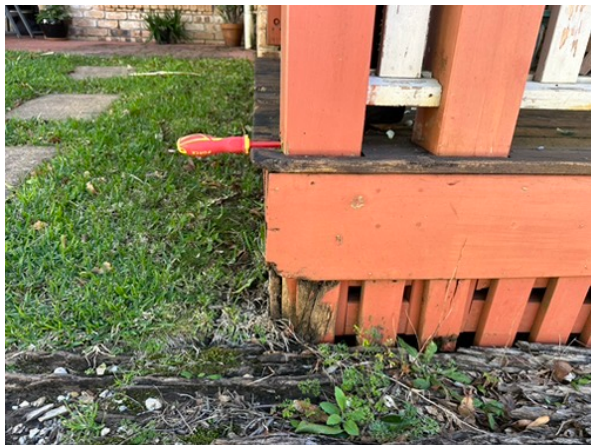
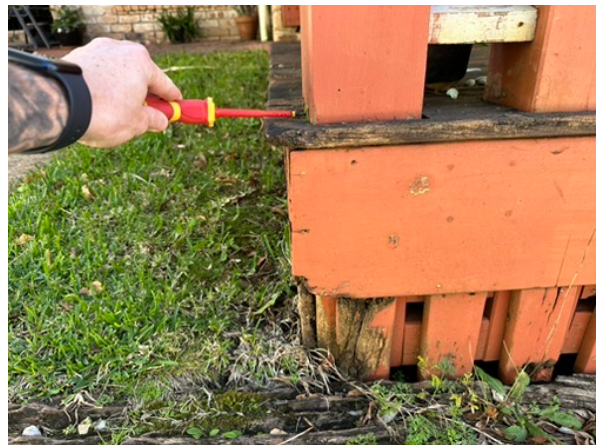
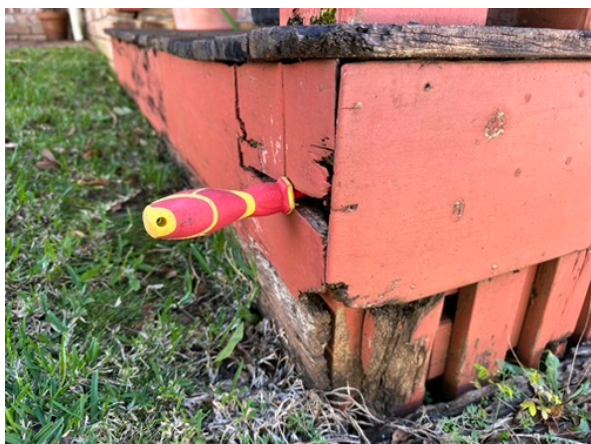
Minor Defect 1.02

Finding: The veranda requires attention, with notable defects observed in the balustrade and one of the support posts. Several areas of the railing show signs of deterioration, including peeling paint and wood decay. Additionally, one of the structural posts exhibits damage near its base, which could affect stability. Immediate repair is recommended to prevent further degradation and ensure safety.

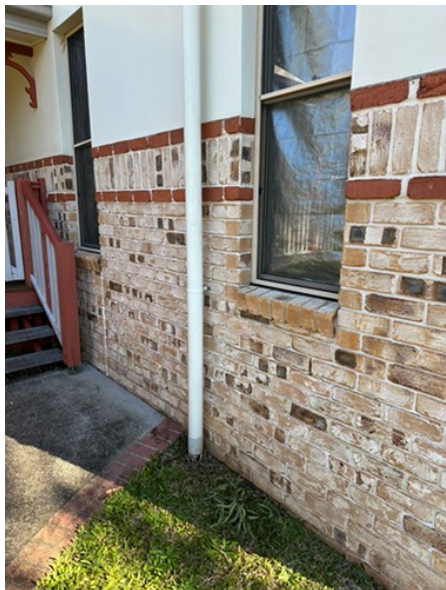
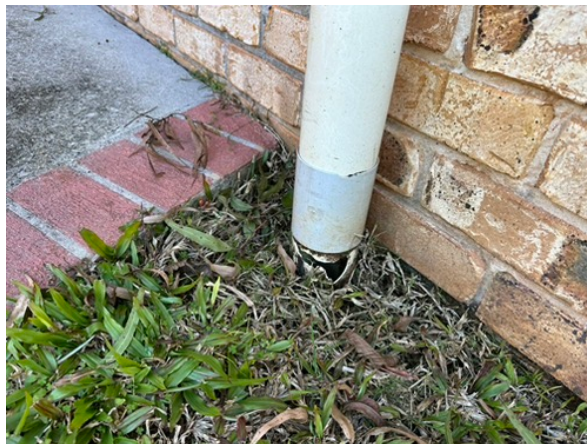
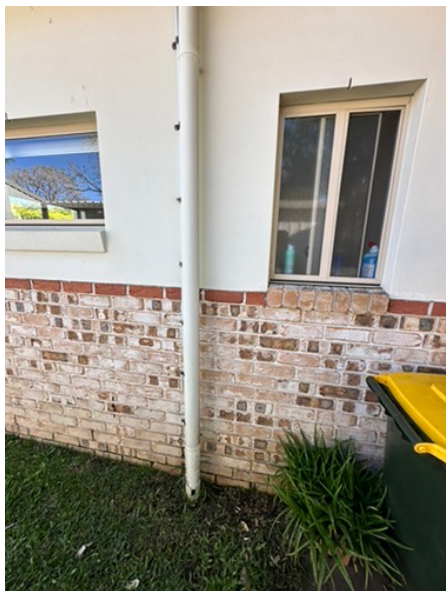
Minor Defect 1.03

Finding: The downpipes located in various external locations of the property show signs of damage and require attention. Visible issues include misalignment and potential blockage at the base, which could lead to inadequate drainage and water accumulation. Prompt repairs or replacement are recommended to avoid further deterioration and to ensure efficient water management around the property.

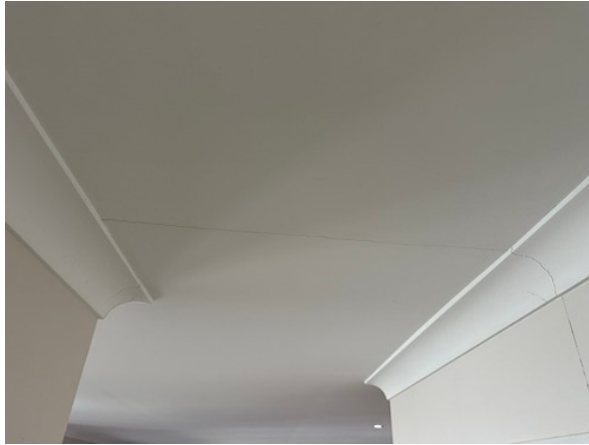
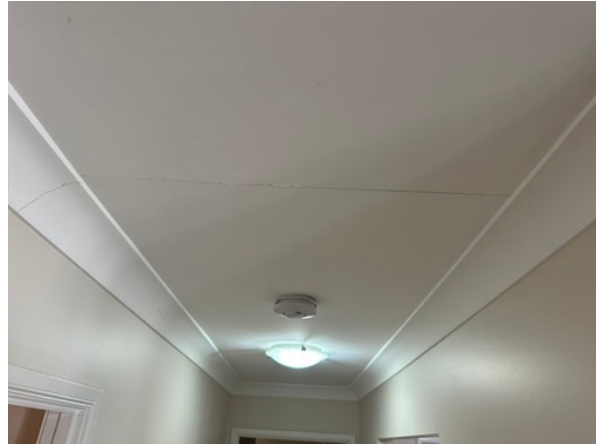
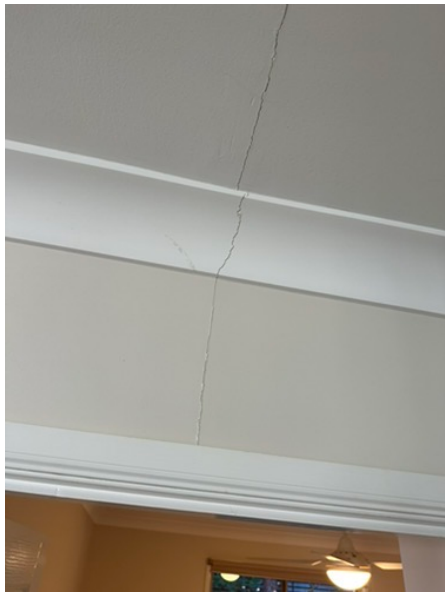
Finding: Cracking is present in the Gyprock and cornice along the hallway, attributed to the lack of expansion joints typical of its original construction method. This issue is common in properties of this age and does not immediately compromise structural integrity. However, monitoring is recommended to ensure no further deterioration.

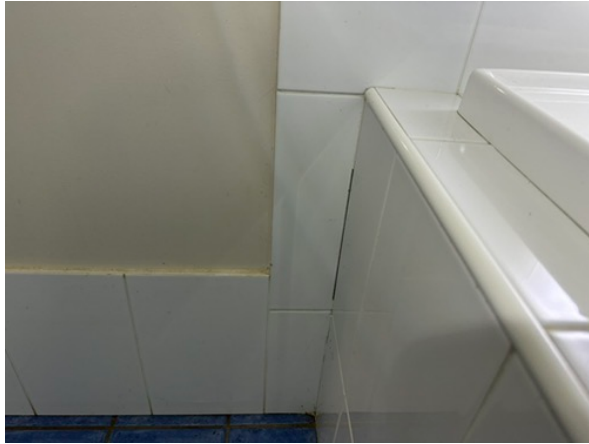
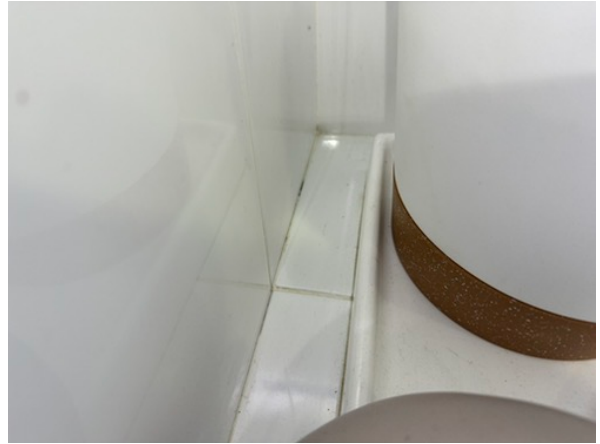
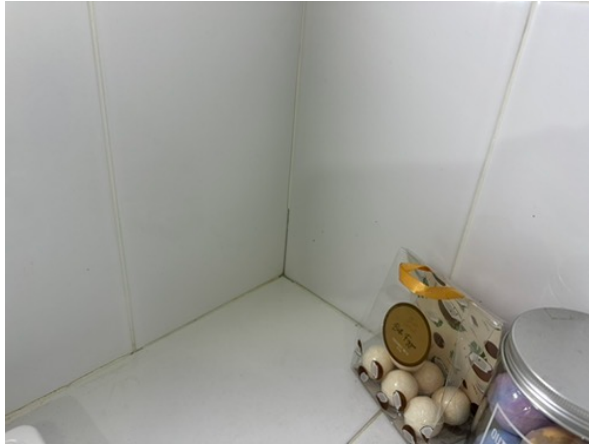
Observation 2.02

Finding: The bathroom exhibits areas where grout and silicone maintenance are required, particularly around the tiles and fixtures. These gaps, though minor, can lead to moisture seeping behind tiles if left unattended, potentially causing more significant damage over time. Proper resealing with grout and silicone is recommended to ensure the integrity of the bathroom surfaces and to prevent water infiltration. This is a straightforward fix and will help maintain the overall condition of the bathroom.

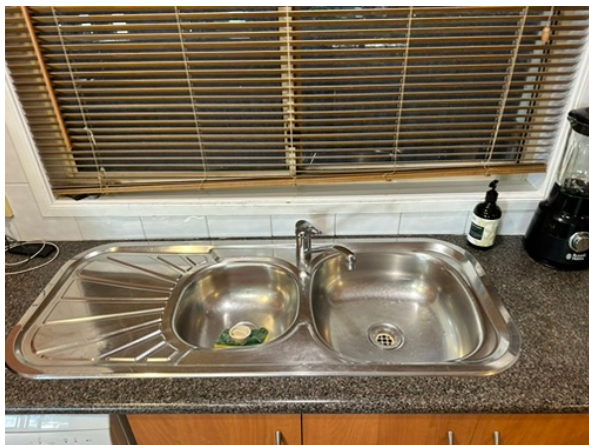
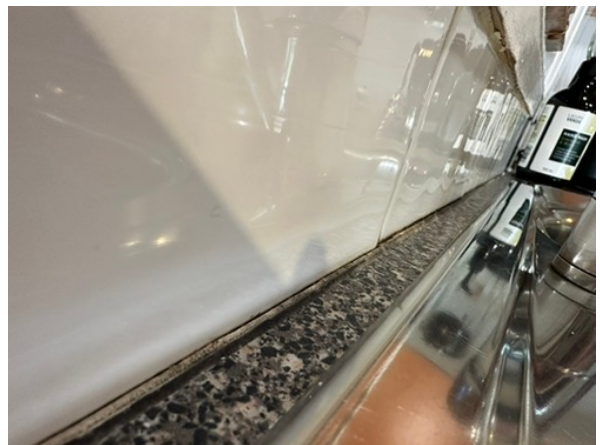
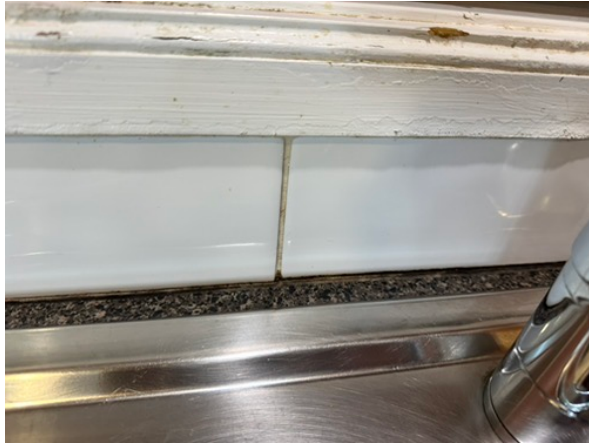
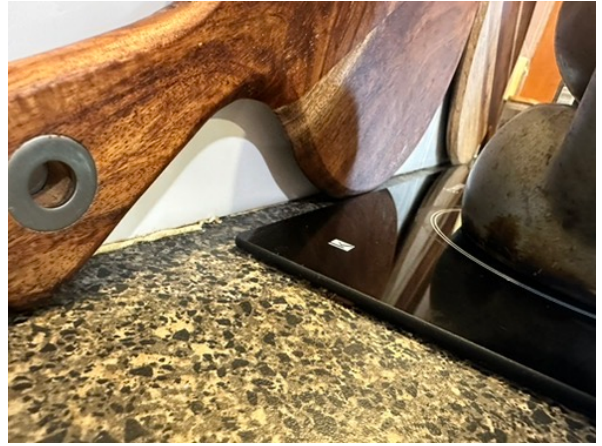
Observation 2.03

Finding: In the kitchen, there is a noticeable absence of grout between some tiles and missing silicone along the countertop edges. These deficiencies can lead to water penetration, potentially damaging underlying structures and surfaces. It is recommended to reapply grout and silicone to prevent moisture ingress and ensure durability. Proper sealing will help maintain the kitchen's integrity and reduce the risk of future issues.

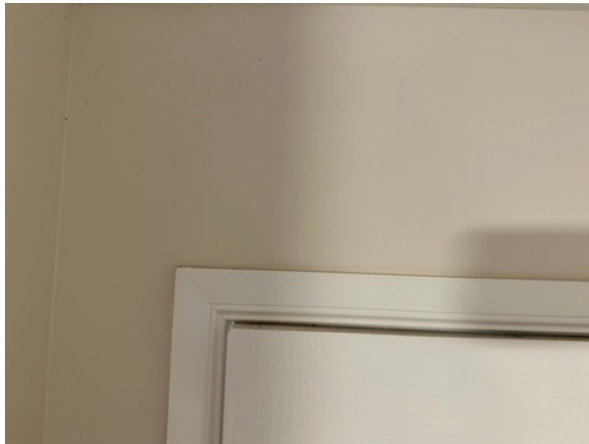
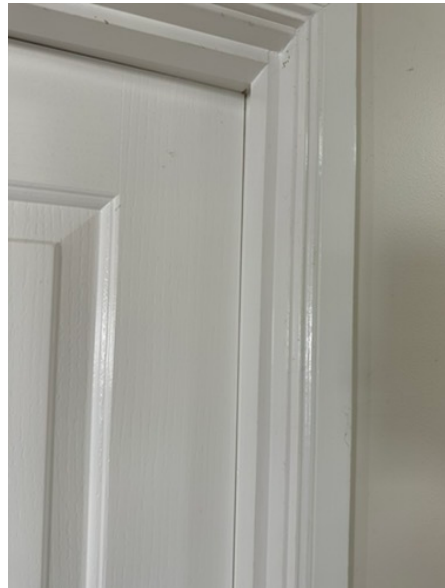
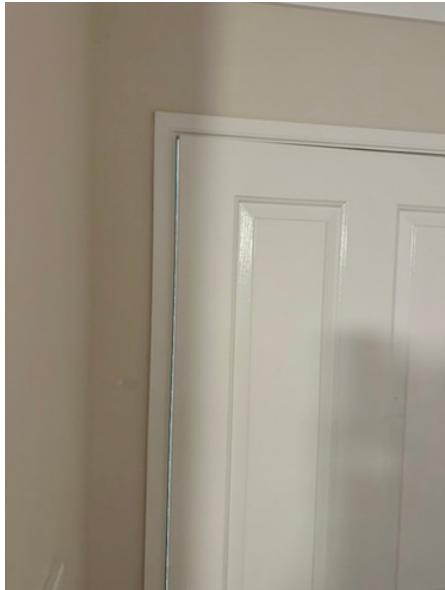
Observation 2.04

Finding: In Bedroom 2, the door is binding slightly against the top of the door jamb. This is a minor defect that can be corrected with some basic maintenance. Adjusting the hinges or slightly trimming the door will likely resolve the issue, ensuring smooth operation. This straightforward fix will enhance functionality and prevent any future wear from continued friction.

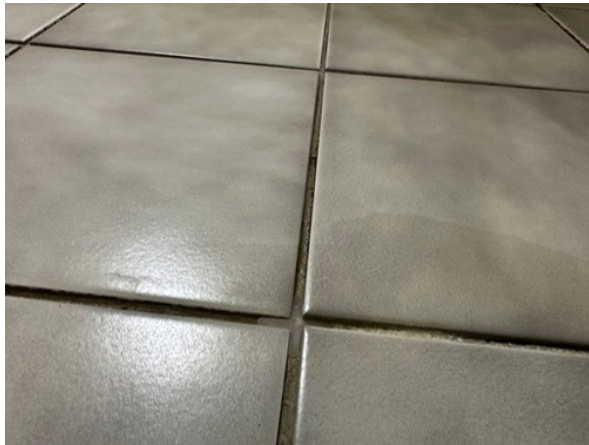
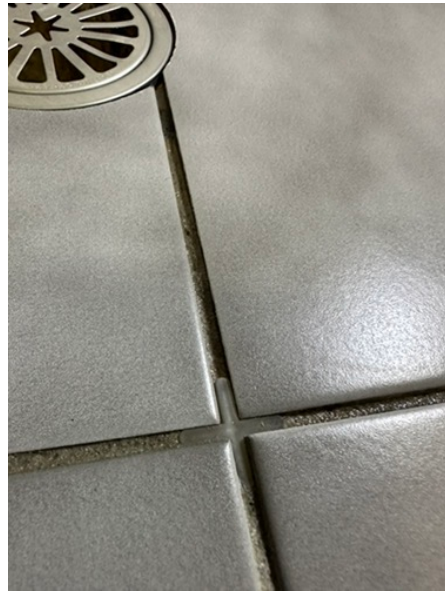
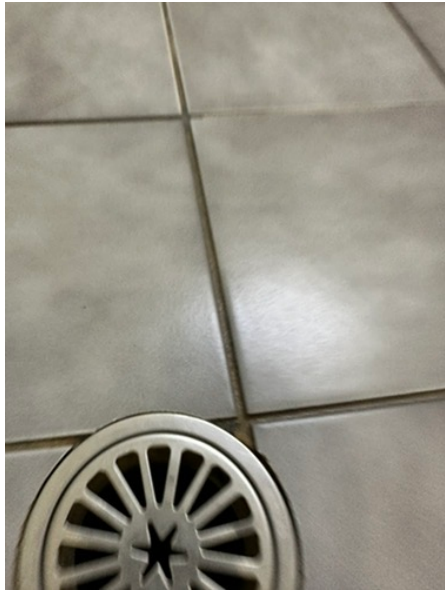
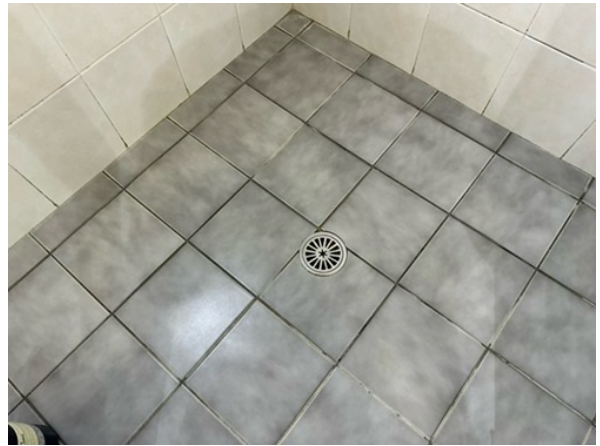
Observation 2.05

Finding: The floor tiles in the ensuite are missing grout in several areas. Although there is no moisture detected, attention to re-grouting is recommended to maintain the integrity of the tiling and prevent potential issues. This is considered a minor maintenance task that can be addressed with ease.

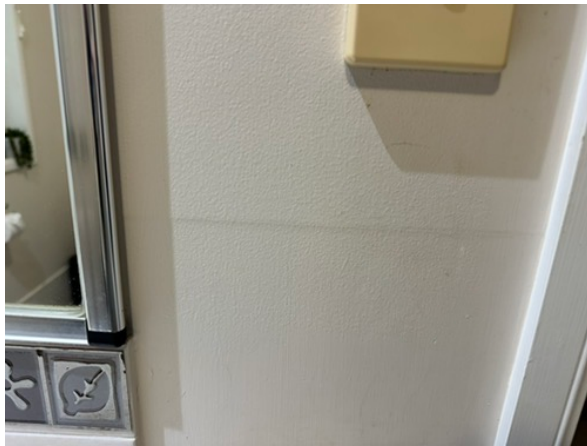
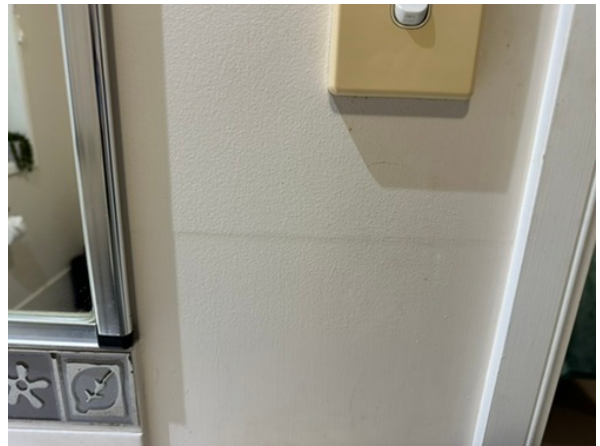
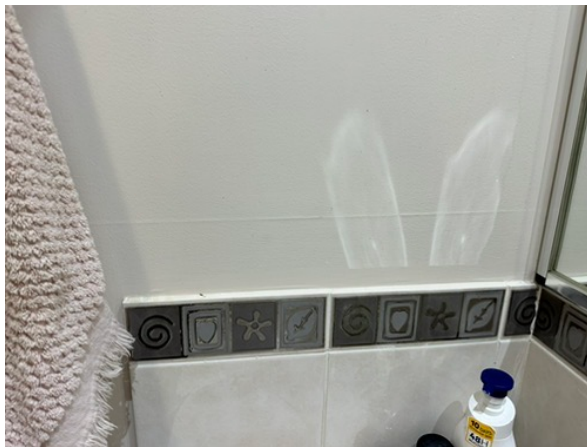
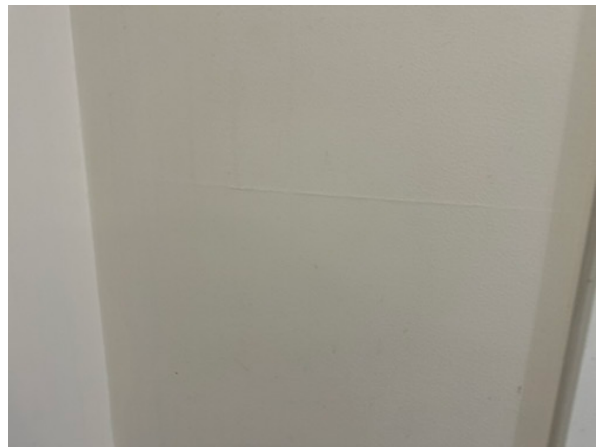
Observation 2.06

Finding: In the ensuite, horizontal cracks are present on the villa board walls. These cracks are in line with the property's age and the inherent characteristics of the sturdy villa board material. While not structurally concerning, addressing these cracks with minor repairs and repainting may be desirable for aesthetic reasons. Regular monitoring is suggested to ensure they do not develop further.

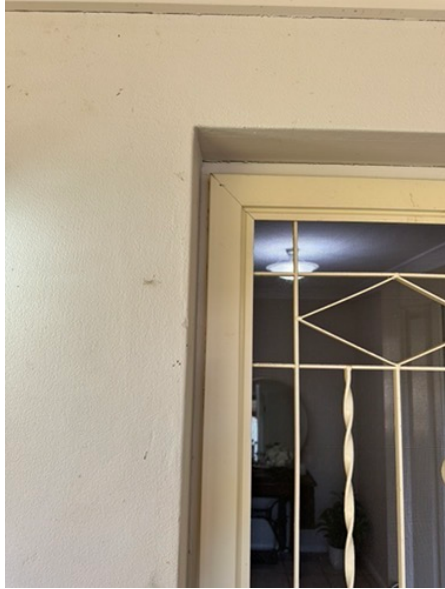
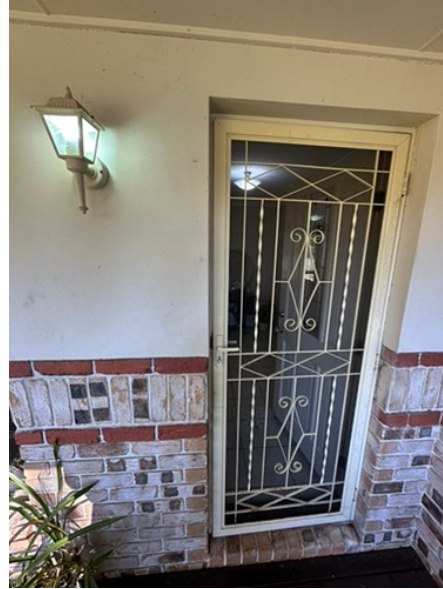
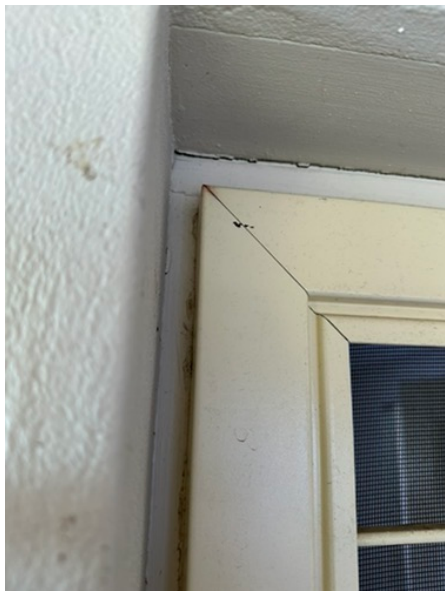
Observation 2.07

Finding: The screen door at the front entry requires some maintenance, as it is currently binding at the top and coming into contact with the door jamb. This issue may affect the door's functionality and ease of use. Adjustments or minor repairs are recommended to ensure smooth operation and to prevent further wear on the door and surrounding structure.

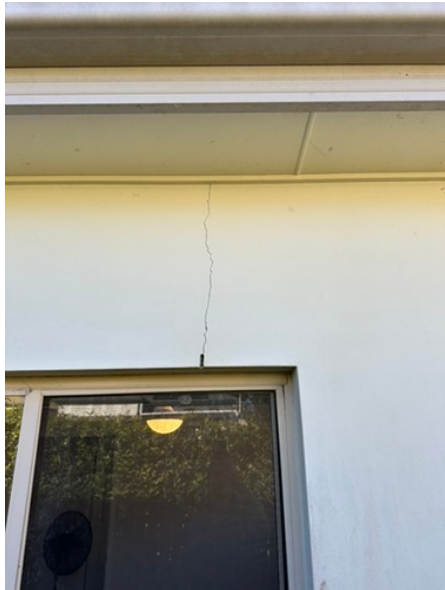
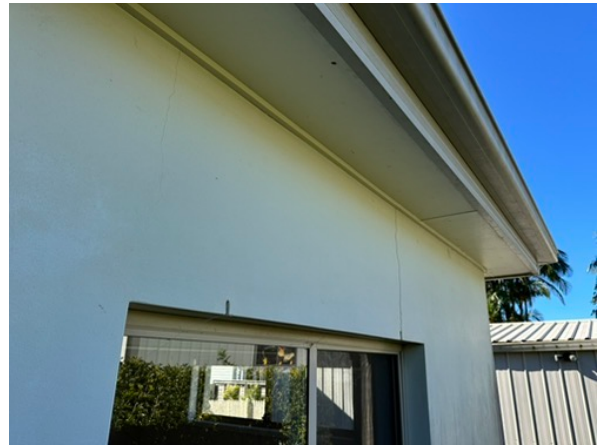
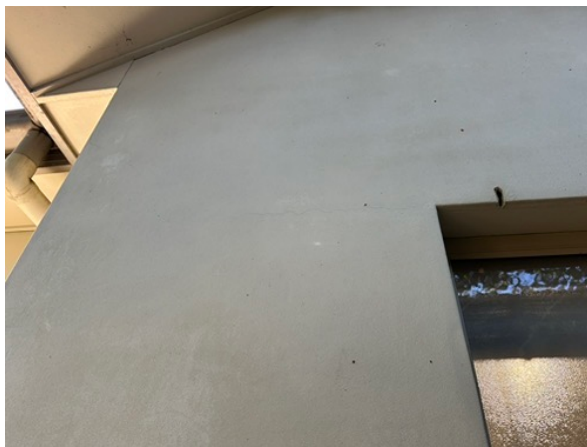
Observation 2.08

Finding: A crack is observed in the brickwork at the backside of the house. This appears to be related to the building's age, as there is no indication of movement around it, and all structures remain straight. At this stage, it is not a significant concern but warrants monitoring over time to ensure there are no changes that might indicate further issues.

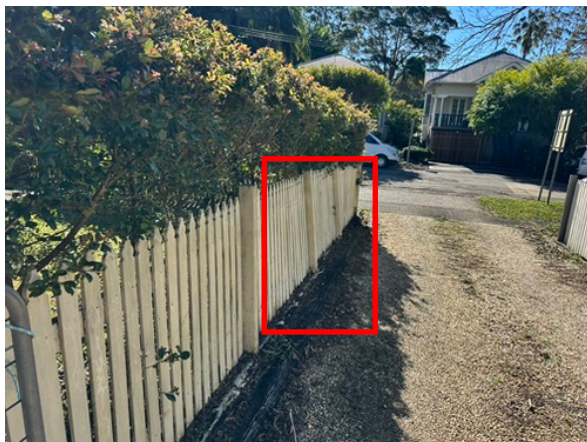
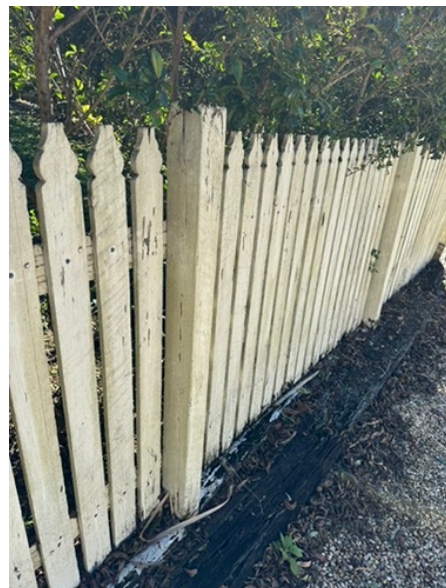
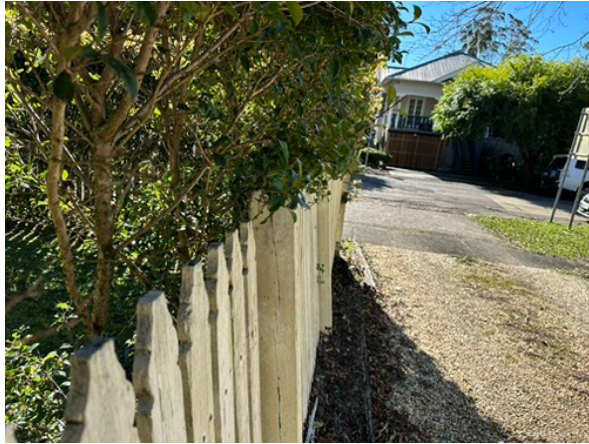
Observation 2.09

Finding: The driveway fence requires maintenance as two of the posts exhibit signs of deterioration and will need replacing. These posts appear weakened, potentially impacting the fence's stability and overall integrity. Immediate attention to replacing these posts will help maintain the fence's function and appearance over time.
