Pest Inspection Report

4/2 Nunyar Court,
Ocean Shores

Regular Visual Termite Inspection Report in Accordance with AS 3660.2-2017

2 Nunyar Crt, Ocean Shores

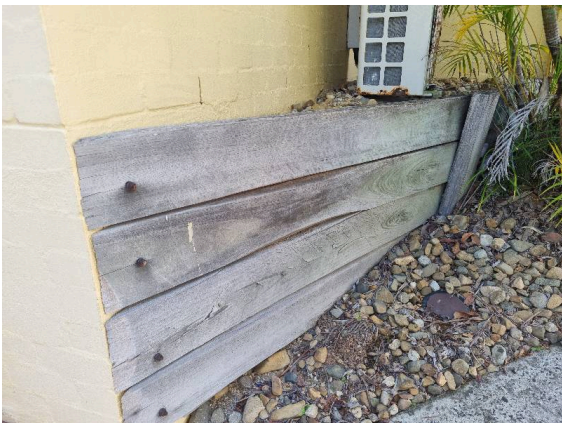
Example of timber retaining wall in direct ground contact adjoining the property which may attract termites and allow for quick undetected termite attack, unit 1.

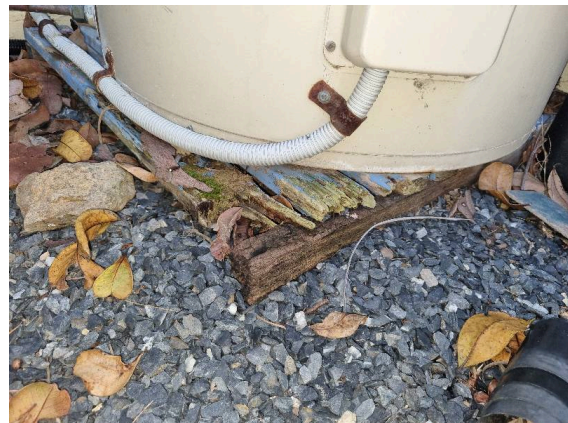
Example of timber base at hot water system in direct ground contact with fungal decay in close proximity to the structure which may attract termites. Unit 2.

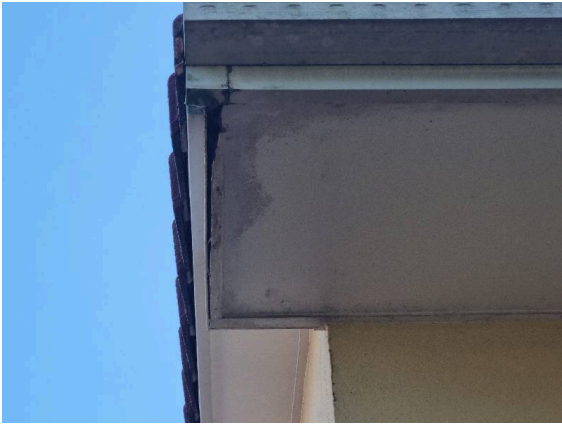
Example of fungal decay and water damage to eaves at unit 2.

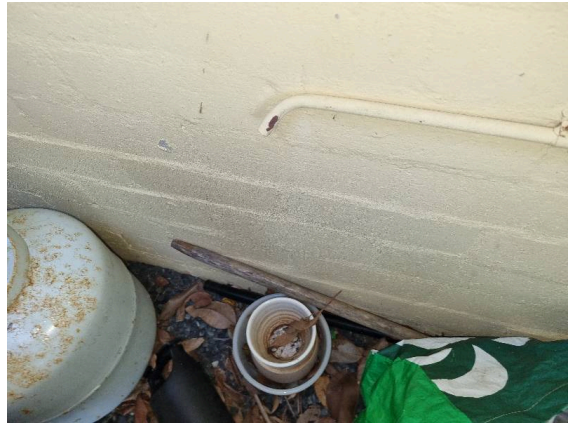
Example of hot water system overflow not connected to drain which can allow moisture to buildup next to property which may attract termites.

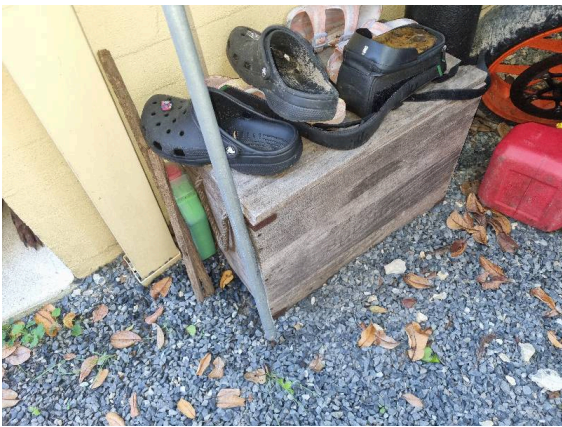
Example of stored timber in direct ground contact adjoining property which may attract termites. Unit 2.

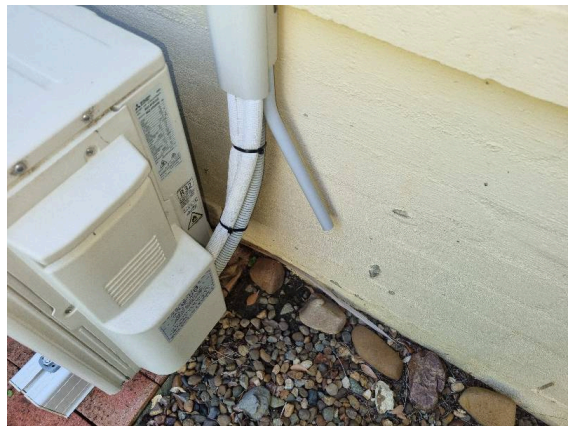
Example of air conditioning condensation pipe not connected to drainage which may allow for moisture buildup next to property which may attract termites.

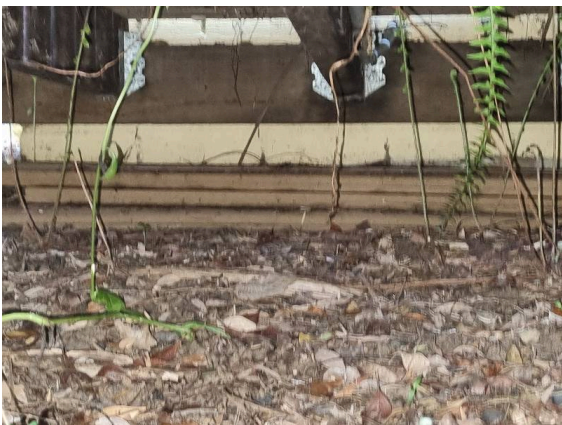
Example of stored timber in direct ground contact under rear deck of unit 4, which may attract termites.

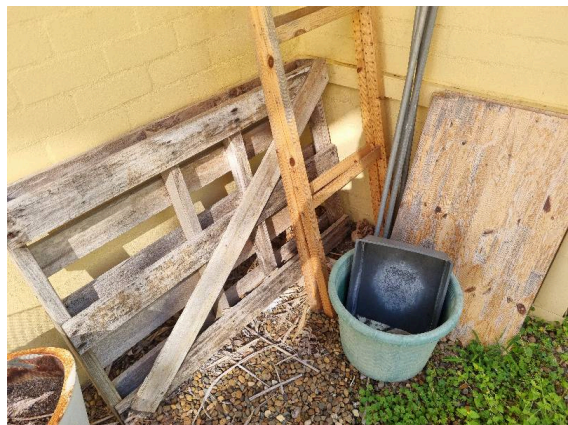
Example of stored timber in direct ground contact adjoining property which may attract termites. Unit 4.

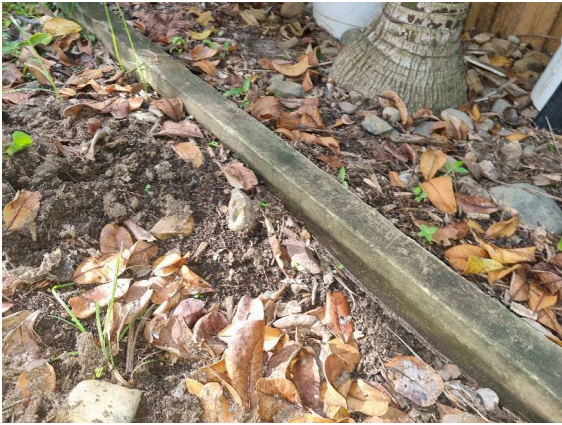
Example of timber garden edging with fungal decay in direct ground contact which may attract termites. Timber edging should be replaced with termite resistant alternatives.

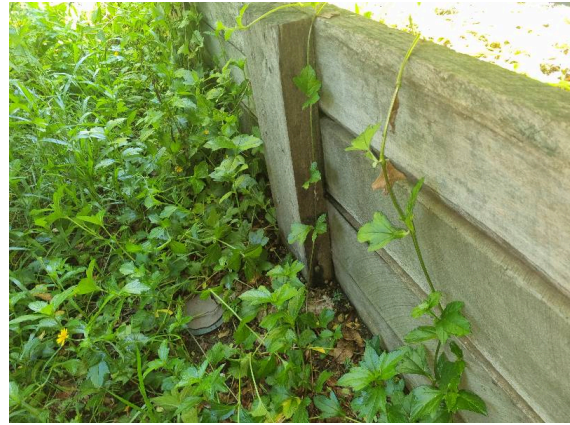
Example of timber retaining wall in direct ground contact which may attract termites. Timber should be replaced with termite resistant alternatives.

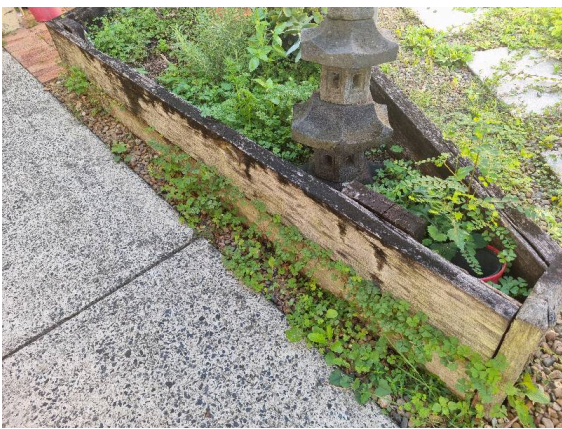
Example of timber plant box in direct ground contact which may attract termites .
