Scout.
HOME INSPECTIONS

Pre-Purchase Building & Timber Pest Inspection Report

50 Shirley Street Byron Bay 2481 New South Wales Australia

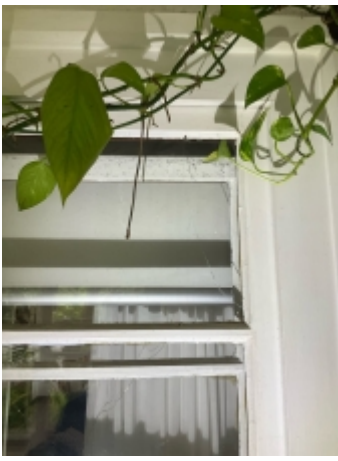
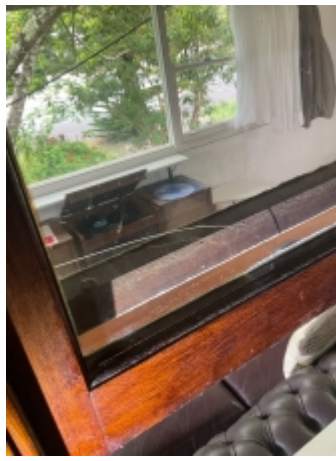
Defect Severity	Minor Defect
Defective Item	Windows
Defect	Cracked Glass Pane
Comment	Cracked/damaged glass panes observed. Contact a licensed glazier for repairs.

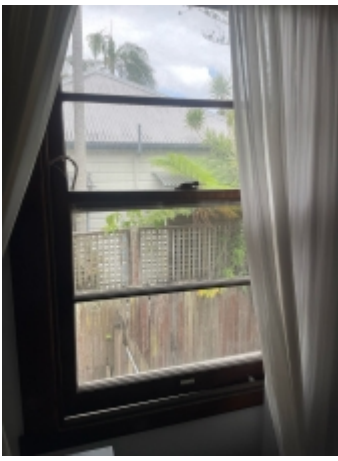
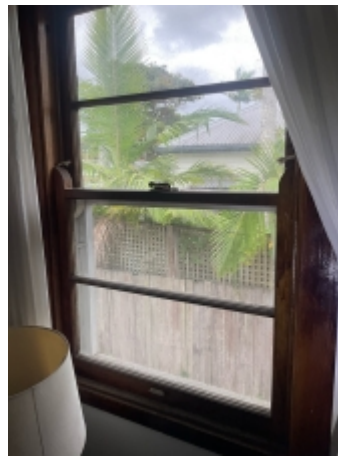
Defect Severity	Minor Defect
Defective Item	Windows
Defect	Sash Cords Broken
Comment	Sash cords damaged/broken, this was evident to numerous windows throughout the home. Contact a licensed glazier for full assessment and repairs where required.

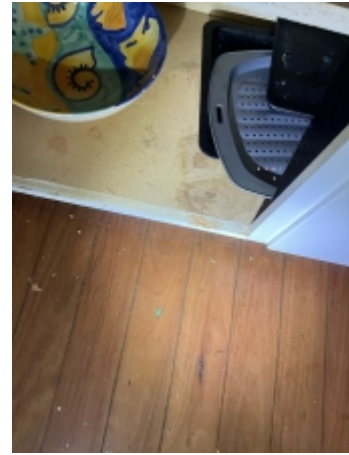
Defective Item	Kitchen cabinets
Defect	General age/deterioration
Comment	General age/deterioration was observed to the kitchen cabinets, some hinges require adjustment. Contact a licensed cabinetmaker for assessment and repairs.

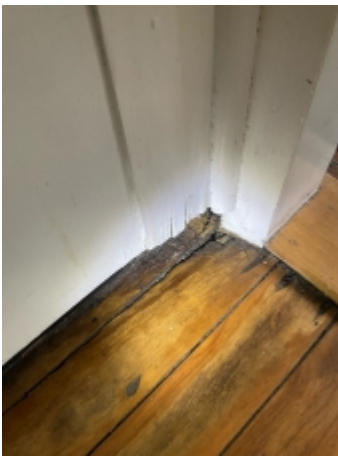
Defect Severity	Minor Defect
Defective Item	Flooring
Defect	Timber Fungal Decay
Comment	Timber fungal decay/rot observed to areas of the timber flooring (no high moisture readings obtained). Contact a licensed carpenter for repair.

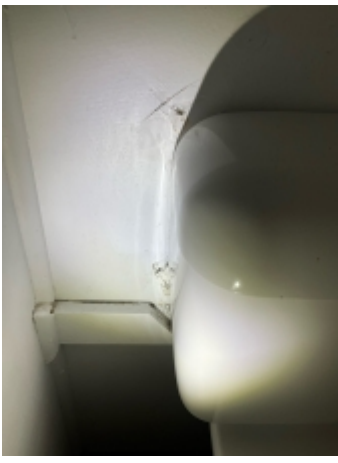
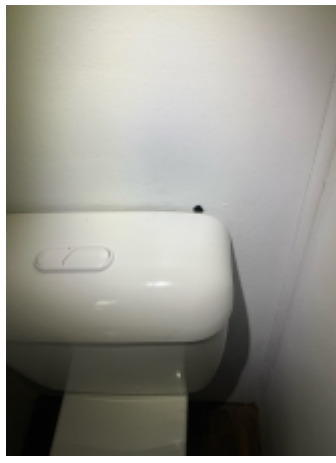
Defect Severity	Minor Defect
Defective Item	Walls
Defect	Damage to wall linings
Comment	Minor damage to wall linings. Contact a licensed painter for repair.

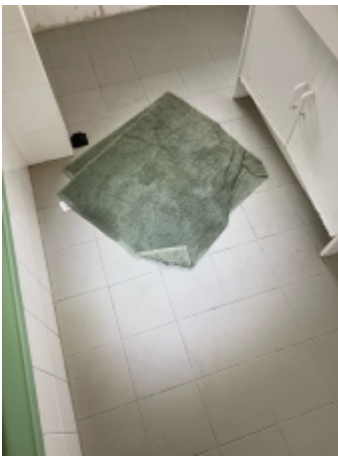
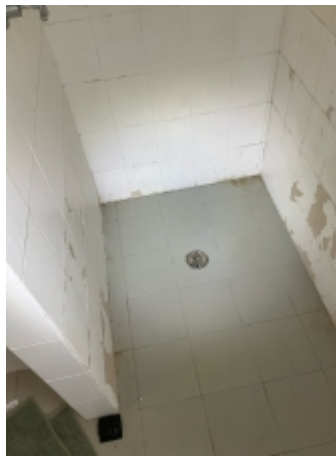
Defect Severity	Minor Defect
Defective Item	Tiled Floors
Defect	Drummy/loose tiles
Comment	Drummy/loose tiles noted in areas, although this is not visibly causing any issues, further uplift and deterioration may occur. Contact a licensed tiler for assessment and recommendations.

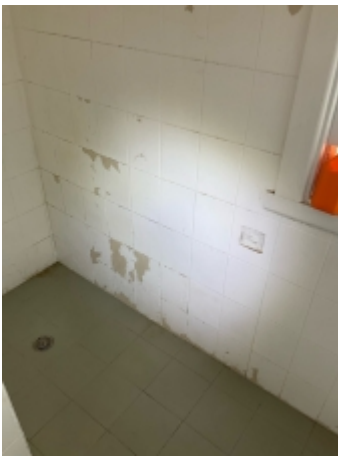
Defect Severity	Minor Defect
Defective Item	Tiled walls
Defect	Paint deterioration
Comment	The tiled walls have been painted over, the painted finish is deteriorated and peeling in areas. Contact a licensed painter for assessment and recommendations.

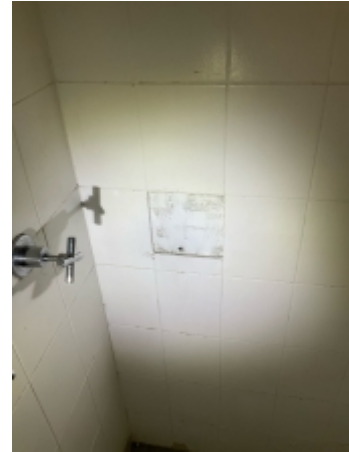
Defect Severity	Minor Defect
Defective Item	Tiled walls
Defect	Missing tiles
Comment	Wall tiles are missing in areas, including the shower recess. Contact a licensed tiler for immediate repair.

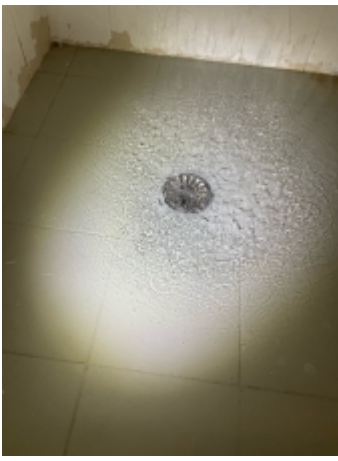
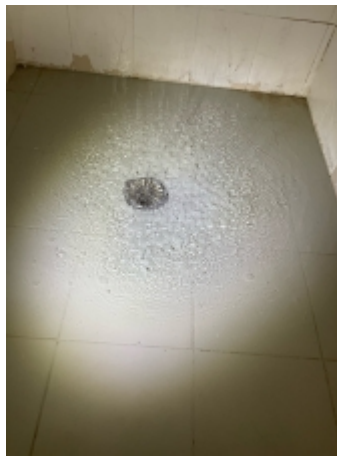
Defect Severity	Minor Defect
Defective Item	Shower
Defect	Waste too high
Comment	The floor waste in the shower is set too high and this is causing ponding. Contact a licensed plumber for assessment.

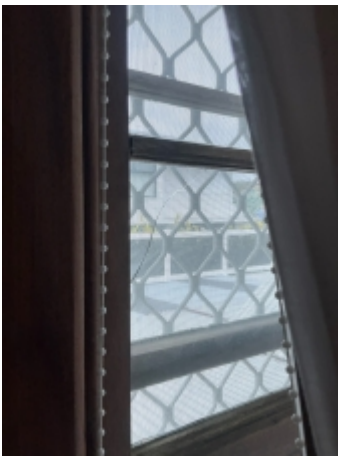
Defect Severity	Minor Defect
Defective Item	Windows
Defect	Cracked Glass Pane
Comment	Cracked/damaged glass pane observed. Contact a licensed glazier for repair.

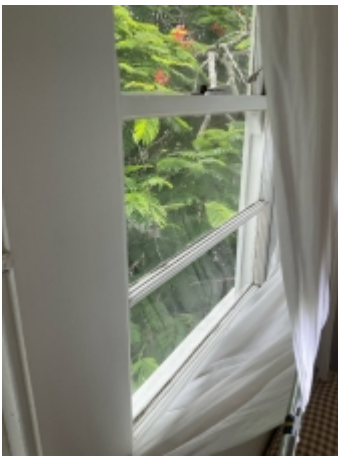
Defect Severity	Minor Defect
Defective Item	Windows
Defect	Cracked Glass Pane
Comment	Cracked/damaged glass pane observed. Contact a licensed glazier for repair.

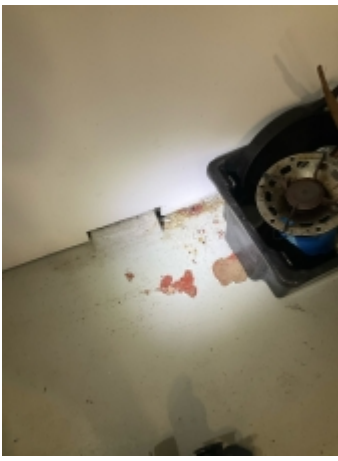
Defect Severity	Minor Defect
Defective Item	Flooring
Defect	Paint deterioration
Comment	The painted finish to the floor has deteriorated due to moisture from the HWS overflow. Contact a licensed plumber for connection of overflow into drainage.

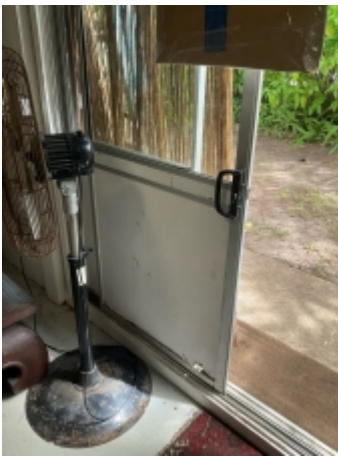
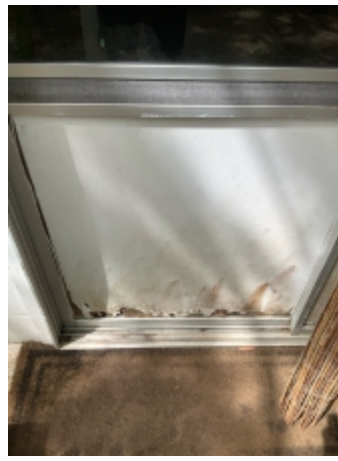
Defect Severity	Minor Defect
Defective Item	Doors and frames
Defect	Missing glazing
Comment	Glazing is missing from the sliding door, the rollers may also require replacement. Contact a licensed glazier for repair.

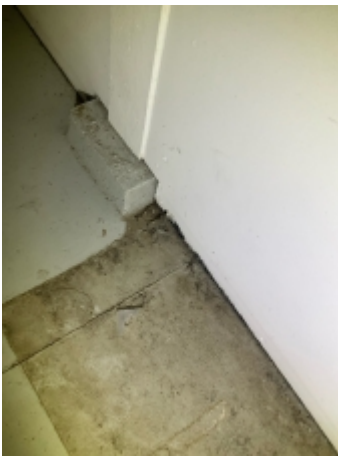
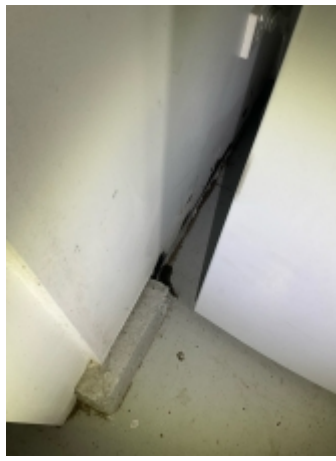
Defect Severity	Minor Defect
Defective Item	Walls
Defect	Moisture staining/damage - dry
Comment	Moisture staining/damage observed, no high moisture readings taken at time of inspection. The cause of the staining/leak may have been repaired, however, the area must be monitored and if further evidence of moisture becomes evident a licensed roof plumber must be engaged for assessment.

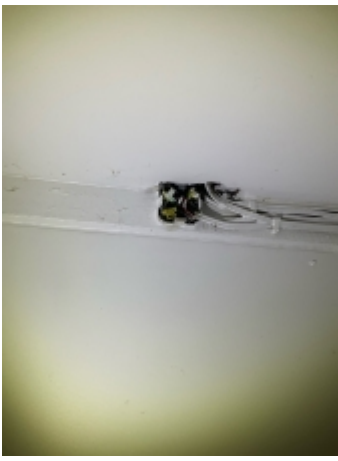
Defect Severity	Safety Hazard
Defective Item	Electrical
Defect	Exposed wires
Comment	Although this inspection does not include the checking of electrical items or installations, it is worth noting that exposed wires were observed where a J-box cover is missing. Contact a licensed electrician for immediate further assessment.

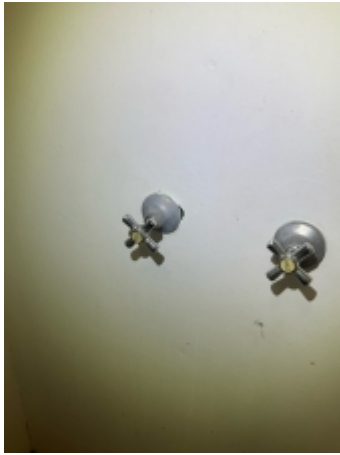
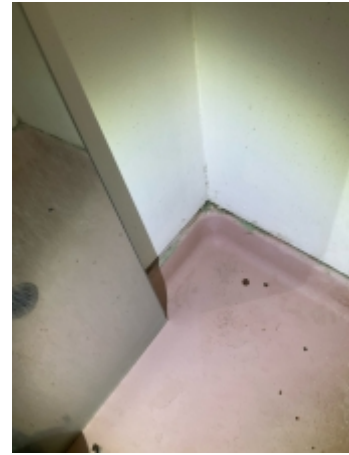
Defective Item	Shower
Defect	Reseal internal corners
Comment	The internal corners of the floor/wall panels require re-sealing to prevent water ingress/egress which can lead to leaking, gaps were also visible behind the taps which require sealing. Contact a licensed plumber for repairs.

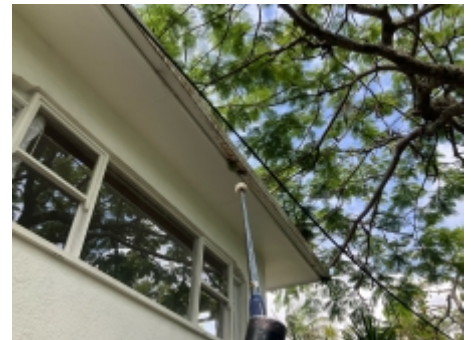
Defect Severity	Minor Defect
Defective Item	Guttering
Defect	Gutter rust
Comment	Rust was observed in areas of the guttering around the home. Contact a licensed plumber for assessment and repairs, full replacement is likely to be required.

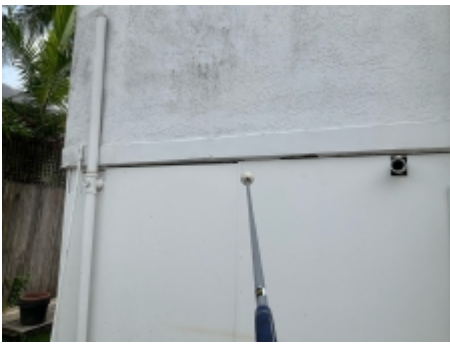
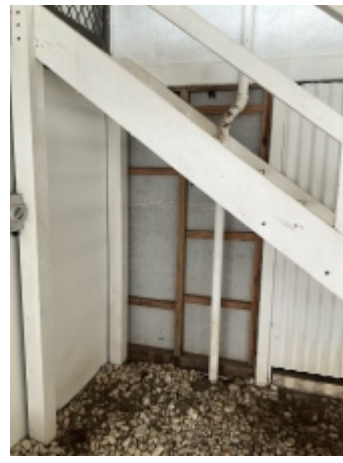
Defect Severity	Minor Defect
Defective Item	External Walls
Defect	Missing cladding
Comment	A section of external cladding is missing, gaps are visible in other areas where water ingress could occur. Contact a licensed carpenter for repairs.

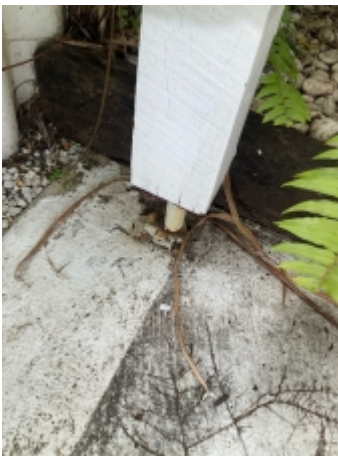
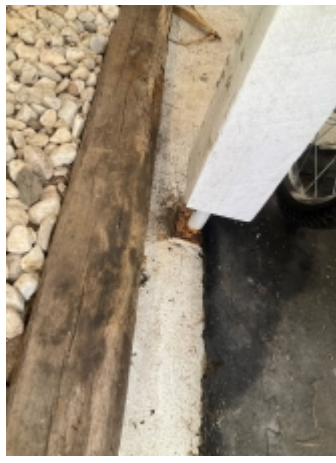
Defect Severity	Minor Defect
Defective Item	Verandas
Defect	Post stirrup rust
Comment	Rust was observed in a number of the post stirrups to the pergola. Contact a licensed carpenter for further assessment and repair where required.

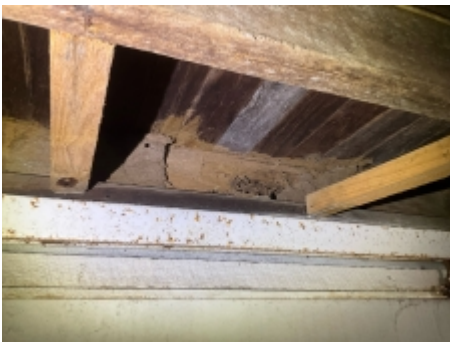
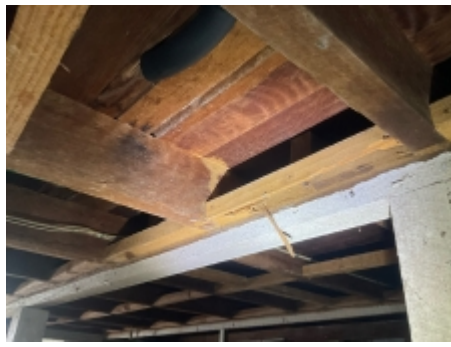
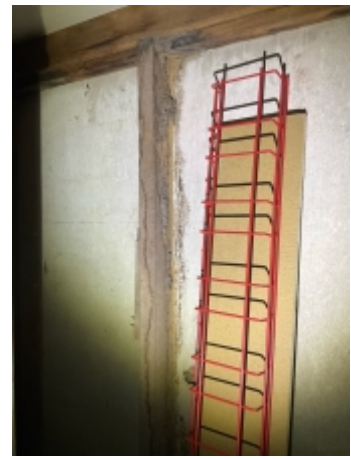
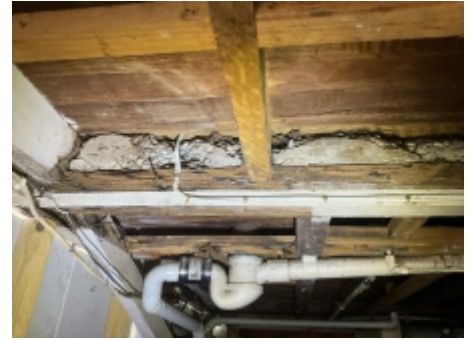
Defect Severity	Major Defect
Defective Item	Subfloor framing
Defect	Termite Damage/workings
Comment	Termite damage and workings were observed in areas of the timber floor framing, and wall framing. Contact a licensed carpenter for full further assessment, and please refer to the visual timber pest inspection section of the report for further details.

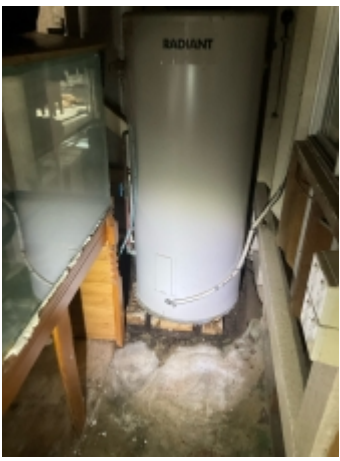
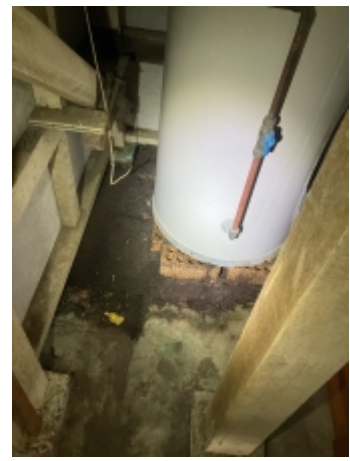
Defect Severity	Minor Defect
Defective Item	HWS
Defect	Overflow not connected
Comment	The HWS overflow is not connected to drainage. Contact a licensed plumber for rectification.

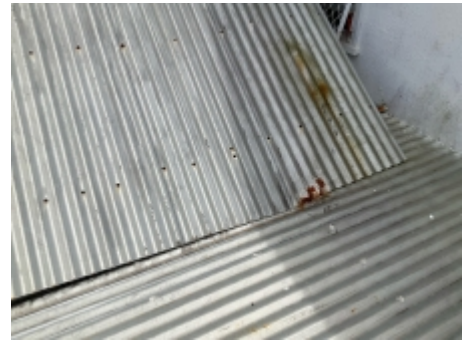
Defect Severity	Minor Defect
Defective Item	Roof cladding
Defect	Rust to cladding
Comment	Rust was observed in areas of the roof cladding to the rear pergola area. Contact a licensed roof plumber for further assessment and repairs where required.

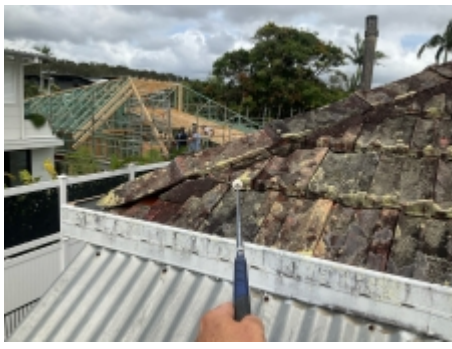
Defect Severity	Minor Defect
Defective Item	Roof tiles
Defect	Repointing
Comment	The mortar between the ridge capping tiles is cracked/falling out and deteriorated in areas. Contact a licensed roof tiler for repairs.

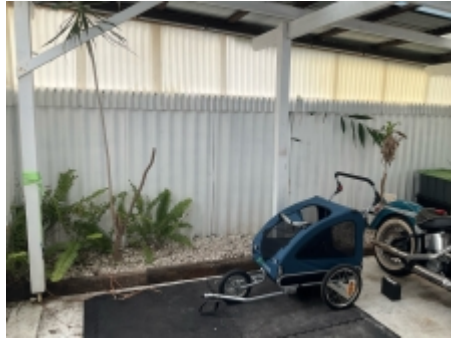
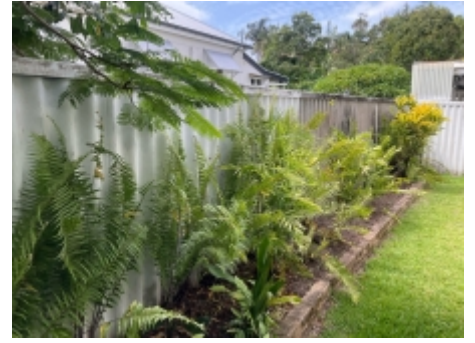
Defect Severity	Safety Hazard
Defective Item	Fencing
Defect	Asbestos
Comment	Although this inspection does not include checking for the presence of asbestos, it must be noted that sections of the fencing appear to be constructed from asbestos sheeting. Contact a licensed asbestos contractor for further assessment.
