## Building and Timber Pest Inspection Report VR

Inspection Date: Thu, 22 Jan 2026

Property Address: 4 Riverside Crescent, Brunswick Heads NSW,  
Australia

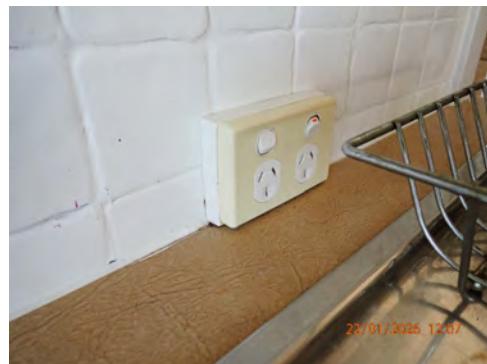
Information: During the inspection, a power point was observed to be installed at approximately the same height as the bench surface and directly behind the sink. The location of the outlet places it within close proximity to a water source.

Electrical outlets positioned near sinks may be exposed to water splash or moisture, which can increase the risk of electric shock, short-circuiting, or damage to the electrical fitting if water enters the outlet. This condition may present a potential safety hazard, particularly during regular use of the sink.

A qualified electrician should be engaged to assess the location and compliance of the power point and provide advice on whether relocation, additional protection (such as appropriate safety devices), or modification is required. This should be attended to as soon as practicable to reduce potential electrical safety risks.

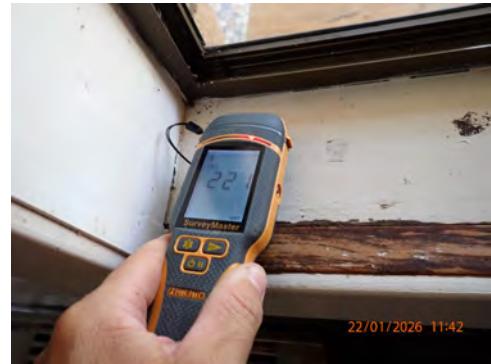
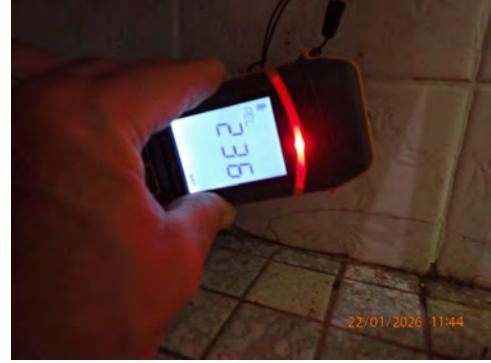
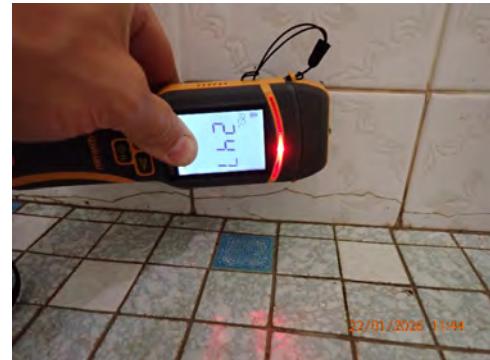
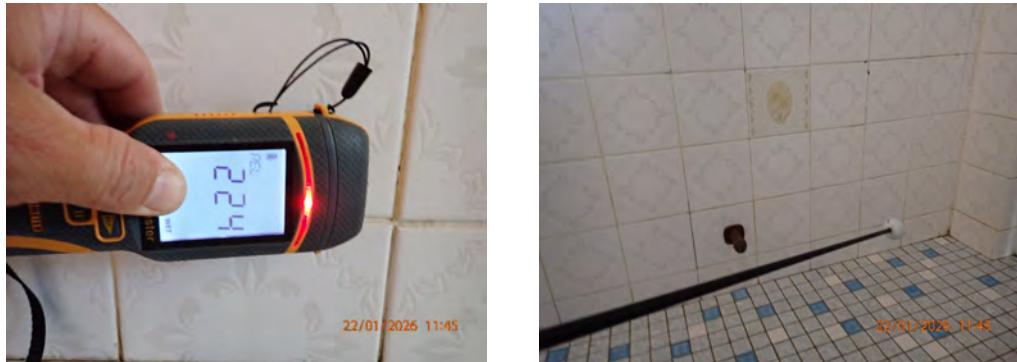
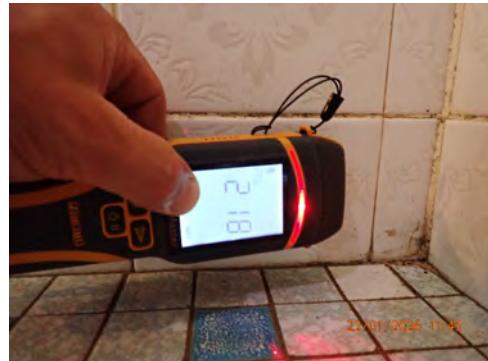
#### Finding 2.01

B | EMR | Moisture readings detected in laundry

During the inspection, elevated moisture readings were detected in the laundry area. The source of the moisture could not be confirmed at the time of inspection.

Moisture in laundry areas is commonly associated with plumbing leaks, failed seals, drainage issues, or moisture migration from adjoining building elements. If left unmanaged, ongoing moisture exposure may lead to deterioration of wall linings, cabinetry, skirtings, and other concealed building components.

The moisture meter used operates on a scale from 0 to 999. Readings above 200 are considered elevated. Concealed damage could not be ruled out, and further invasive inspection may be required to determine the full extent of any concealed moisture-related issues.

A licensed plumber or licensed builder, depending on the suspected source, can be engaged to investigate and rectify the cause of moisture ingress. This should be addressed as soon as practicable.

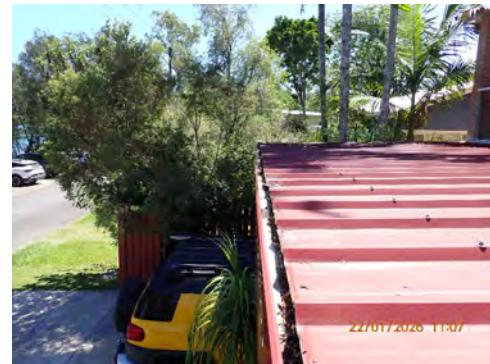
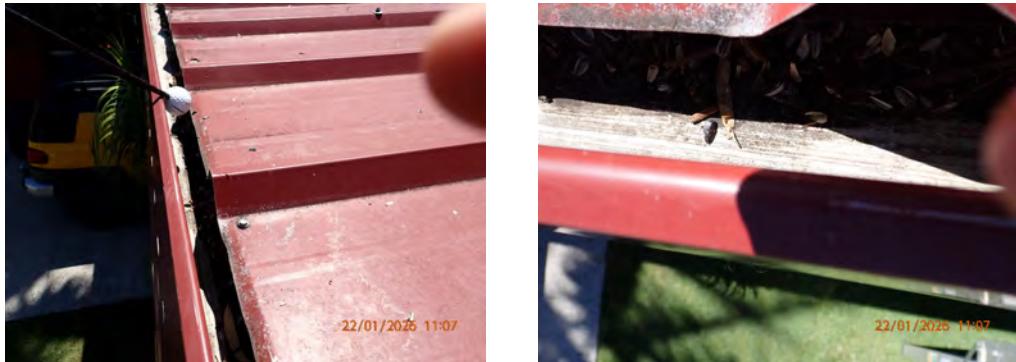
Information: All gutters and roof areas should be kept clear of debris to ensure proper water flow and to prevent blockages, overflow, and premature deterioration of roofing and drainage components. Debris build-up can also create moisture-retention points that may become conducive to timber decay and termite activity if left unmanaged.

It was also observed that the gap between the roof sheeting and the gutter is insufficient, which can restrict effective water discharge into the gutter, increase the likelihood of overflow, and accelerate deterioration of the guttering and adjacent building elements.

Regular cleaning, maintenance, and adjustment of gutter positioning or roof edge detailing should be carried out as part of routine property upkeep to improve drainage performance and reduce the risk of moisture-related damage.

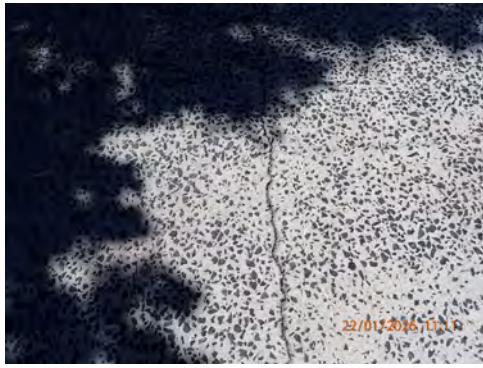
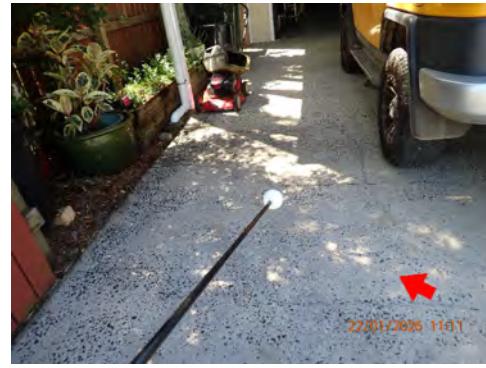
B | Crack | Driveway cracking observed

At the time of inspection, noticeable cracking was observed to sections of the concrete driveway. This type of cracking is common in residential driveways and is generally associated with normal ageing of the concrete, thermal movement, and minor ground settlement over time.

The cracking did not appear to affect the immediate usability of the driveway at the time of inspection. Maintenance or repair options, such as crack sealing or localised patching, can be considered to improve presentation and limit future deterioration. Any remedial works may be undertaken at the clients discretion, with periodic monitoring recommended as part of routine property maintenance

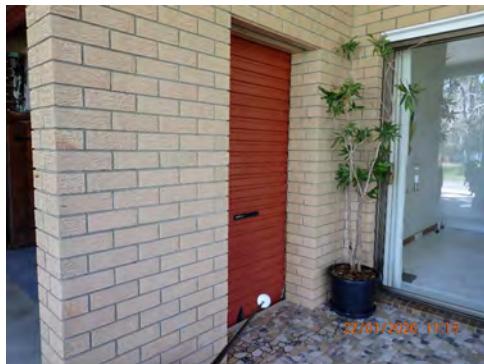
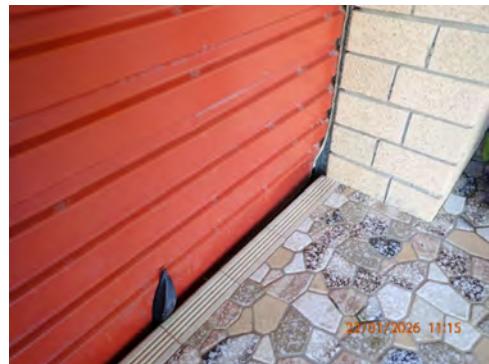
### Finding 3.04

Building: Main Building  
Location: front porch  
Finding: Garage Door - Damage  
Information:

During the inspection, it was noted that the small garage door at the front had some damage. To ensure the security and functionality of the garage, it may be beneficial to address this issue.

The client can consider consulting with a garage door company to assess the extent of the damage and discuss potential repair or replacement options. This will help maintain the door's performance and appearance. Taking action can be done at the client's discretion, based on their priorities and preferences.

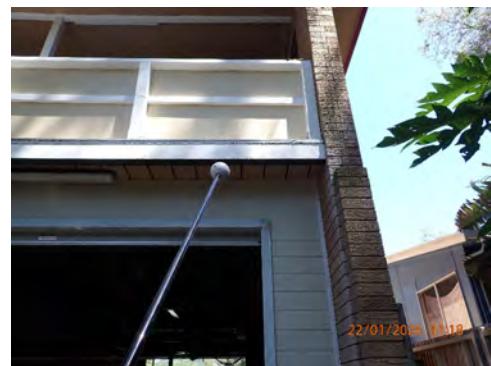
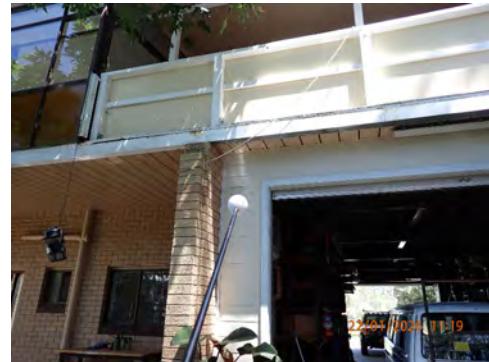
### Finding 3.05

Finding: B | Corrosion | External steel beam – rusting observed

Information: At the time of inspection, the external steel beam was observed to show signs of surface rusting. Minor cracking and displacement to the adjacent brickwork was also noted, which is commonly associated with the natural expansion of steel as it corrodes over time.

This condition is relatively common in properties where steel elements are exposed to weather and moisture. Maintenance works such as rust treatment, application of protective coatings, and localised brickwork repairs may be considered to limit further deterioration and improve presentation. Depending on the extent of corrosion and masonry movement, consultation with a licensed builder and/or a structural engineer may be required to provide further advice on appropriate remedial measures. Any works may be undertaken at the owner's discretion, with periodic monitoring recommended as part of routine property maintenance.

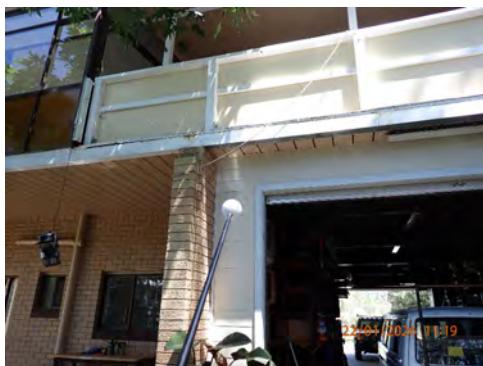
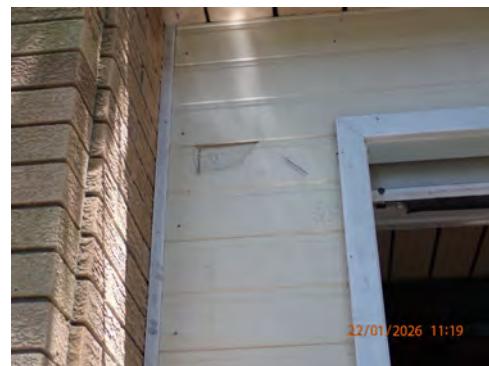
### Finding 3.06

Building: Main Building  
Location: Garage Rear  
Finding: B | Cladding | Damaged external wall cladding

During the inspection, damage was observed to the rear of the garage external wall cladding. The condition was noted in accessible areas and may include cracking, impact damage, deterioration, or localised movement of cladding elements.

Damage to external cladding commonly occurs due to weather exposure, moisture, thermal movement, impact, or age-related deterioration. If left unaddressed, damaged cladding may allow water ingress, lead to further deterioration of underlying wall components, and reduce the overall weather resistance and appearance of the building.

A licensed builder or suitably qualified tradesperson should be engaged to assess the affected areas and carry out repair or replacement of damaged cladding as required. These works should be undertaken as soon as practicable to maintain the integrity and presentation of the external building envelope.

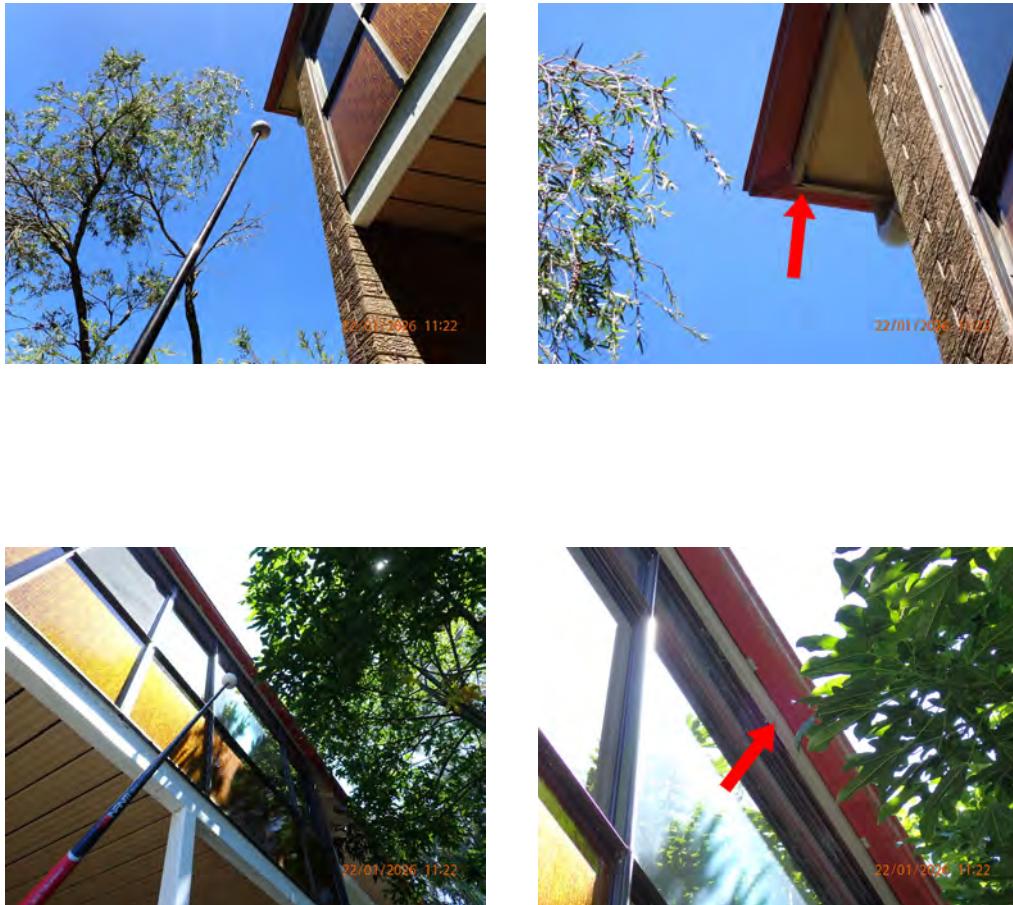
**Finding 3.07**

Finding: R | Decay | Evidence of minor wood rot to fascias and bargeboards

Information: During inspection, evidence of minor wood rot (fungal decay) was observed affecting fascias and bargeboards in this area. Some superficial repairs appear to have been attempted. Wood rot occurs when cellulose materials such as timber are exposed to persistent dampness. Fascias and bargeboards are particularly vulnerable to deterioration from faults in roof plumbing and constant weather exposure.

The source of moisture contributing to this decay should be identified and addressed. A licensed roof plumber should be engaged to assess all roof plumbing and rectify any contributing defects. Following this, a licensed carpenter or builder should replace affected sections of fascia and bargeboards.

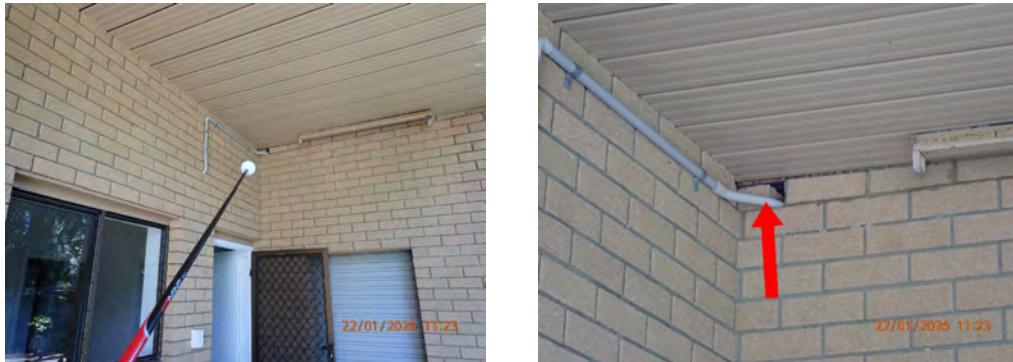
### Finding 3.08

Building:	Main Building
Location:	rear porch Rear
Finding:	B   Masonry   Loose brick to section of building
Information:	<p>During inspection, a loose brick was observed to this section of the building. Loose masonry can occur due to age, movement, mortar deterioration, or inadequate bonding and may lead to instability or allow moisture ingress into adjoining building elements if left unmanaged.</p> <p>A licensed builder or qualified bricklayer can be engaged to resecure or replace the affected brickwork.</p>

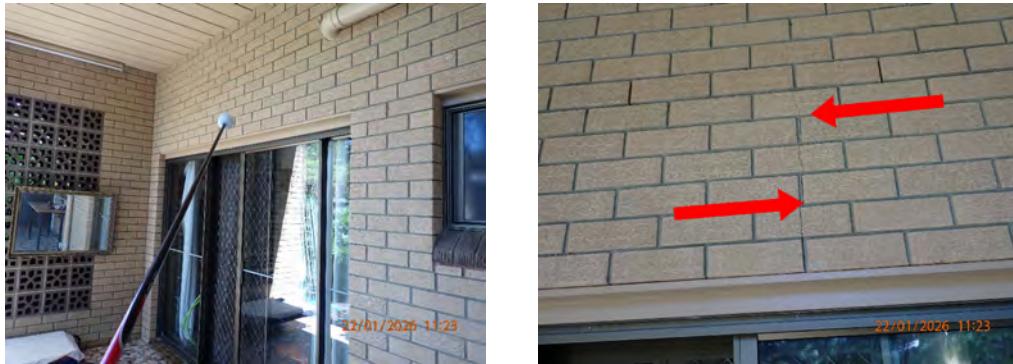
### Finding 3.09

Building: Main Building  
 Location: rear porch Rear  
 Finding: B | Crack | Brickwork cracking above sliding door  
 Information: At the time of inspection, cracking was observed to the brickwork above the sliding door. Cracking in this location is commonly associated with normal building movement, thermal expansion and contraction, or minor settlement around openings such as doors and windows.

The cracking did not appear unusual for a property of this age and construction and is a common occurrence where masonry is supported over openings. While primarily a maintenance and presentation-related matter, periodic monitoring is recommended to ensure the cracking does not worsen over time.

If improvement to appearance or reassurance is desired, consultation with a licensed builder may be undertaken at the owner's discretion to assess the cracking and carry out localised repairs or sealing as required.

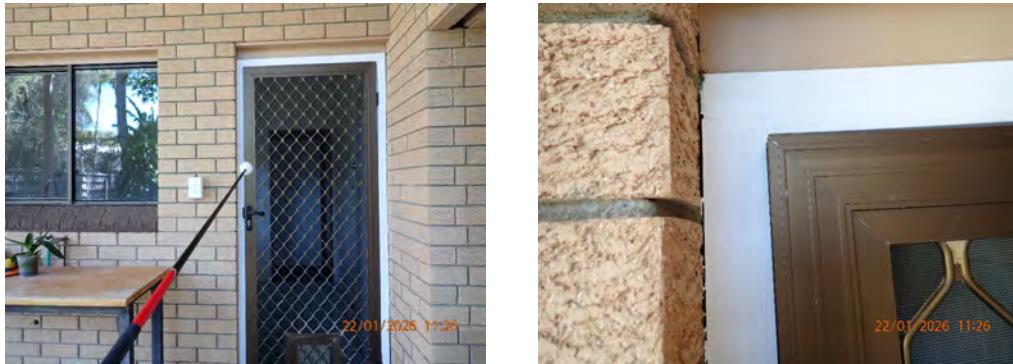
### Finding 3.10

Building:	Main Building
Location:	Rear
Finding:	WD   Door   Flyscreen door not closing properly
Information:	<p>At the time of inspection, the flyscreen door was observed not to close correctly. This condition may be due to misalignment of the door frame, worn or loose hinges, track issues, or a faulty latch mechanism.</p> <p>A flyscreen door that does not close as intended reduces functionality and may allow insects and pests to enter the dwelling. In some cases, ongoing misalignment can also lead to further wear to hinges, rollers, or the door frame if left unaddressed.</p> <p>A licensed carpenter or door specialist should be engaged to assess the door alignment, hardware, and closing mechanism and carry out adjustment or repair as required. These works should be attended to as soon as practicable to restore proper operation.</p>

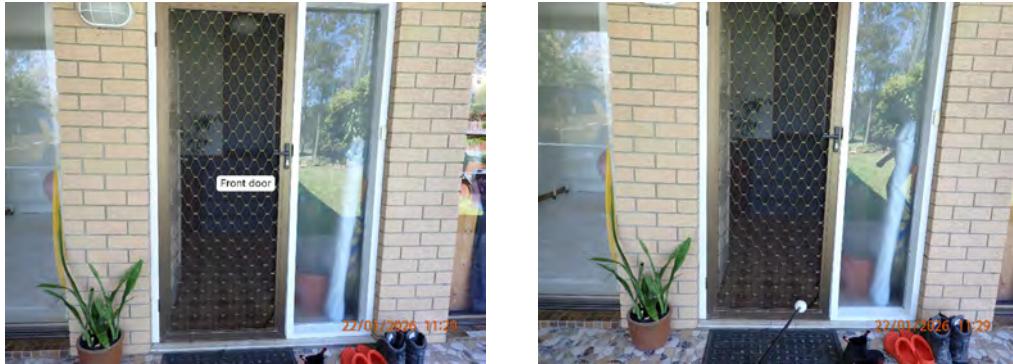
### Finding 3.11

Building:	Main Building
Location:	All Areas, Rear
Finding:	Flyscreens - Damaged
Information:	<p>It was observed that the window flyscreens is damaged, with tears and holes present in the mesh. This damage is likely due to general wear and tear, accidental impact, or prolonged exposure to weather. A damaged flyscreen can reduce ventilation effectiveness, allow insects to enter the building, and may also detract from the overall appearance of the window. Additionally, gaps in the flyscreen can provide easy access for pests, which could lead to further maintenance issues. It is recommended that a qualified handyman or window contractor be engaged to repair or replace the damaged flyscreen. This work should be carried out at the client's earliest convenience to restore the function of the window and maintain a pest-free environment.</p>

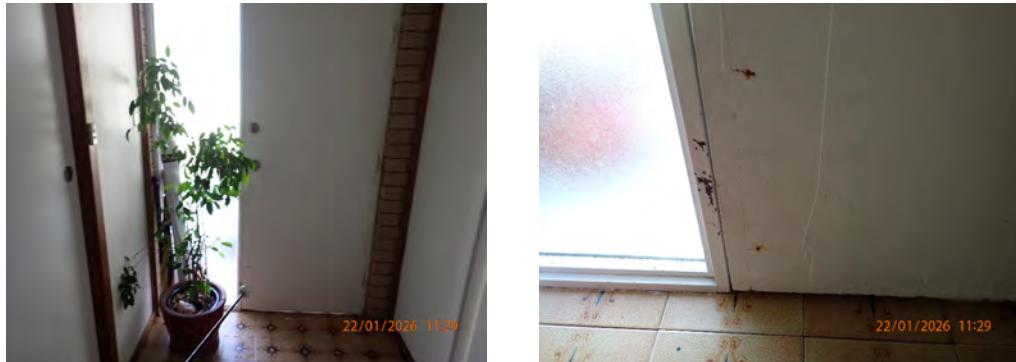
Building:	Main Building
Location:	All Areas, Rear
Finding:	WD   Door   Damage to door noted
Information:	<p>During the inspection, damage was observed to the front door. The damage was noted in accessible areas and may include surface deterioration, impact marks, wear to edges, or damage to door components.</p> <p>Damage of this nature commonly occurs due to general use, impact, moisture exposure, or age-related wear. While the condition may primarily affect presentation and functionality, further deterioration can occur if left unaddressed.</p> <p>A licensed carpenter or door specialist can be engaged to assess the extent of damage and carry out repair or replacement as required. These works can be undertaken at the owner's discretion, with monitoring recommended as part of routine maintenance</p>

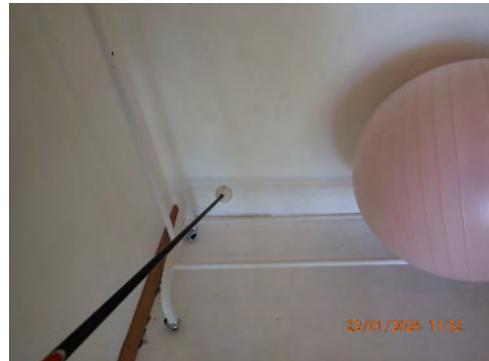
### Finding 3.13

Finding: B | Skirting | Section of skirting missing or incomplete

Information: During the inspection, sections of skirting were observed to be missing, incomplete, or not securely fixed. Missing or poorly fitted skirting leaves gaps at wall and floor junctions, detracting from presentation and allowing dust and debris to accumulate. Prolonged exposure of unprotected wall edges may also result in minor damage or moisture absorption.  
A licensed carpenter should be engaged to install, refix, or complete the skirting to match adjoining finishes and ensure a neat, consistent appearance. These works can be carried out at the owner's discretion

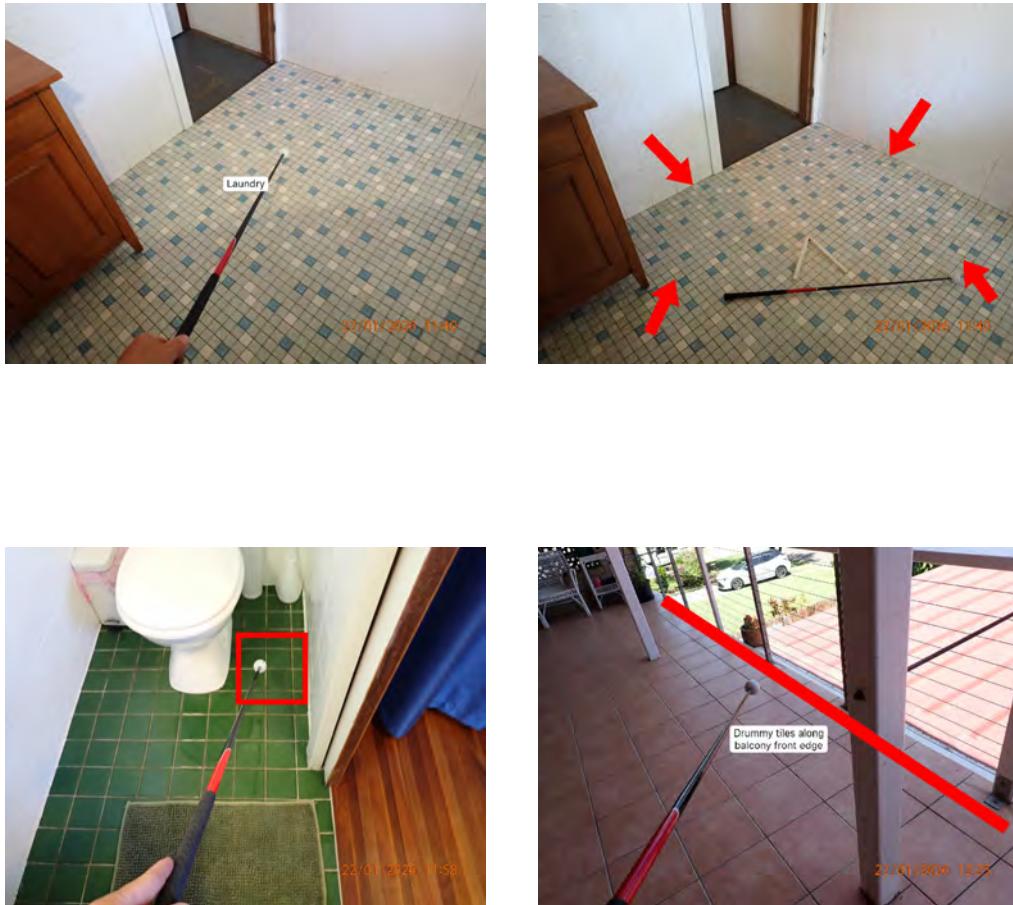
### Finding 3.16

Building:	Main Building
Location:	All Areas All Areas, Ground Level
Finding:	Tiles - Drummy
Information:	<p>Drummy tiled areas were identified at the time of inspection. The term 'drummy' refers to tiles that have become detached from their fixing, despite otherwise being in relatively good condition. Such defects are generally caused by physical or moisture damage to the area. Drummy tiled areas may also be a direct result of poor workmanship during the construction process.</p> <p>Tiled areas may swell and shrink with changes in air humidity if the area has sustained moisture damage. Any exposure to moisture is capable of causing tiled areas to become drummy and/or cracked over a prolonged period of time. Drummy tiled areas generally require removal and replacement of affected tiles, with adequate sealant and grouting.</p> <p>Specialist trades are available for these types of services. A licensed builder may be required to undertake works if damage is extensive or if secondary building defects have resulted. Otherwise, it is advised that a tiling contractor be appointed to perform works as necessary. Immediate action is recommended to ensure that no further damage is sustained in the affected area.</p>

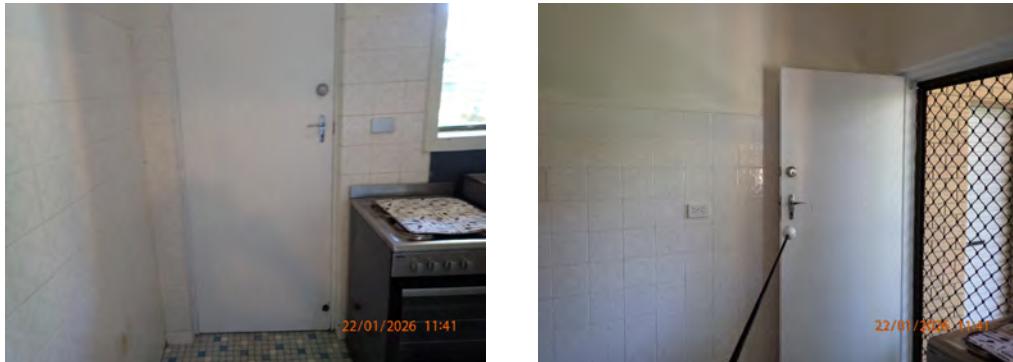
Finding: WD | Door | Dent/crack to door

While not uncommon, damage of this nature may affect presentation and could worsen over time if left unmanaged. A licensed carpenter or door specialist should be engaged to repair or replace the affected door as required. These works can be carried out at the owner's discretion.

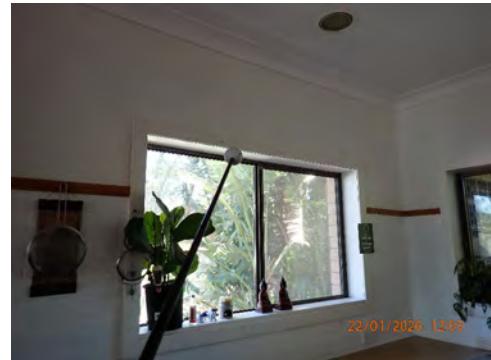
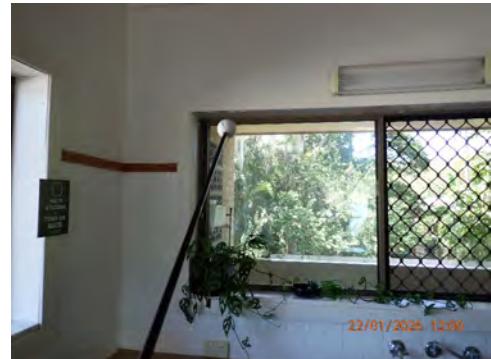
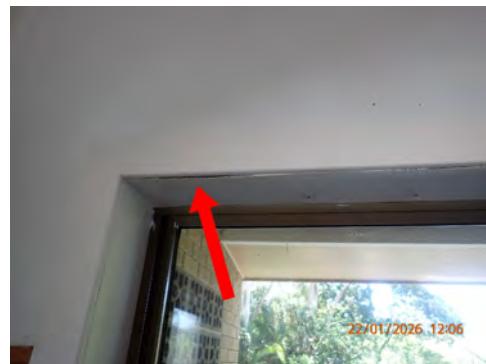
### Finding 3.20

Finding: WD | Window | Damage noted to multiple windows

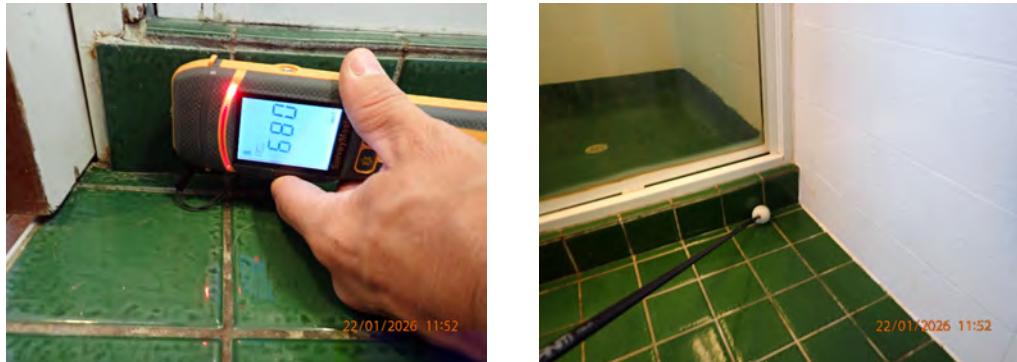
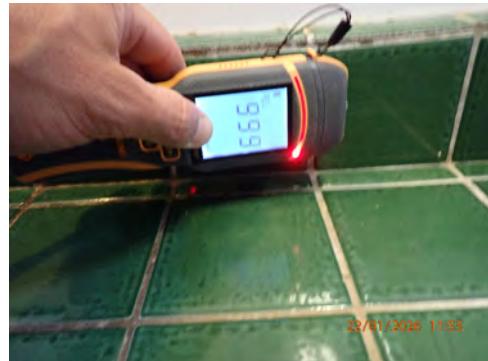
### Finding 3.24

Building: Main Building  
Location: Ensuite - Master  
Finding: B | EMR | Moisture detected to shower hob  
Information: At the time of inspection, moisture was detected to the shower hob. No active water leakage was confirmed at the time of inspection.

Ongoing monitoring and routine maintenance of grout and sealant is recommended as part of normal property upkeep. If moisture readings persist or increase, consultation with a licensed builder or waterproofing specialist may be undertaken at the owner's discretion to provide further advice or carry out remedial works if required.

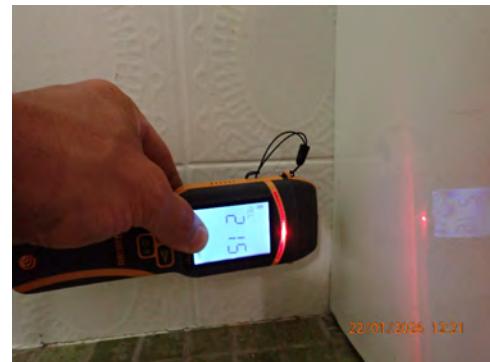
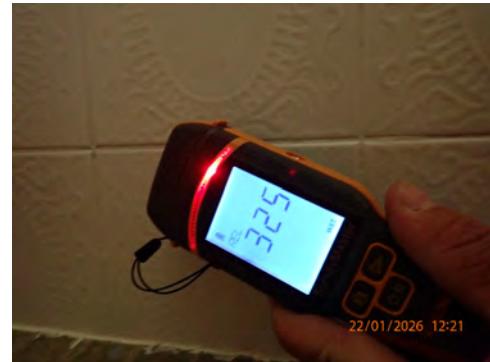
### Finding 3.32

Building: Main Building  
Location: Bedroom 2 ensuite  
Finding: B | EMR | Moisture observed at ensuite basin junction

The moisture meter used operates on a scale from 0 to 999. Readings above 200 are considered elevated. Concealed damage could not be ruled out, and further invasive inspection may be required to determine the full extent of any concealed moisture-related issues.

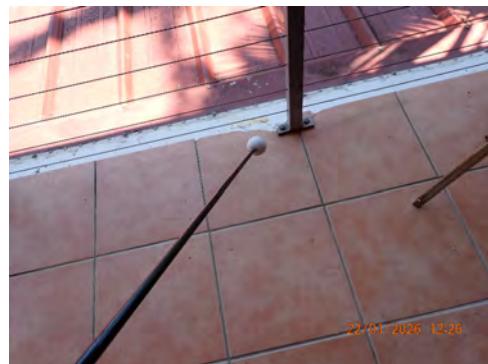
### Finding 3.34

If left unmanaged, cracked tiles may worsen over time and can allow moisture to penetrate beneath the tiled surface, potentially leading to deterioration of underlying materials. A licensed tiler or builder should be engaged to assess and repair or replace the affected tiles as required. These works should be attended to as soon as practicable.
