Pre Purchase Building & Pest Inspection 17/42 Bilin Road Myocum

Property Address: 17/42 Bilin Road Myocum 2481

Inspection Date: 4 Feb 2026

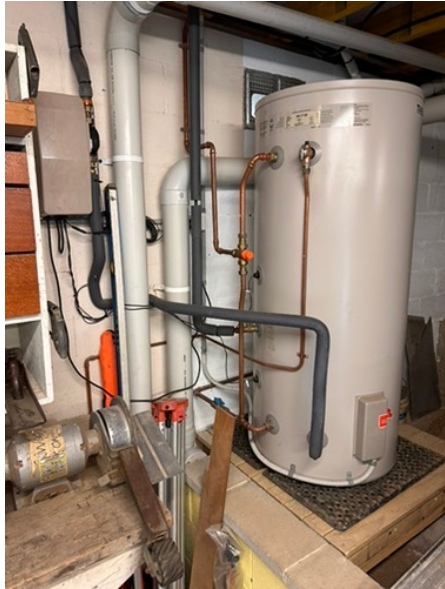
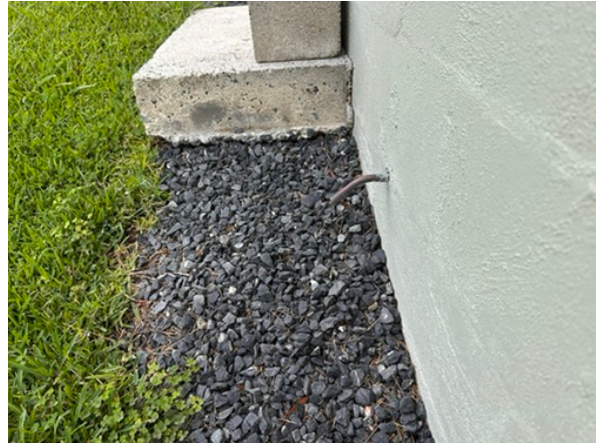
Conditions conducive to timber pest attack 1.01

The hot water system overflow spout is placed too close to the house, which could lead to moisture issues affecting the building's integrity. It's important to redirect the overflow spout further away from the structure to prevent potential water damage. A plumber can easily adjust the spout to ensure water is safely diverted away, protecting your property from unnecessary dampness and ensuring peace of mind.
