# Pre Purchase Building & Pest Inspection 100 Redgate road

Property Address: 100 Redgate Road South Golden Beach 2483

Inspection Date: 21 Jan 2026

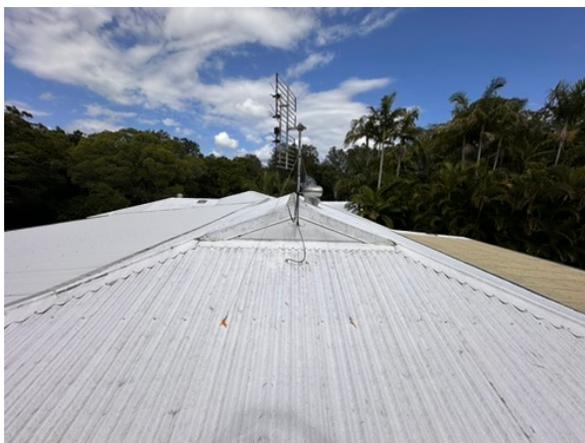
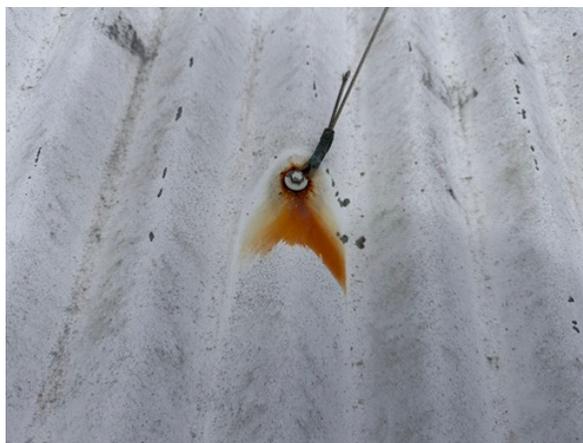
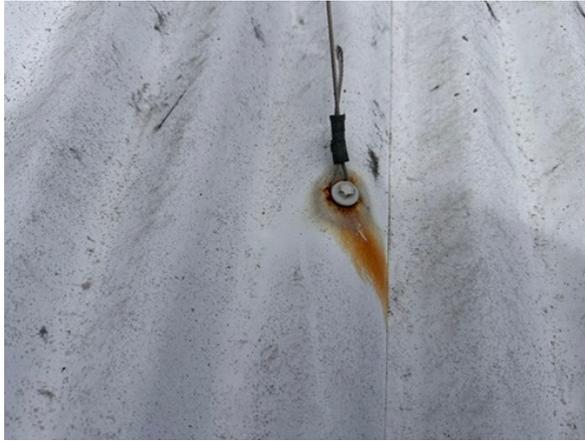
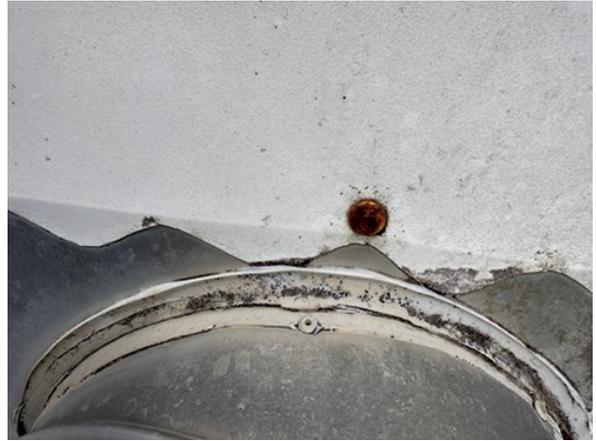
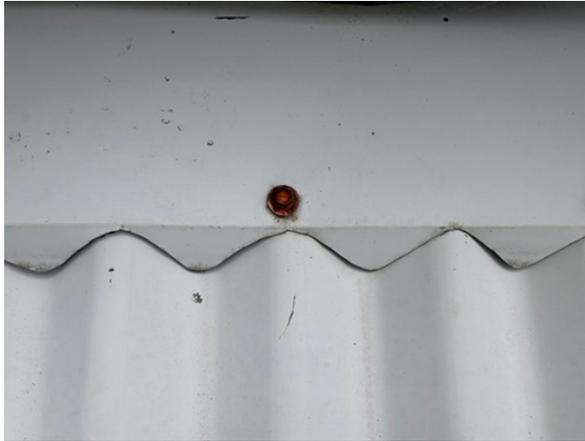
### Minor Defect 1.01

**Location:** Roof exterior

**Finding:** The roof's got some rust taking hold, mostly around the fixtures and edges. While it's not urgent right now, it would be wise to consider swapping out those rusty parts sooner rather than later to prevent further damage. A good idea might be to replace the affected sections and apply a protective coating to the entire roof. Taking care of this now could save you from bigger headaches down the line.

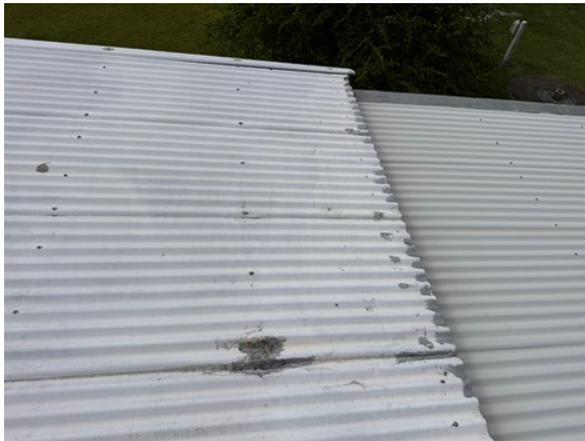
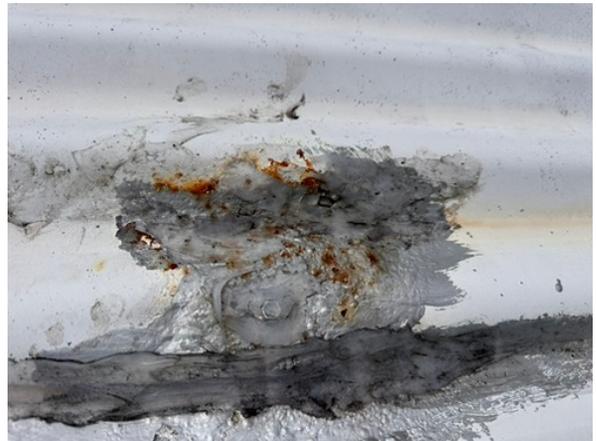
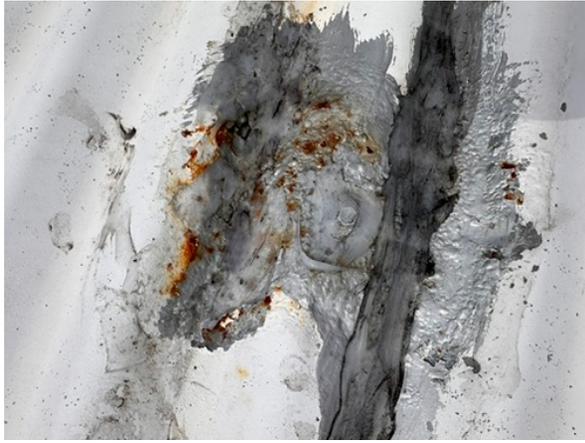
## Minor Defect 1.02

**Location:** Secondary Dwelling Roof Exterior

**Finding:** One of the sheets on the secondary dwelling's roof exterior has been patched with silicon, indicating potential wear or damage. While this is a temporary fix, it might not hold up against weather conditions over time. I'd recommend considering a replacement of the affected sheet to ensure the roof remains secure and waterproof. Taking this step will help prevent future leaks and maintain the integrity of the roof.

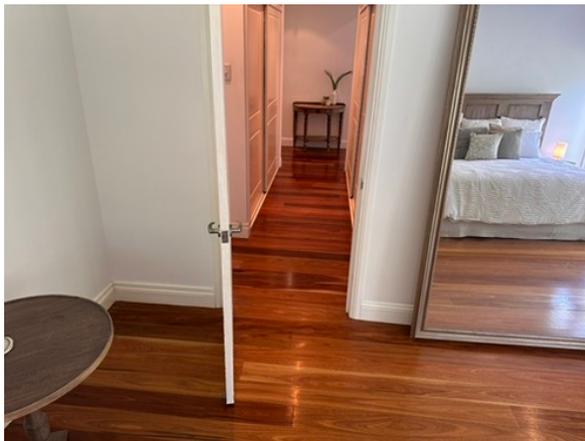
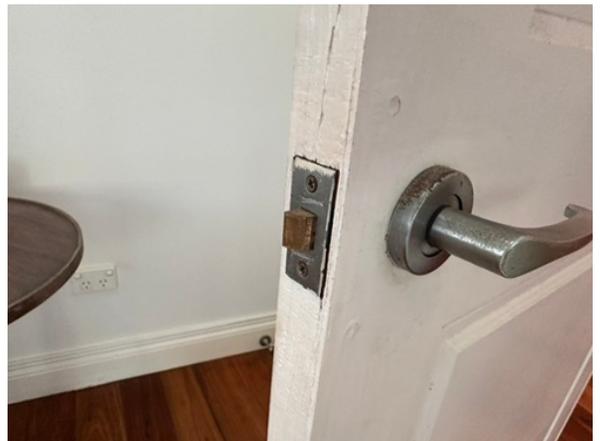
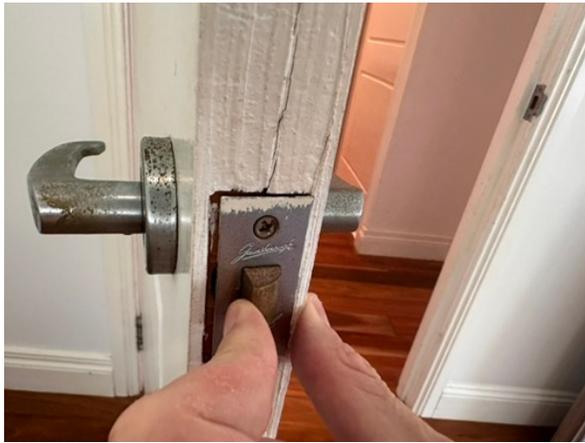
**Location:** Master bedroom

**Finding:** The door latch in the master bedroom is visibly worn and appears slightly misaligned, which might be impacting its functionality. This can lead to issues with locking and closing securely, compromising privacy. It would be a good idea to have a handyman realign the latch and check for any potential wear that might require replacement. This small fix will ensure the door operates smoothly and maintains the overall comfort of the room.

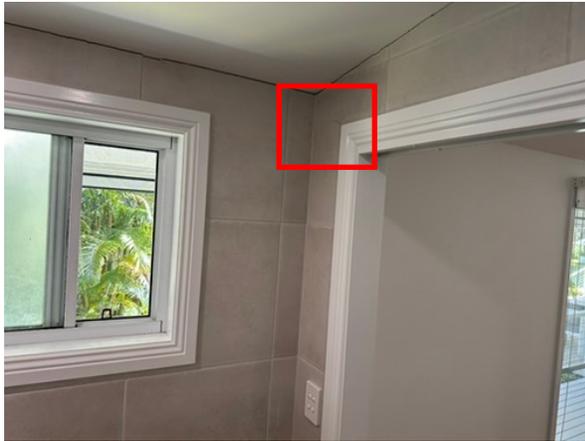
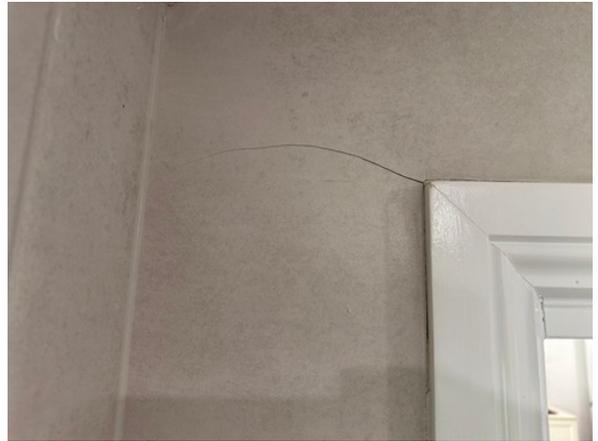
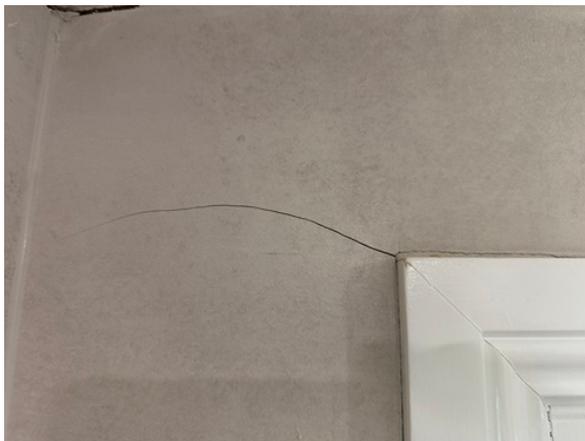
## For your information 2.02

**Location:** Granny Flat Area Inside The House

**Finding:** It looks like there's a small crack in one of the tiles near the door frame. While it doesn't appear to be a current concern, it's a good idea to keep an eye on it for any changes. A simple remedy could be to reapply some sealant to ensure it's secure. Regularly checking the area will help catch any potential issues early on, so you can address them before they become a bigger problem.

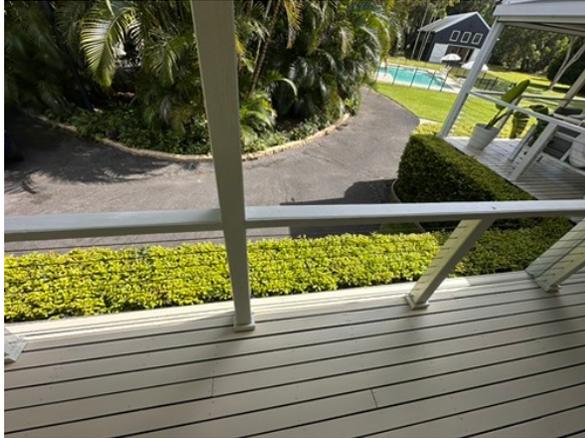
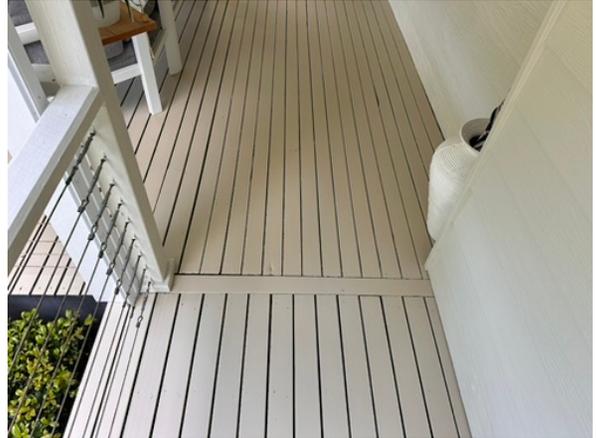
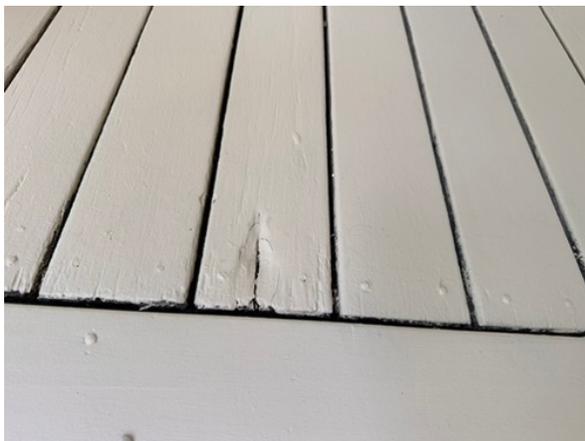
## For your information 2.03

**Location:** Front Deck

**Finding:** The front deck has a couple of boards showing signs of aging, indicating they may soon require replacement or some maintenance. These boards are starting to wear, which is typical over time, but it's a good idea to consider replacing them sooner rather than later. To keep the deck in good condition, a targeted replacement of these aging boards would be beneficial. Regular treatment and sealing of the entire deck can also help prolong its lifespan and maintain its appearance.

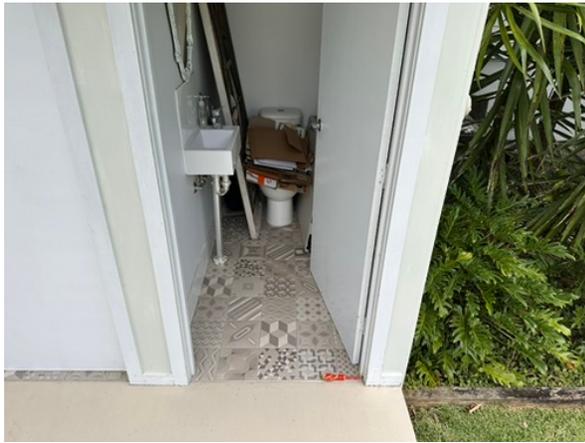
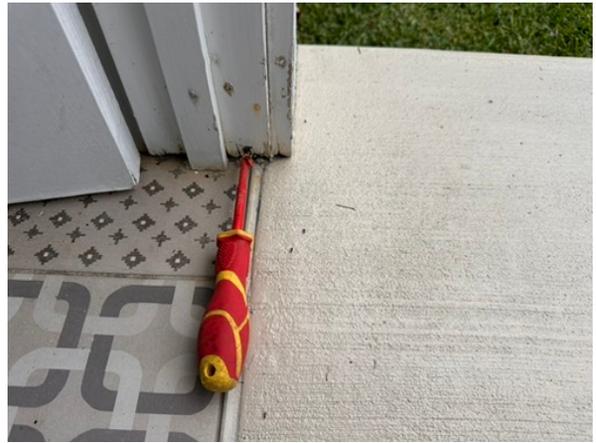
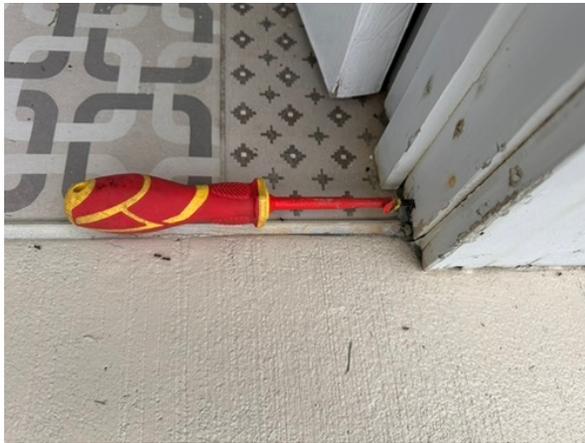
## For your information 2.04

**Location:** External Bathrooms

**Finding:** The bottom of the door jamb in the external bathrooms is showing noticeable signs of deterioration, possibly due to moisture exposure. This can lead to further structural weaknesses if not addressed promptly. To remedy this, it's advisable to remove any damaged material and replace or reinforce the area with water-resistant wood or composite materials. Additionally, applying a sealant or protective coating can help prevent future damage. Regular maintenance and inspections will ensure the longevity of the repair.

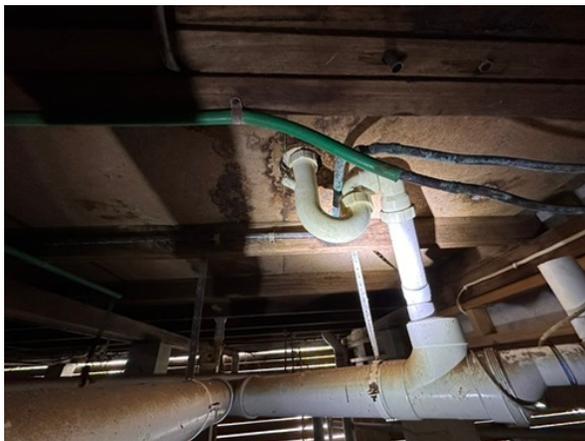
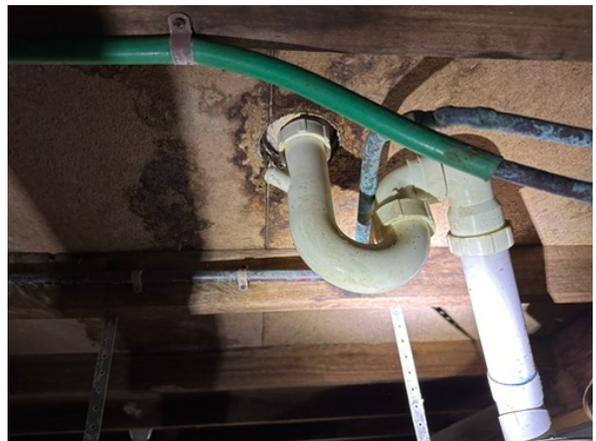
## For your information 2.05

**Location:** The Secondary Dwelling Subfloor

**Finding:** In the secondary dwelling subfloor, there are noticeable signs of an old water leak, though it appears to be dry now. It seems the leak was around the plumbing area, likely corrected over time. While it's not actively leaking, it's smart to replace any affected materials to prevent mold or structural issues down the line. It would be beneficial to have a professional assess the plumbing to ensure nothing's been overlooked and to keep everything in tip-top shape.

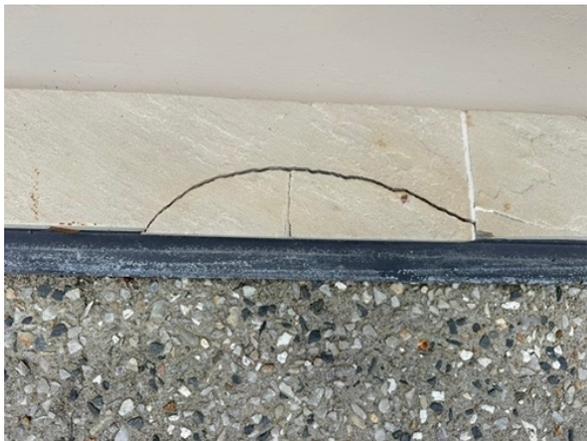
## For your information 2.06

**Location:** Barn

**Finding:** The barn has a cracked tile in a high-traffic area, which could potentially worsen with regular use. This type of defect not only detracts from the aesthetic appeal but also poses a tripping hazard. To fix this, consider replacing the cracked tile promptly. Choose a durable tile that matches the existing ones for a seamless look. Consulting a professional for installation could ensure it withstands future wear and tear, maintaining both the safety and charm of the space.

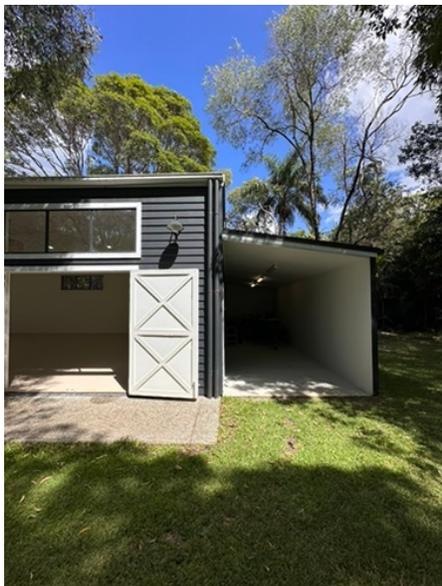
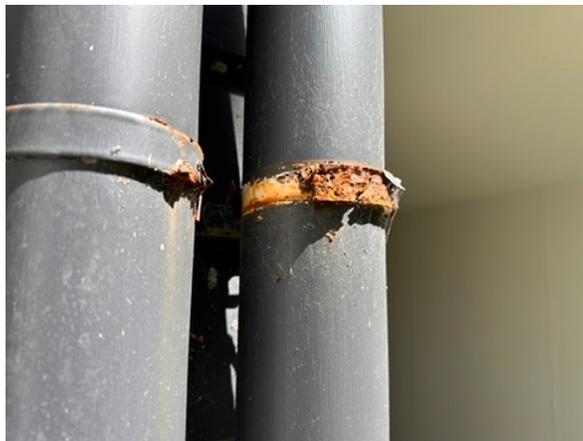
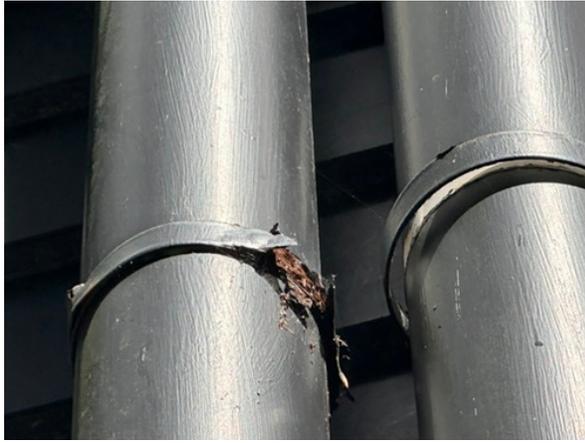
## For your information 2.07

**Location:** Barn

**Finding:** The barn is experiencing an issue with rusted out downpipe brackets, which need replacing. It's a pretty straightforward fix, but important to address sooner rather than later to prevent further damage. I recommend getting a professional to replace these brackets with new, rust-resistant ones to ensure the downpipes are securely attached and functioning properly, safeguarding the surrounding structure.

**Lastly, rusted downpipe brackets in the barn should be replaced to safeguard structural integrity. Addressing these issues will ensure the structure remains secure and protected.**

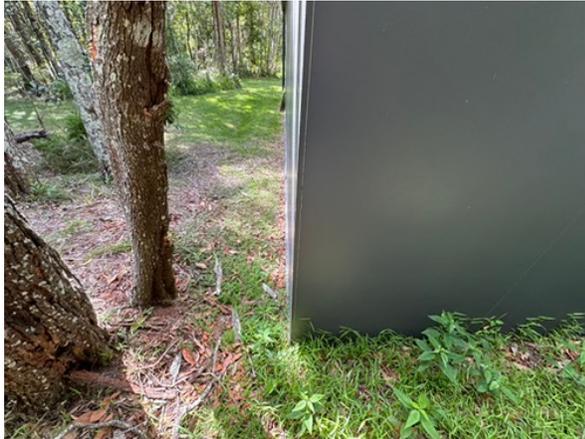
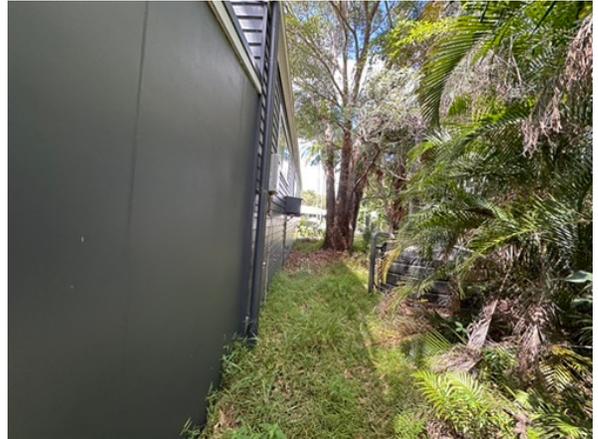
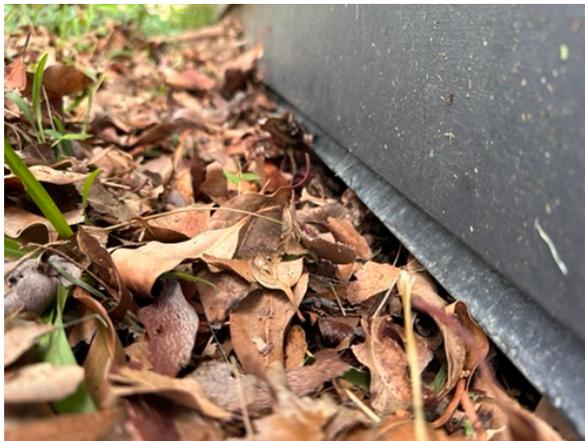
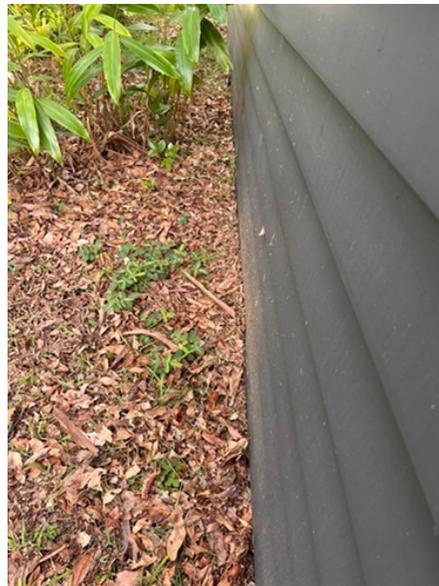
### Conditions conducive to timber pest attack 3.01

**Location:** Barn

**Finding:** The barn currently lacks a visible barrier on one side, where grass and leaves are directly against it—offering an easy path for termites. To address this, it's recommended to clear vegetation and leaves away, creating a gap of at least 100mm . Installing a physical or chemical termite barrier will further protect the structure, preventing termite entry and potential damage.

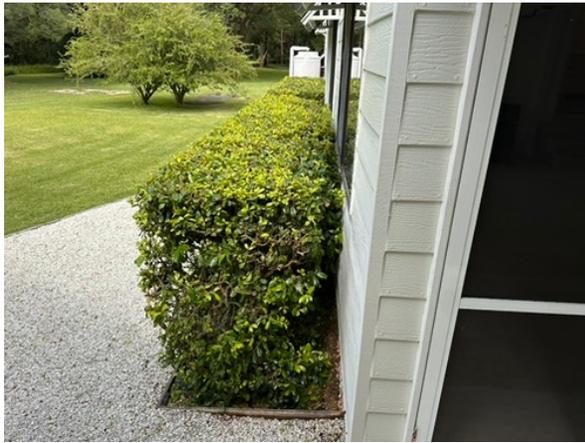
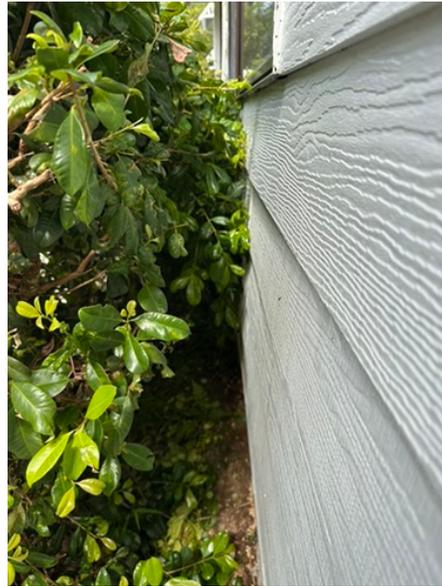
### Conditions conducive to timber pest attack 3.02

**Location:** Secondary Dwelling Exterior

**Finding:** The secondary dwelling's exterior has plants up against the house, causing a potential termite risk. This close contact can act as a bridge for termites to access the structure. To mitigate this, it's recommended to trim or remove these plants and ensure a clear visible barrier between vegetation and the exterior walls. This will help in preventing termite infestation and protect the integrity of the dwelling.
