PEST AND BUILDING PRE-PURCHASE REPORTS

BUILDING & PEST INSPECTIONS

157 Coopers Shoot Road
Coopers Shoot

157 Coopers Shoot Road, Coopers Shoot.

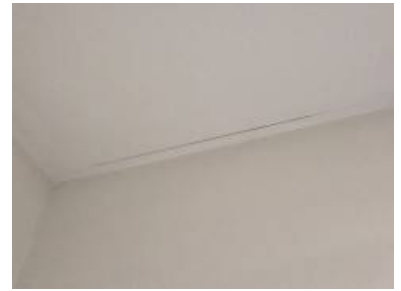
Some ceiling corners in ensuite bathroom needs resetting and repainting.

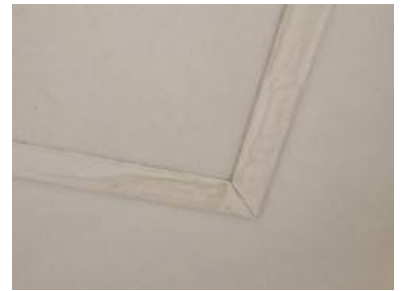
Signs of past water penetration to Man hole in pantry.

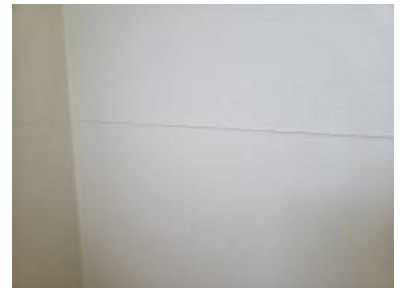
Minor cracks to some wall sheet joints to toilet room in ensuite. *These types of cracks are common and are generally due to minor settlement &/or material shrinkage.*

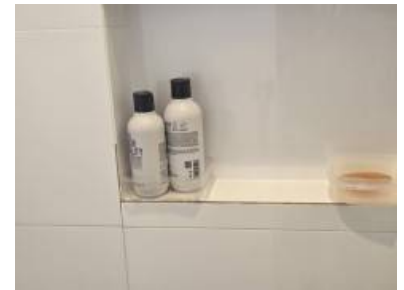
Shower neash in ensuite needs resealing.

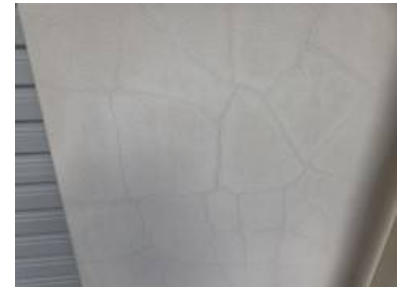
Cracks present to some render. *These types of cracks are normal / common and are generally due to material shrinkage consistent with the age of the building.*

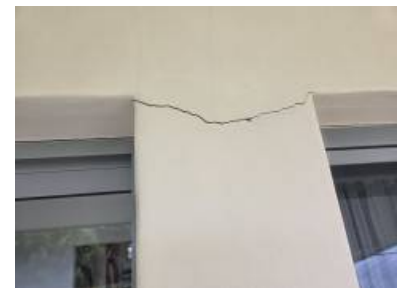
Cracks to brickwork at Master bedroom between windows
Minor.

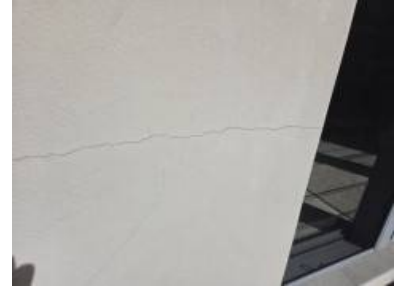
Cracks present to some render.

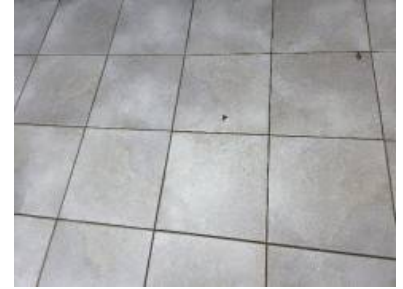
Some floor tiles require re-grouting / sealing.

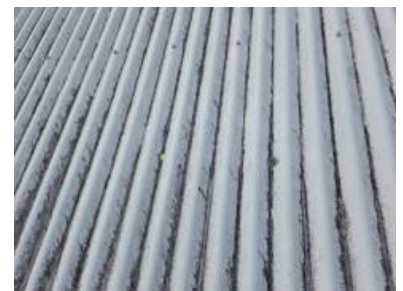
Satisfactory, Needs cleaning.

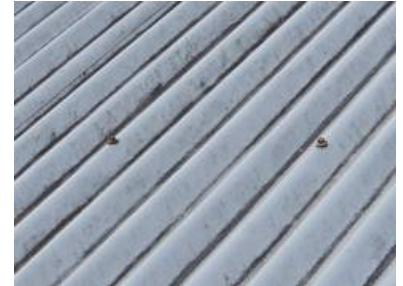
Condition:
Some roofing screws show signs of rust and require replacement. Failure to do so may allow the rusted screws to cause rust to the roof sheeting.

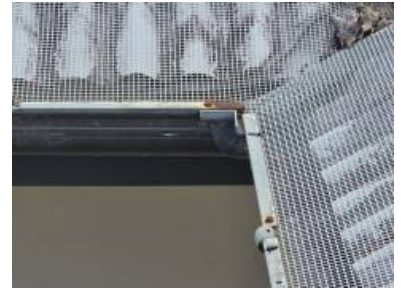
Rust to some gutter guard needs replacing.

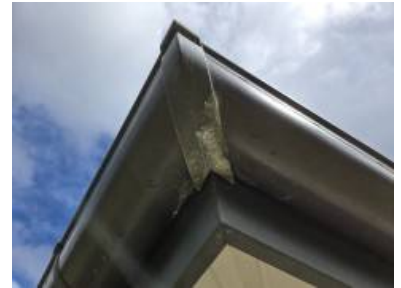
Surface rust to some gutter joins requires repair with kill rust.

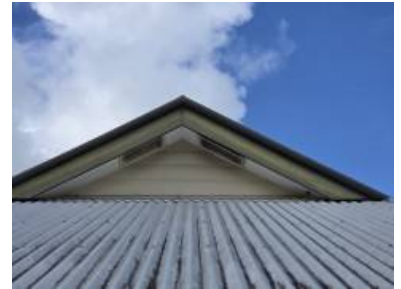
Some fascia boards need repainting at apexes.

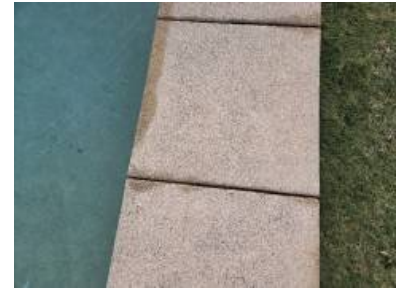
Some mortar to the perimeter pool paver coping has eroded. The coping pavers requires re-grouting with mortar.

I recommend a qualified swimming pool builder / specialist be engaged for further inspection of the swimming pool.

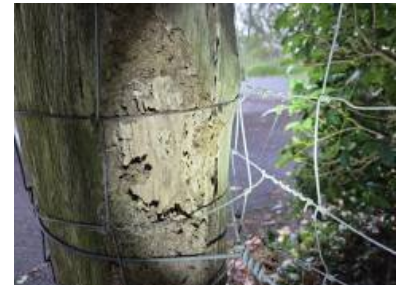
Affected timbers were mainly but not limited to the following fences - Posts.

The visible damage to the timbers appears to be moderate. Further damage may exist in concealed areas. Please refer to the definitions section of this report - Section 1.2 - Timber Damage.
