Inspection Report

Naraic Building & Pest Inspections Pty Ltd

2 Jonson Street, Byron Bay, NSW, 2481

Pest And Building Inspection

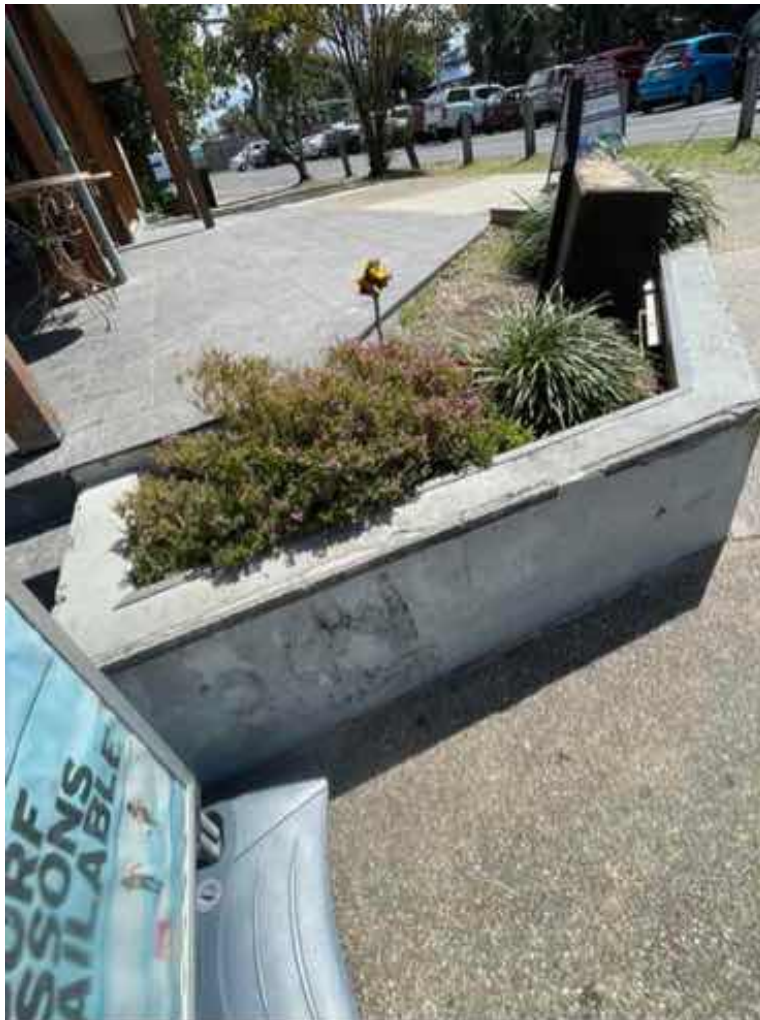
Salt residue/damp damage evident to retaining wall. A qualified landscaping or brick laying contractor should be engaged for advice and recommendations.

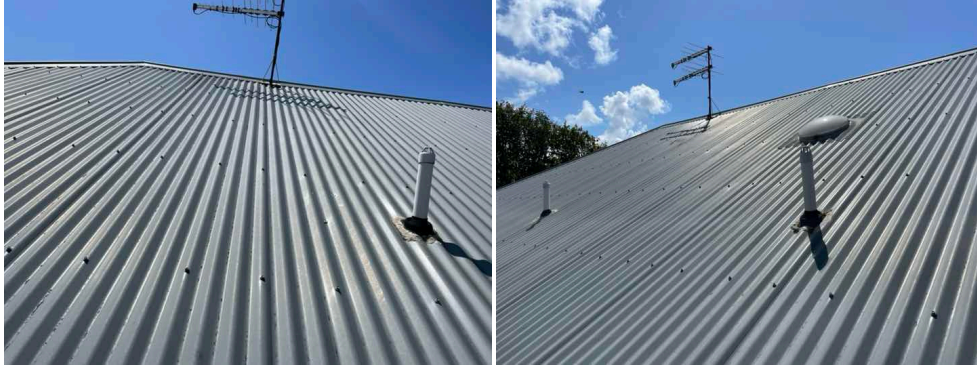
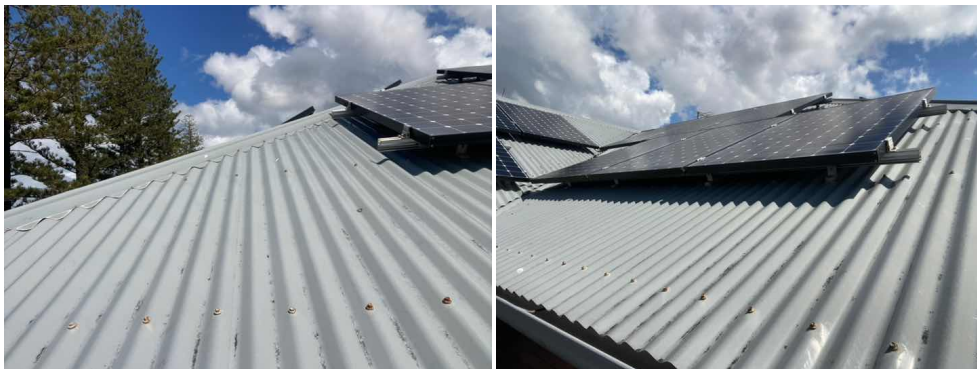
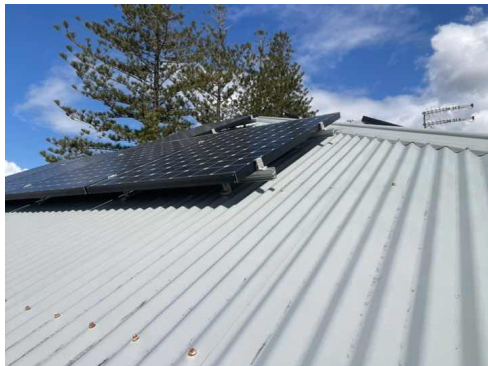
Corrosion noted to the screw fixings of the metal roof. Have these checked and replaced by qualified roofing contractor.

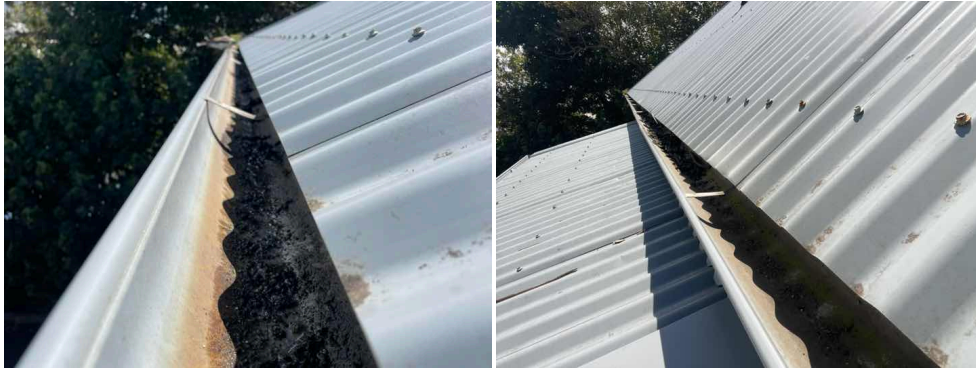
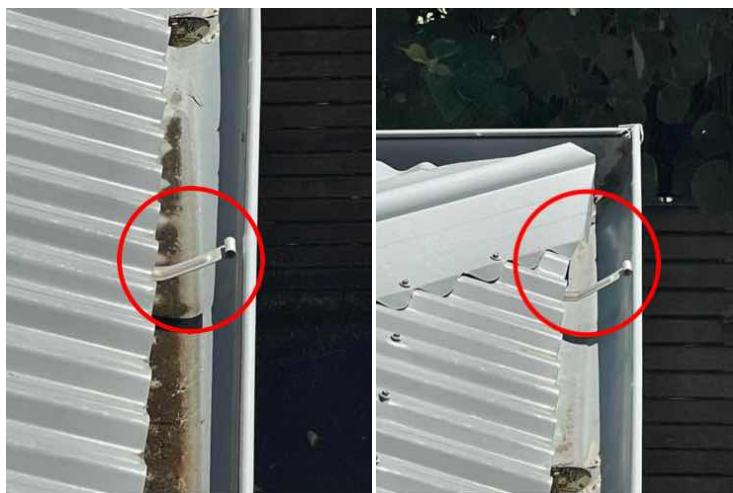
The gutter clips have detached in areas. Recommendations: This can be rectified by maintenance contractors.

Debris in guttering areas- this requires cleaning out to prevent blocking of downpipes and leaking into eaves and fascia. Have gutters cleaned and assessed by a plumber for adequate fall. Regularly clean to prevent ponding. Ponding water will contribute to rust.

Gutter ponding - This can relate to poor fall, inadequate down pipes, gutter or debris build up. If debris presence has been noted above clean same out and re-assess for any ponding. If clean guttering is ponding it can be a blocked down pipe or the guttering fall is inadequate. A qualified roof plumber should be engaged for advice and recommendations.

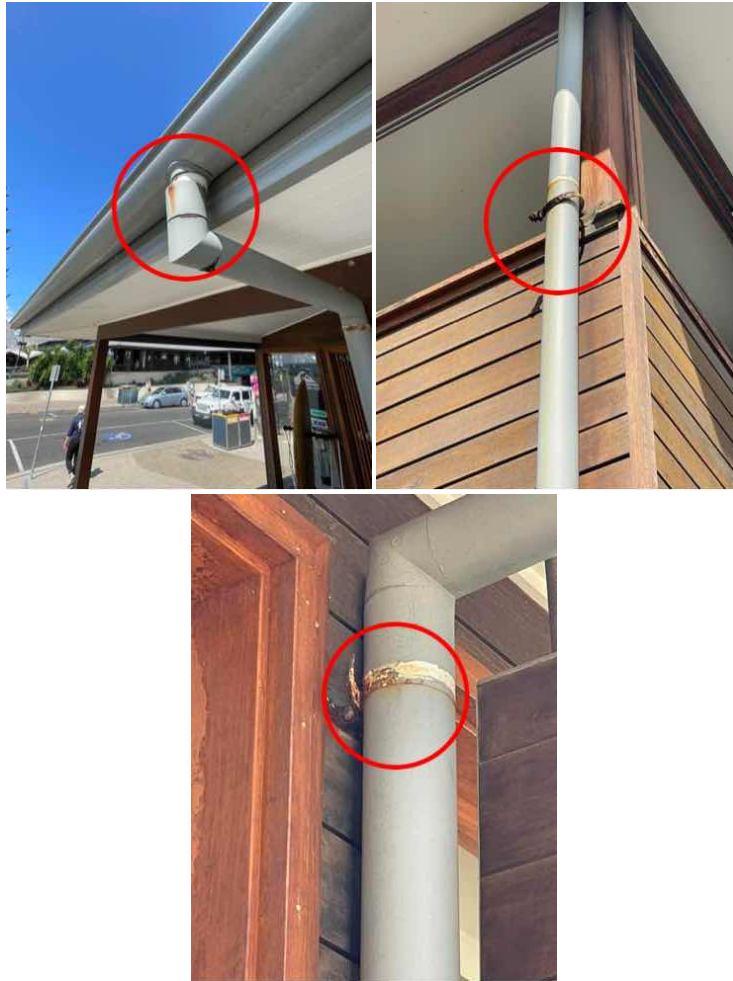
Rusty brackets

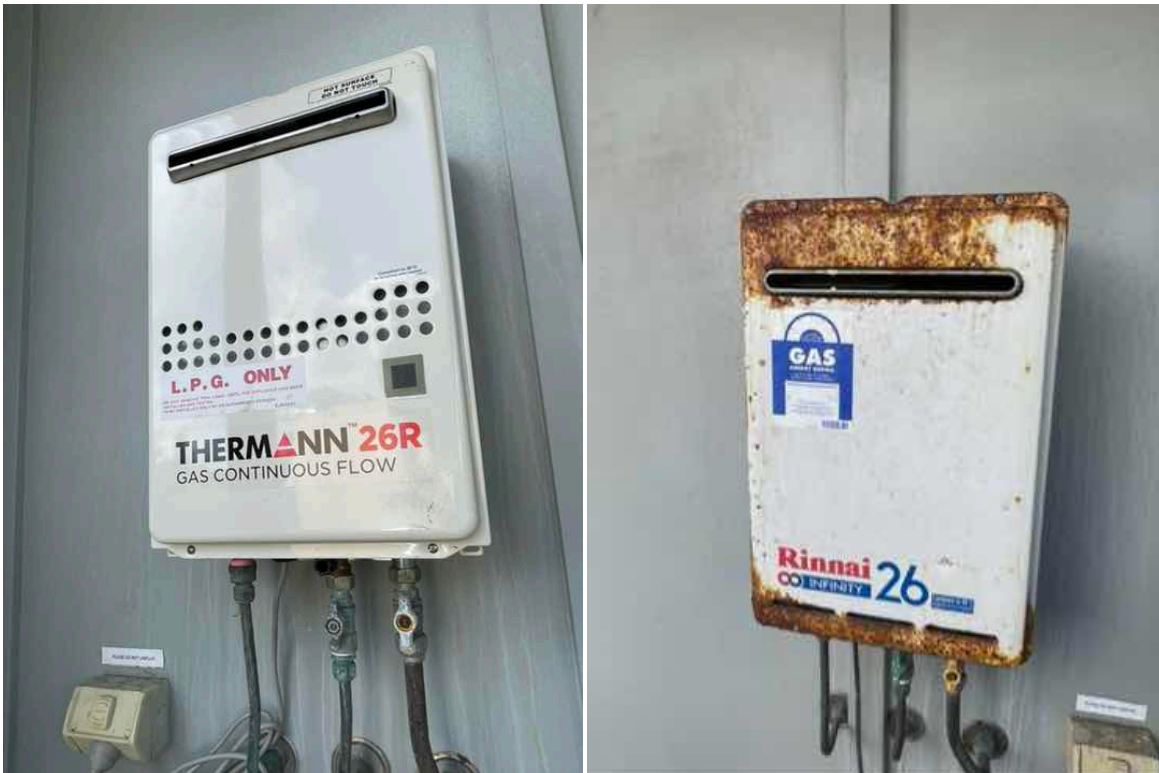
General rust deterioration was observed on the hot water unit casing. We recommend you replace the unit.

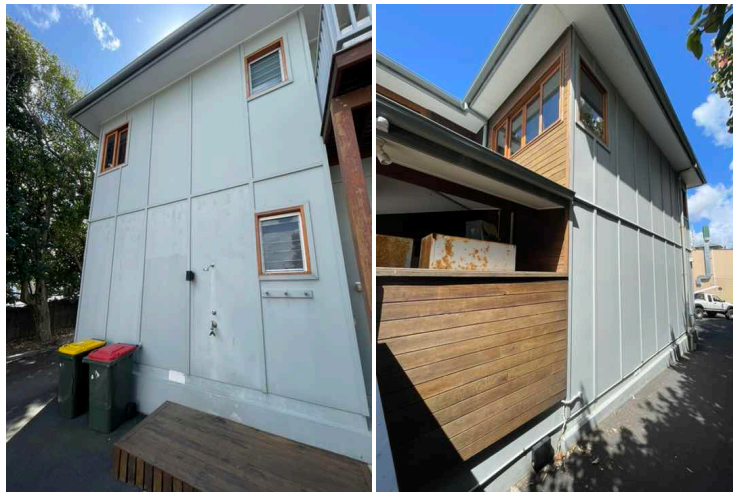
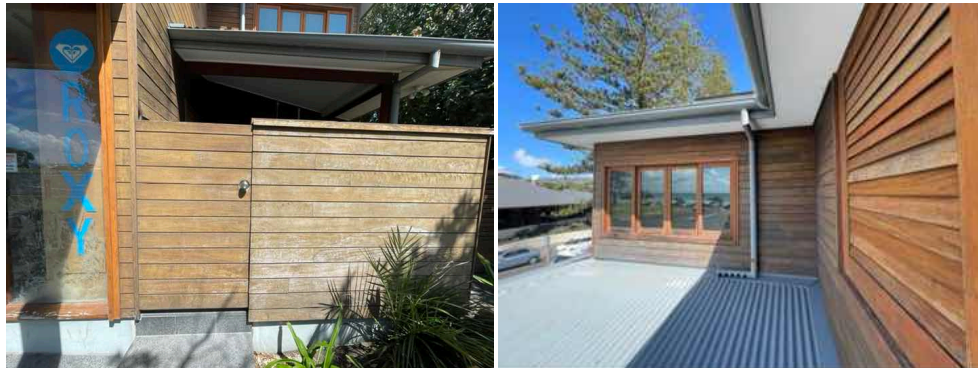
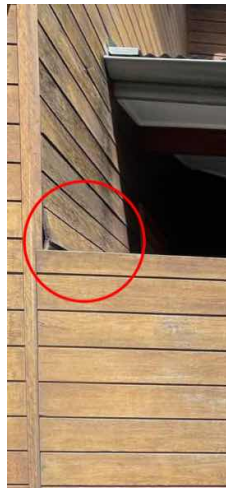
Paneling/cladding damaged. Have a suitably qualified tradesman assess and repair.

Cladding fixings are rusting and coming through the paint.

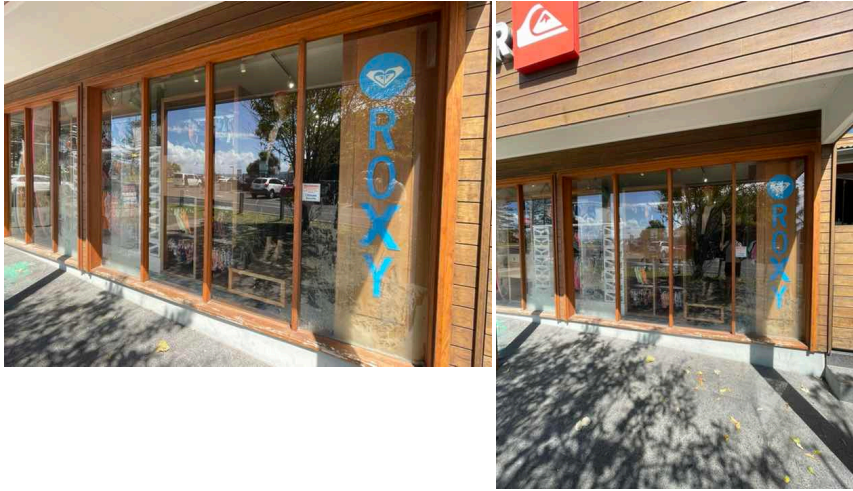
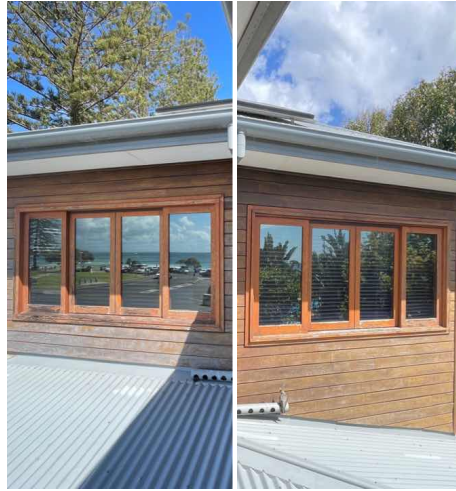
Cracked window pane. A qualified glazier should be engaged to repair.

Sections of the external windows have paint deterioration. Engage a qualified painter for repairs.

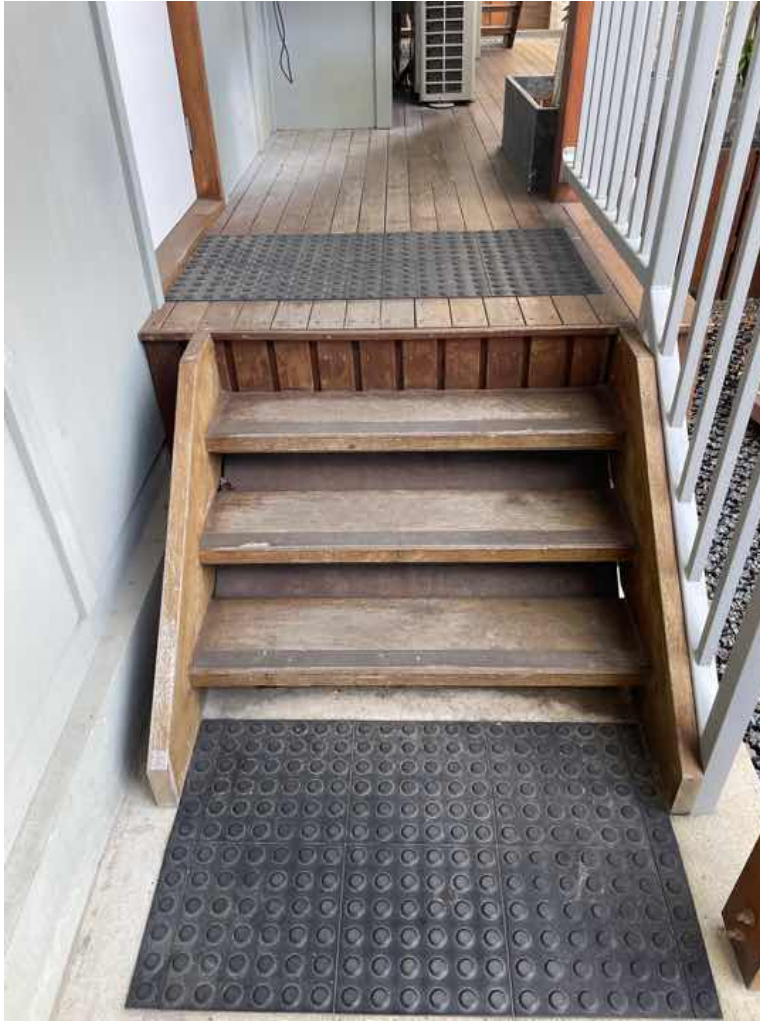
There are no rails on the stairs. This presents a fall risk. Have repaired immediately.

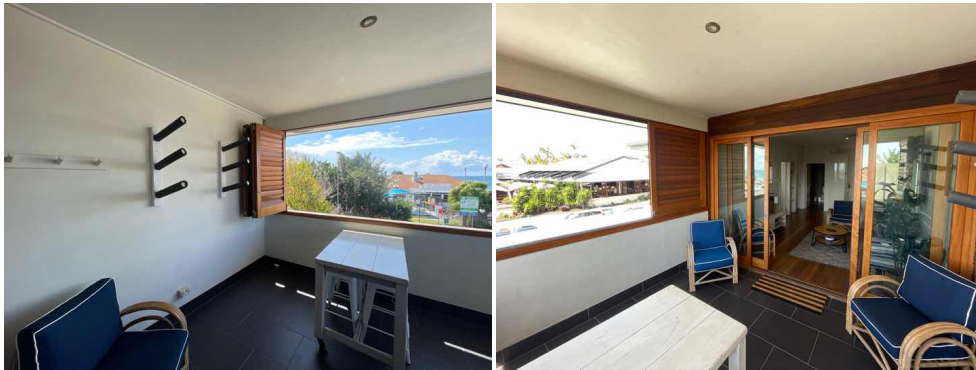
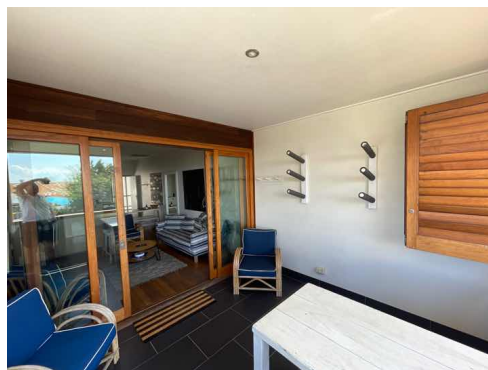
Minor eave deterioration & ageing evident. Recommendations: Maintenance works, general upkeep should be carried out.

Settlement Cracks Noted. These are typical and generally patch and paint will suffice, however monitoring these cracks is advised for 12 months and if they become worse, further investigation by a suitably qualified professional is advised.

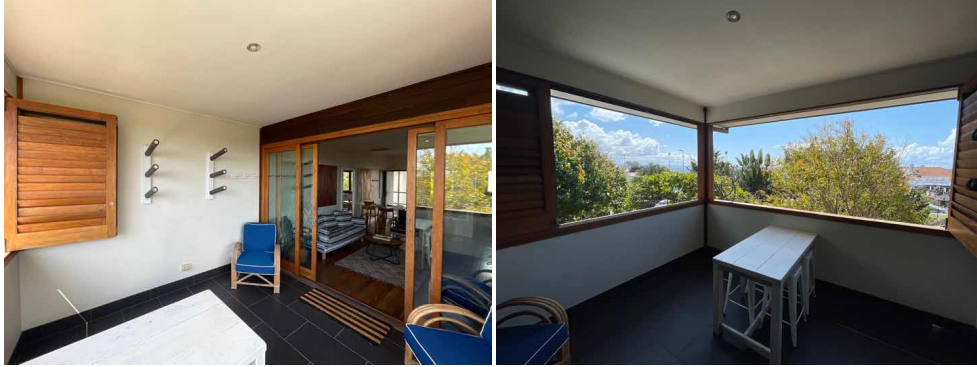
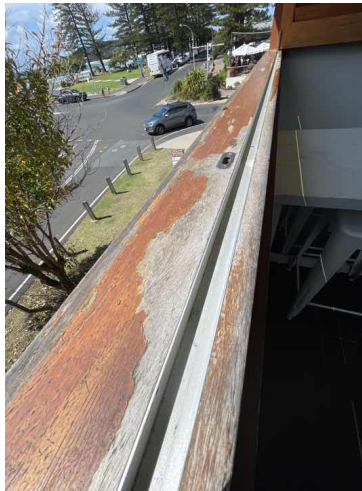
Minor eave deterioration & ageing evident. Recommendations: Maintenance works, general upkeep should be carried out.

Settlement Cracks Noted. These are typical and generally patch and paint will suffice, however monitoring these cracks is advised for 12 months and if they become worse, further investigation by a suitably qualified professional is advised.

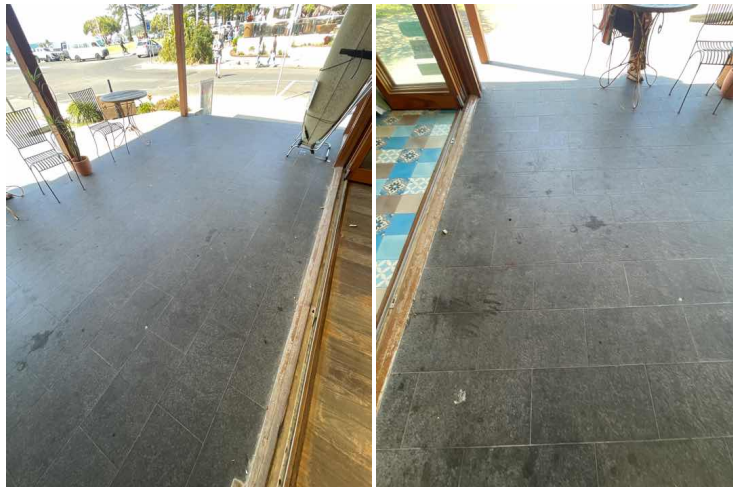
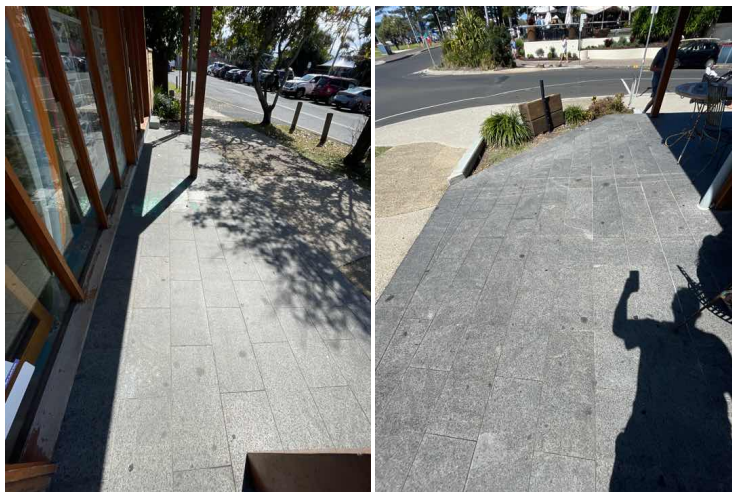
Tiles are drummy and loose. This needs to be fixed by a qualified tiler to eliminate any water penetration issues.

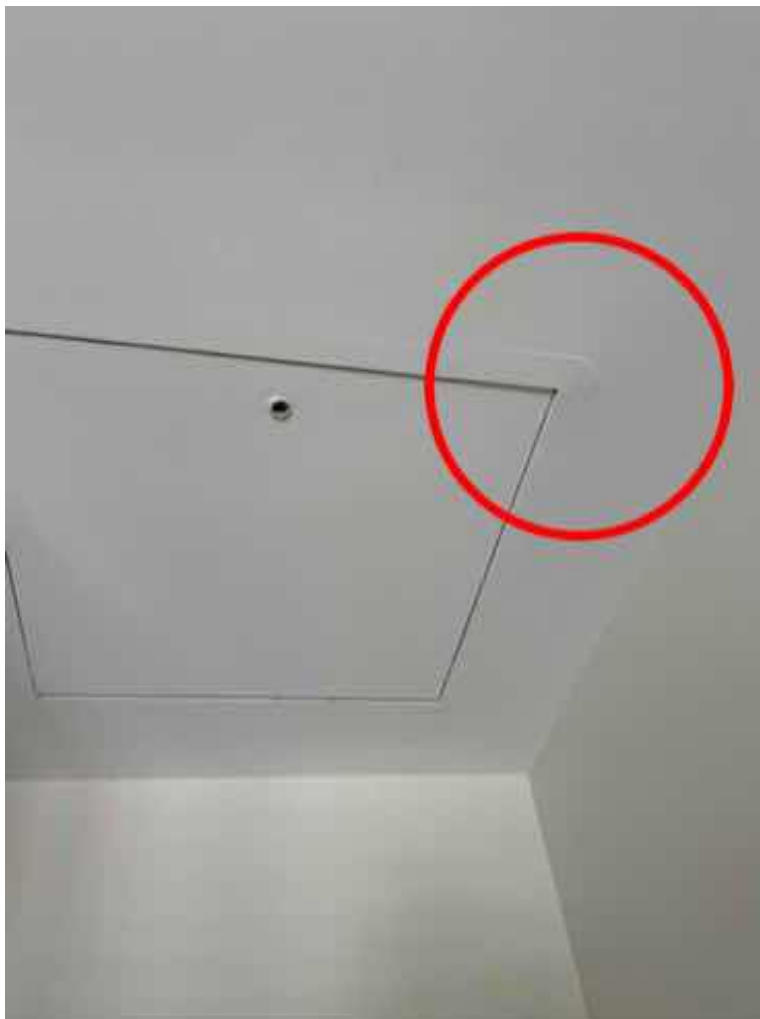
Settlement Cracks Noted. These are typical and generally patch and paint will suffice, however monitoring these cracks is advised for 12 months and if they become worse, further investigation by a suitably qualified professional is advised.

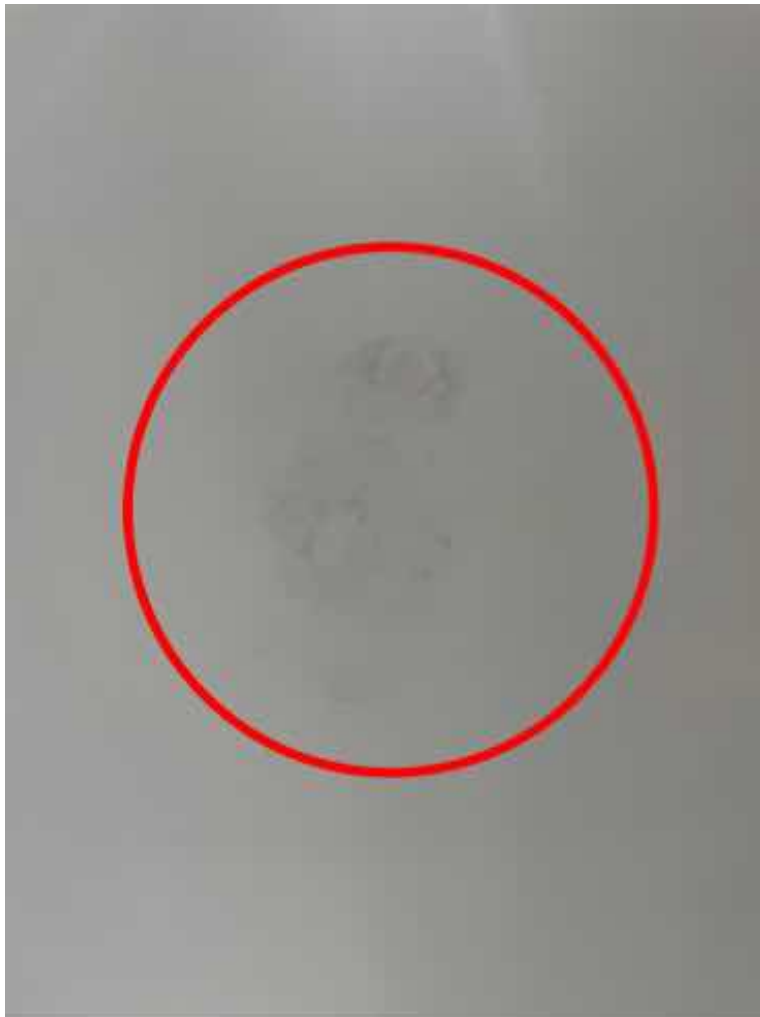
Ceiling stains - Moisture readings obtained. In the absence of rain It's difficult to ascertain with certainty the location of the leak. A qualified roofer/roofing plumber should be engaged for advice and recommendations. All water damaged plaster should be replaced.

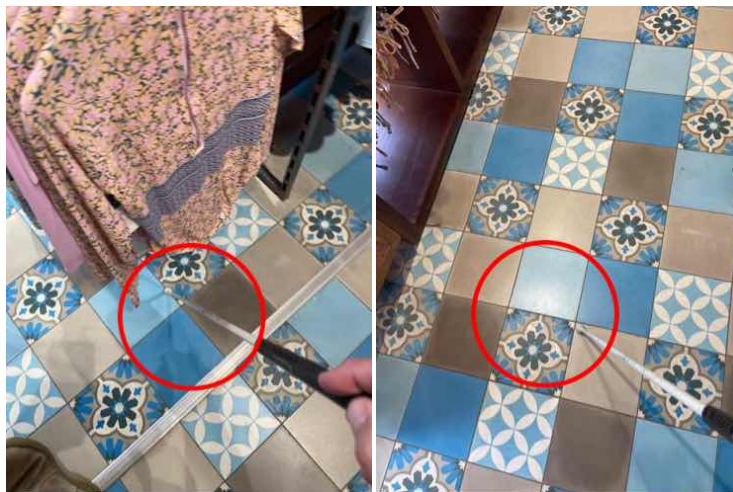
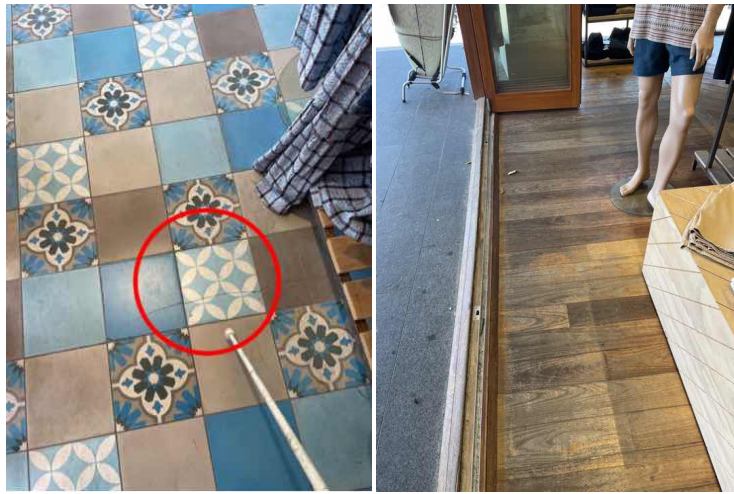
Cracked floor tiles noted. A qualified tiler should be engaged for repairs.

Drummy/loose tiles observed. Tile lift and further deterioration likely. Contact a qualified tiler for repairs.

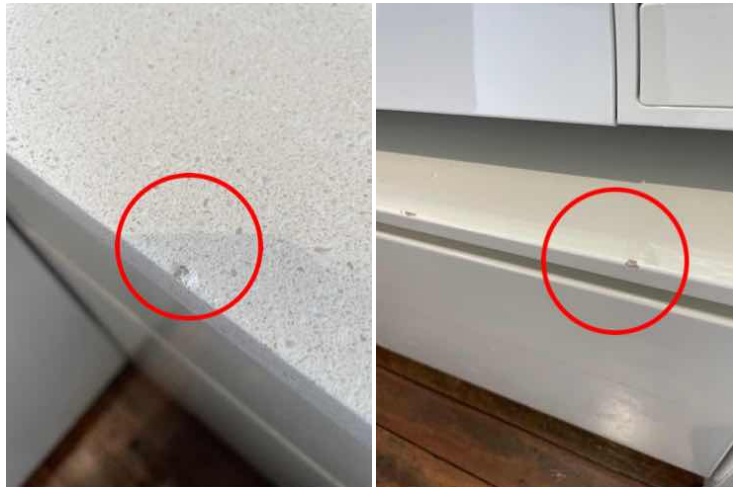
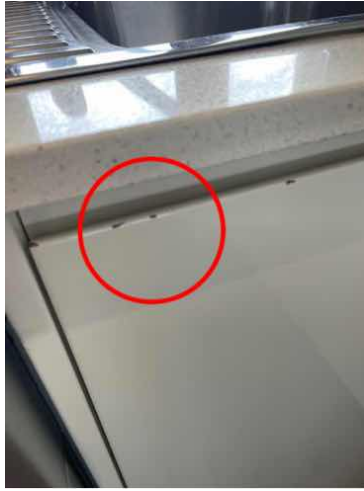
Adjustment to cabinet doors required, in some instance hinges may need to be replaced.
Damage was noted to the bench top, contact a joinery company for repairs
