BUILDING & PEST INSPECTIONS

49 Shelley Drive
Byron Bay

BPI - INSPECTION REPORT

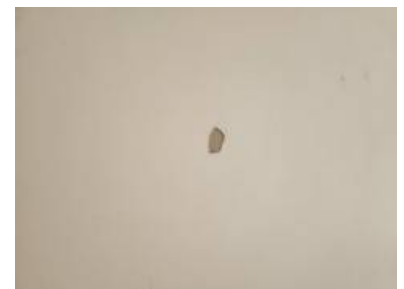
Some minor damage to wall sheeting requires touching up / repair / repainting.

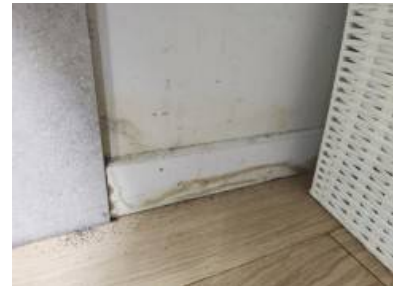
Signs of past water penetration to skirtings under vanity in granny flat.

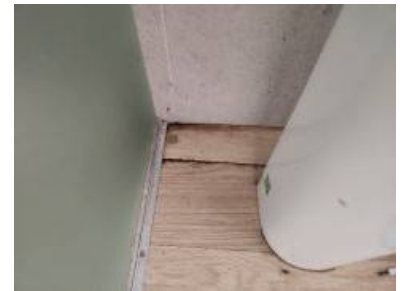
Some flooring shows signs of water penetration / damage to under vanity in granny flat from leaking shower.

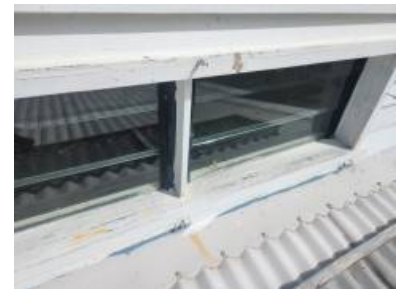
Some highlight window frames show signs of weather damage and require repair / repainting.

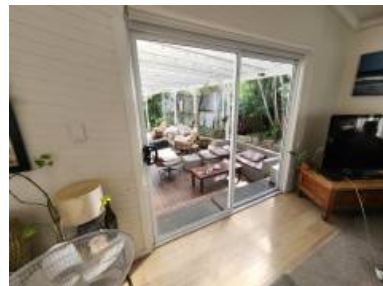
Binding / Loose Fitting / Badly Fitted Doors
Some external slider rollers show signs of wear or are worn and require replacement.

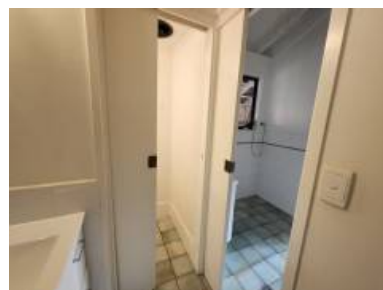
Some slider rollers show signs of wear or are worn and require lubrication / replacement.

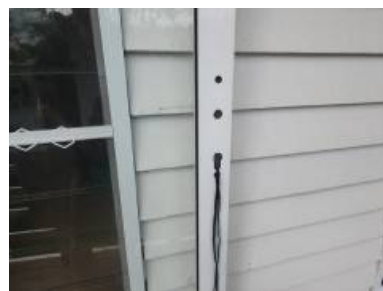
Door Hardware
Handle is missing to bedroom external door.

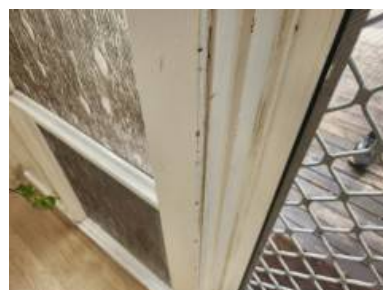
Door Frames
Paintwork to some door frames requires touching up / repainting.

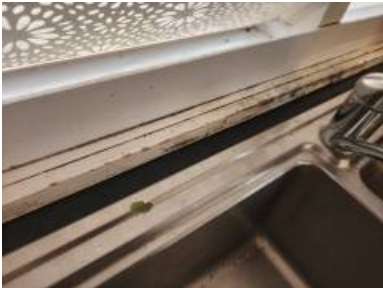
Signs of past water penetration to bench top at sink.

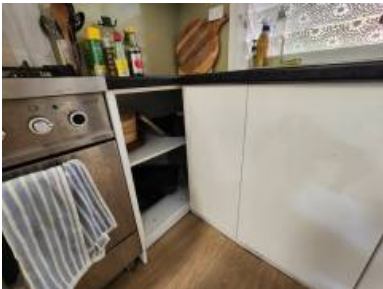
Cabinet door is missing.

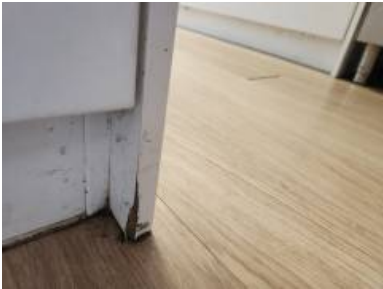
Some cabinets are damaged at bases and requires repair or replacement.

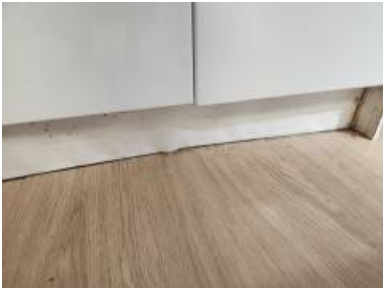
Evidence of water penetration / damage to some cupboard kickboards & need replacing.

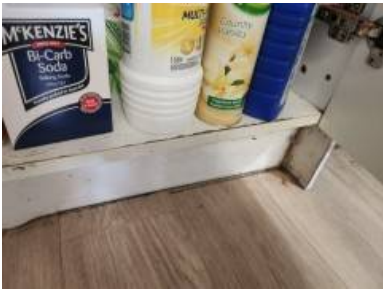
Evidence of water penetration / damage to sink cupboard.

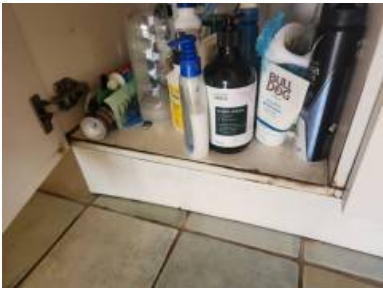
Damage
Signs of past water damage to Bathroom vanity cabinet.

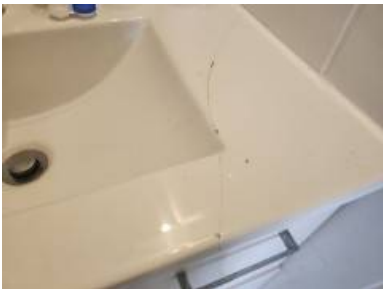
Cracks to vanity bowl.

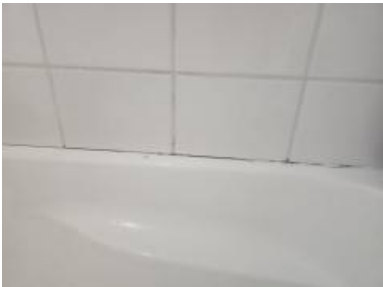
Adequately Sealed
Junctions of Bathroom bath / wall tiles require resealing with silicone.

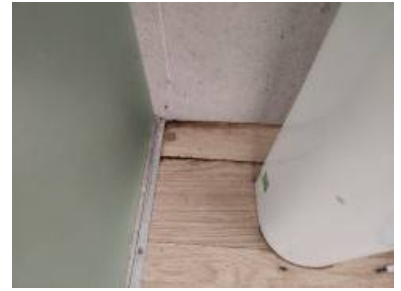
There are signs of high moisture levels to the granny flat floor next to the Bathroom. I recommend that a plumber be engaged to inspect the taps / washers, conduct a compression check on the pipes. If not leaking pipes then I recommend engaging a shower sealer to reseal and water proof the shower floor and walls.

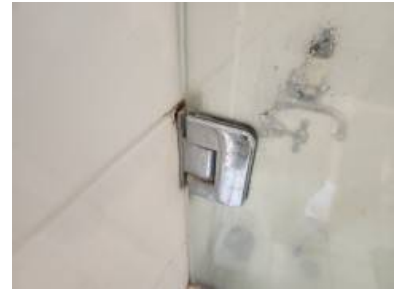
Shower screen hinges need refixing.

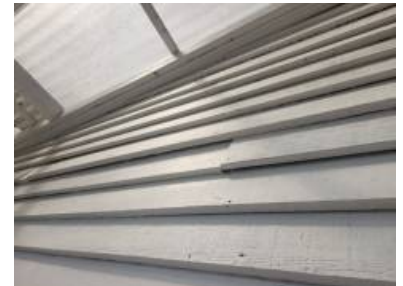
Some Timber weatherboards require refixing.

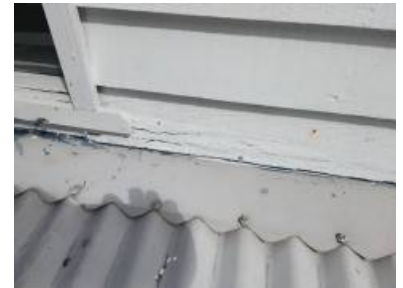
Some Timber weatherboards show signs of weather damage and require repair over lounge room roof and front of garage.

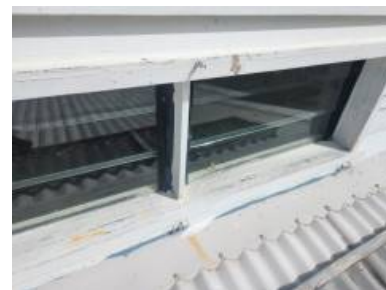
Some frames show signs of weather damage and require repair / repainting.

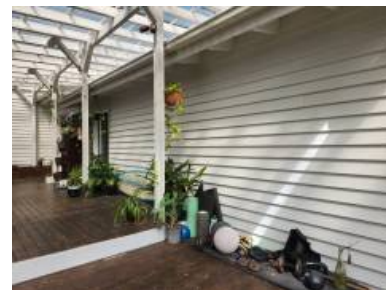
The external paintwork / finish to the external surfaces and timberwork is generally satisfactory. There are some sections / areas that require touching up / repainting.

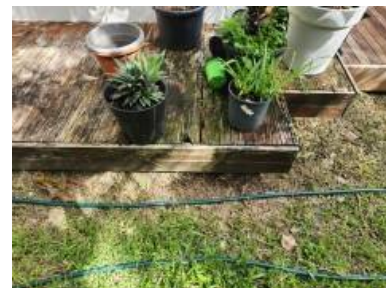
Some verandah decking & framing timbers show signs of weather damage / decay and require replacement.

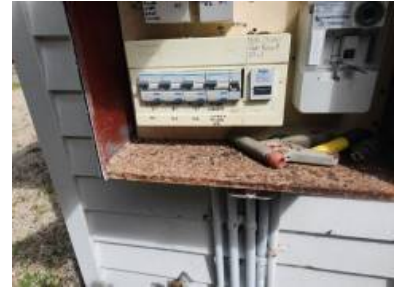
Meter box is showing signs of rust and requires repair.

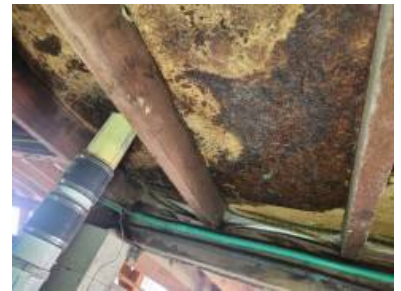
Some flooring shows signs of current water damage to Toilet and requires replacement. A leak is present.

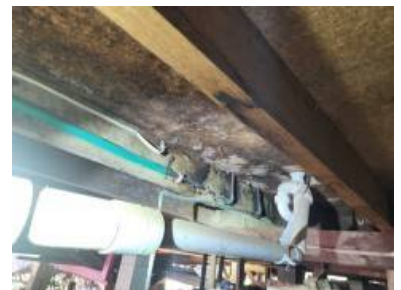
Some flooring shows signs of water damage to Bathroom and requires replacement.

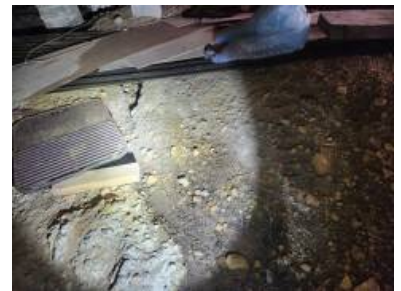
There are signs of past water ponding within the subfloor area.

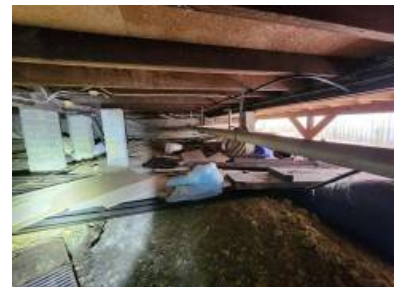
Remove rubbish.

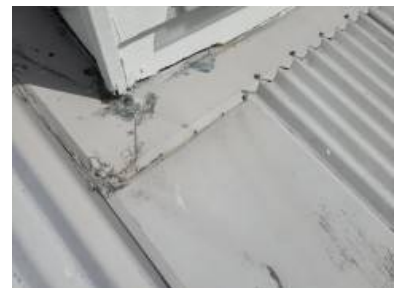
Condition:
Some flashings / joins require refixing / resealing to prevent water penetration.

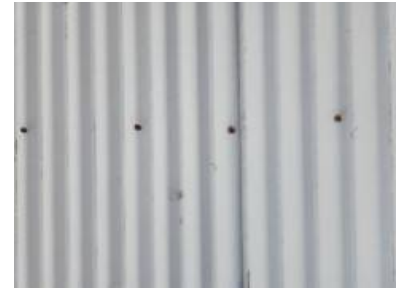
The sheet roofing and flashings are in generally satisfactory condition. Most roofing screws show signs of rust and require replacement.

Most roofing screws show signs of rust and require replacement. Failure to do so may allow the rusted screws to cause rust to the roof sheeting.

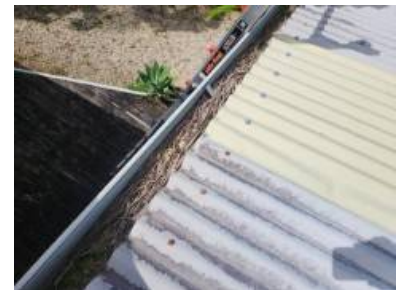
Some sections of guttering are full of debris and require cleaning. Failure to do so may allow water to become blocked and back flow into the roof void causing water damage.

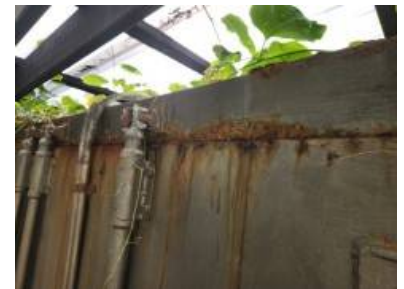
Condition:
Some framing shows signs of rust and requires repair / painting with Killrust or better.

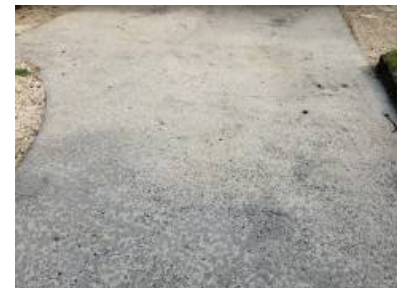
Some surface cracks to concrete slabs.
