Pre Purchase Building & Pest Inspection 26 ribbonwood place

Property Address: 26 Ribbonwood Place Suffolk Park 2481

Inspection Date: 13 Apr 2026

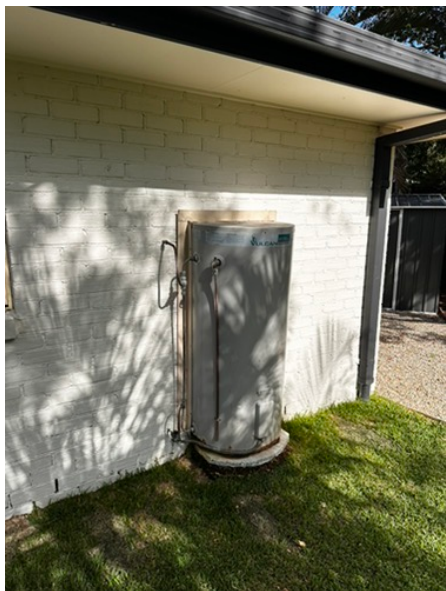
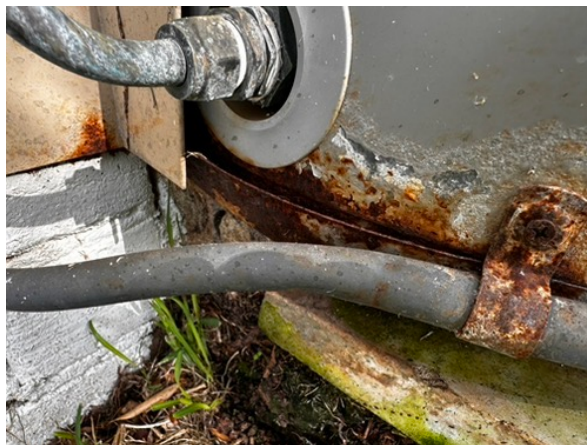
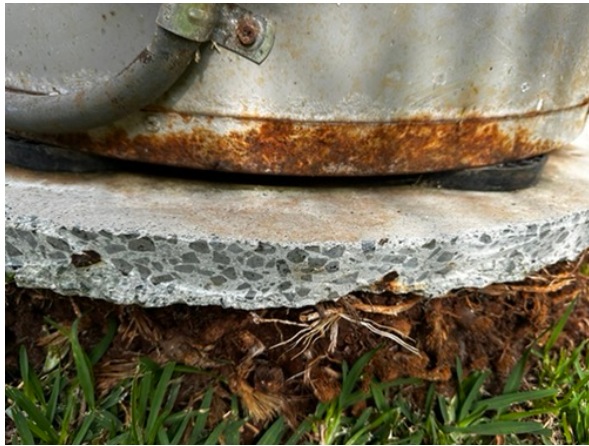
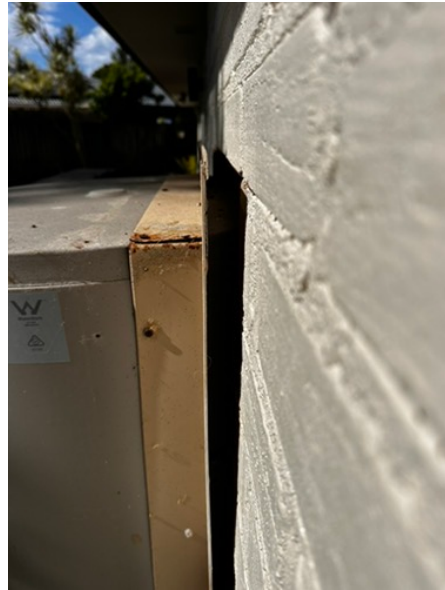
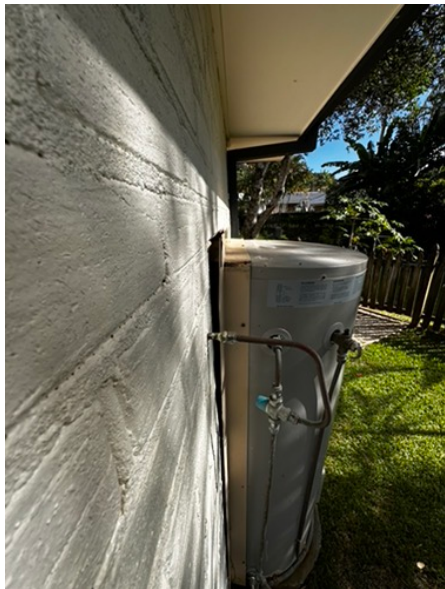
Minor Defect 1.01

Location: Hot Water System

Finding: The hot water system is noticeably leaning and showing significant rust at its base, which suggests it's in need of replacement. This could lead to efficiency issues and even potential failure. For peace of mind and to prevent future headaches, it'd be wise to consider installing a new hot water system before moving in. This ensures both safety and reliability in the long run.

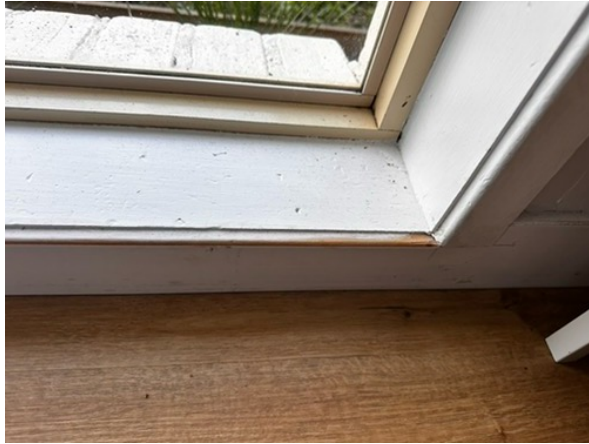
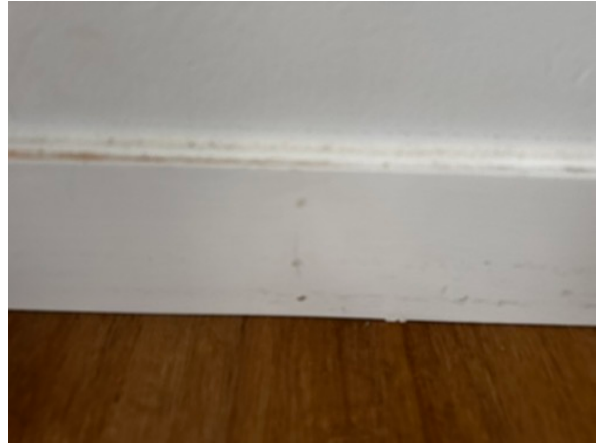
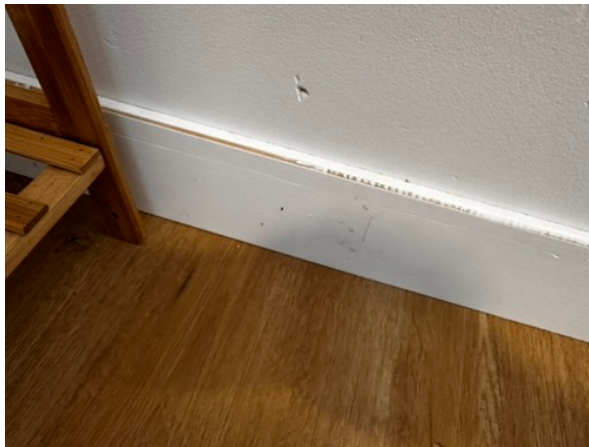
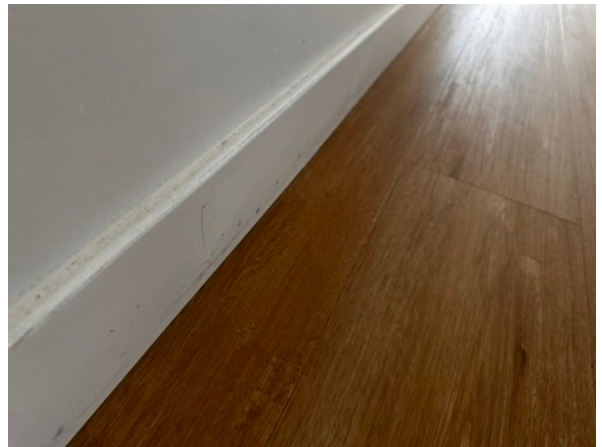
Finding: The skirting boards throughout the house are lacking a proper coat of paint, which leaves them exposed to potential moisture damage. It's important to finish them off with a good quality paint to seal and protect the wood. This simple fix not only spruces up the appearance but also keeps moisture at bay. It would be wise to address this promptly to maintain the integrity

and look of the skirtings.

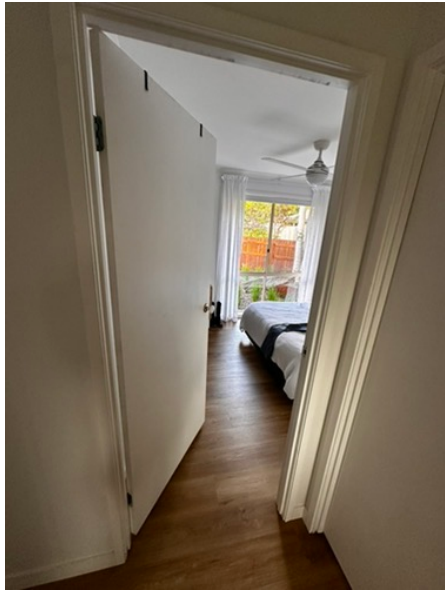
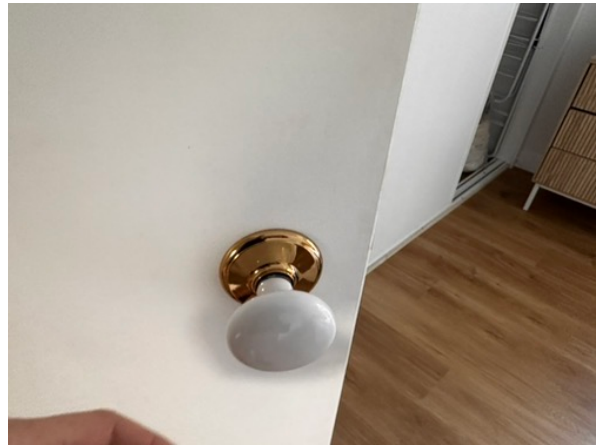
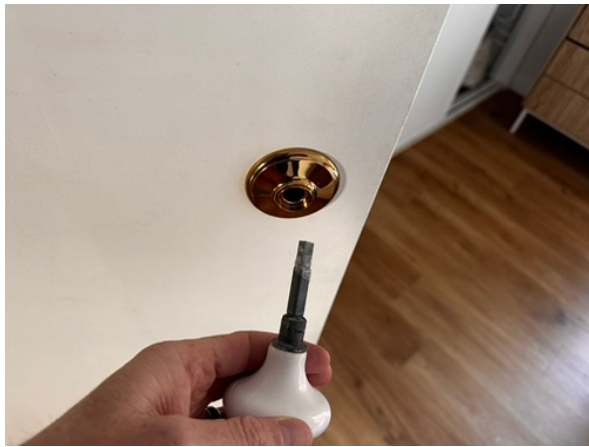
For your information 2.02

In Bedroom 2, there's an issue with the door handle, which is coming off and may not secure properly. This is a minor maintenance concern but can be inconvenient for residents. To fix it, it's recommended to either tighten the current screws, ensuring that all components are aligned correctly, or replace the handle if it appears worn out. This should help restore full functionality and prevent any further issues.

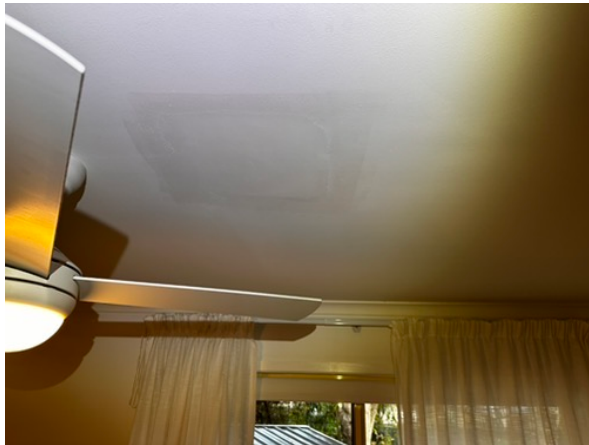
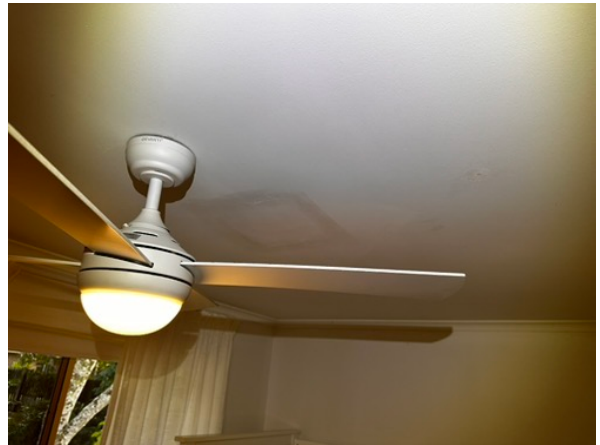
For your information 2.03

Location: Bedroom 3

Finding: In Bedroom 3, there's a noticeable patchwork on the ceiling that stands out, although it poses no structural concerns. The patch could have been due to a previous repair, but it wasn't blended smoothly with the surrounding surface. To improve the aesthetics, it's recommended to sand down the patch slightly and apply a fresh coat of paint to match the existing ceiling color. This will help achieve a seamless look, ensuring the repair is less conspicuous.

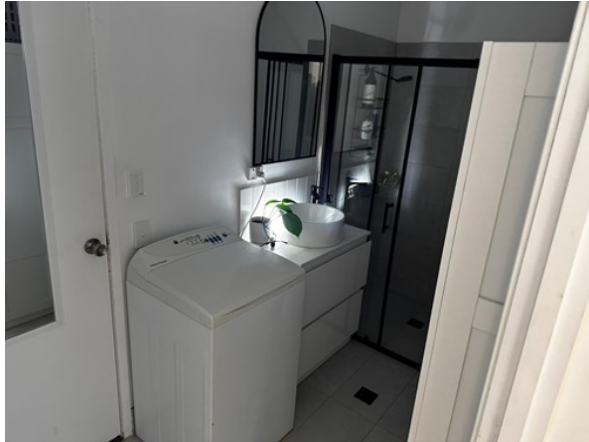
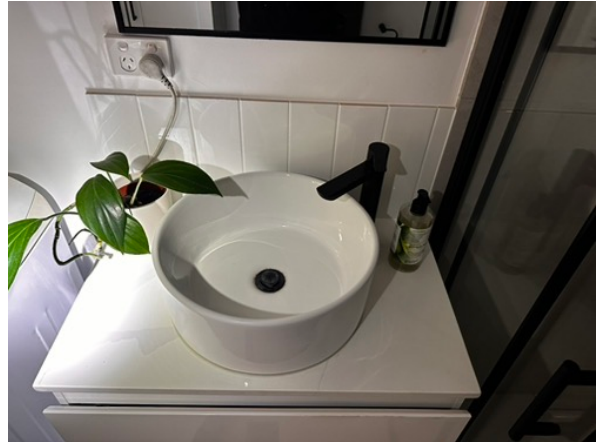
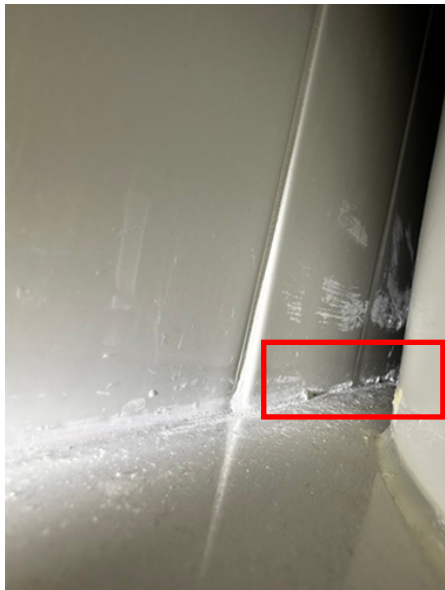
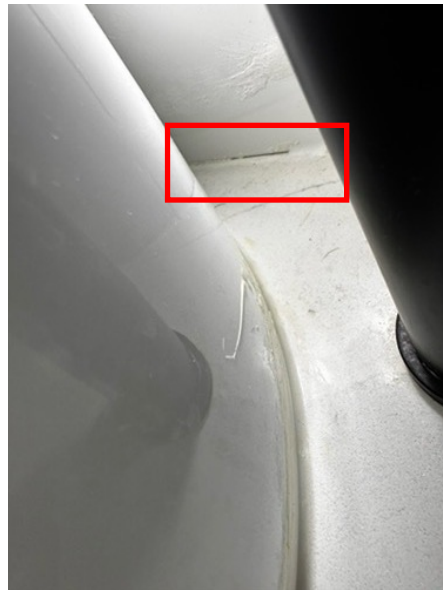
For your information 2.04

Location: Laundry/Bathroom

Finding: In the laundry/bathroom area, some grout and silicon seem to be in need of a bit of TLC. You'll notice sections where these materials have either worn away or are absent, which could lead to moisture seeping through and causing potential damage. It's a good idea to reapply grout and silicon in those areas to prevent any water-related issues down the track. A little maintenance now can save a lot of hassle later!

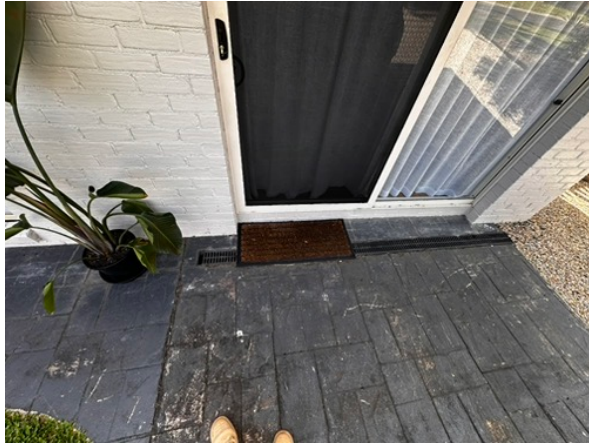
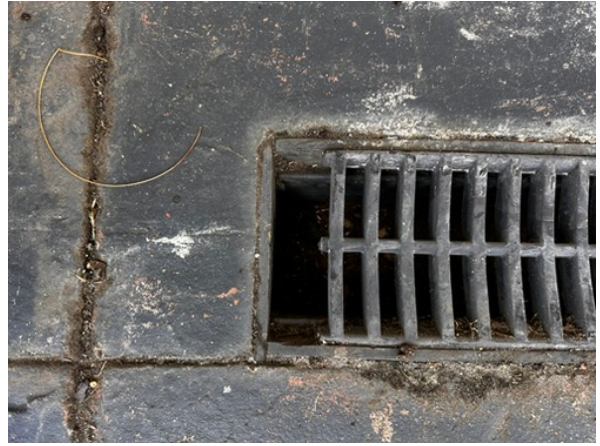
For your information 2.05

Location: Driveway Grate Drain

Finding: The driveway grate drain shows signs of damage, impacting its functionality to divert water away effectively. Immediate maintenance is recommended to replace or repair the broken sections of the grate. This will prevent potential water pooling, which could lead to further damage or slippery surfaces. Addressing this promptly will help maintain the integrity of the driveway and ensure safe access.

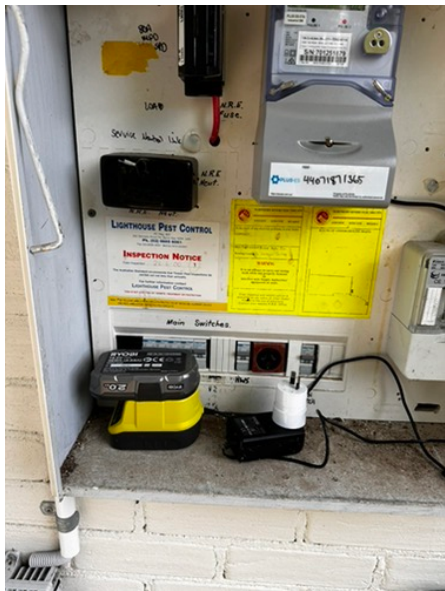
Location: All areas

Finding: It looks like the last termite inspection or treatment noted here was way back in 2000. While no termites have been found, it's a common practice to have regular treatments in this area to prevent any future issues. To ensure peace of mind, it would be wise to book a professional termite inspection and consider a preventive treatment to keep the property in top shape. This proactive step can help protect the entire home from potential pest problems down the road.
