Building and Pest Report

37 Sandstone Cres Lennox Head

Pest And Building Inspection

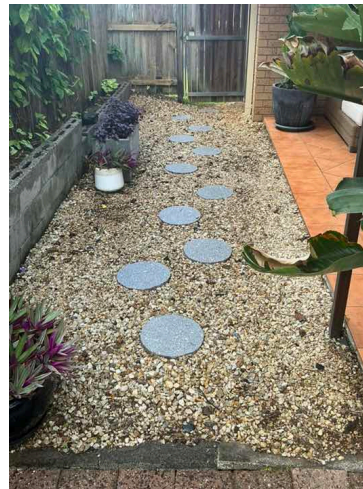
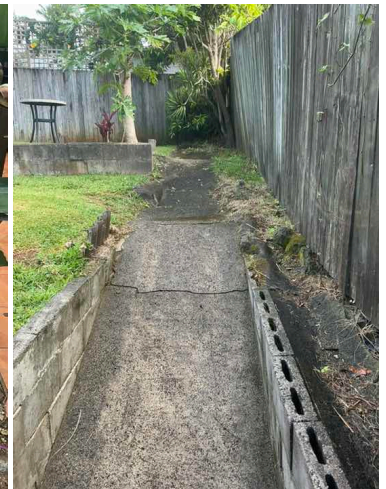
Common cracks and settlement were observed on paths. Whilst these cracks appeared to be typical at the time of inspection, we strongly recommend you monitor these cracks and if worsening occurs contact a concreter for further advice.

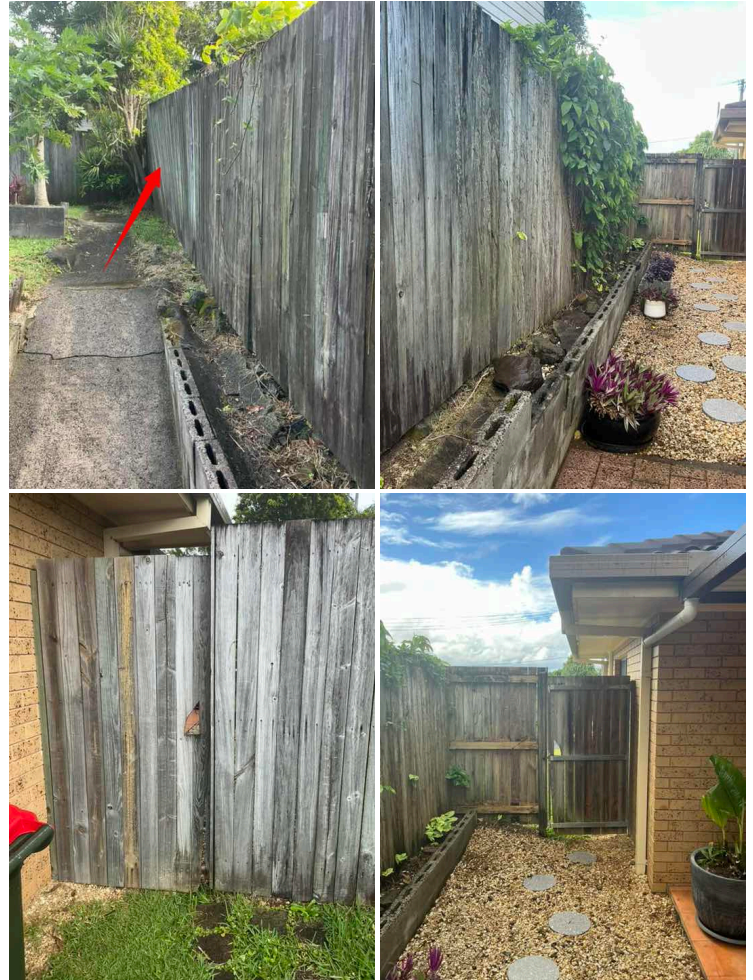
#1. Fence rot/leaning. Repairs are required by a fencing contractor to avoid unsafe conditions.

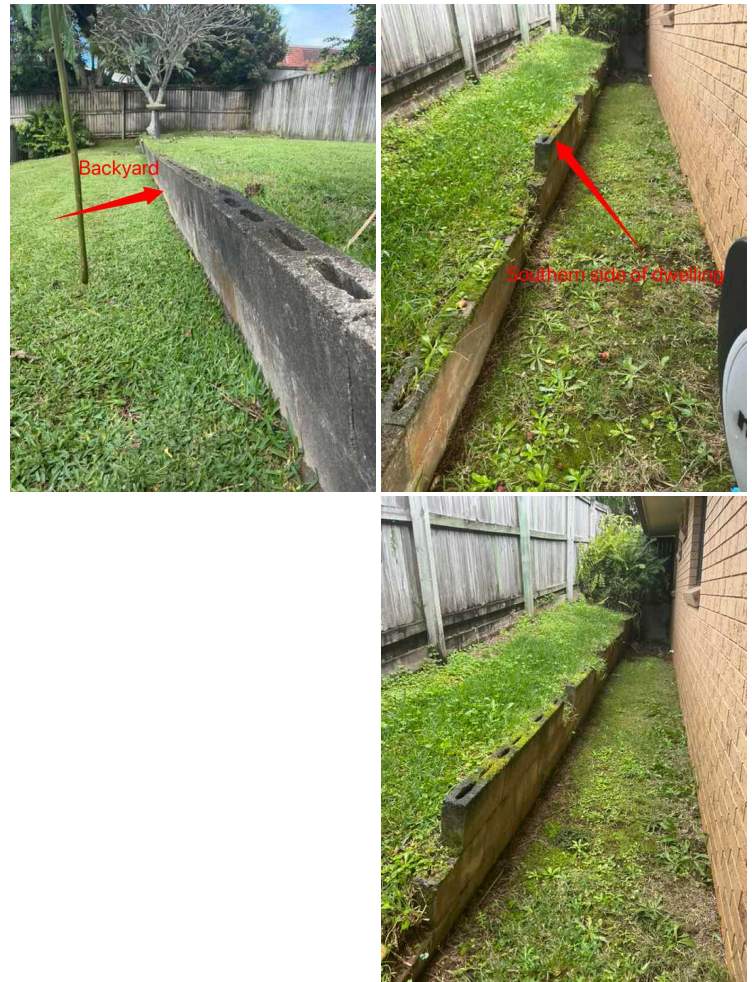
#2. Retaining wall leaning due to deterioration and age. A qualified brick layer should be engaged for advice and recommendations.

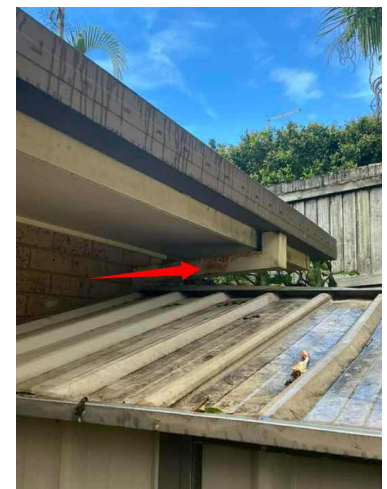
#3. Rusted pipe work. Have a qualified plumber assess and repair as required.

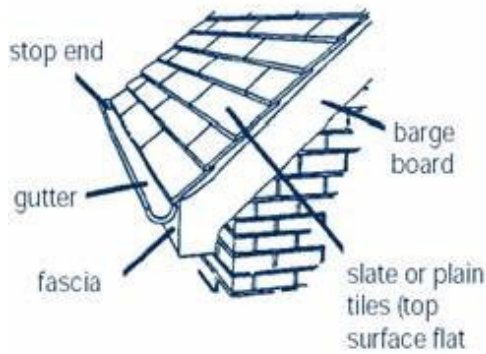
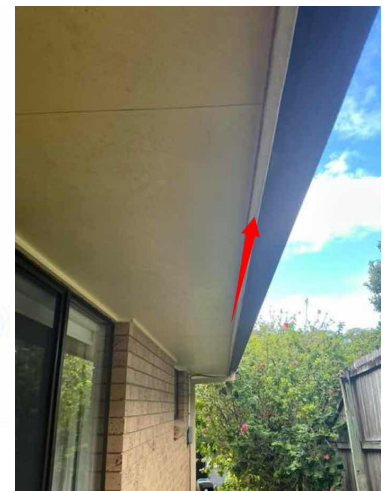
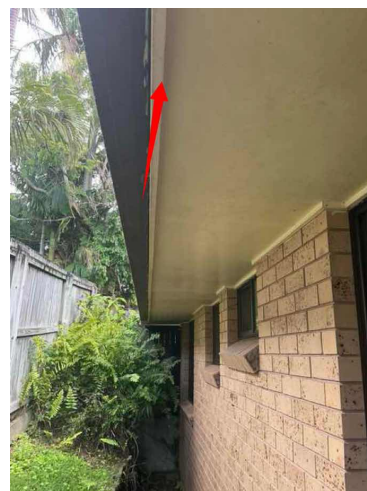
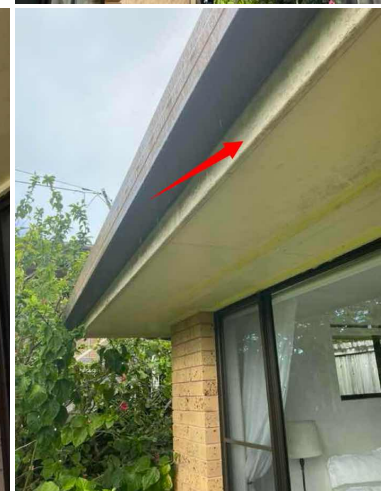
#4. Paint / finish was deteriorated in areas and is in need of maintenance - Sanding back affected areas and painting required.

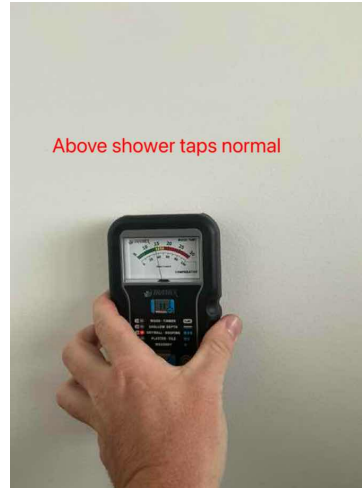
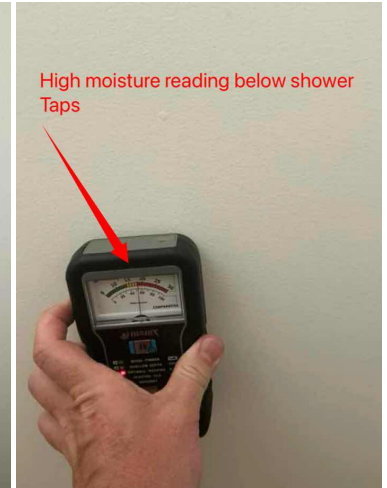
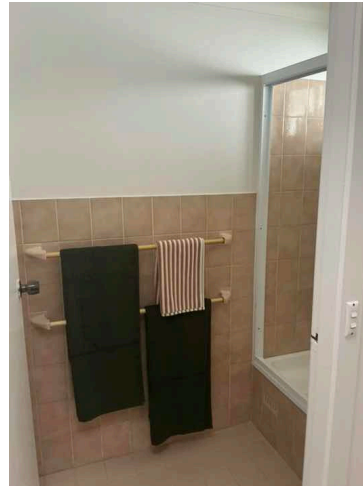
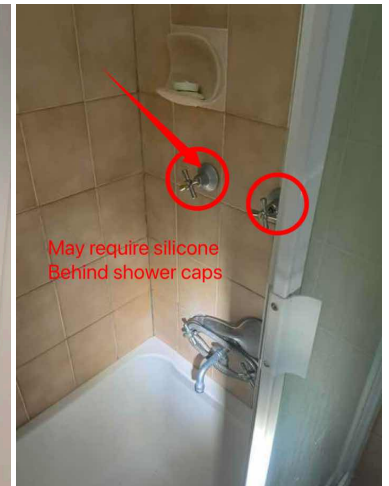
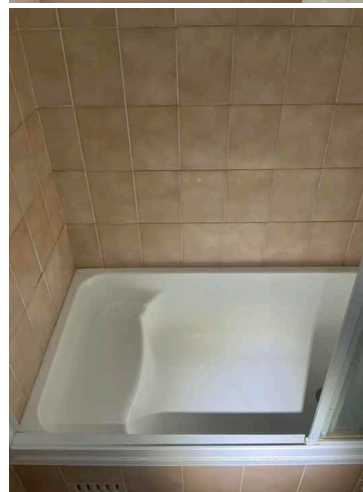
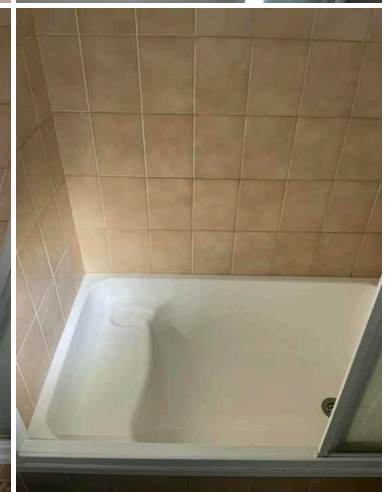
On inspection, defects were present that will require further assessing and recommendations by licensed and qualified trades persons, please read below for details.
