# BPI BUILDING & PEST INSPECTIONS

McGrath Byron Bay

5/7 Oceanside Place  
Suffolk Park

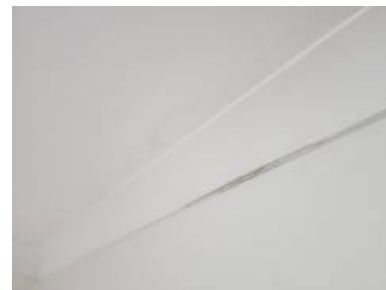
There is evidence of water penetration to ceiling sheeting to bathroom from the vent pipe seal leaking on the roof.

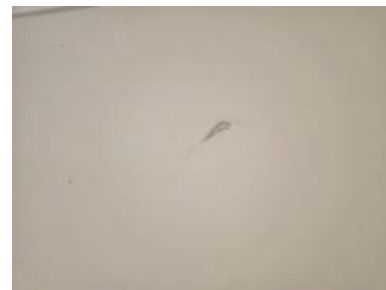
Some minor damage to wall sheeting requires touching up / repair / repainting.

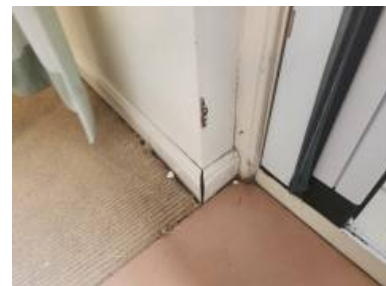
There is evidence of water penetration / damage to wall sheeting to base of bedroom door to southern patio top floor.

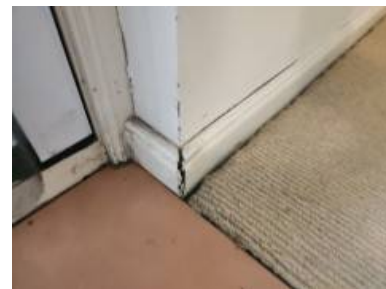
Signs of past water penetration to skirtings at bedroom door southern patio.

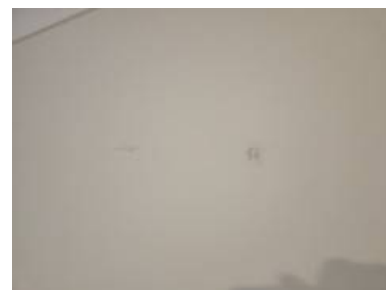
As with most buildings of this age, various paintwork / walls require touching up / repainting to improve the cosmetic appearance.

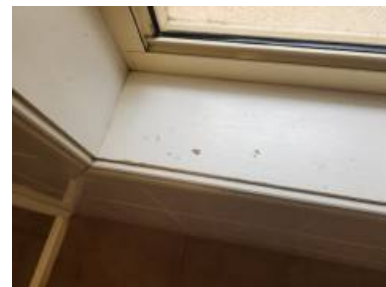
Some window reveals require touching up / repainting.

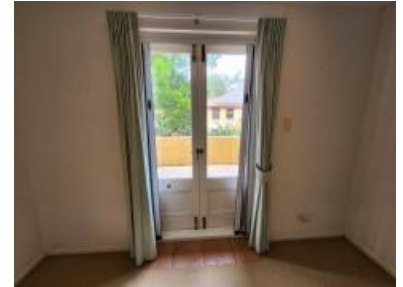
Door is binding and requires repair / easing / adjustment.

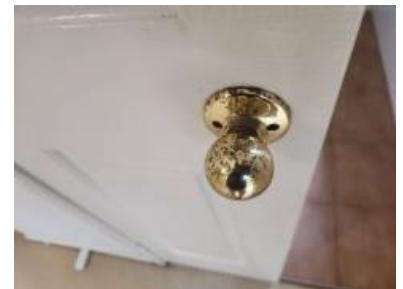
Signs of corrosion to some door handles.

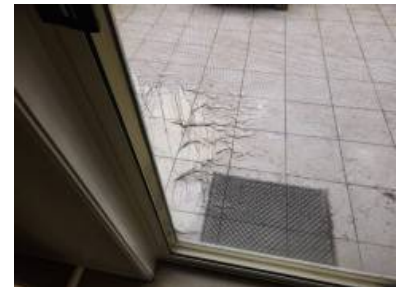
Some insect gauze to screen doors requires repair / refixing.

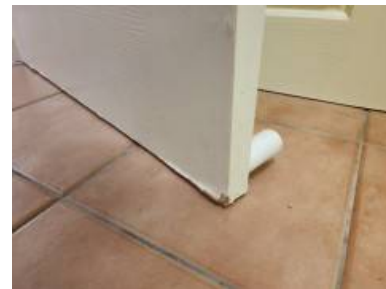
Base laundry of door shows signs of damage and requires repair / sealing.

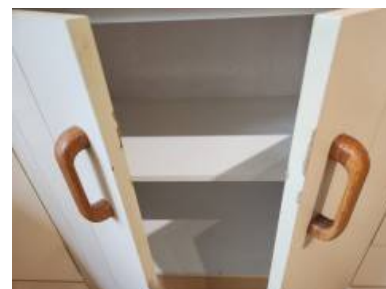
The Kitchen cabinetry / bench tops / laminate show evidence of general wear & scratches.

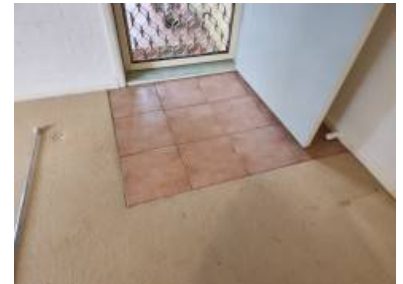
Some drummy floor tiles to front entrance. Floor tiles become drummy due to the loss of adhesion to the underside of the tiles and may become loose or cracked. I recommend that a qualified tiler be engaged for further inspection / advice.

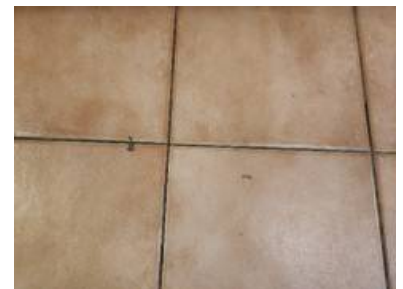
Percussion chips to some floor tiles.

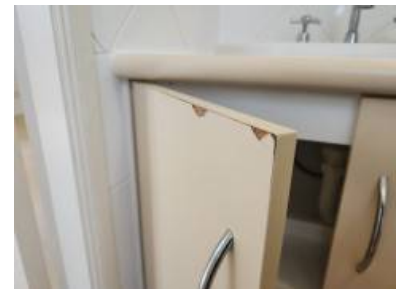
Signs of past water damage to the Ensuite vanity cabinet.

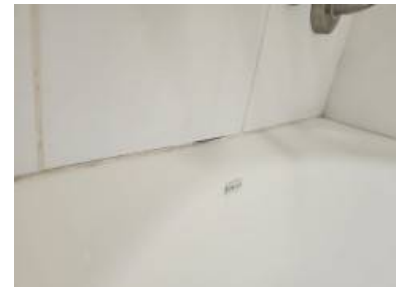
Junctions of Bathroom bath / wall tiles require resealing with silicone.

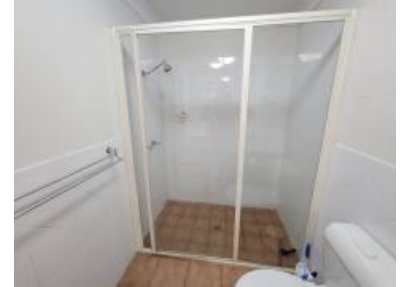
Bathroom shower screen door is binding on the frame and requires adjustment / refixing.

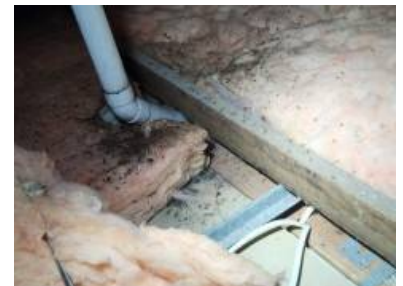
There is evidence of water penetration below vent pipe within the roof void.

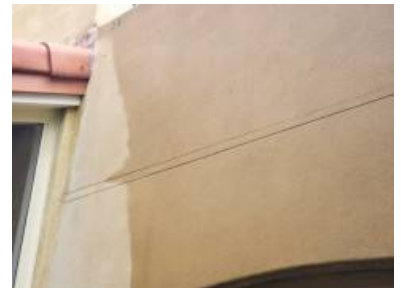
Cracks present to some render.

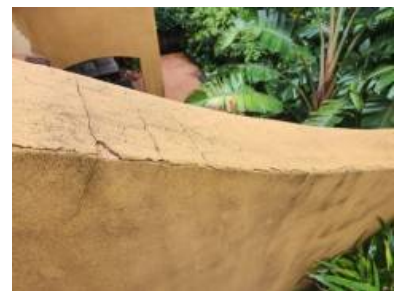
Cracks present to some render.

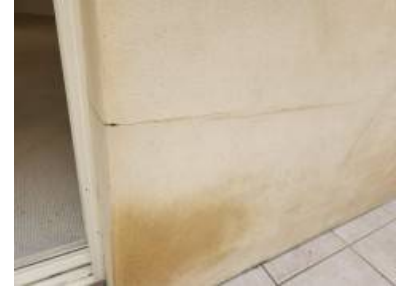
Hairline cracks to some rendered walls.

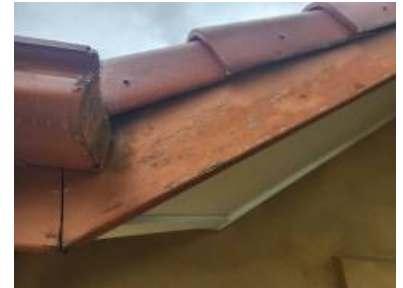
External paintwork / finish to various external surfaces and timberwork is generally poor. Various sections / areas require touching up / repainting.

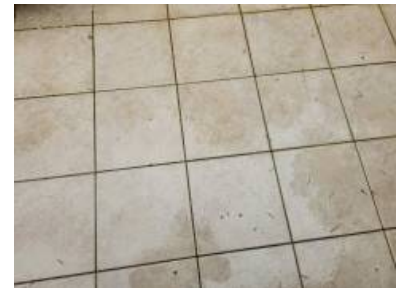
Front & back patio floor tiles require re-grouting / sealing to stop water penetration coming through into garage area.

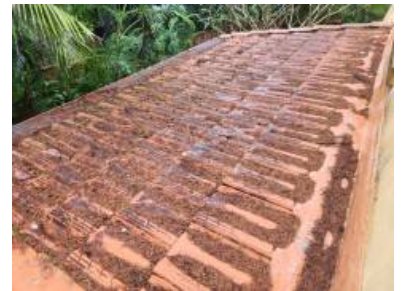
Some areas need cleaning.

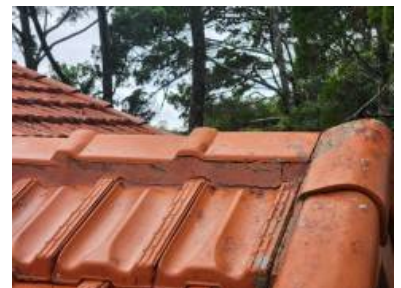
The pointing to the capping tiles shows evidence of cracking / deterioration. I recommend all capping tiles be re-pointed to aid in preventing leaks.

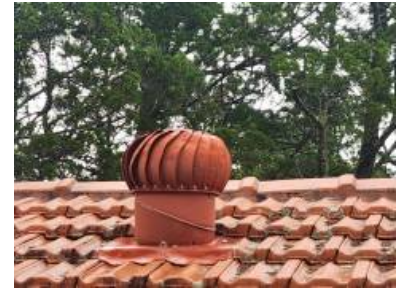
Wirly bird shows signs of hail damage.

Vent seal above bathroom requires resealing.

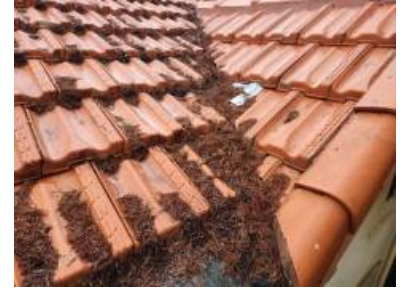
Some sections of valleys are full of debris and require cleaning. Failure to do so may allow water to become blocked and back flow into the roof void causing water damage.

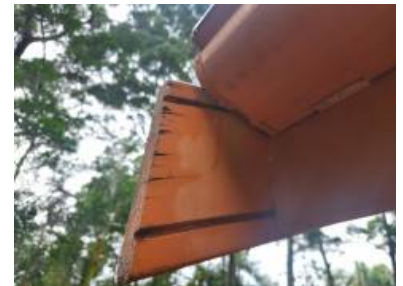
Some fascia timbers show signs of weather damage and require repainting.

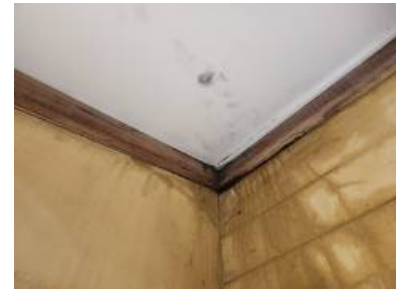
Some eave soffit sheeting shows signs of water damage and requires repair / resealing to front entrance.

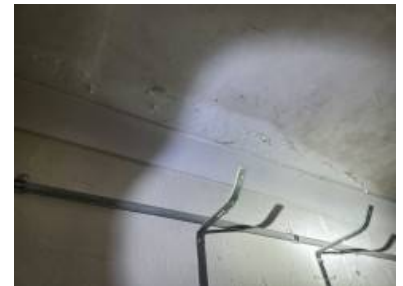
Ceiling shows signs of water penetration and damage coming through from deck above.

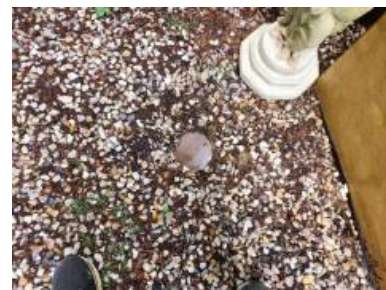
We found evidence of a Termite Monitoring and Baiting System to the perimeter of the residence. These may have been installed in respect to termite control or protection. We strongly recommend any prospective purchaser attempt to verify this information and obtain copies of all relevant documentation.
