BUILDING & PEST INSPECTIONS

17 Avocado Crescent
Ewingsdale

BPI - INSPECTION REPORT

Special Purpose building report of subfloor area.

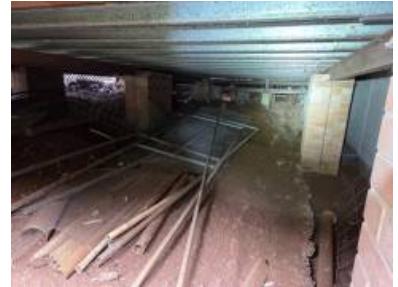
Bearers and Joists

Satisfactory.

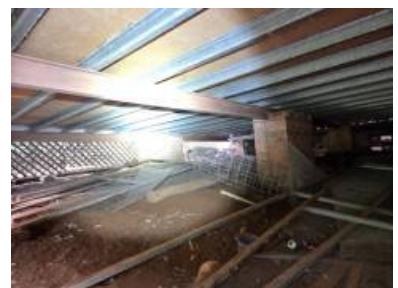
Piers / Stumps / Posts - Type(s)

Brick piers.

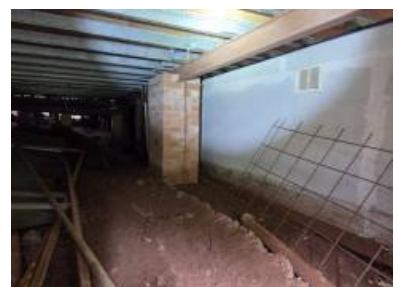
Piers / Stumps / Posts - Condition

Satisfactory.

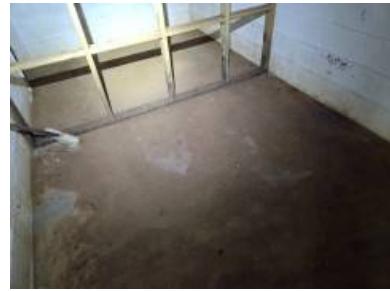
Dampness and Drainage

There is evidence of excessive water ponding / damp soil within the subfloor area. This may be due to a drainage problem or some other factor. You should engage a qualified plumber / drainer for further investigation / rectification.

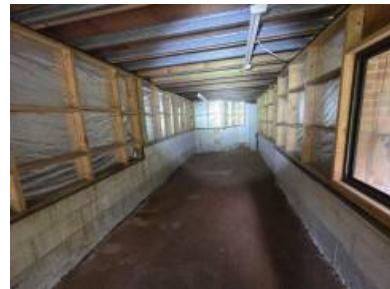
The work shop areas in the subfloor area appear to take in water during periods of heavy rain. This should not be used as a habitable area.

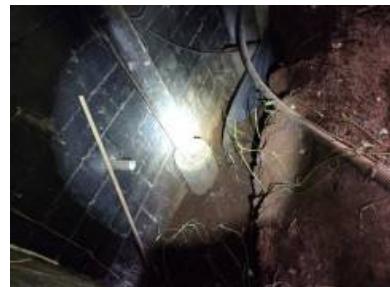
Although I'm not a plumber or structural engineer, the work shop area subject to water ingress should not affect the structural integrity of the building as long as the pump is kept clean, maintained and gets used when water starts pooling.

There are no signs of mould or damp issues to the house above at the time of the inspection.
