# BUILDING AND PEST REPORT

1/4 Durroon Court Ocean Shores NSW 2483

## Part 1: Purpose and Scope of Inspection

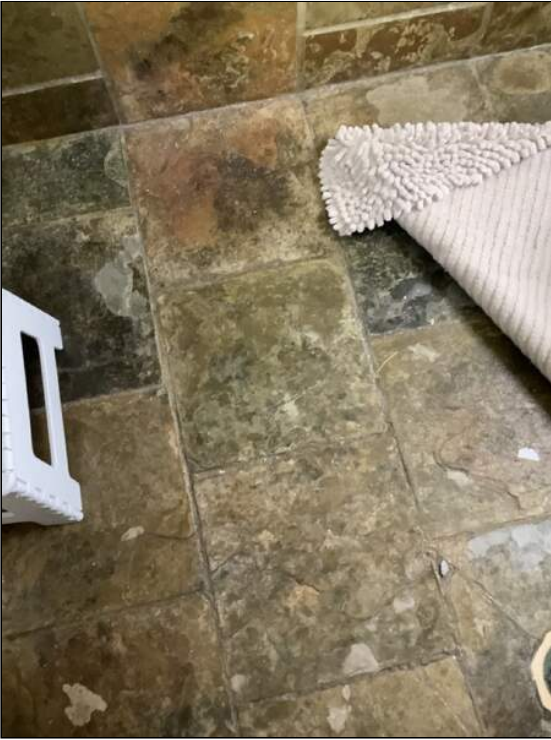
**Drummy tiles**  
**Location (Optional): Bathroom**  
**Details (Optional): This is considered not uncommon for slate**  
**Defect Rating: Minor Defect**

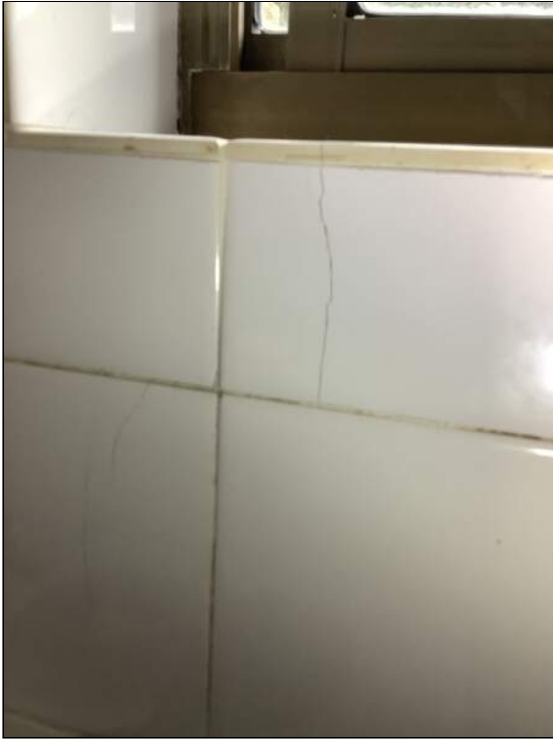
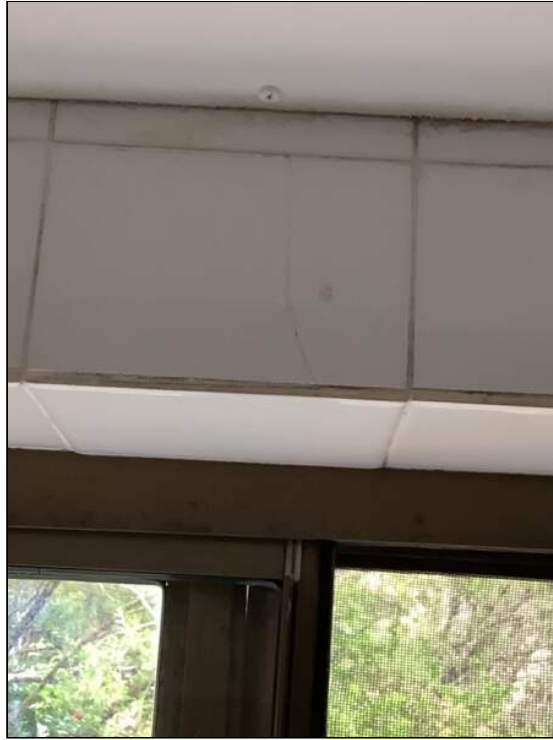
Laundry; Are the tiles free of cracks, drumminess, or loose/missing grout/sealant? **Cracked tiles**  
**Location (Optional): Laundry**  
**Details (Optional): Some cracked wall tiles evident.**  
**Defect Rating: Minor Defect**

**Cracked tiles**  
**Location (Optional): Laundry**  
**Details (Optional): Some cracked wall tiles evident.**  
**Defect Rating: Minor Defect**

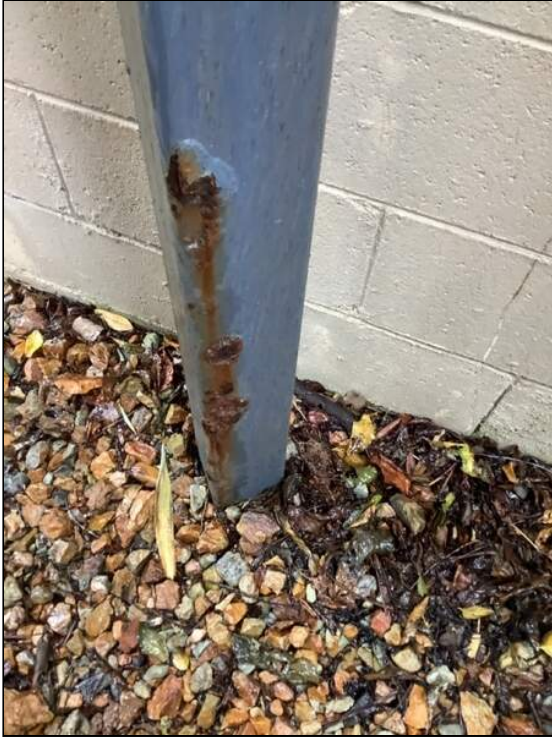
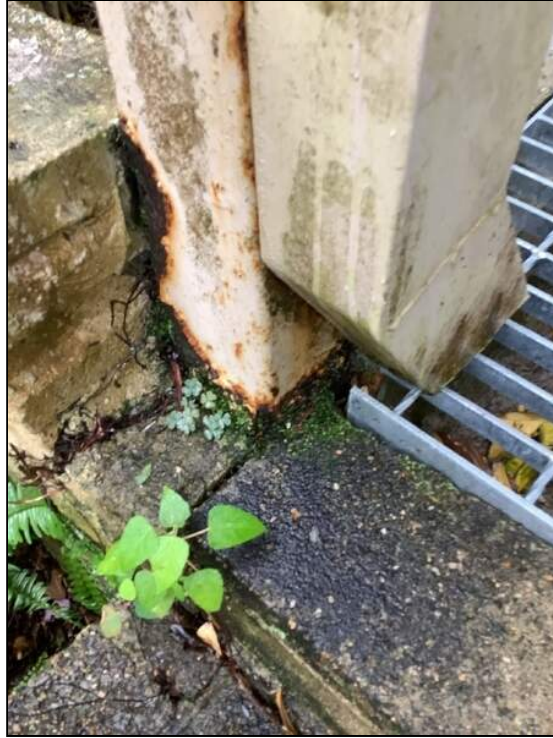
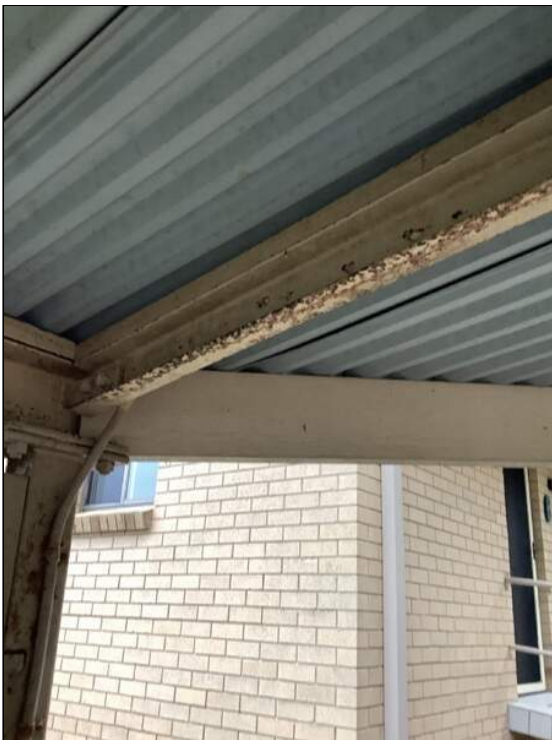
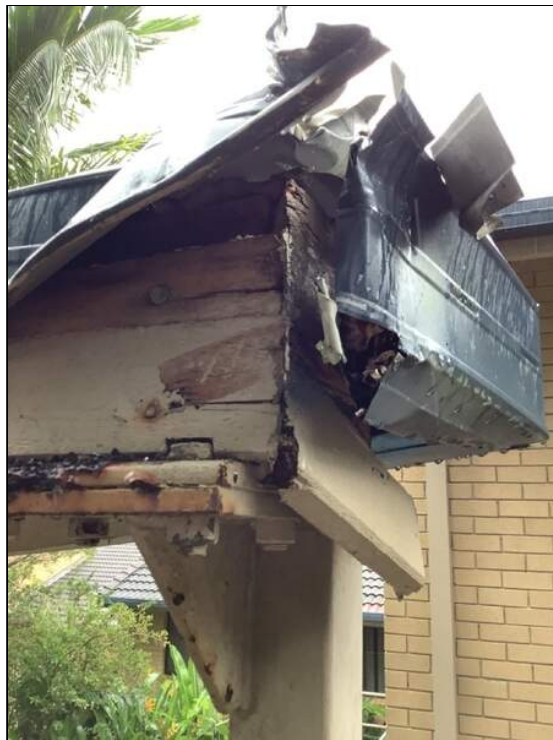
Details (Optional): Rusty components to external structures evident. All of these issues are possibly Body Corporate repairs

Defect Rating: Minor Defect

**No**  
**Location (Optional): External**  
**Details (Optional): Rusted components to external structures evident. All of these issue are possibly Body Corporate repairs**  
**Defect Rating: Minor Defect**

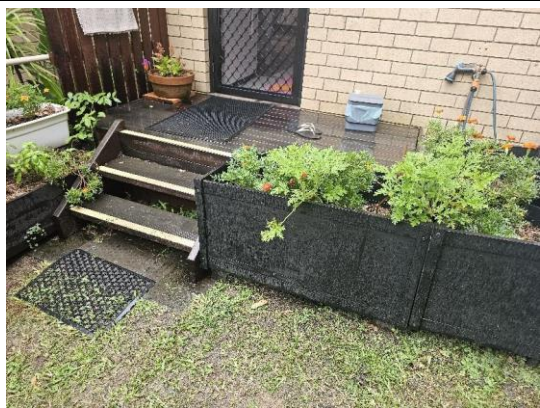
High Risk Area(s) to which Access <u>should</u> be gained, or fully gained, since they may show evidence of Timber Pests or damage include:	• No access under deck.
---	-------------------------

No access under deck
