Pre Purchase Building & Pest Inspection 425 Tyagarah Road

Property Address: 425 Tyagarah Road Myocum 2481

Inspection Date: 16 Feb 2026

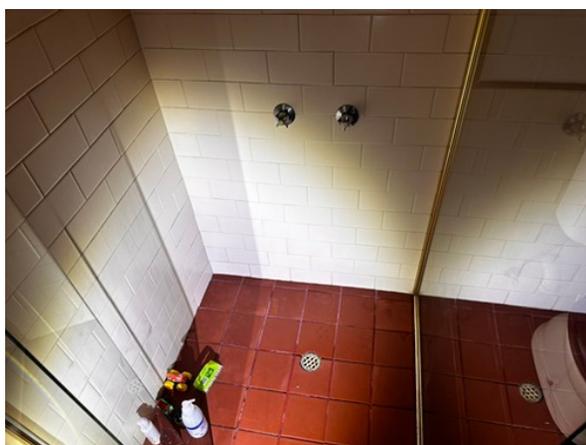
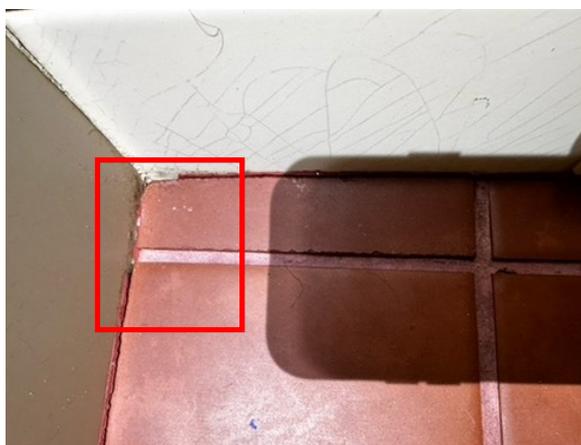
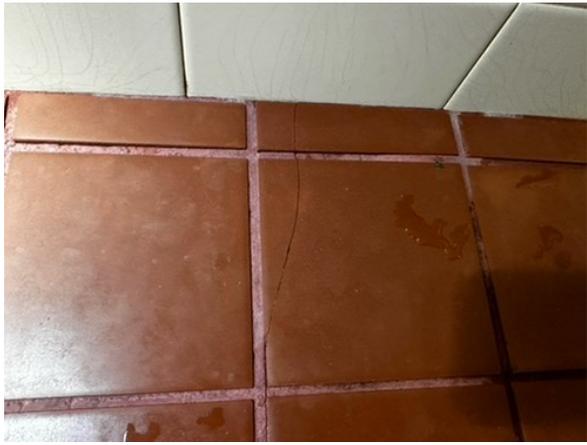
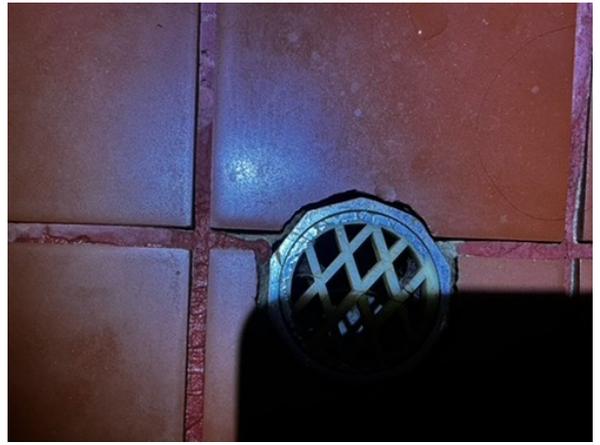
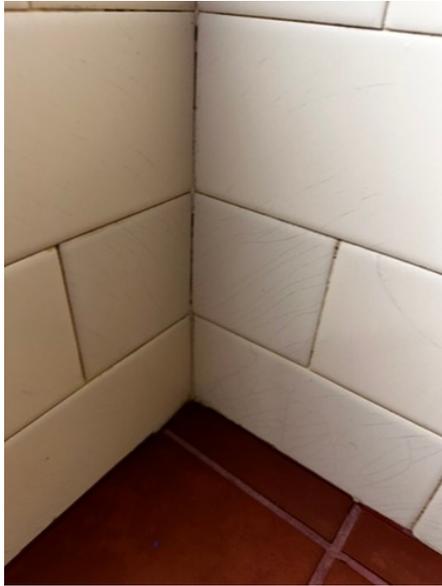
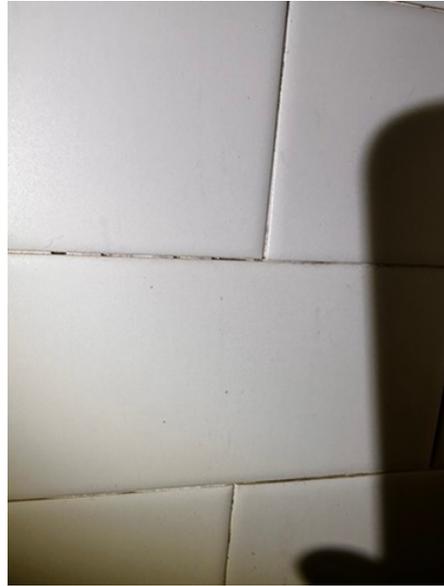
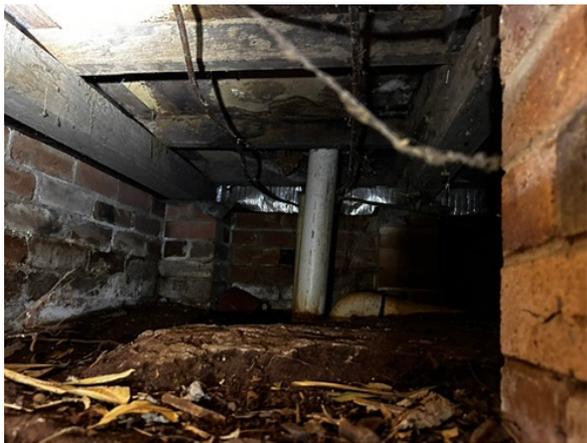
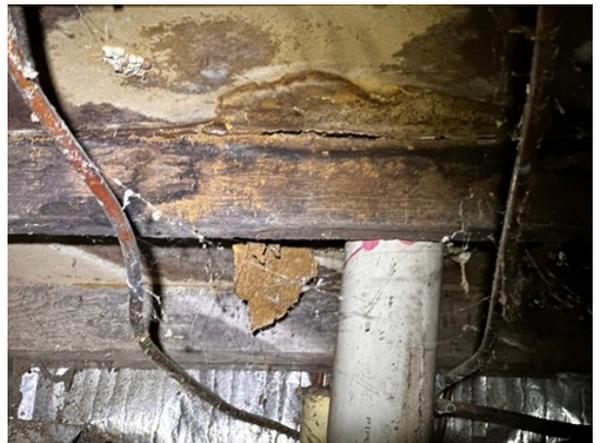
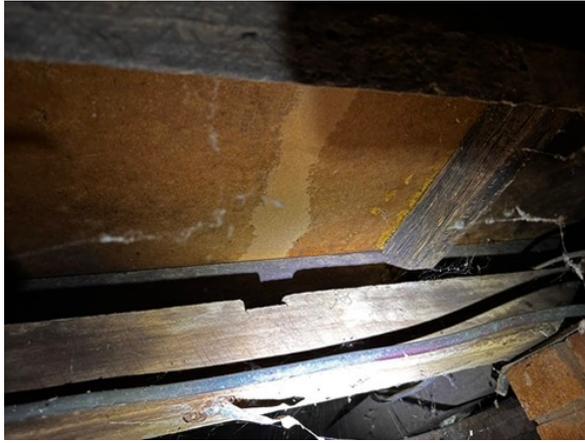
Minor Defect 1.01

Location: Bathroom

Finding: The bathroom shower is not properly sealed, leading to water leakage into the subfloor. This issue requires renovating to prevent further damage. Addressing the leak promptly by resealing the shower area and inspecting the subfloor for potential repairs can help mitigate further moisture-related problems. It's advisable to consult a professional to ensure the job is done effectively.

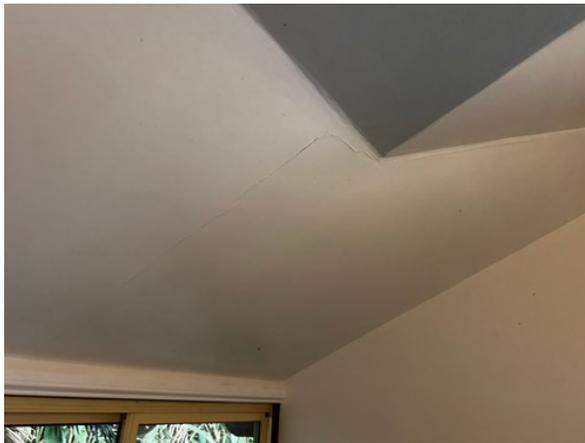
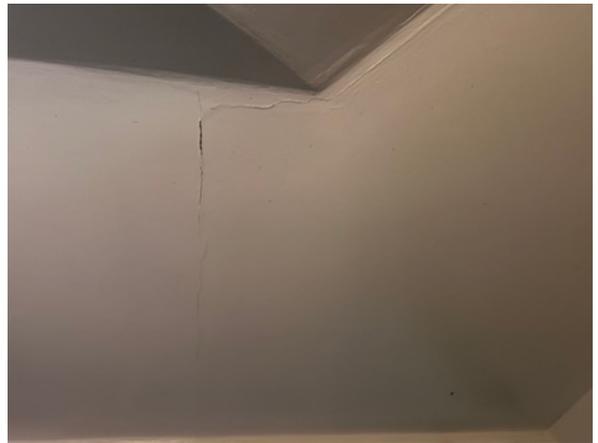
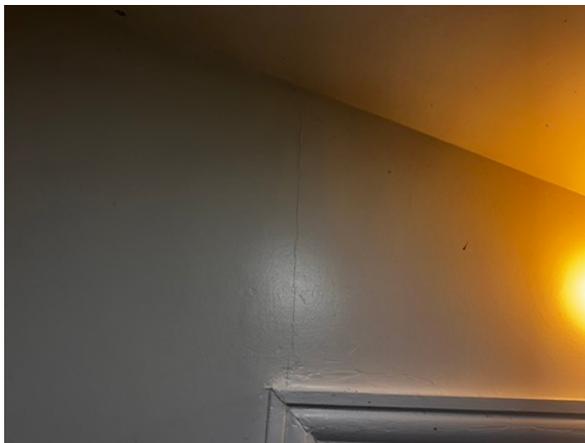
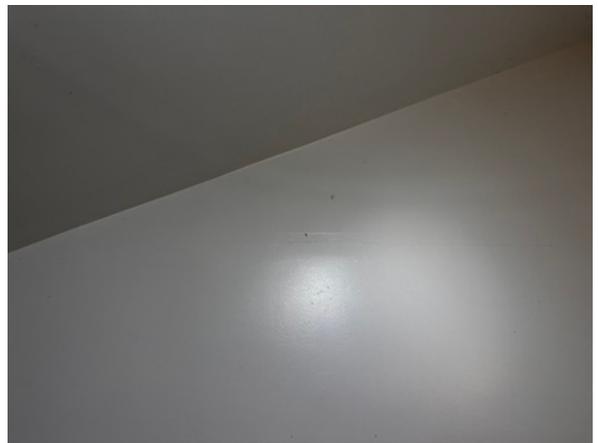
Minor Defect 1.02

Location: Bathroom

Finding: The bathroom shows noticeable cracks in the ceilings and walls, a common issue in older homes due to natural settling. While these cracks aren't a current structural concern, they could worsen over time. It's advisable to monitor them and consider cosmetic repair to prevent moisture infiltration. For long-term peace of mind, a professional assessment might be beneficial to ensure there aren't any underlying issues. Prompt attention can help maintain the integrity and appearance of the space.

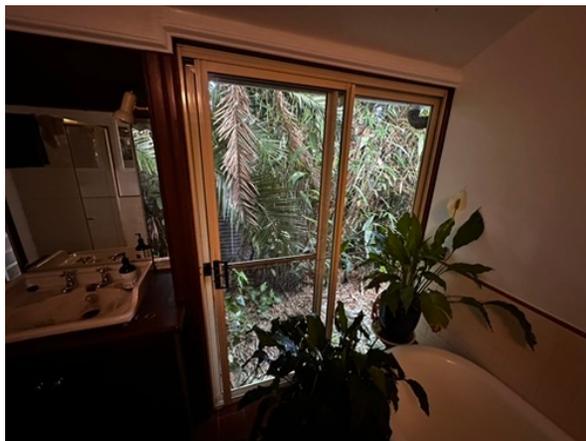
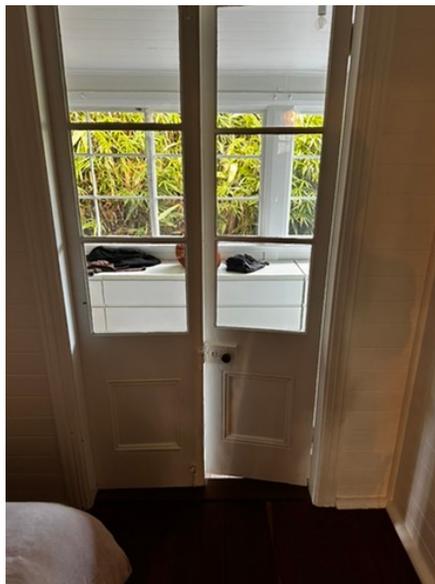
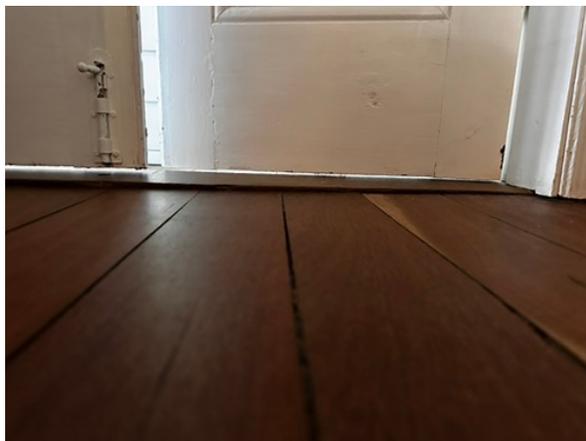
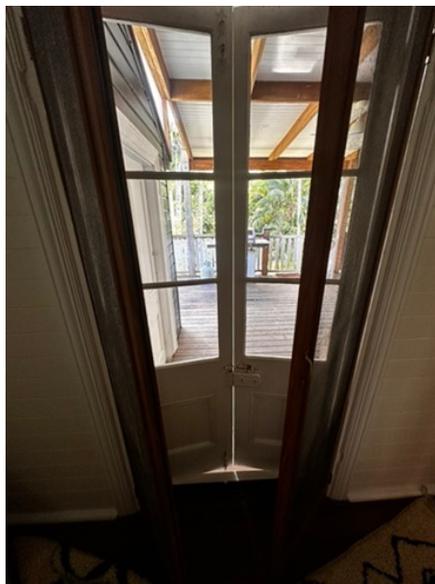
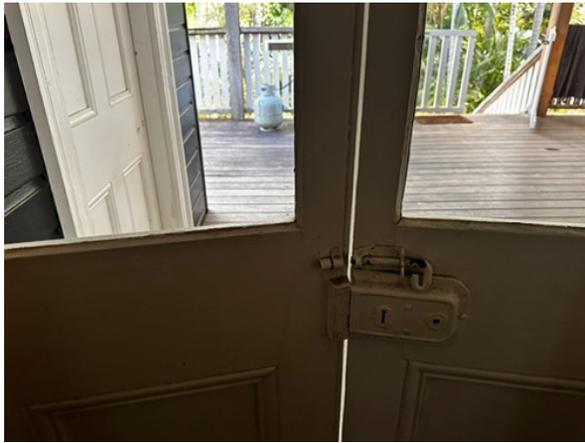
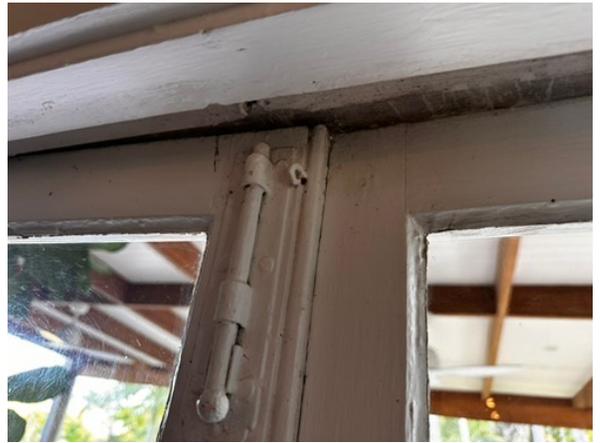
Location: Various Doors

Finding: The doors in this charming older home are showing signs of wear and could use a touch of maintenance. They aren't closing as smoothly as they should, and there's some visible misalignment. It's a common issue with age that often requires a little TLC. Lubricating the hinges and adjusting the frames should help them swing freely again. If more serious work is needed, consulting a professional carpenter might be wise to ensure they're operating perfectly. It's a small fix that can make a big difference in day-to-day convenience.

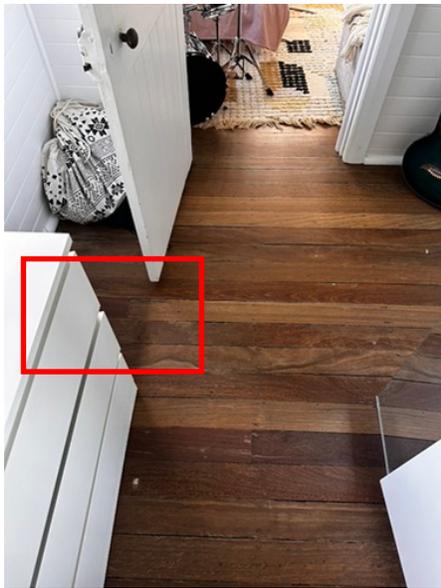
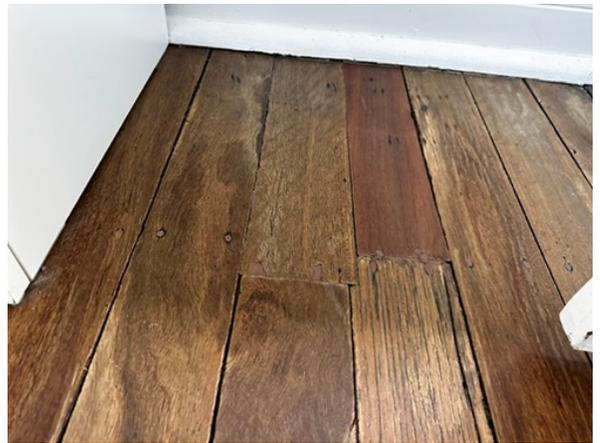
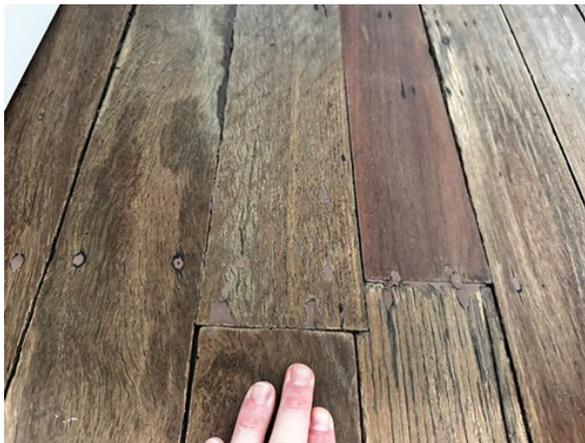
For your information 2.02

Location: Western Sun Room

Finding: In the Western Sun Room, there are some loose floorboards that might catch your attention. This is a common issue and can usually be fixed easily. To address this, you might consider securing the boards with screws or nails, ensuring they're flush with the rest of the floor. It's a straightforward task that will help prevent any future tripping hazards and keep everything feeling solid underfoot.

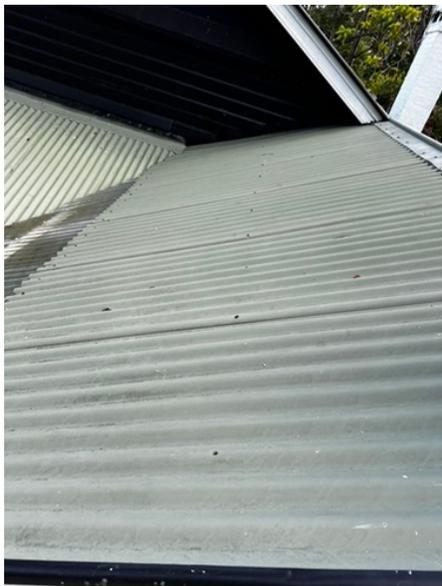
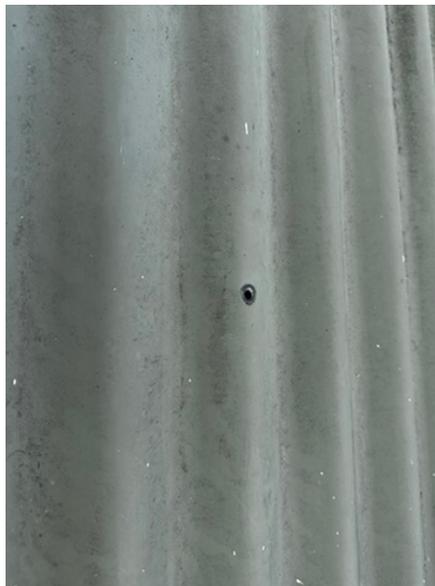
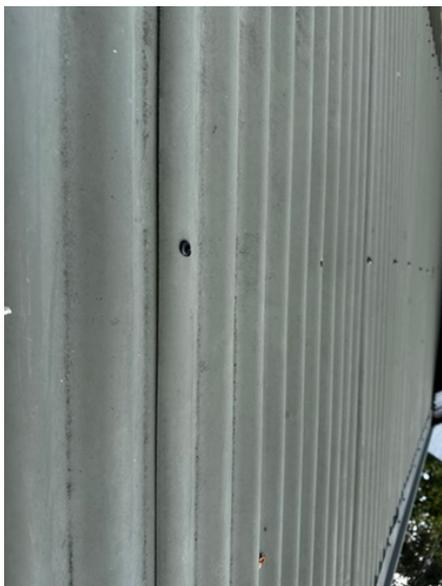
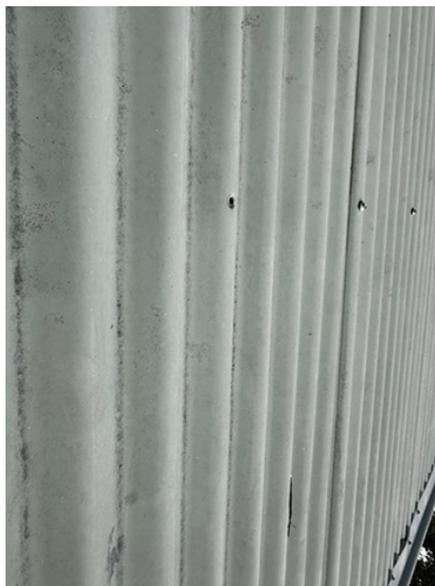
For your information 2.03

Location: Roof exterior

Finding: The roof exterior has a few missing screws, which could lead to potential issues like leaks or further damage if not addressed. To maintain the roof's integrity and prevent water ingress, it's advisable to replace the missing screws with new ones that match the existing roofing materials. It's a relatively simple fix that can save you hassles down the road.

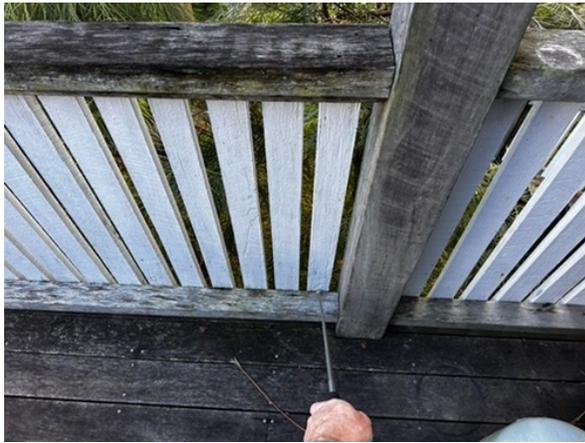
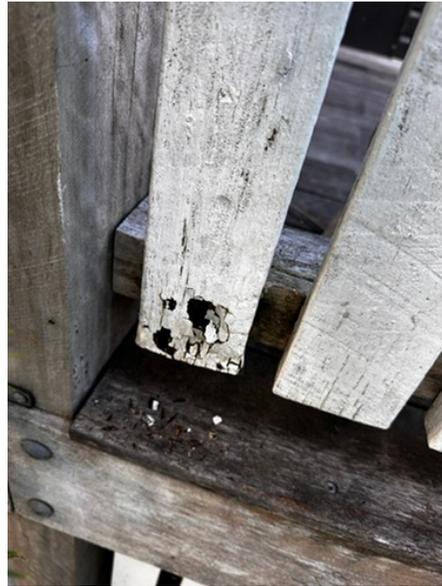
For your information 2.04

Location: Deck

Finding: The deck's balustrade has a section with noticeable rot, as shown in the images. This issue is isolated to just one part, so it's a fairly straightforward fix. I recommend replacing the affected piece to prevent any safety concerns. It's a quick job for a carpenter and will restore the integrity and appearance of the balustrade. Regular maintenance checks can help prevent similar issues in the future.

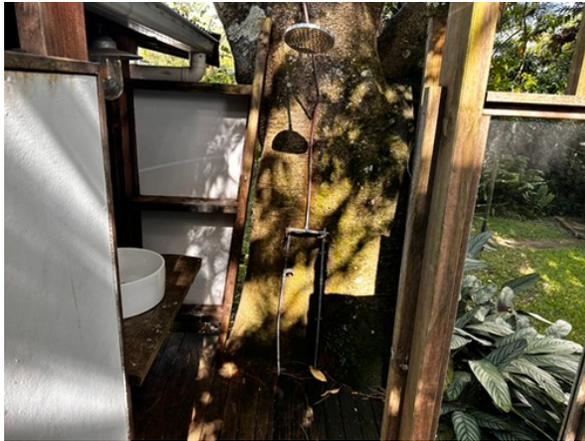
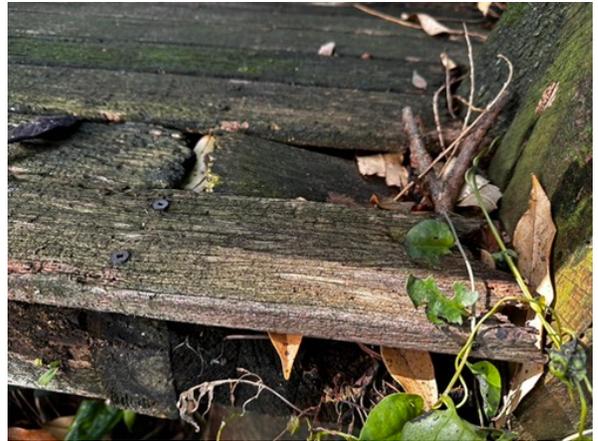
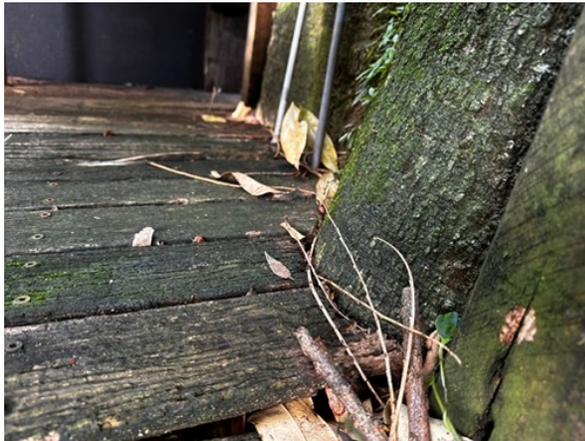
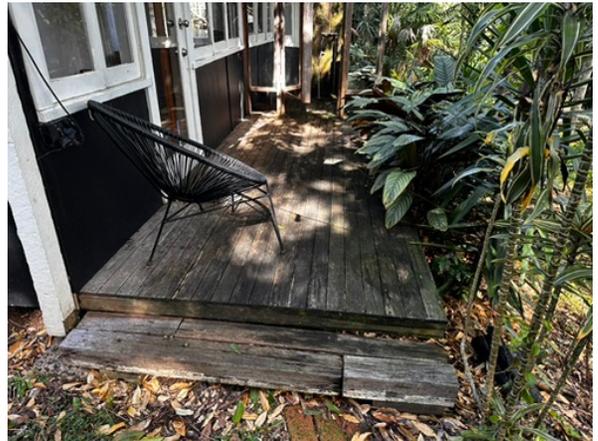
For your information 2.05

Location: Villa Deck

Finding: The deck in the Villa is clearly showing signs of wear and tear, with noticeable deterioration and potential safety issues, like loose boards and visible gaps. It's probably time for a bit of TLC to prevent any further damage. To keep everything safe and sound, we recommend replacing the damaged boards and securing any loose areas. Regular maintenance, such as sealing and cleaning, will help extend the deck's life and keep it looking fresh.

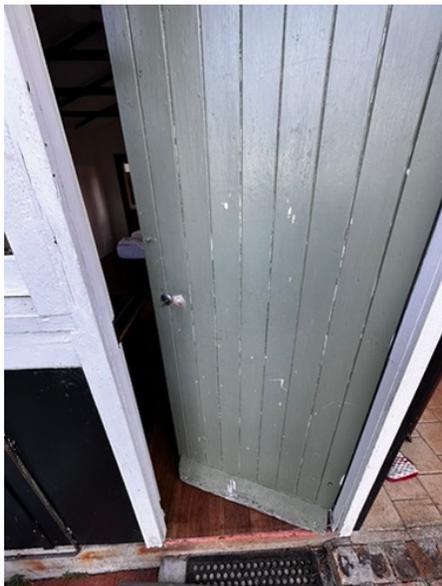
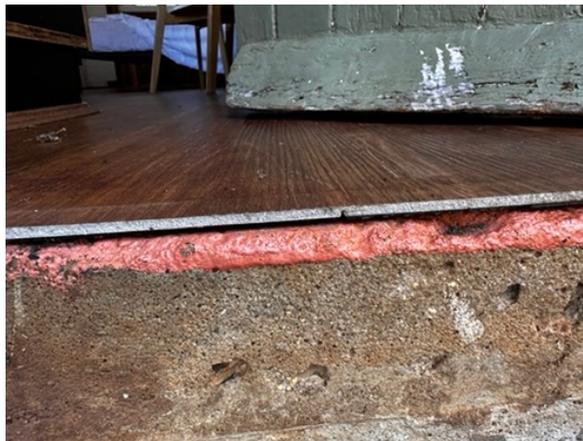
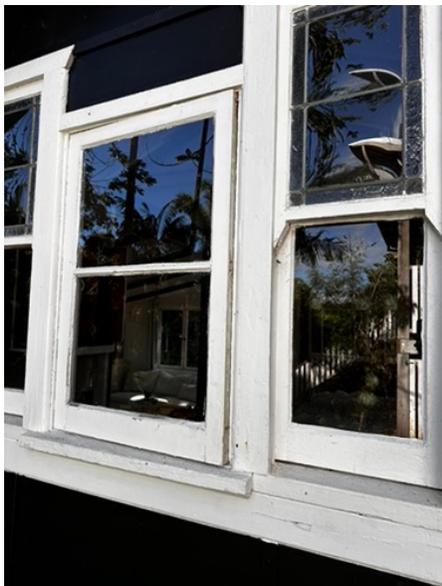
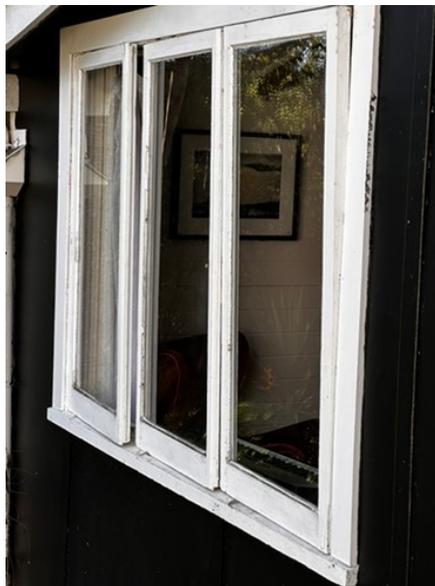
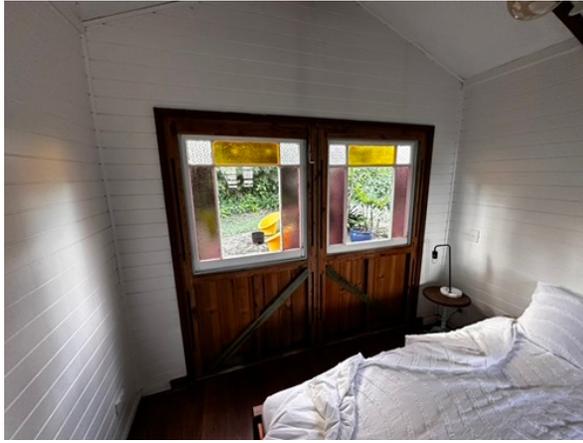
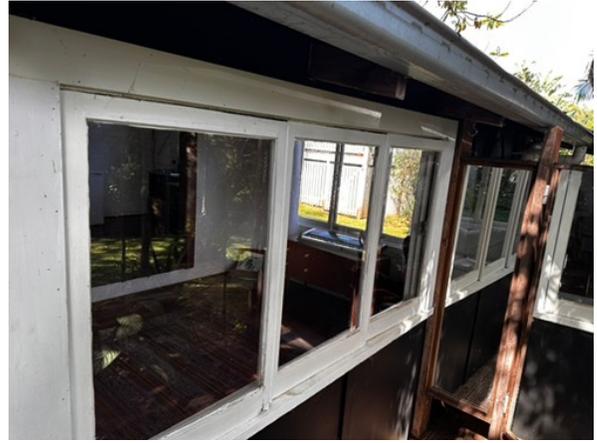
For your information 2.06

Location: Villa Doors /windows

Finding: The villa's doors and windows are experiencing issues with opening and closing properly, likely due to misalignment over time. This can be inconvenient and may impact the overall security and insulation of the space. To rectify this, consider having a professional adjust the alignment and inspect the frames for any warping or damage. This simple maintenance can enhance functionality and extend the lifespan of these fixtures.
