Sanctuary Pest Management

Regular Visual Termite Inspection Report in Accordance with AS 3660.2-2017

16 Rosewood Ave, Bangalow 2479

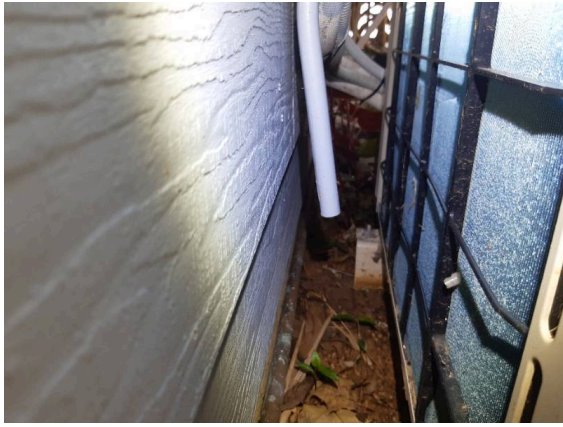
Example of air conditioner outlet pipe not attached to drain. Moisture may attract termites.

Termite damage located was inactive at time of inspection.
Recommend attaching air conditioner outlet pipes to drains.
No termites found.

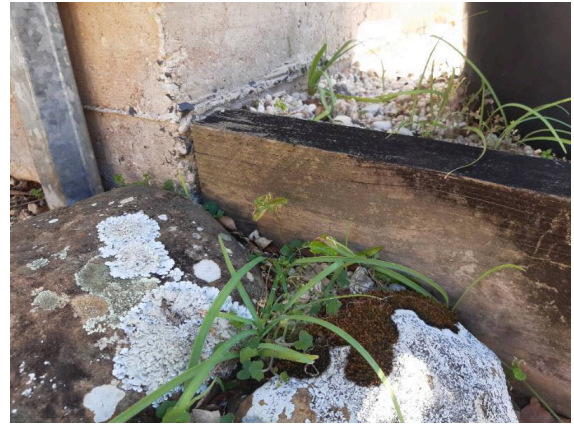
Example of landscaping timber near building. May attract termites.

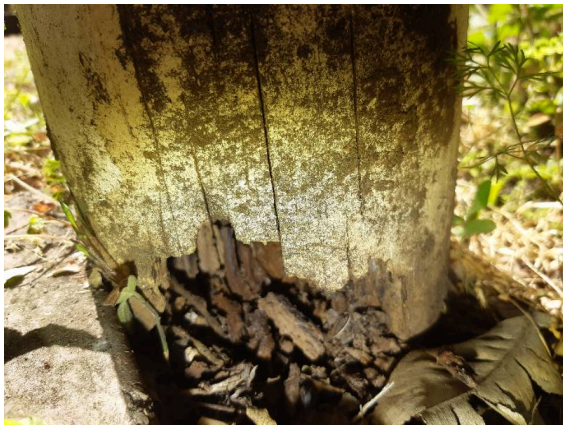
Example of decay in post at House. May attract termites.

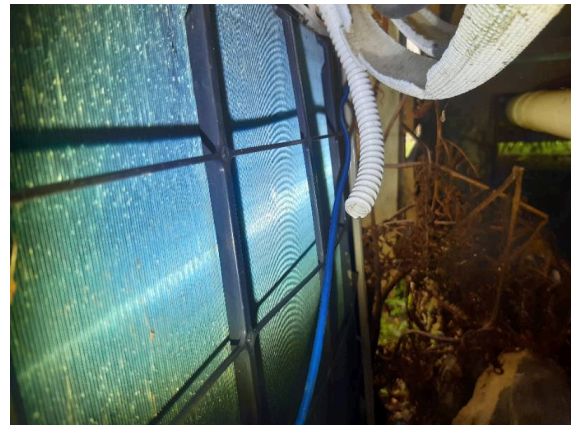
Example of air conditioner outlet pipe not attached to drain. Moisture may attract termites.

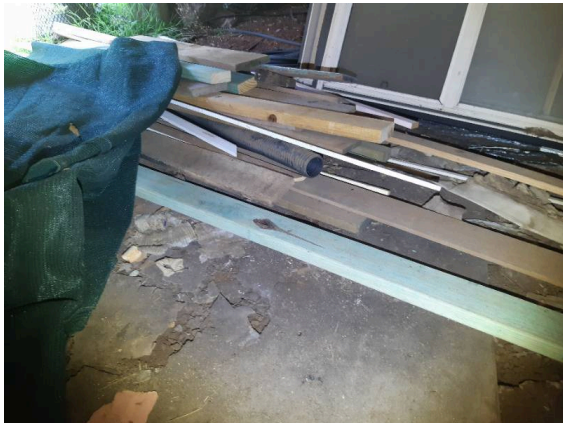
Example of timber on ground in subfloor. May attract termites.

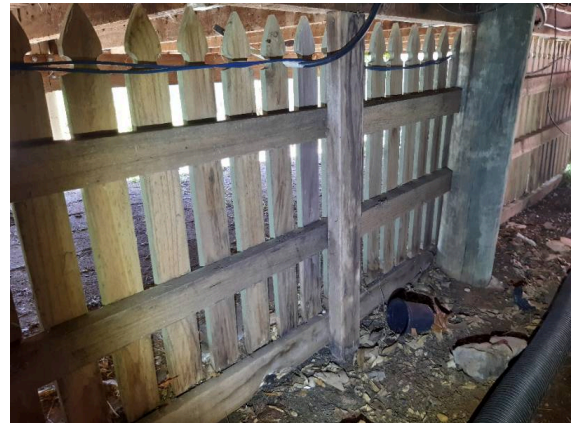
No termite barrier or inspection zone in place. May allow concealed access.

Where the report indicates that there is no termite inspection zone, some form of termite risk management needs to be put in place to reduce the risk of unseen termite entry at this property. this property.

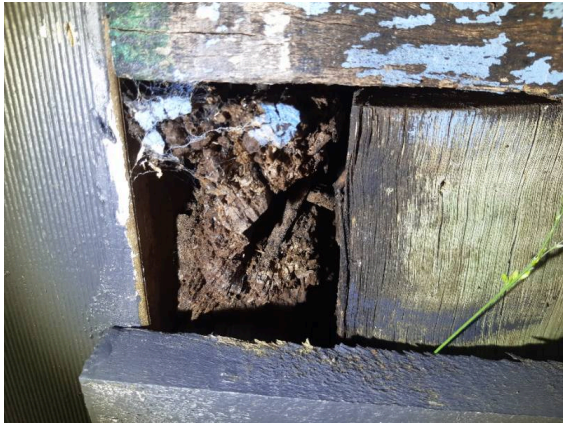
Example of decay in decking. May attract termites.

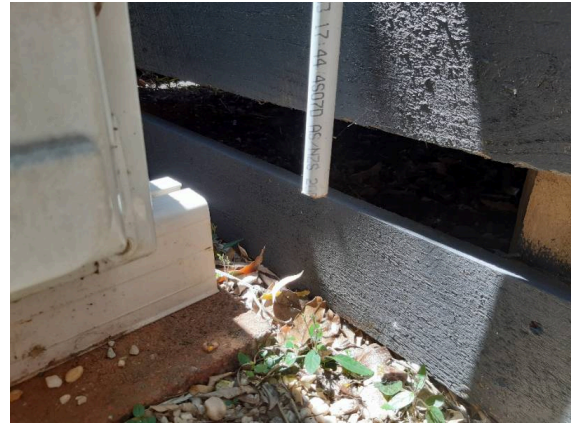
Example of air conditioner outlet pipe not attached to drain. Moisture may attract termites.

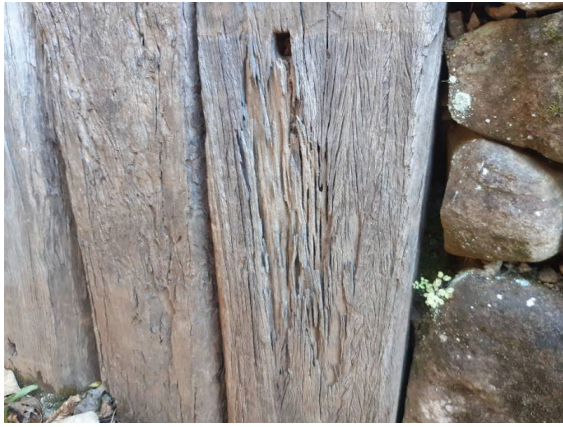
Termite Damage Extent - Moderate to Extensive

Example of termite damage in landscaping timber. Inactive at time of inspection.

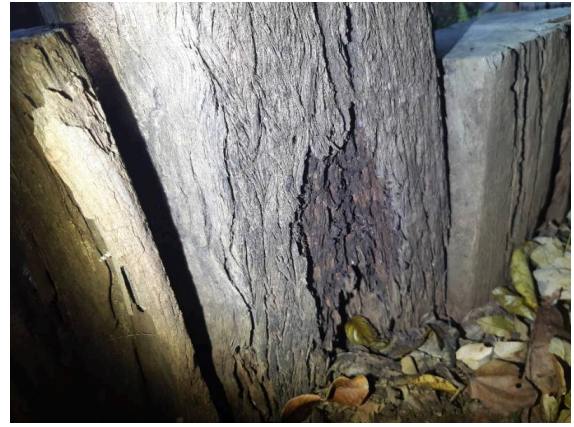
Example of termite damage in landscaping timber. Inactive at time of inspection.

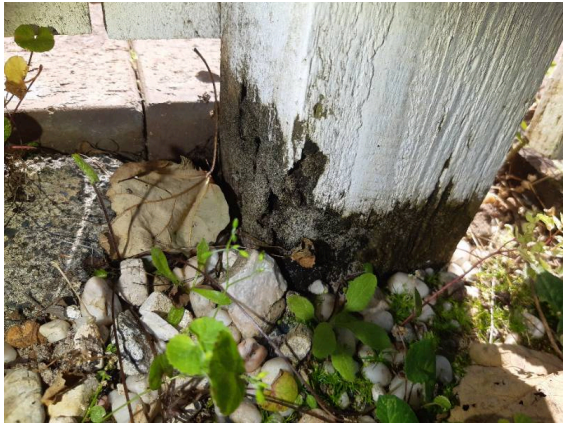
Example of decay in fence. May attract termites.

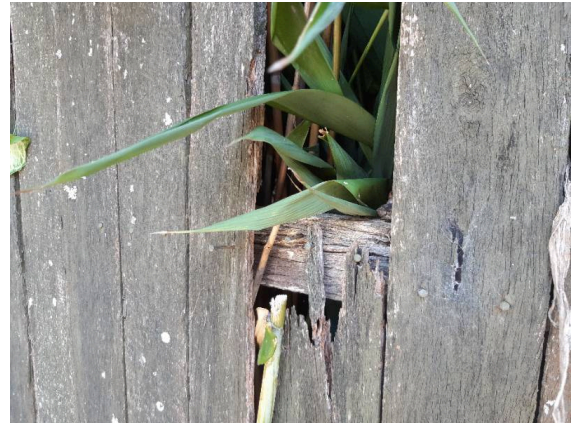
Example of decay in fence. May attract termites.

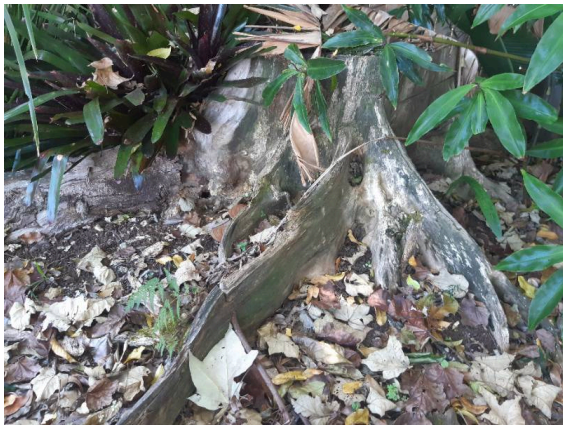
Example of decay in stump. May attract termites.

Yes
Remove stumps against or near structure
IMPORTANT: Vegetation on or against the structure is a termite management hazard, as it can allow undetected termite entry or compromise the effectiveness of an installed termite system. It is the owner's responsibility to remove these hazards. Also refer to SECTION 3.15 for further information.

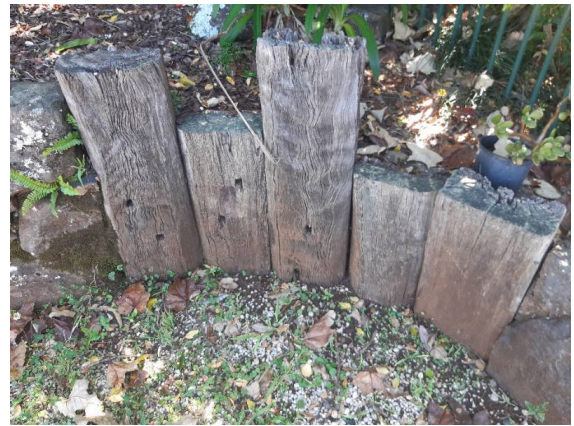
Example of landscaping timber on site. May attract termites.

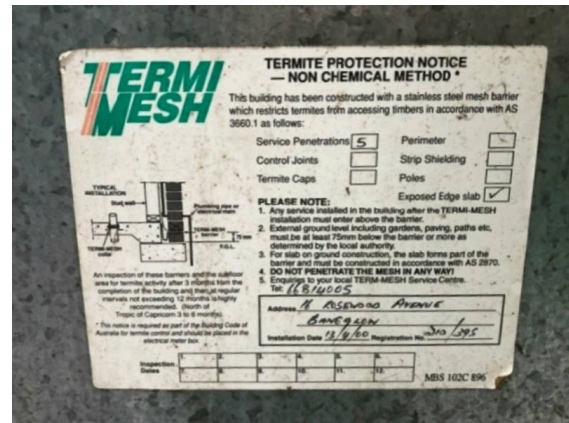
Image of Termite Management Sticker

Termimesh Termite Protection installed to Studio.
